Imagery Update: Construction is Ongoing at the Natanz Tunnel Facility

March 25, 2024

By David Albright, Sarah Burkhard, Spencer Faragasso, and the Good ISIS Team

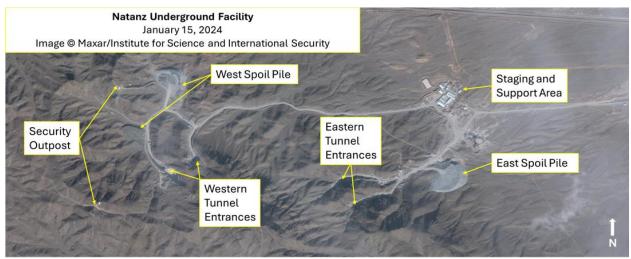
In fact, the tunnel complex is more deeply buried than the Fordow underground enrichment plant, with more entrances and no apparent ventilation shaft, making it harder to destroy than Fordow and certainly harder than a surface facility. Figure 1 provides an overview of the complex.

Figure 1. A January 2024 overview of the tunnel complex under construction just south of the Natanz Fuel Enrichment Plant.

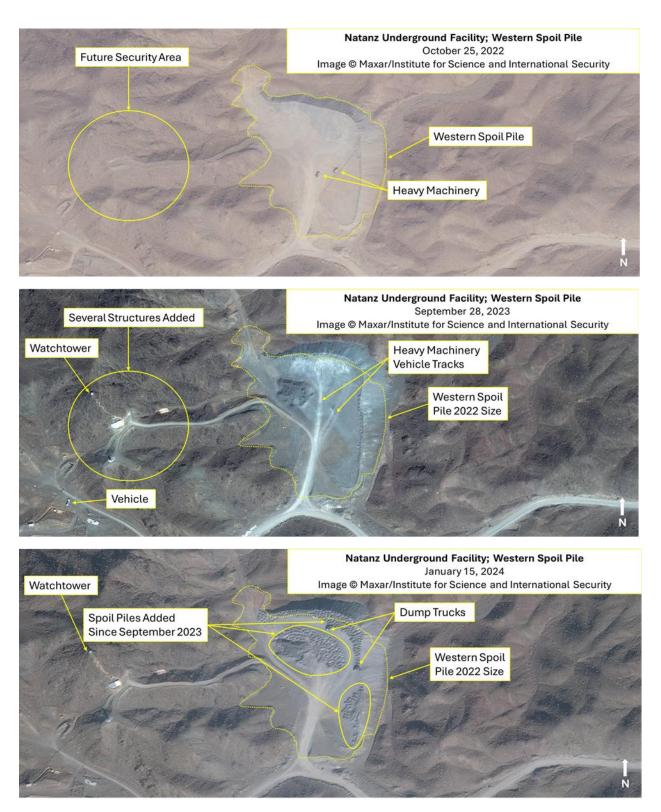
Two security outposts were added near the Western tunnel entrances. A highland security monitoring station and a watch tower were constructed roughly 450 meters southwest from the main Western tunnel entrance (see Figure 6). Construction on the security area began in May 2023 and finished around early August 2023. Another security outpost was constructed northeast of the Western tunnel entrances, near the Western spoil piles.

Figure 2. The three images show the changes near the Western tunnel entrances. A security area was added, and the spoil pile near the tunnel entrances has expanded since October 2022.

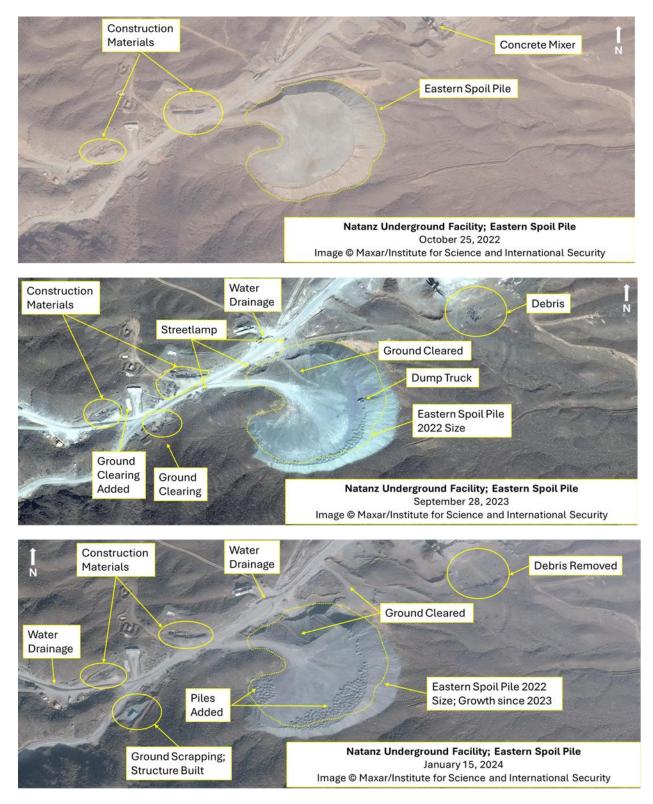
Figure 3. The three images show the changes near the Eastern tunnel entrances. Construction materials were added, and the nearby spoil pile has also expanded since October 2022.

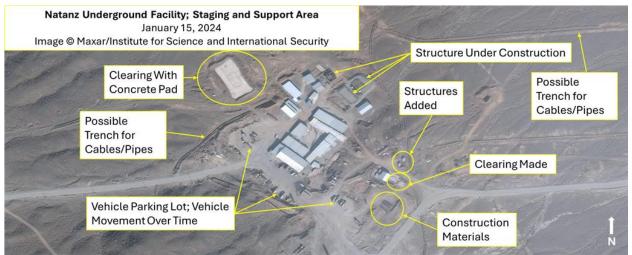
The new paving material production plant, built in addition to the existing concrete batch plant near the staging and support area, could be an indication of a transition from tunnel construction to equipment installation. Once the tunneling work is complete, the need for less dusty conditions (with vehicles traveling in and out of the tunnels) will become increasingly important. The equipment needs to be kept clean and the air handling/filtering systems do not work well in dusty conditions either. Thus, asphalt and/or concrete road surfaces will likely be installed throughout the complex.

Figure 4. The staging and support area as seen on January 15, 2024. Several buildings, structures, and ground clearings have appeared at the support area.

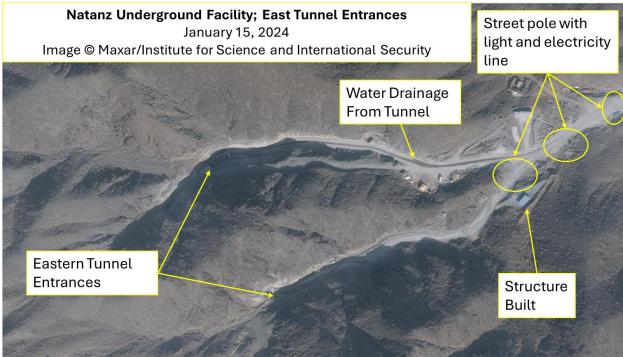
Other signs of continued construction exist. Around both the Western and Eastern tunnel entrances and spoil piles there are visible tire tracks as well as vehicles that can be seen moving periodically. The vehicles appear to be trucks and other heavy machinery, like bulldozers, used to move and haul debris, construction materials, and equipment. The number of vehicles parked at the staging and construction support area between the Eastern and Western tunnel entrances changes frequently. Several new buildings, structures, and clearings have also appeared at the staging and support area (see Figure 4). Images from October 2022 and into January 2024 show construction materials positioned along the road leading to the Eastern tunnel entrances. A January 15, 2024, image shows additional clearings and ground scraping near the Eastern tunnel entrances, where small structures were built (see Figure 5).

Images taken between October 2022 and January 2024 show water drainage coming from both the Western and Eastern tunnel entrances (see Figure 5 and 6). It is unclear what the source of

the water is, perhaps a byproduct of the construction process, but most likely from natural ground water. Earlier in the tunnel excavation process, water outflow was frequently detected from the secondary eastern tunnel; this earlier outflow was assessed to be likely an unexpected and possibly ongoing challenge encountered during excavation.

Figure 5. An image of the Eastern tunnel entrances from January 2024. A new structure has been added along the road running towards the tunnels. Water drainage flow has been visible from both of the Eastern tunnel entrances.

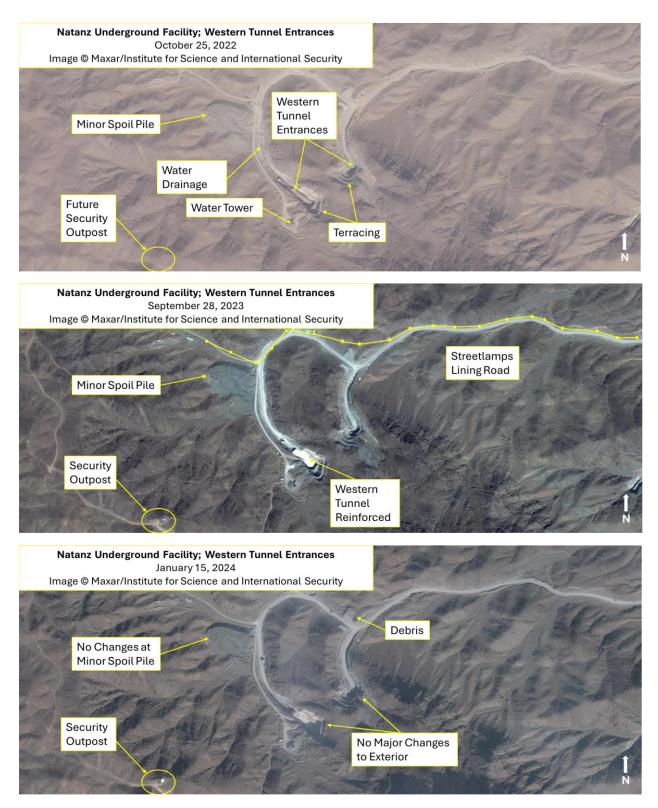
Visible efforts have been made to reinforce and strengthen the main Western tunnel entrance, otherwise the tunnel entrances themselves are largely unchanged. A large part of the Western tunnel entrance extension has now been covered, possibly with soil or concrete, in order to reinforce it and provide additional protection to enhance the entrance's survivability (see Figure 6). The same is expected for the main Eastern tunnel entrance extension.

Figure 6. Images of the Western tunnel entrances between October 2022 and January 2024. The main tunnel's entrance extension has been covered to increase its strength. A security outpost has also been built.

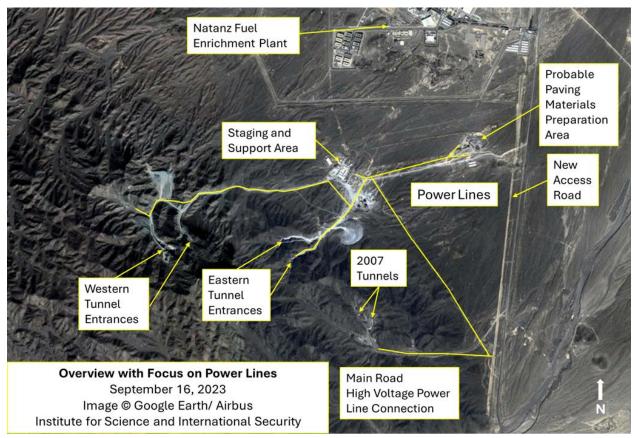
Poles can be seen dotting the roads leading in the direction of the Eastern and Western tunnel entrances (see Figures 6 and 7). These poles serve a dual purpose as holding streetlamps as well as a transformer and the electrical line. The power line can be traced back to the main road leading to the Natanz enrichment plant, and appears to serve the tunnel complex built in 2007, and a newly built, likely production plant for paving materials (see Figure 7). Further, a wide, newly graded access road running parallel to the main road can be seen, connecting the 2007 tunnel and the Mt. Kolang Gaz La complex, and extending further north towards the Natanz enrichment plant.

Figure 7. An overview of the Natanz Mt. Kolang Gaz La tunnel complex and connected power lines that run throughout.
