## ISIS Analysis of IAEA Report on Syria: IAEA Concludes Syria “Very Likely” Built a Reactor

Paul Brannan

May 24, 2011

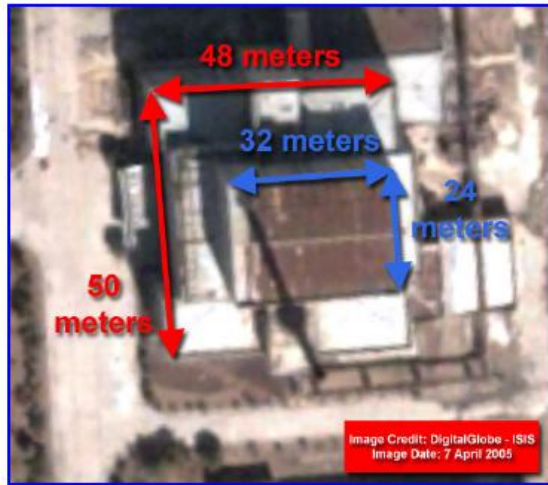
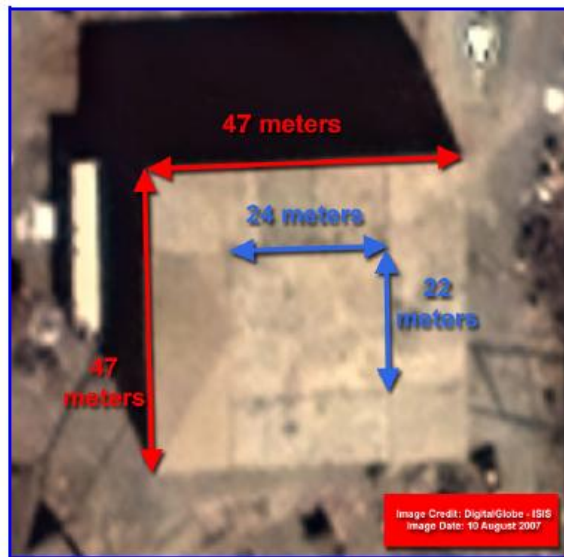
**While the IAEA has assessed in previous reports that the equipment and materials associated with the destroyed building were similar to what would be expected at a reactor, it did not offer a conclusion or explain the evidence in detail until now.** The report notes that the dimensions of the destroyed reactor building were similar to the dimensions of North Korea’s reactor at Yongbyon. After locating the destroyed building in commercial satellite imagery in October of 2007, ISIS noted that the dimensions of the Syrian building, as well as what would later be revealed as the top of the main reactor hall, were very similar to those of the Yonbgyon reactor (see figure 1).<sup>1</sup>

Figure 1. Commercial satellite imagery comparison of the Yongbyon reactor in North Korea and the Syrian reactor building approximately a month before the bombing. The outer dimensions of the building are very similar and the dimensions of the center reactor hall are also similar.

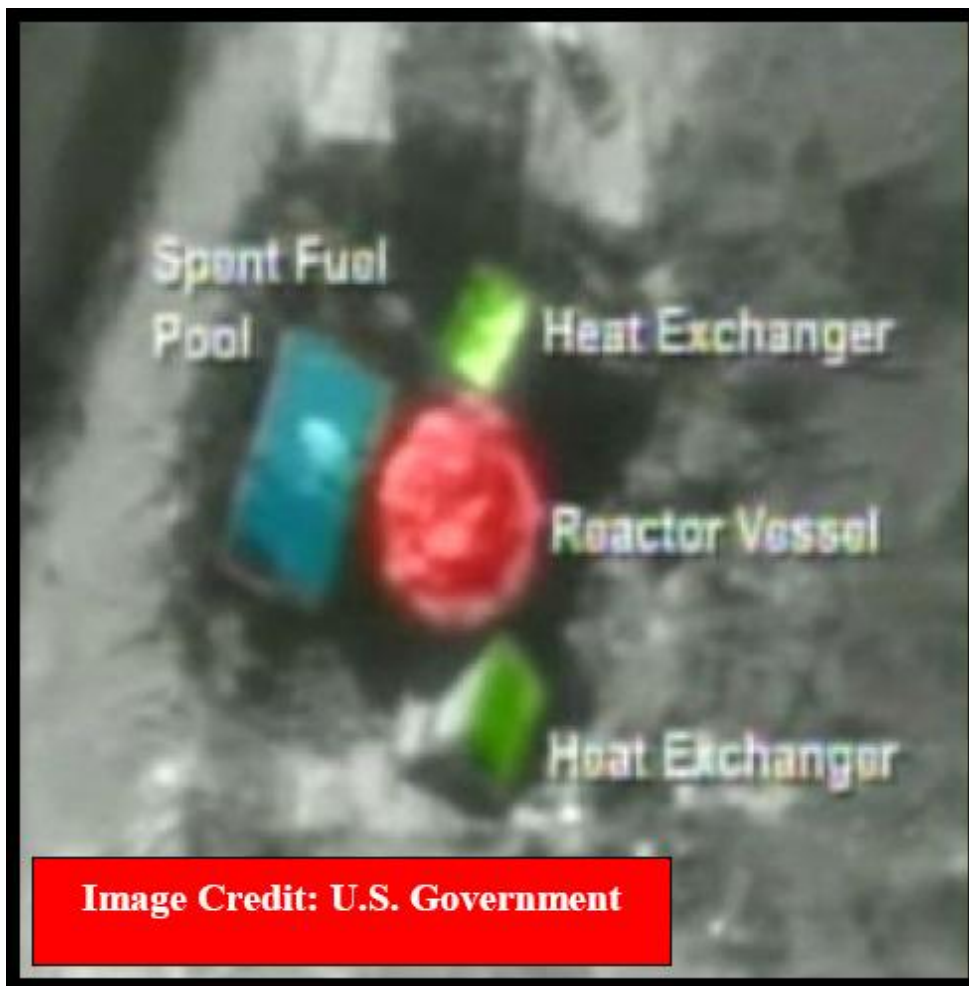
The IAEA also said that imagery of the building after the bombing showed the presence of such features as a containment structure, heat exchangers and a spent fuel pond—all of which would be

expected in a nuclear reactor. In an April 2008 briefing, the US intelligence community presented a satellite image from after the bombing and highlighted some of these features (see figure 2).<sup>2</sup>

Figure 2. Image of the site of the bombed Syrian reactor building from US intelligence community briefing in April 2008. The image highlights the reactor vessel, heat exchangers, and a spent fuel pond.

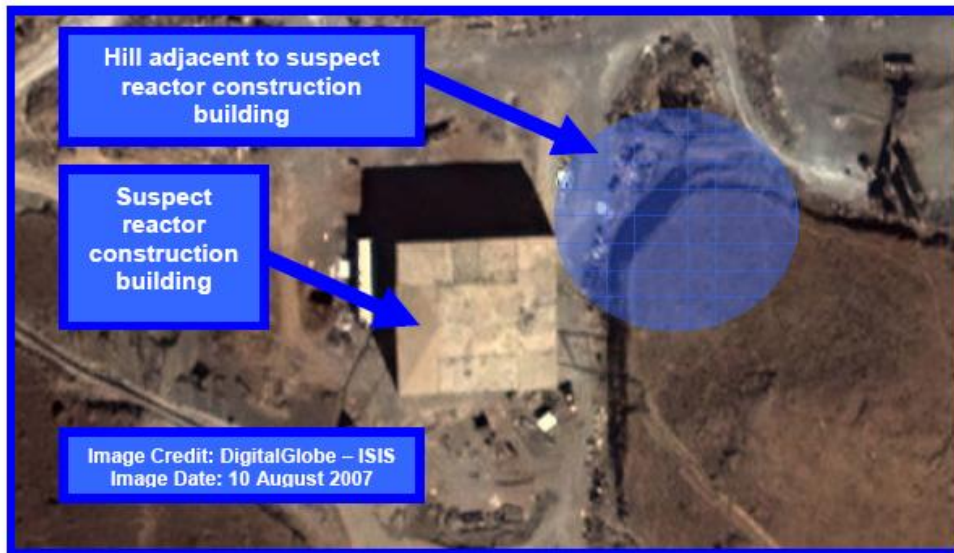
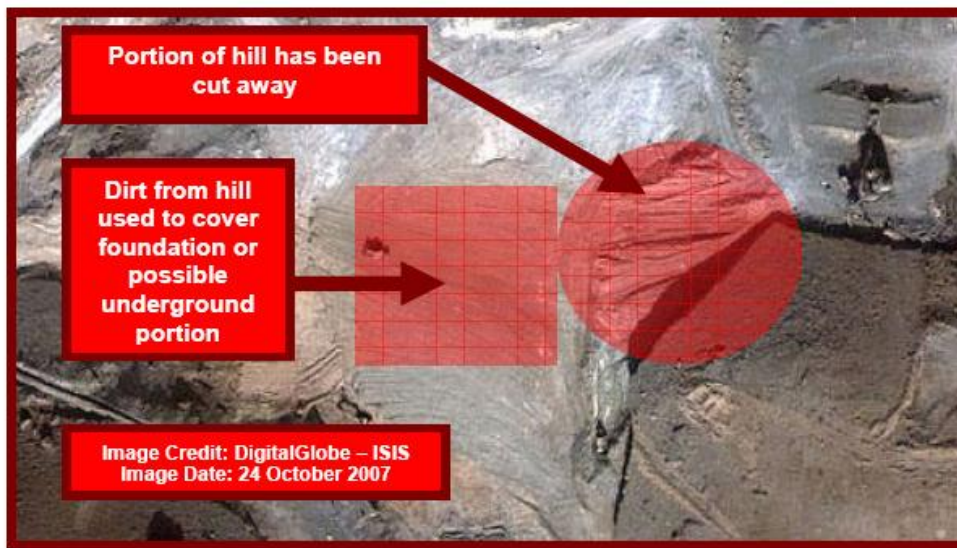
The IAEA report outlines the suspicious concealment activity that took place at the site of the reactor building after the bombing. It cites commercial satellite imagery showing “Syrian efforts to recover equipment and material from the destroyed building,” and notes that whatever remained of the building was “demolished and buried.” ISIS noted in an October 2007 report that Syria had used earth from a nearby hill to bury the remaining foundation of the reactor building (see figure 3).<sup>3</sup> Figure 4 is a satellite image from the US intelligence community briefing in April 2008 showing bulldozers in the process of burying the foundation.

Figure 3. Commercial satellite imagery showing the site of the reactor building before and after the bombing. In the second image, a section of the hill has been removed in order to bury the remaining building foundation.

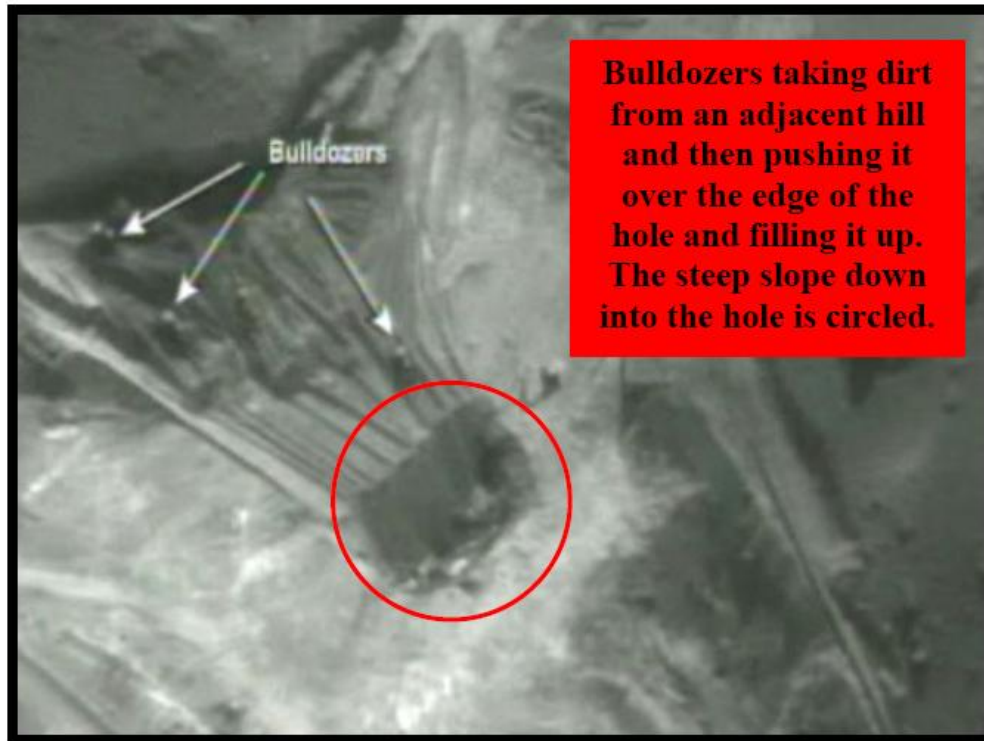
Figure 4. Satellite image from US intelligence community briefing in April 2008 showing bulldozers taking dirt from the hill and burying the remaining building foundation.

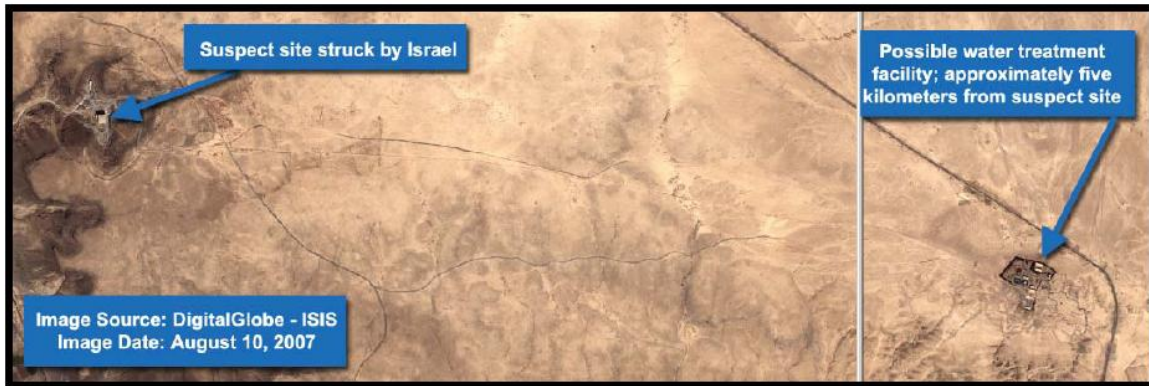
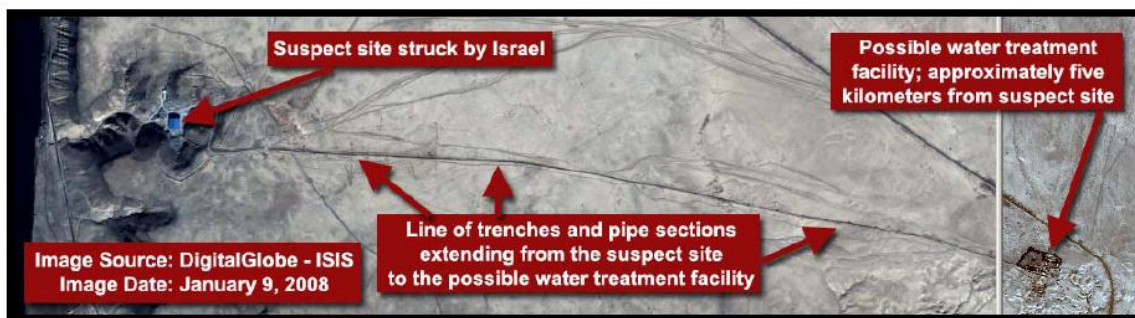
Syria stated that the piping and pumping equipment near the reactor building was intended to supply water to a nearby water treatment facility. The Agency has assessed, however, that prior to the bombing the water pumping system was connected to the suspected reactor building, not to the water treatment facility. It found that after the bombing, Syria “reconfigured the pumping infrastructure to remove sections of the return pipe and to install a new large diameter water pipe connection from the [Dair Alzour Site Pump House] to the [Water Treatment Facility].” This activity can be seen in commercial satellite imagery in a January 2008 ISIS report (see figure 5).<sup>4</sup>

Figure 5. Comparison of commercial satellite imagery before and after the bombing, showing the area in between the reactor building and the water treatment facility. The line of trenches and pipe sections between the two sites after the bombing likely represents this effort by Syria to install a large diameter pipe from the Dair Alzour site to the water treatment facility.

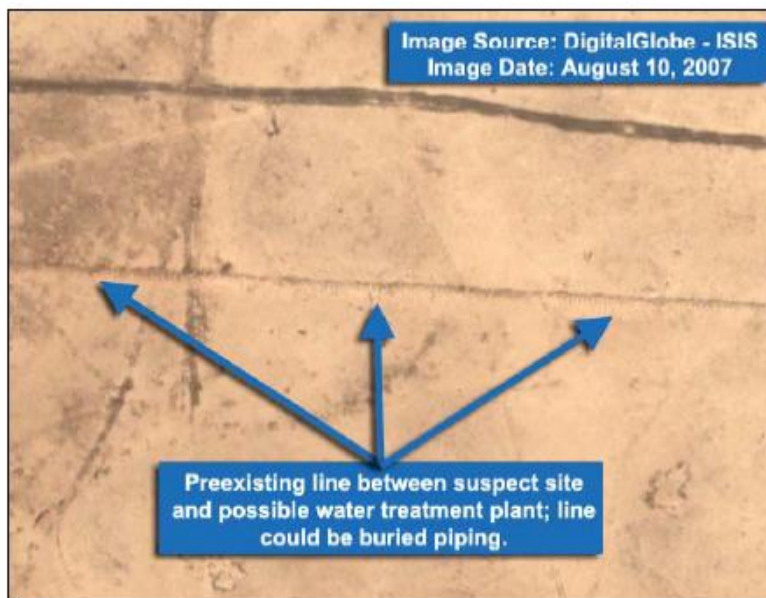
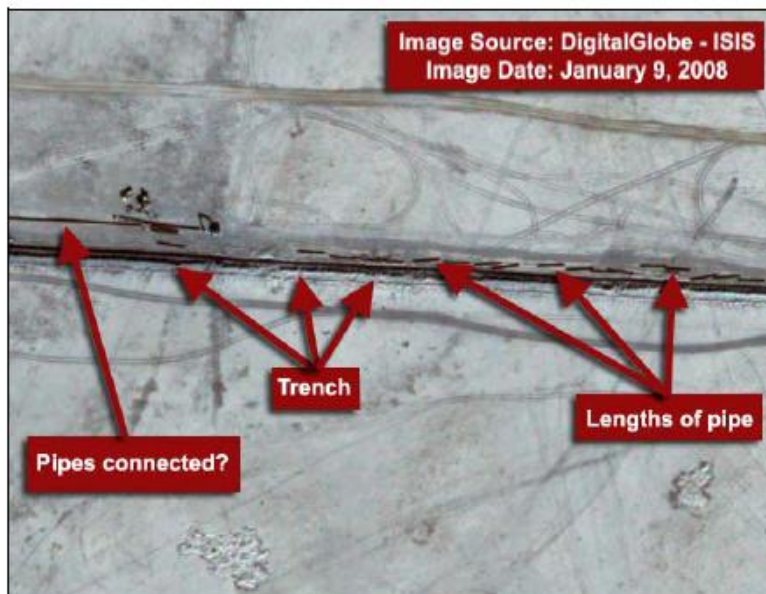
In the same report, ISIS noted that there was a faint line between the reactor building and the water treatment facility in imagery prior to the bombing and speculated that there may have been existing buried piping between the sites (see figure 6). The IAEA has assessed that there was small diameter piping between the reactor building and the water treatment facility which likely contained treated water or power lines. US government experts also assessed that there existed buried piping between the reactor building and the water treatment facility prior to the bombing, and that it contained power lines—supplying electrical power to the reactor building.<sup>5</sup>

January 9, 2008 image of the same area with line of trenches and pipe sections between suspect site and possible water treatment facility. The preexisting line in the August 10, 2007 imagery follows virtually the exact same path of the entire length of the line of trenches and pipe sections between the suspect site and the possible water treatment facility in the January 9, 2008 imagery.

Figure 6. Close-up commercial satellite image showing what was likely buried piping containing power lines between the reactor and the water treatment facility, before and after the September 2007 bombing.
