## Mysterious Fire and Explosion in the New Natanz Advanced Centrifuge Assembly Facility

By David Albright, Sarah Burkhard, and Frank Pabian

July 3, 2020

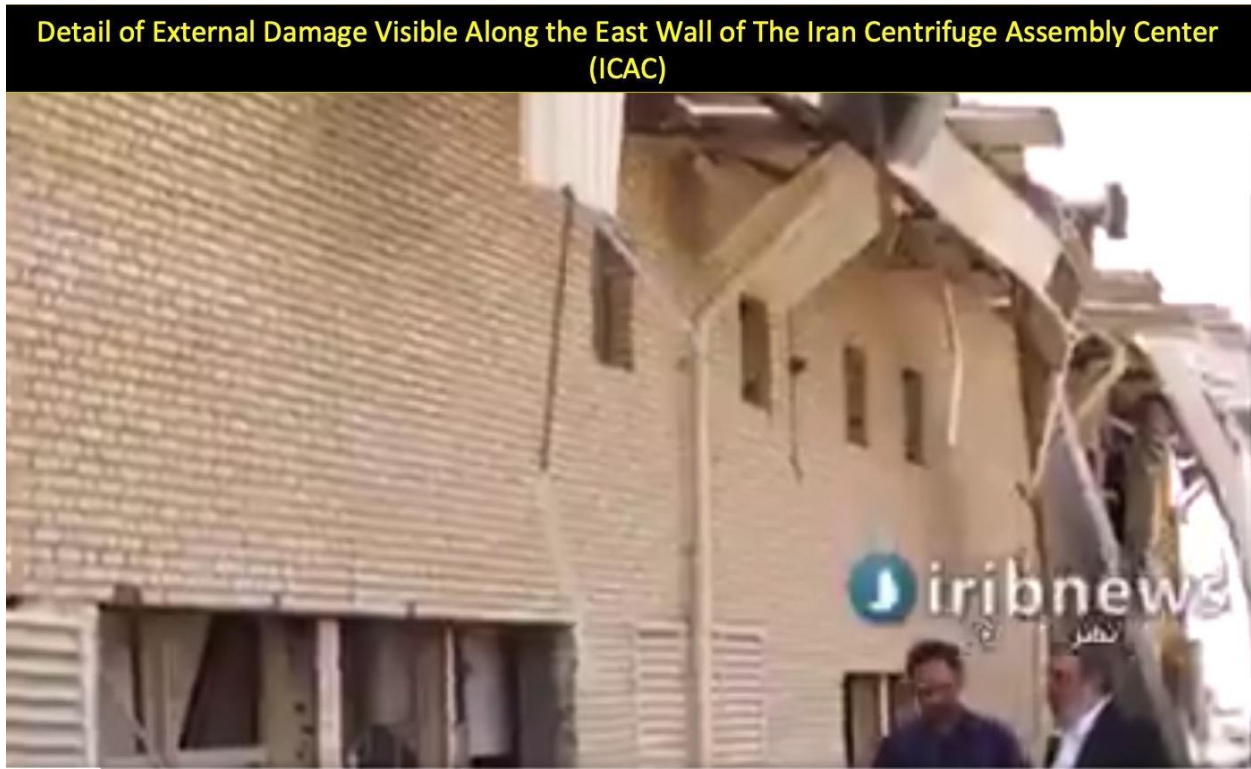
Based on the post-fire and explosion photo published by the AEOI, the incident appears to have caused significant structural damage to the building, visible as cracks in the walls, and doors unhinged, along with destroyed roof panels. A freeze frame from another video shows the eastern wall damage in more detail with the area cordoned off with yellow tape (see Figures 3 and 4). The area of the most severe damage is visible in the northeast corner of the building where there are twin vent stacks on the roof, suggesting that the section under the stacks was the center of the fire and explosion (see Figures 5 and 6). Our assessment is that the area likely contained twin auxiliary diesel generators for electric back-up power and some onsite fuel storage. While that section might be described as a "shed," it was clearly not the only part that suffered damage, and it was an integral part of the ICAC building.

**Figure 3.** Closeup of the east wall of the ICAC showing severe roof damage.

Detail of External Damage Visible Along the East Wall of The Iran Centrifuge Assembly Center (ICAC)

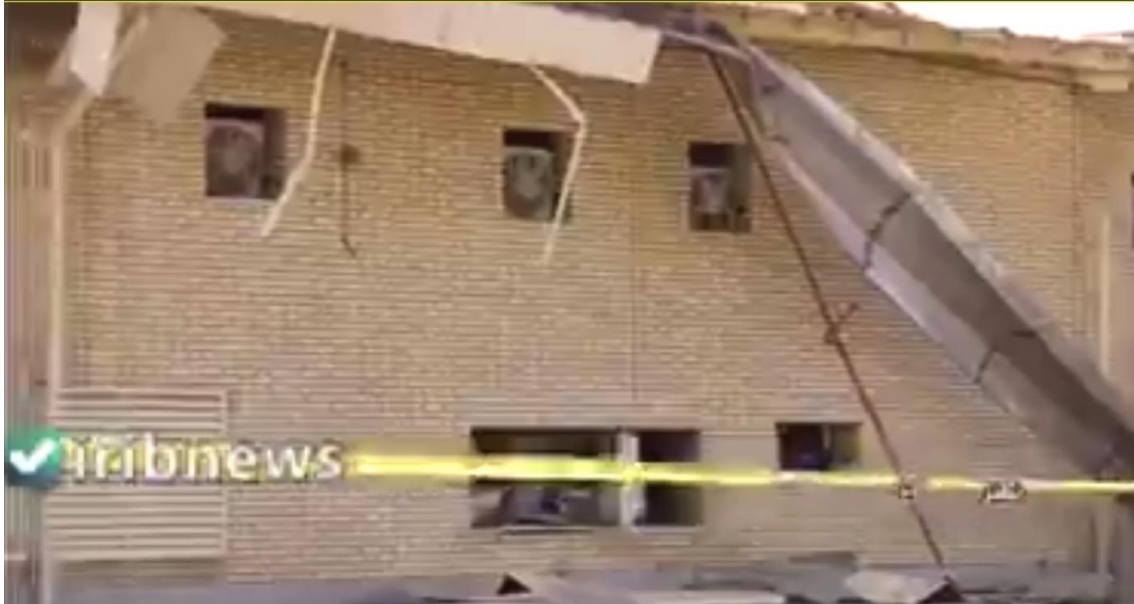
Figure 4. Closeup of the east wall of the ICAC showing the building had been cordoned off with yellow tape.

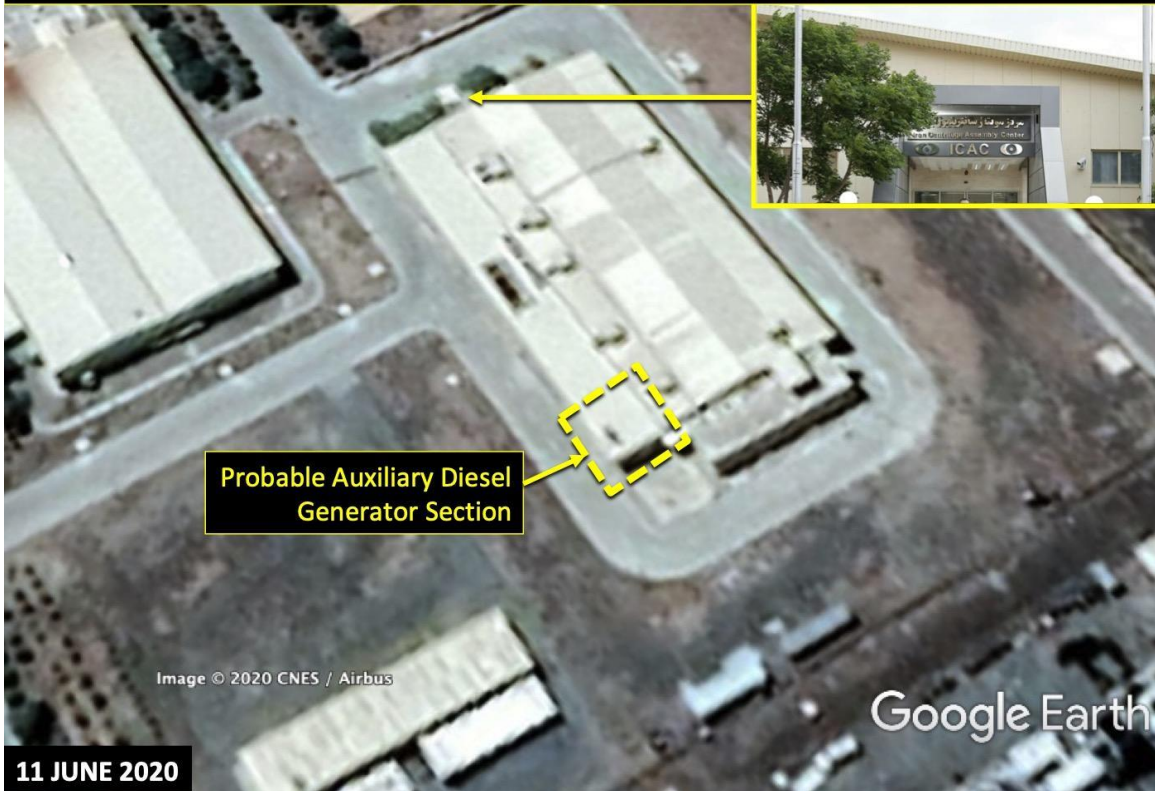
Explosion and Fire likely in Utility Support Area of The Iran Centrifuge Assembly Center (ICAC)  
Likely Housing Auxiliary Diesel Generators

Figure 5. The fire and explosion centered in the north east corner of the ICAC building (north is to the lower right). Inset is part of a photo taken in early 2019. Source:

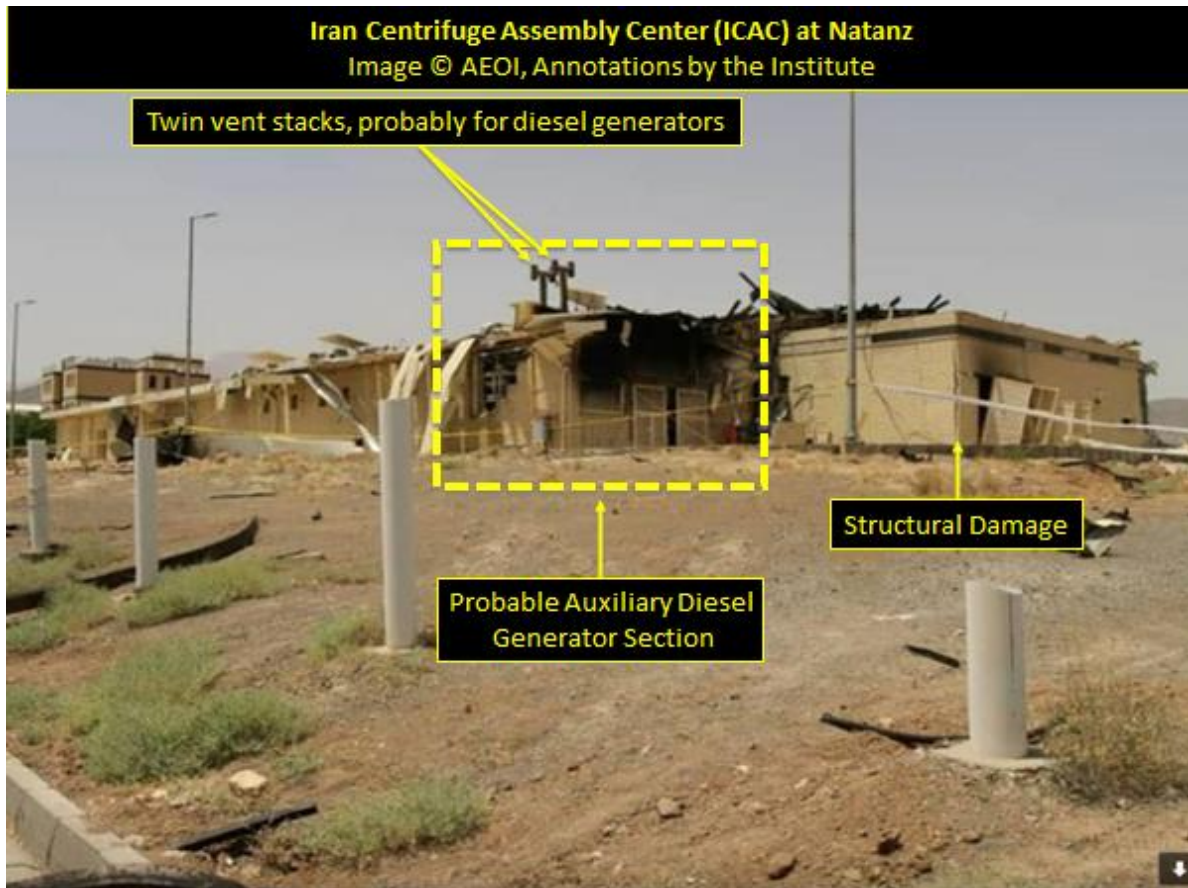
**Figure 6.** A ground photo of the northeast corner of the ICAC building showing that the most severe fire and explosion damage centered in an area likely to house auxiliary diesel generators and fuel given the presence of twin ventilation stacks on the roof above that section.

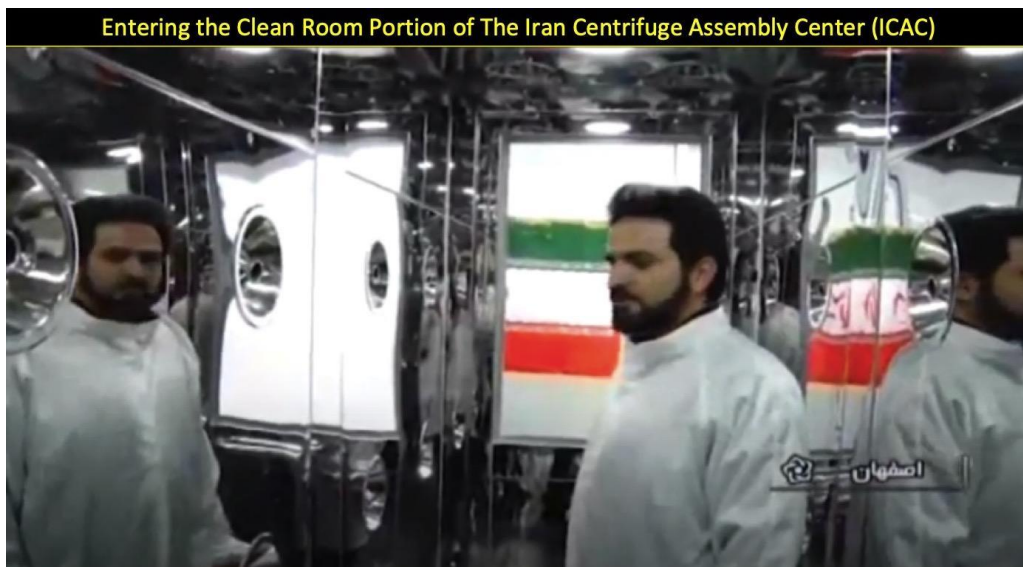
**Figure 7.** During a 2018 promotional video tour, a reporter is shown entering the portal to the clean room section of the ICAC. The lack of bonnets and facial hair coverings indicates that the clean room was not yet fully operational at that time.
