Update on the Site of the Alleged Explosion at the Parchin Military Complex

October 21, 2014

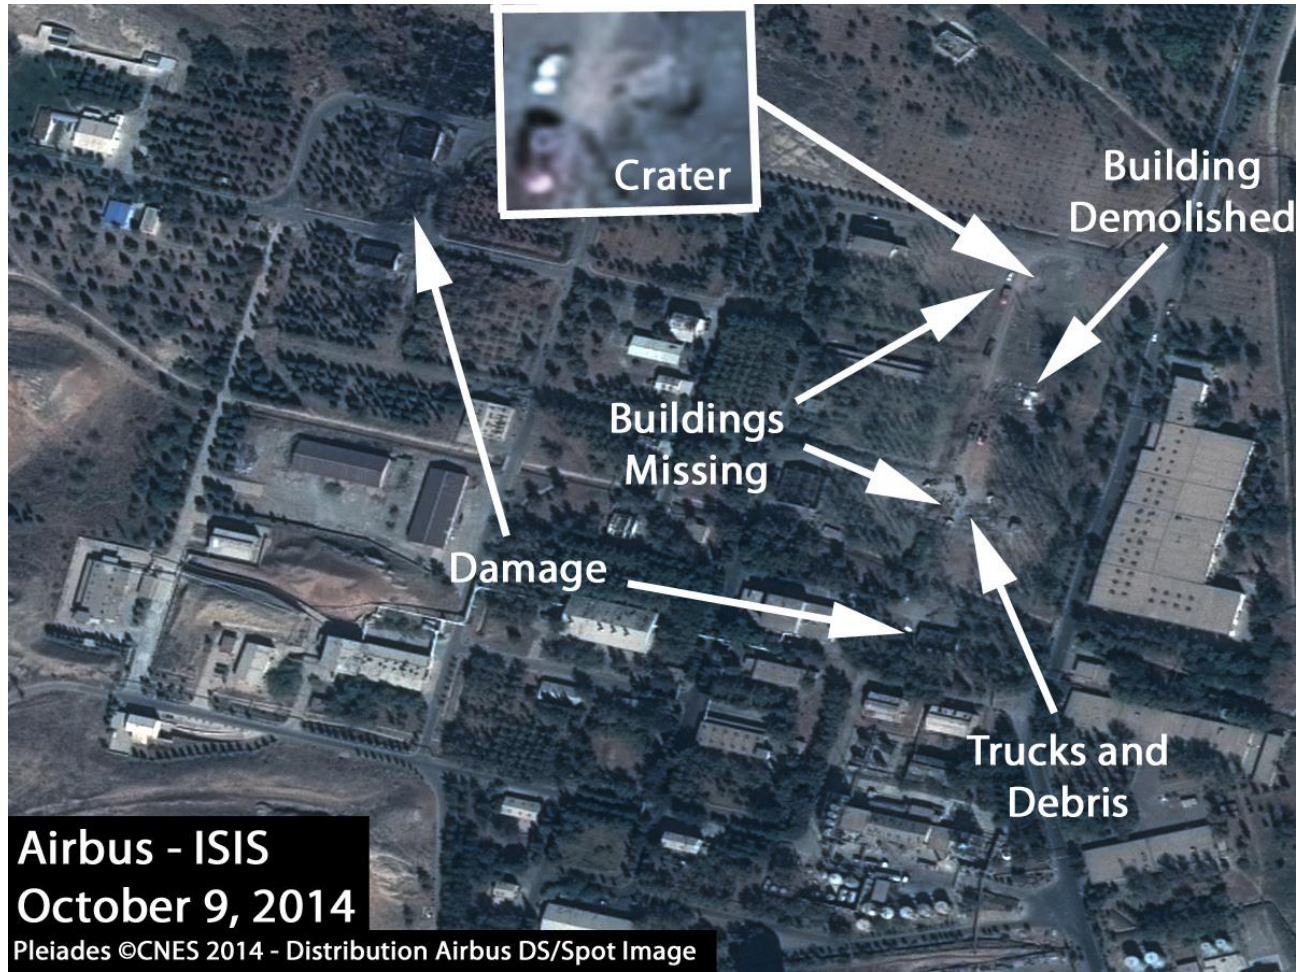
The most recent image from October 9 continues to show several signatures consistent with a major explosion and associated clean-up activities (see figures 1 and 2). The building that previously looked damaged, one that was closest to what appeared to be the central explosion or fire area, has now been dismantled. Also, at least four large trucks now appear at the site. One of these trucks appears to be a large open bed truck possibly dedicated to the removal of rubble and debris. Overall, the shape and size of these trucks are consistent with those of either fire or debris removal trucks.

provide enough information to determine whether this crater was caused by the explosion, an attack, or something else. Figure 2 shows this crater, which appears about 100 meters north of what is believed to be the main explosion area. Given the proximity to the main explosion area, it is likely that this damage (and the resulting crater) was caused by post-explosion excavation or a sympathetic explosion (e.g. gas line break and subsequent explosion) rather than a bomb. It is likely that the initial explosion was generated within one building, causing the destruction of other buildings.

Figure 2. Airbus imagery dated October 9, 2014 showing the status of the site of the alleged explosion or fire at the Parchin military complex.
