Continued Monitoring of the Yongbyon Nuclear Site

By David Albright and Sarah Burkhard

April 18, 2018

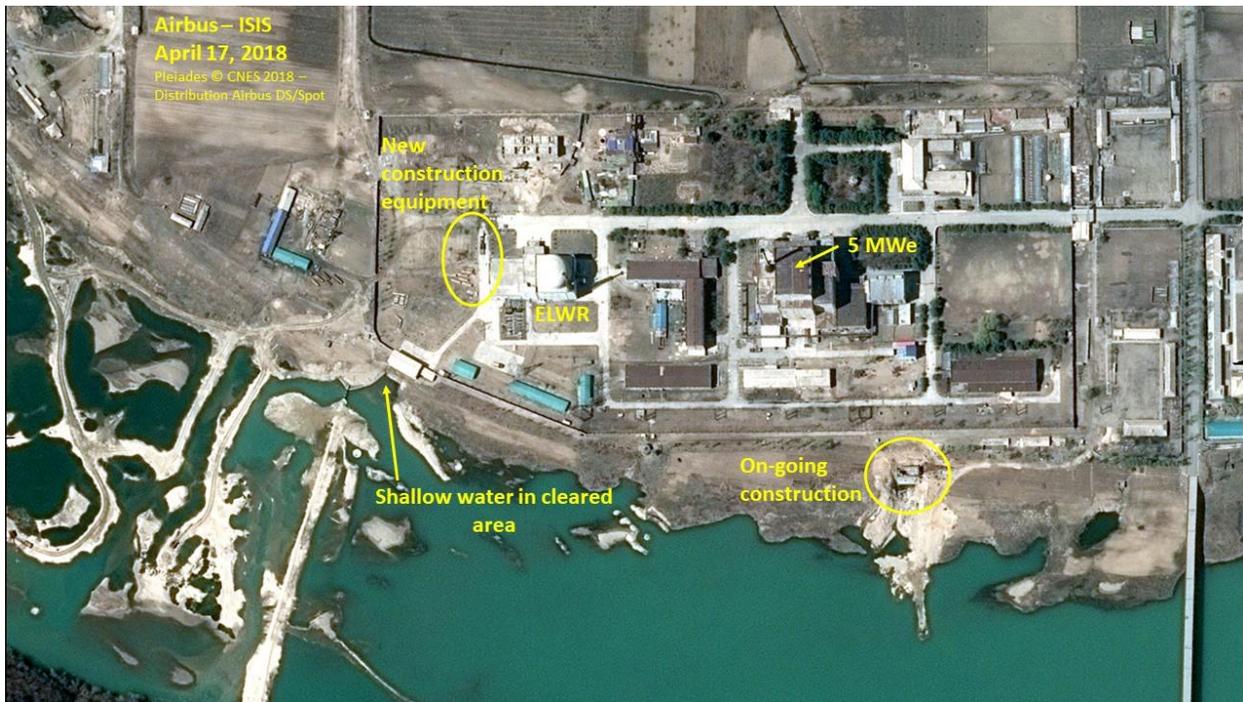
Based on assessing April 17, 2018 Airbus imagery, the water discharge portion of the 5 MWe reactor's secondary cooling system seems to be undergoing continued construction (see figure 1). A building-like structure has been constructed in the sand. No obvious signs of current water outflow are visible, but light water outflow may have caused some minor erosion in the estimated area of the end of the discharge pipe. This was already visible at the end of March 2018 (see figures 2 and 3). The building structure is rectangular and nondescript, but it could possibly become a pump house similar to the pump house for the ELWR further downstream.

The Institute reported in early April that the ELWR showed possible visible signs of operation or pre-operational testing.⁶ It cannot be discerned from the April 17, 2018 Airbus image whether the reactor is operational (see figure 1). The image does show that the cleared area in the river by the pump house appears filled with water. Moreover, it appears shallower than its surrounding water, indicated by the discoloration. It is unclear whether the pump house is for water intake or discharge. Additionally, new construction material is visible outside the reactor.

Figure 1. The construction by the secondary cooling discharge pipe of the 5 MWe reactor is on-going. A building-like structure, possibly a pump house, is visible in recent Airbus imagery.

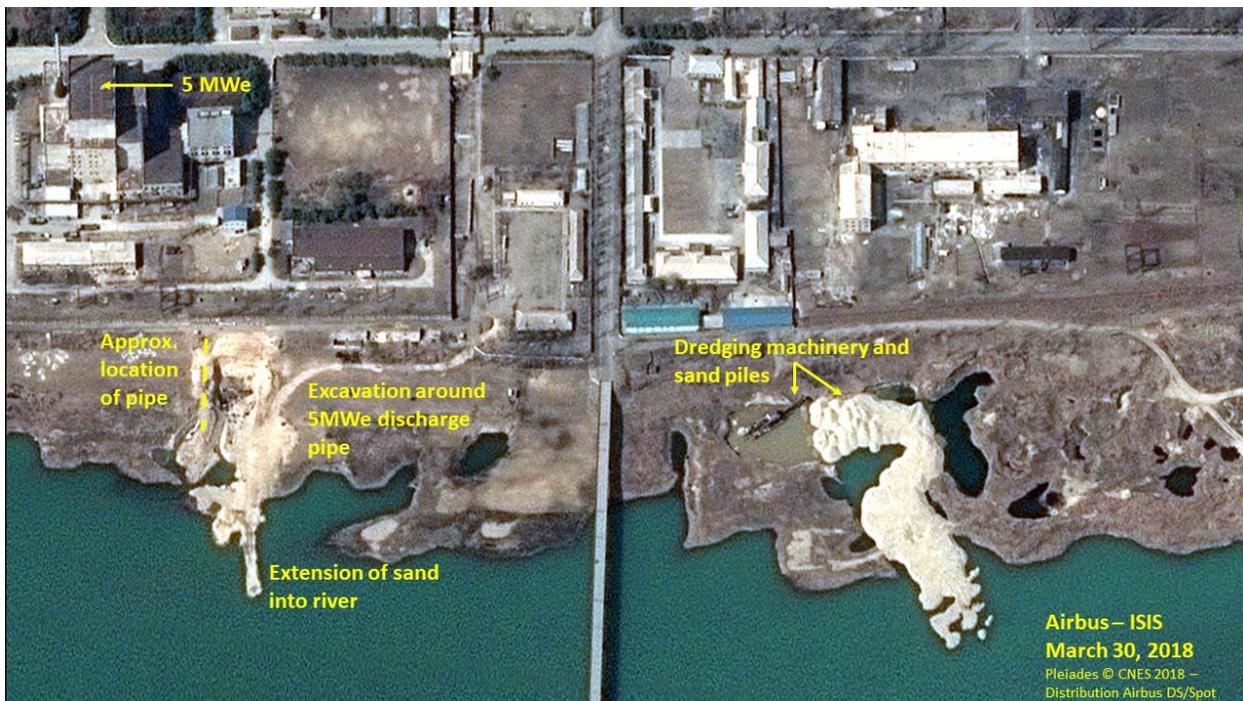
Figure 2. A March 30, 2018 Airbus image shows the beginning of the construction by the discharge pipe.

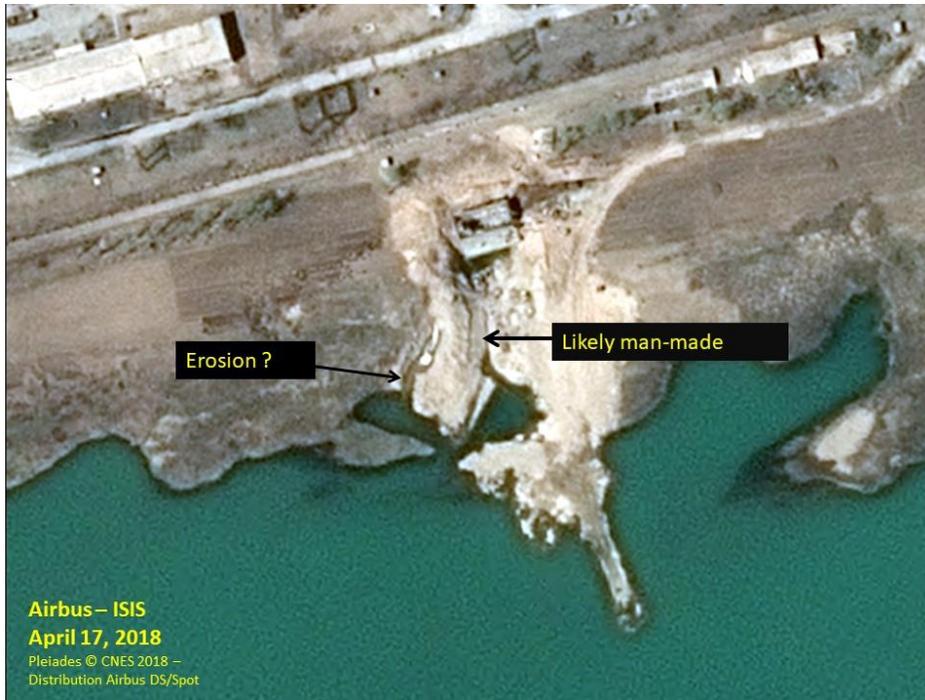
Figure 3. A small channel to the river is visible, possibly from erosion, which may have been caused by light water outflow. Another visible connection to the river is likely man-made.

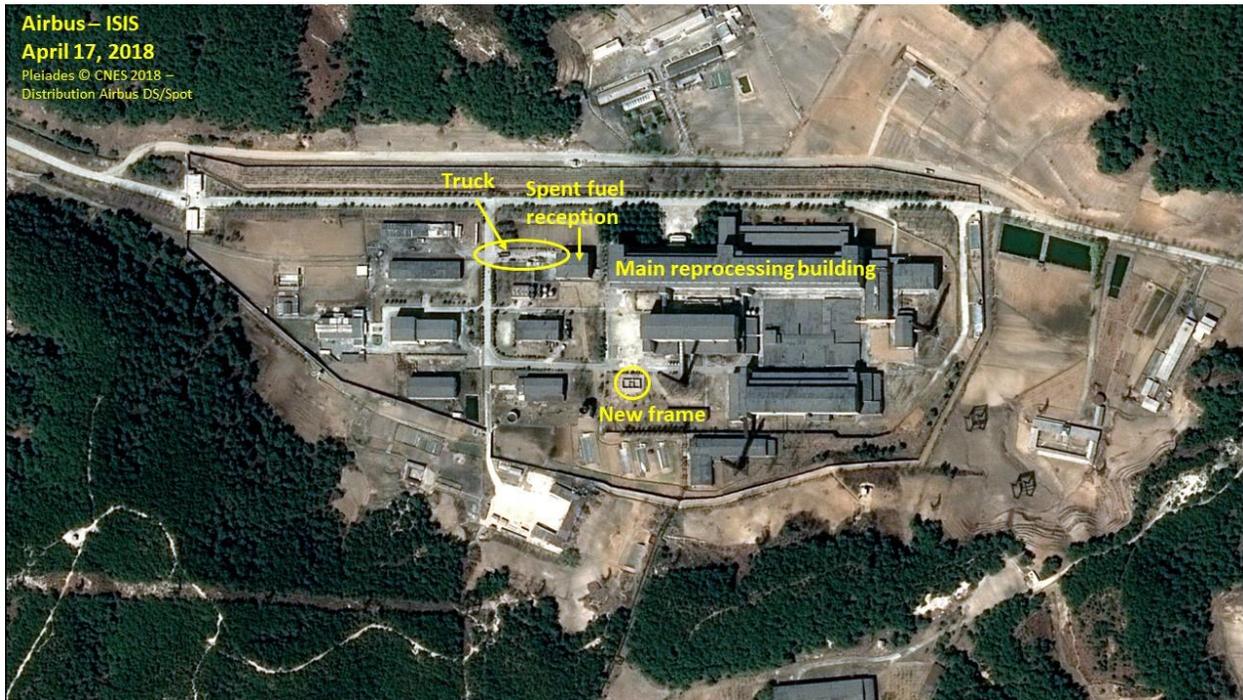
In recent months, there has been no indication of reprocessing visible at the Radiochemical Laboratory. Only small visible changes can be noted in the most recent Airbus image from April 17, 2018. A truck is seen nearby the spent fuel reception building, and a previously-seen unidentified object remains nearby. However, the coal-fired thermal plant that produces steam for the reprocessing plant shows no significant signs of activity (see figures 4 and 5).

Figure 4. The Radiochemical Laboratory shows no major visible signs of activity.

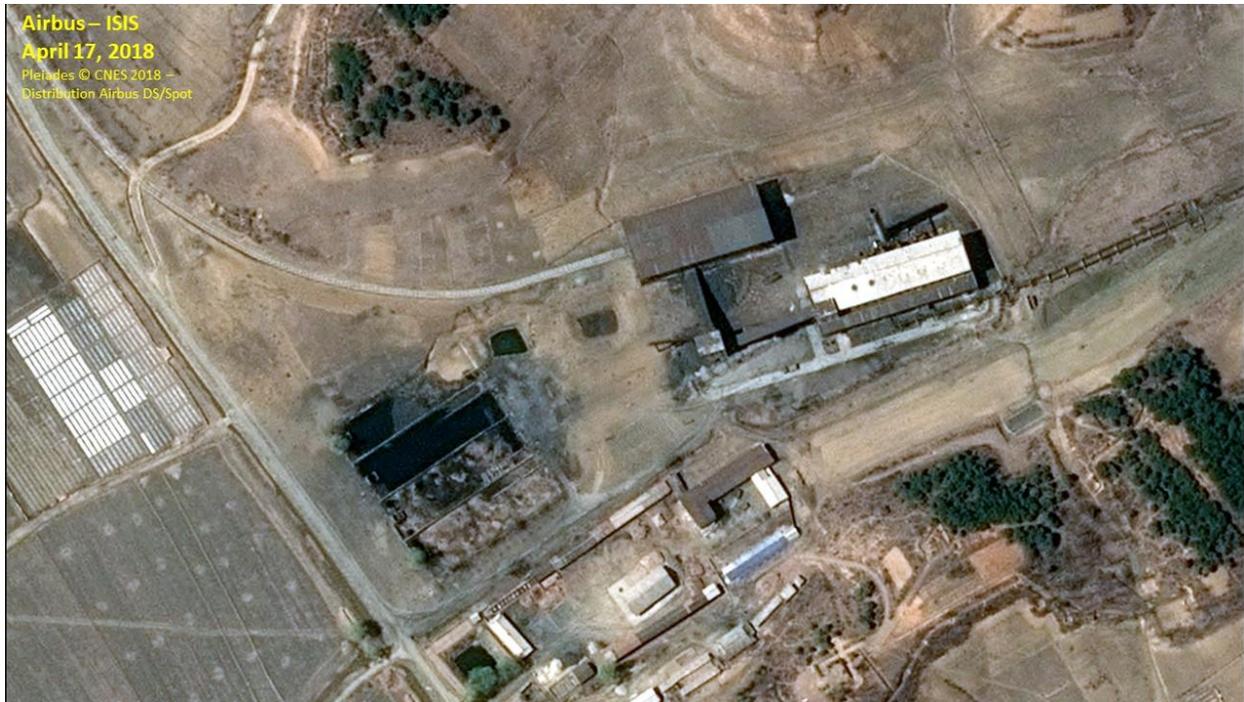
Figure 5. The coal-fired steam generation plant shows no visible signs of operation. Operation would indicate the operation of the nearby Radiochemical Laboratory.

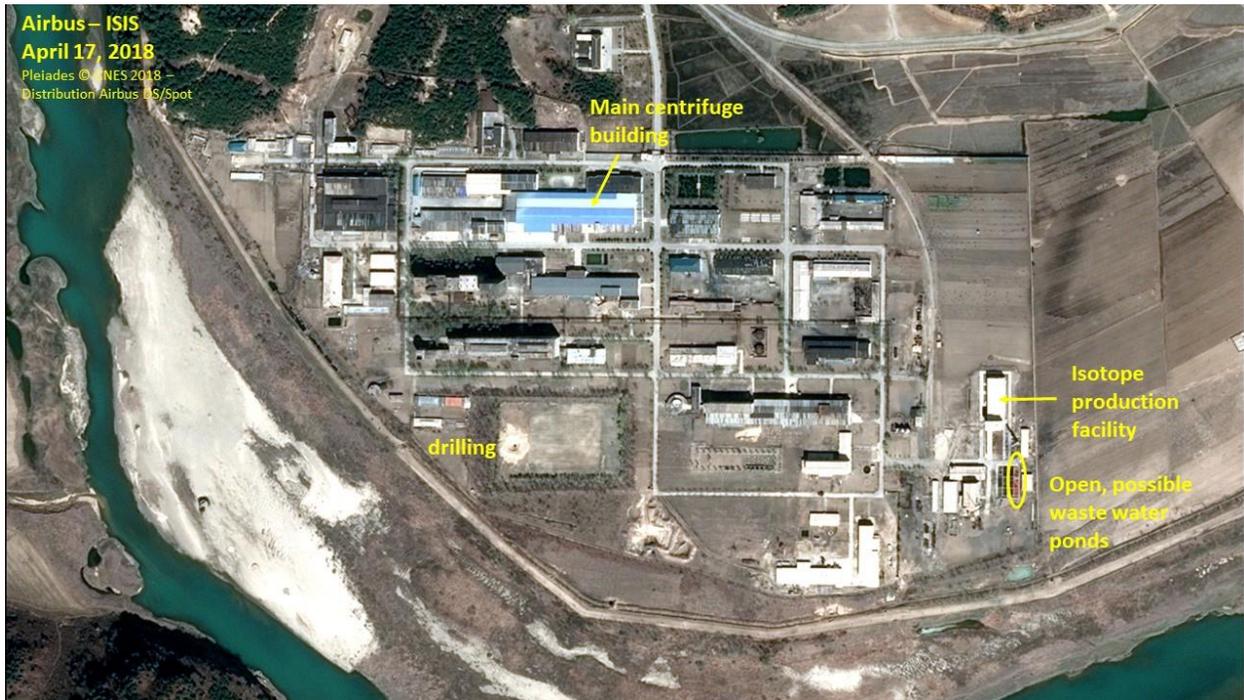
More than likely, the gas centrifuge plant continues to operate. The operational status of the Isotope Production Facility is unclear. However, visible are what appear to be newly opened, possible waste water ponds, some of which were covered in a March 30, 2018 image (see figure 6). The content of the uncovered ponds appears reddish in color.

Figure 6. No major signs of activity at the Fuel Fabrication Complex are visible. A small drilling project, and newly opened possible waste water ponds by the Isotope Production Facility, are visible.
