Yongbyon: Monitoring Activities during Shutdown of 5 MW Reactor

David Albright and Serena Kelleher-Vergantini

December 5, 2014

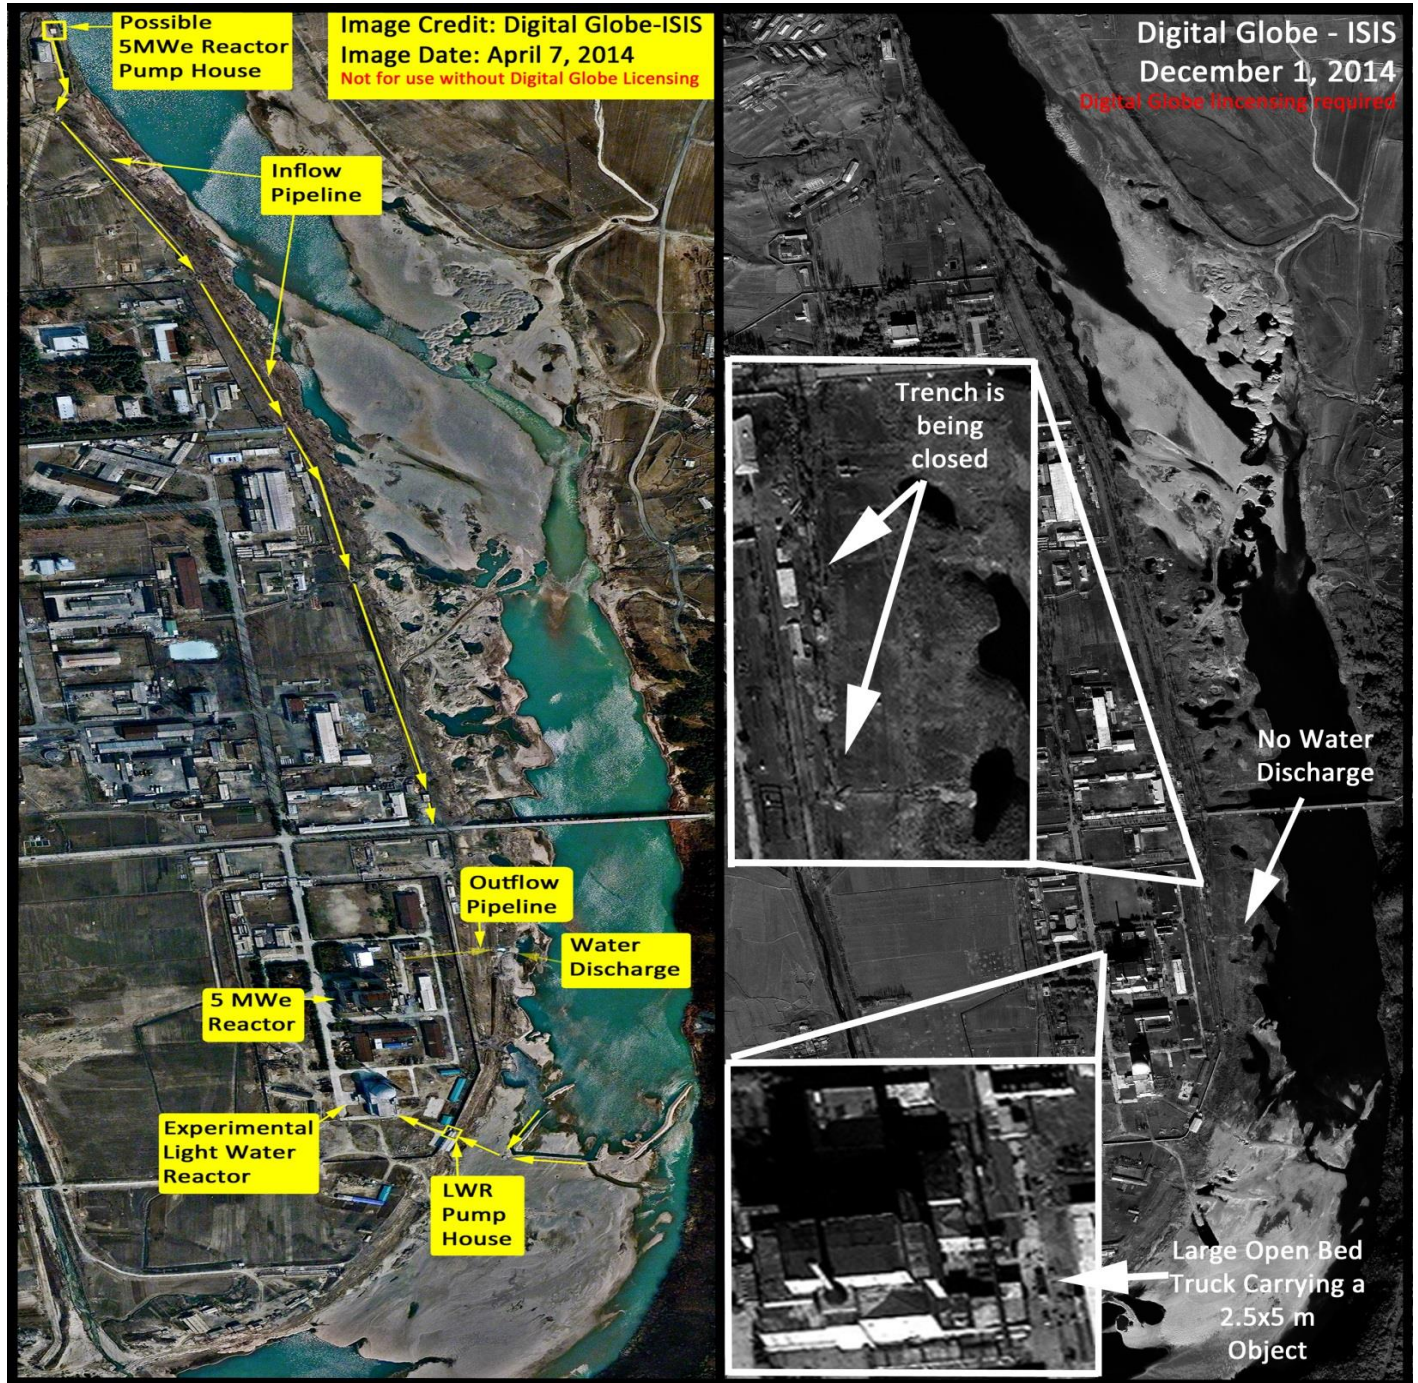
Analysis of new imagery dated December 1, 2014 appears to support the assessment that the reactor is still not operating at a significant level but instead undergoing some type of maintenance or renovation that started in about August 2014. The December 1, 2014 image shows a very long open bed truck in front of the 5MWe reactor. This truck appears to be carrying a 5 meter by 2.5 meter rectangular or cylindrical tank. One technical expert consulted by ISIS who has often visited the Yongbyon reactor site observed that the truck looks like one carrying CO₂ gas used in the reactor's primary cooling system. This truck has been spotted several times in this location while the reactor was operational. It is unlikely this truck is used to remove spent fuel from the reactor.

that the secondary cooling system intakes water via a long pipeline buried north of the reactor and discharges hot water into the river via a shorter pipeline buried east of the reactor (see figure 1).

However, since August 2014, these signatures of steam and water discharges have been absent in the imagery. In the December 1, 2014 image, there is no steam venting from the turbine building and no water is being discharged from the secondary cooling system's discharge pipeline. The precise reason for the shutdown has not been announced by North Korea. Nonetheless, ISIS assesses that it could be due to maintenance or renovation activities relating to the reactor's cooling system. For this reason, ISIS assesses that the reactor is likely partially or completely shut down for maintenance and will likely be restarted.

Figure 1. Digital Globe imagery showing North Korea's Yongbyon 5 megawatt-electric (MWe) and experimental light water reactors, and the respective water inflow and outflow systems of the 5MWe reactor on April 7 and December 1, 2014.

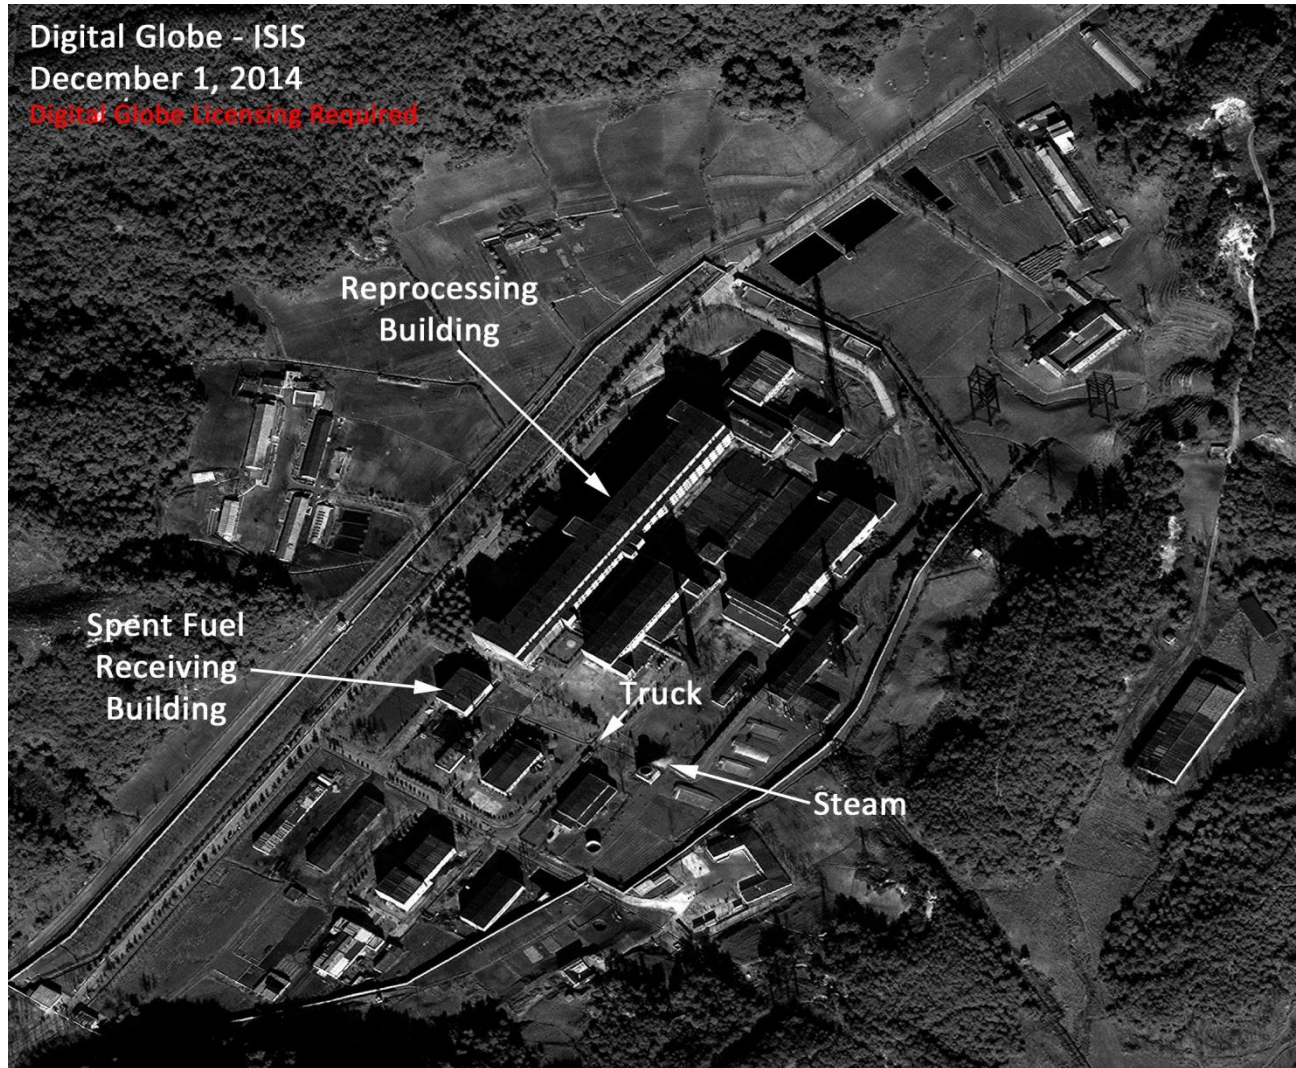
Some activities have been detected at the reprocessing plant, which is located across the river southeast of the reactor sites. Imagery from November 4th analyzed by [38 North](#) showed that light steam was exiting from what appears to be a small cooling tower or venting system at the site and several vehicles as well as a

larger truck (possibly a spent fuel truck) were located close to the spent fuel receiving building at the reprocessing site. More recent imagery dated December 1st also shows light steam exiting from the same cooling tower or venting system. It also shows that a truck (possibly a same spent fuel truck) and a vehicle are present.

Figure 2. Digital Globe imagery showing the Yongbyon Reprocessing Facility on December 1, 2014.
