Damage to the Iran Centrifuge Assembly Center (ICAC) at Natanz Is Far More Severe and Extensive Than Previously Reported

By David Albright, Sarah Burkhard, and Frank Pabian

July 8, 2020

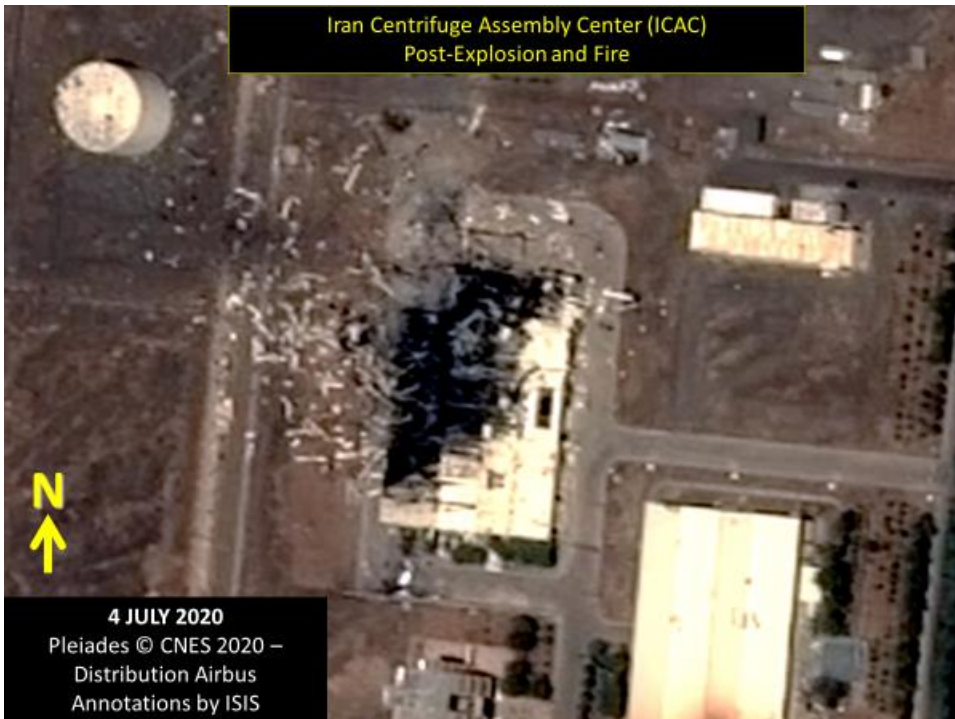
Figure 2. The ICAC Building as it appeared in this July 4, 2020 CNES/Airbus satellite image acquired the day after the explosion and fire.

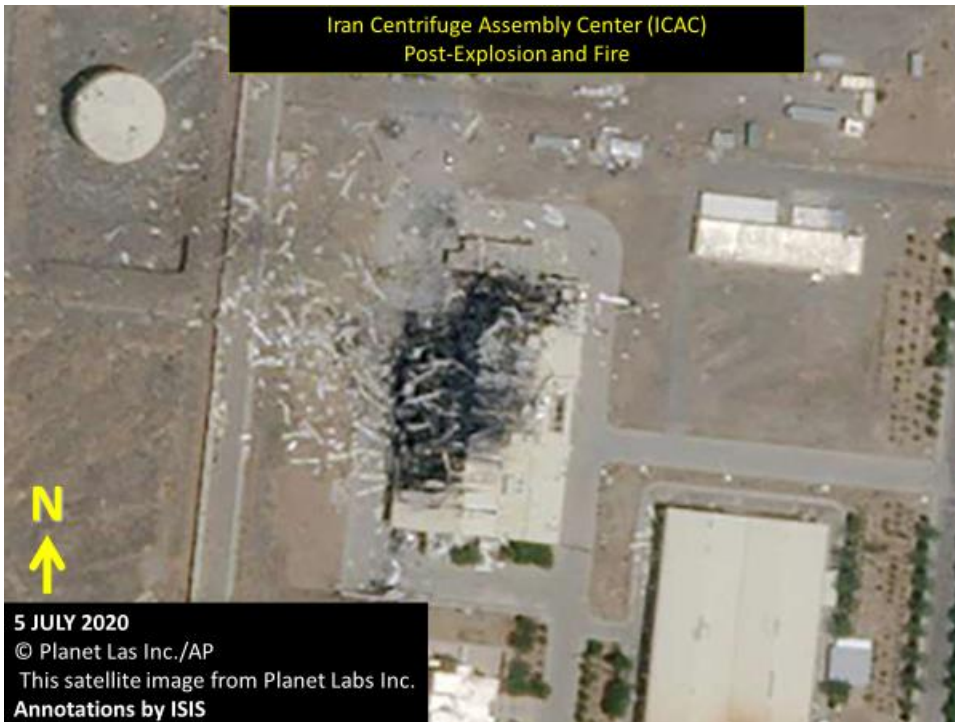
Figure 3. The ICAC Building as it appeared in this July 5, 2020 Planet Labs satellite image as published by CNN and AP.

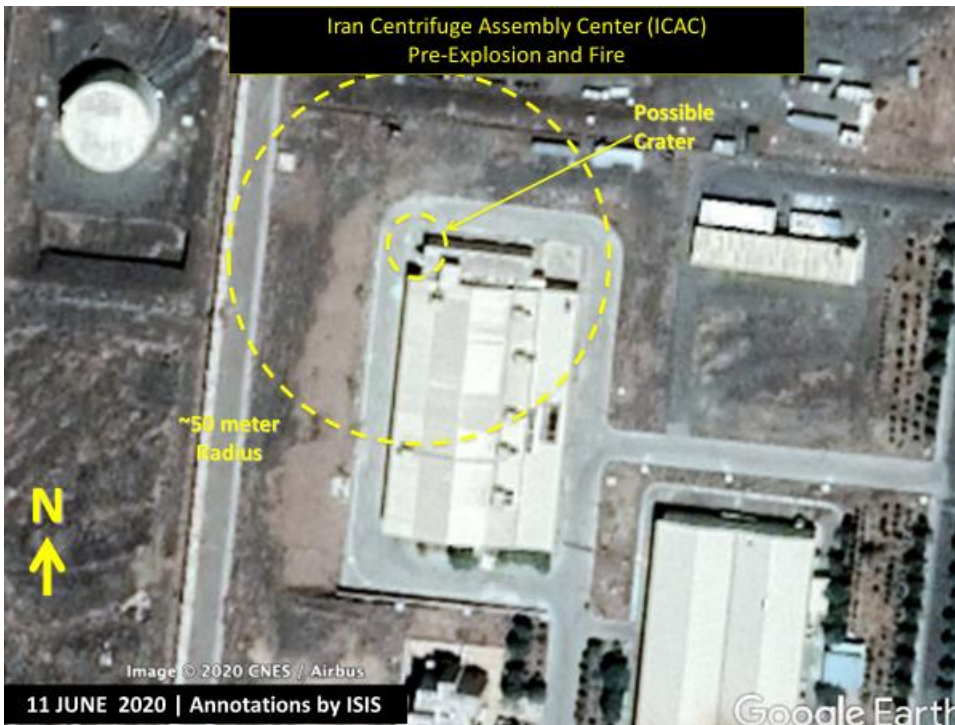
Figure 4. The ICAC Building as it appeared in this June 11, 2020 CNES/Airbus satellite image as found on Google Earth showing the subsequent location of a possible crater and the approximate blast and damage area from the explosion and fire.

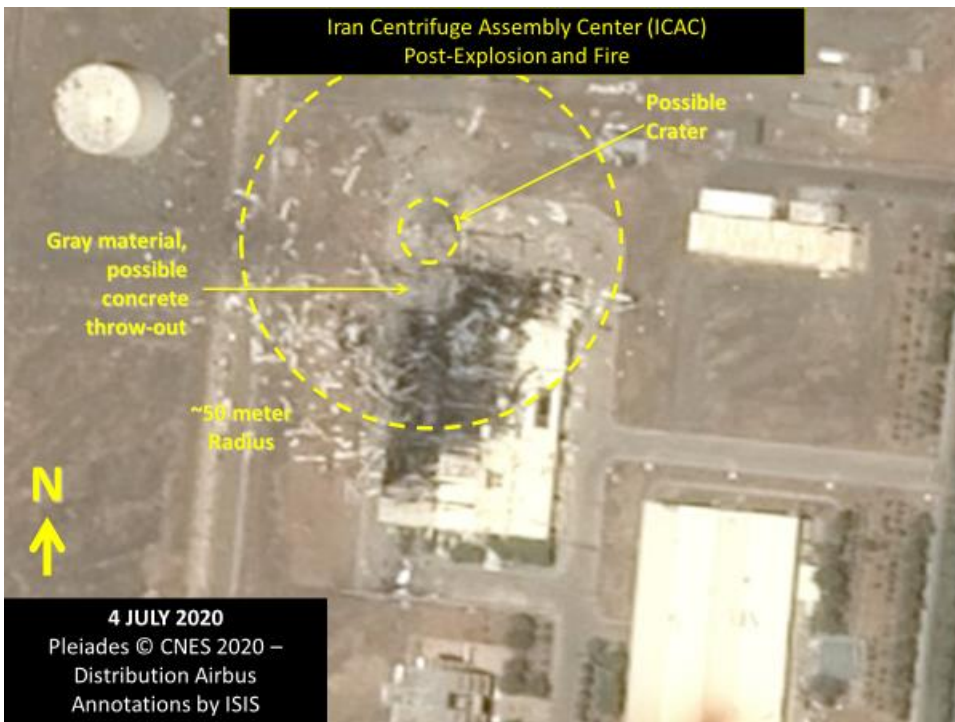
Satellite imagery further shows that the damage appears to have been caused by a large single point detonation, possibly creating a crater that is centered at the northwest corner of the ICAC. That explosion, evidently causing or coinciding with a fire, may well have involved an explosives device (that is also consistent with other open source reporting²).

Figure 5. The ICAC Building as it appeared in this July 4, 2020 CNES/Airbus satellite image acquired the day after the explosion and fire, showing the location of a possible crater and the approximate blast and damage area from the explosion and fire.

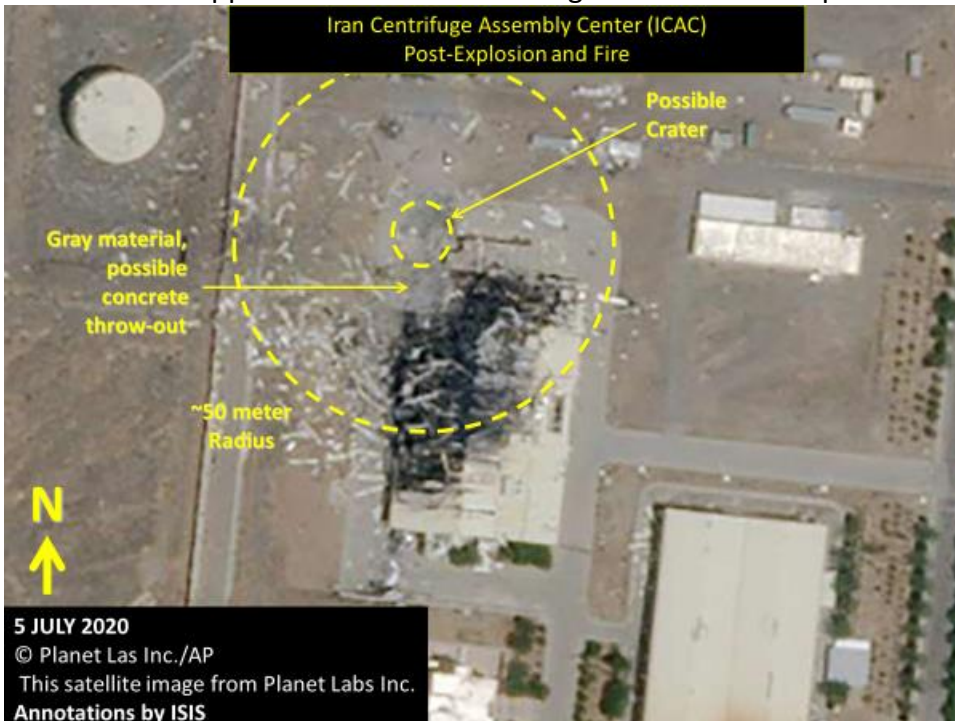
Figure 6. The ICAC Building as it appeared in this July 5, 2020 Planet Labs satellite image as published by CNN and AP, showing the location of a possible crater and the approximate blast and damage area from the explosion and fire.

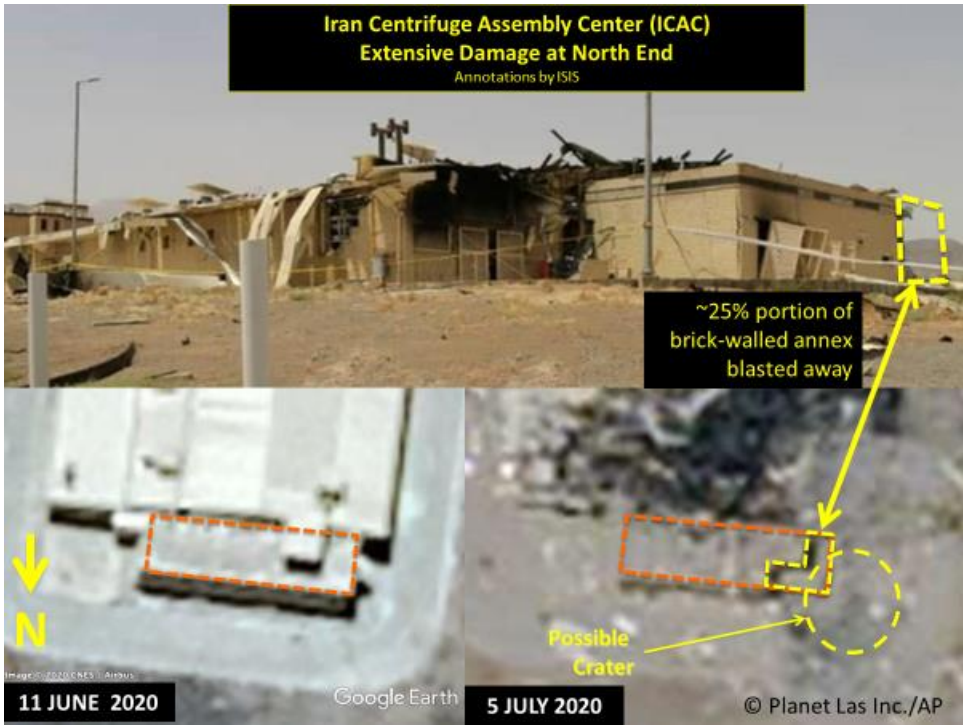
It was not until commercial satellite imagery became available that the true nature of the damage could be observed. In the images now available to the Institute, a July 4 image from *Airbus/CNES*, and a July 5 image by *Planet Labs*, it is clear that a major explosion took place, destroying nearly three quarters of the main centrifuge assembly hall, generating a fire that blackened a major portion of the building, the blackening visible where the roof had been blown away by the explosion. Although we had originally concluded, based on the ground imagery, that the explosion and fire had most likely occurred in the northeast corner of the building in an area of the building that likely contained auxiliary diesel generators, it is now clear from the overhead satellite imagery that the explosion was actually centered at the northwest corner. Figures 1 – 3 contain overhead imagery of the building before and after the explosion. Unlike the northeast corner, which was blackened by fire and exhibited signs of some structural damage, the northwest corner of the ICAC building, including a large portion of a brick-walled annex, was completely obliterated. Moreover, a debris field of building materials (primarily roofing panels) is also distributed in a roughly radial pattern, extending to a radius of over half a football field, from that same point. What we perceive might be a crater, roughly 10 meters in diameter, is visible in the center of that circular pattern (see Figures 4 – 6). What appears to be some gray concrete throw-out material is also visible in the area where the corner of the building had been. That center-point of the possible crater is located just outside the building, which would be accessible by vehicle, suggesting that a vehicle-borne explosives device cannot be ruled out at this time (see Figure 7).

The ICAC was also involved in assembling other centrifuge components, according to an expert. An annex to this building reportedly was planned for assembling centrifuge motors and ancillary equipment. The 230 meter square annex is located at the back of the building (see Figure 7), where approximately one quarter of the annex was razed by the blast.

Figure 7. The top ground image is of the north end of the ICAC Building as published by the Atomic Energy Organization of Iran as it appeared following the explosion and fire showing where a section of the annex was blasted away. The lower left image is from Google Earth and shows the appearance of the 30 meter long annex pre-incident, while the lower right image of the annex from July 5, 2020 (as published by CNN) shows by comparison that approximately 25 percent of the annex was blasted away, as well as its proximity to the possible crater.
