Update on the Site of the Alleged Explosion at the Parchin Military Complex

October 21, 2014

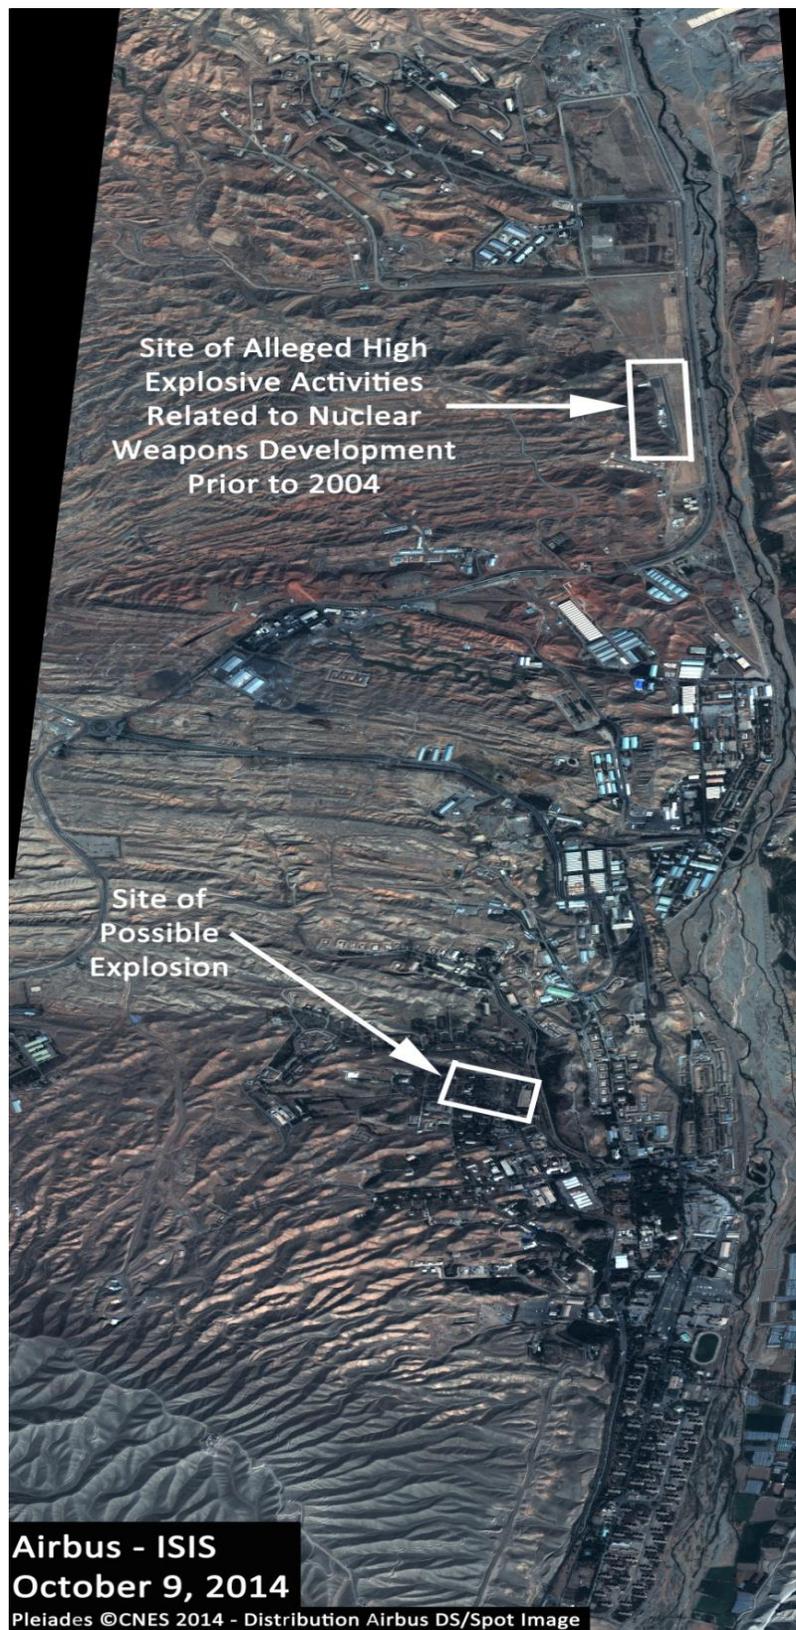
The most recent image from October 9 continues to show several signatures consistent with a major explosion and associated clean-up activities (see figures 1 and 2). The building that previously looked damaged, one that was closest to what appeared to be the central explosion or fire area, has now been dismantled. Also, at least four large trucks now appear at the site. One of these trucks appears to be a large open bed truck possibly dedicated to the removal of rubble and debris. Overall, the shape and size of these trucks are consistent with those of either fire or debris removal trucks.

Figure 1. Airbus imagery dated October 9, 2014 showing the Parchin military complex, in its entirety, four days after a reported explosion.

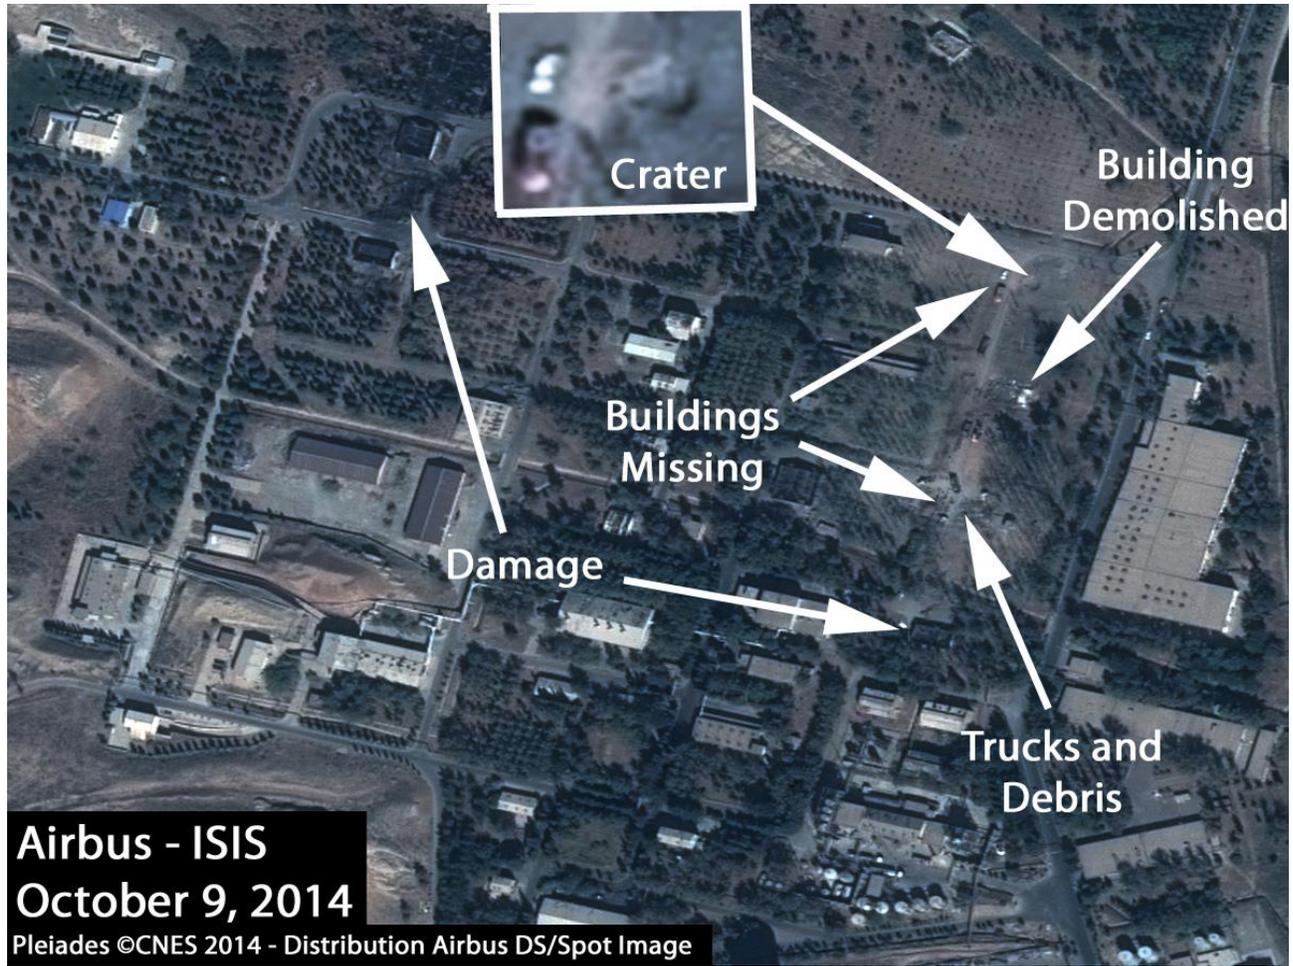
It is important to note that determining whether this damage was caused by an explosion and fire or an attack is very difficult given the little information available. Although satellite imagery from October 7 and 9 identified a single 4.5-meter-wide crater at the site of the northernmost building, imagery alone does not

provide enough information to determine whether this crater was caused by the explosion, an attack, or something else. Figure 2 shows this crater, which appears about 100 meters north of what is believed to be the main explosion area. Given the proximity to the main explosion area, it is likely that this damage (and the resulting crater) was caused by post-explosion excavation or a sympathetic explosion (e.g. gas line break and subsequent explosion) rather than a bomb. It is likely that the initial explosion was generated within one building, causing the destruction of other buildings.

Figure 2. Airbus imagery dated October 9, 2014 showing the status of the site of the alleged explosion or fire at the Parchin military complex.

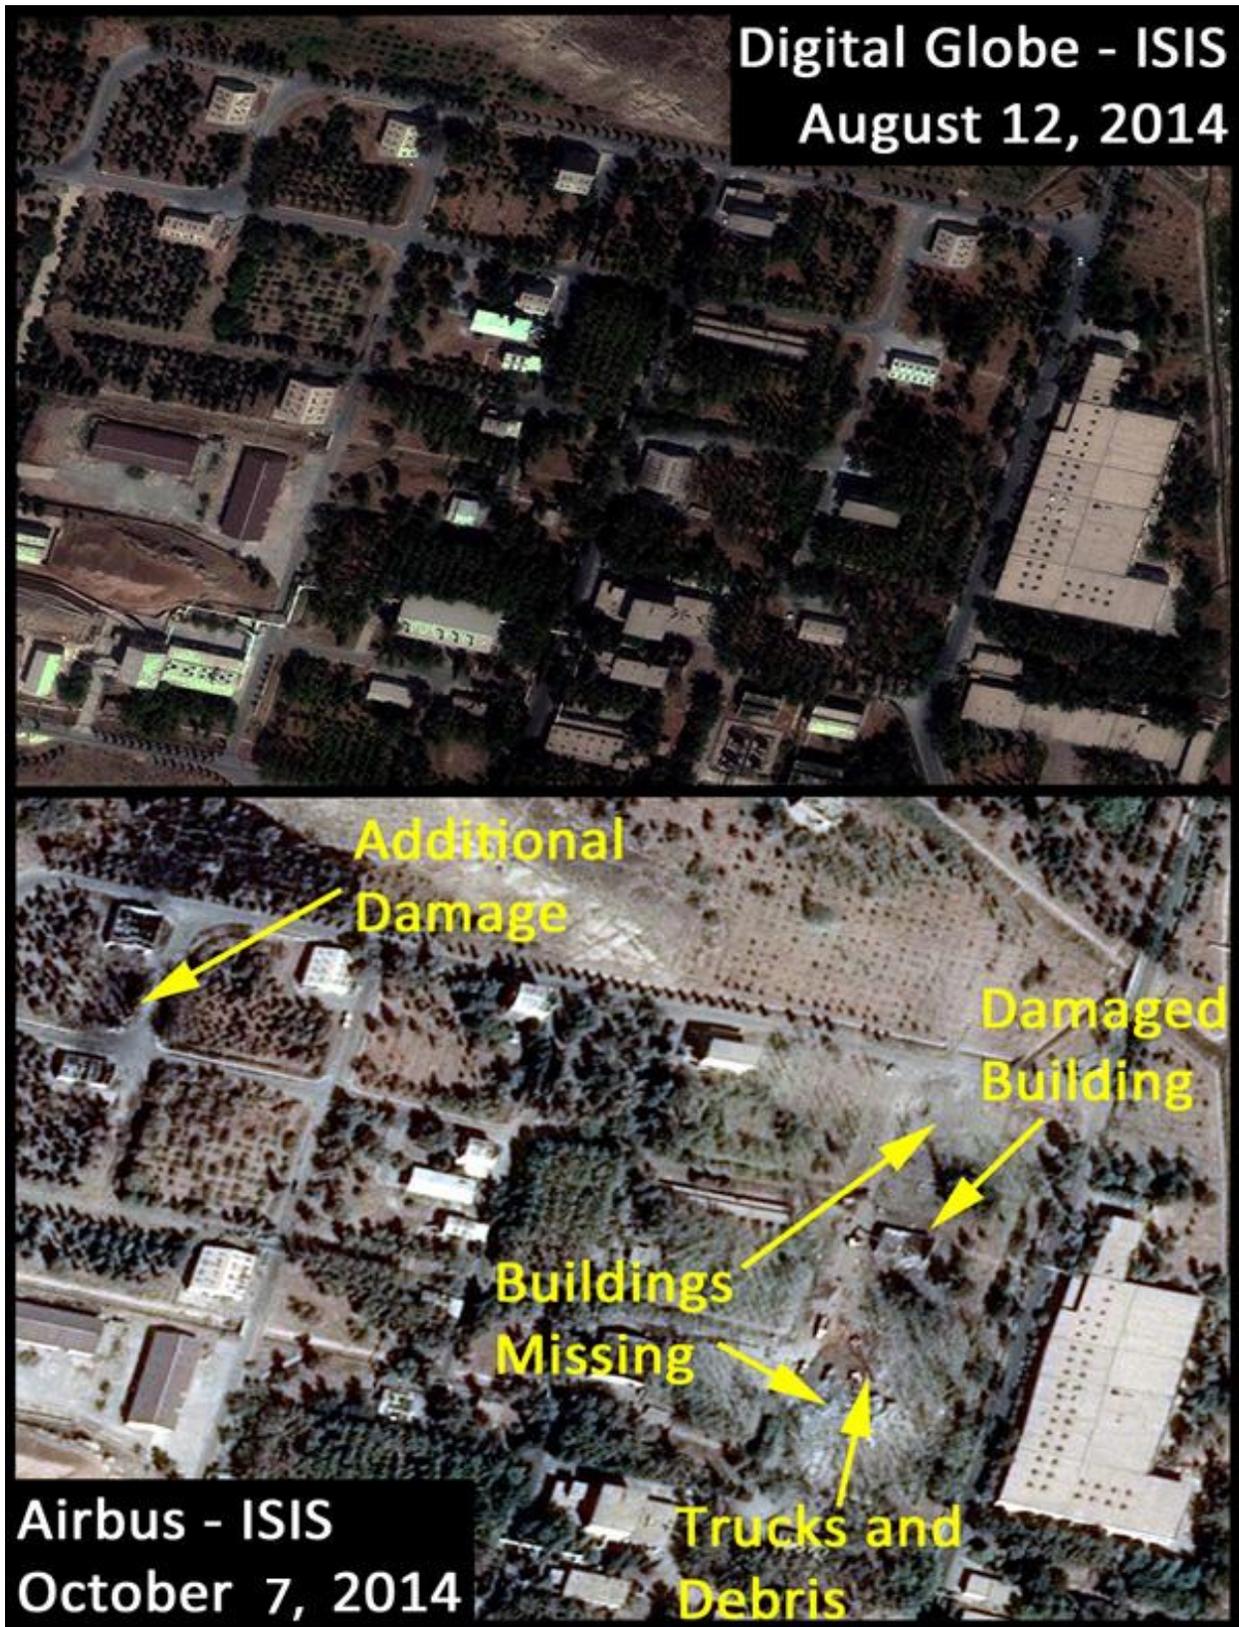
An October 7 image, the first image ISIS purchased after the reported explosion, already showed several signatures that coincided with those expected from an explosion. As figure 3 shows, two buildings that were present in August 2014 were no longer there, while a third building appeared to be severely damaged. In total at least six buildings appeared damaged or destroyed. Several trucks were already present at the site. The irregular line and color of the vegetation strongly suggested that an explosion, with a resulting fire and scattering of debris, occurred. Additionally, a layer of grey colored dust and debris was visible at the center of the probable explosion area and was scattered throughout the surrounding vegetation. Although the large building east of the main explosion area appears to present a wavy roof line, suggesting damage, as pointed out to us by an observant reader, ISIS assesses that this is an optical illusion and not an indication of any structural damage caused by the blast. The waviness is caused by a combination of the processing of the satellite image, a discrepancy with the underlying elevation data used in the image processing, the “look angle” of the satellite, and by the fact that the structure appears to be built into a hillside.

Figure 3. Before and after imagery of a possible site of the reported explosion. Digital Globe imagery from August 12, 2014 and Airbus imagery from October 7, 2014.
