## Update on the Site of the Alleged Explosion at the Parchin Military Complex

David Albright, Joseph S. Bermudez Jr.\*, and Serena Kelleher-Vergantini

October 21, 2014

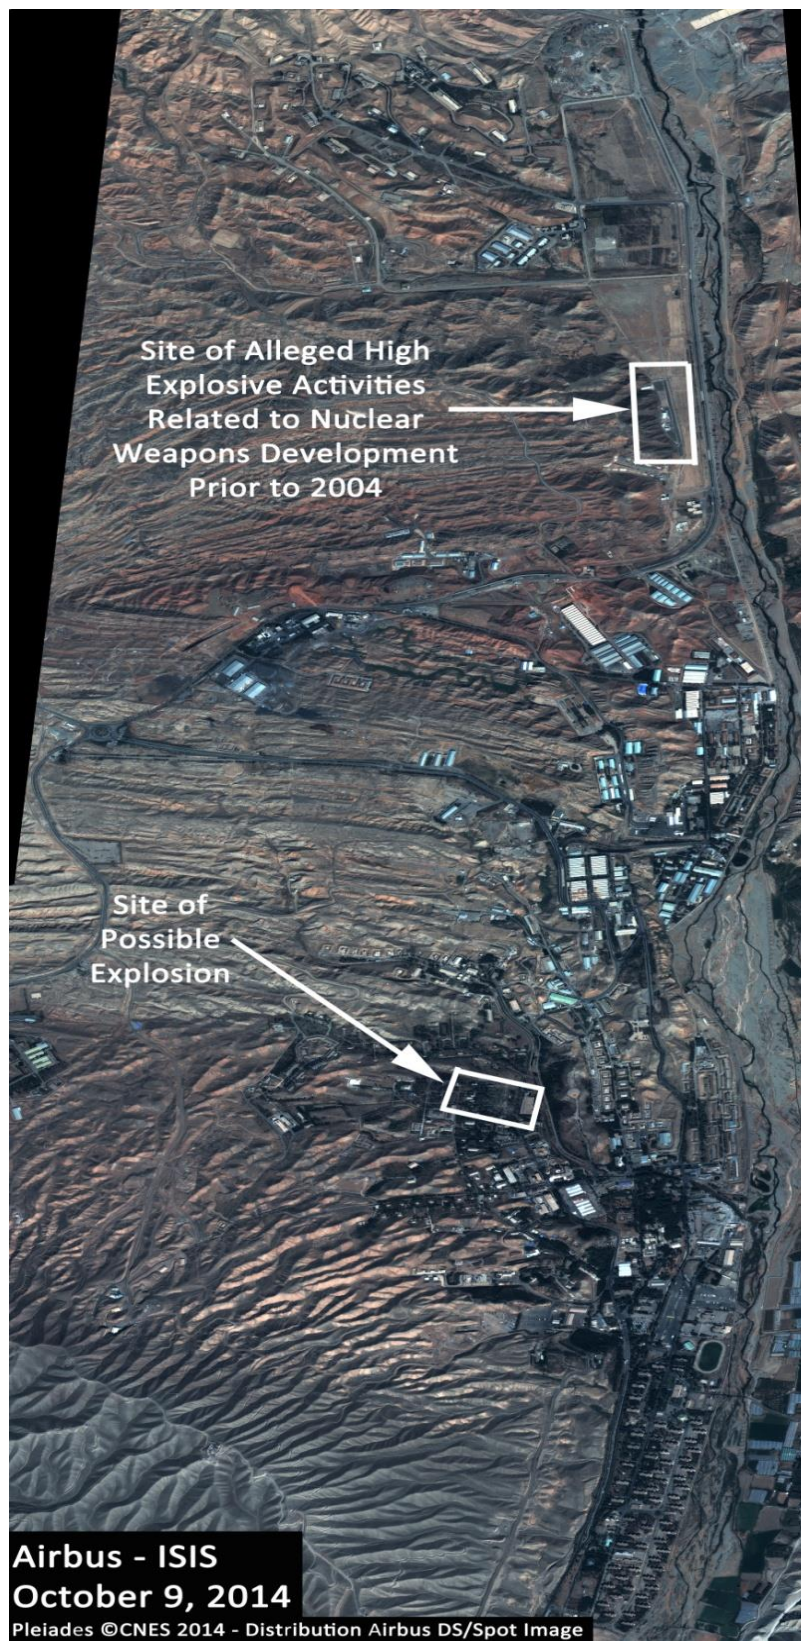
The most recent image from October 9 continues to show several signatures consistent with a major explosion and associated clean-up activities (see figures 1 and 2). The building that previously looked damaged, one that was closest to what appeared to be the central explosion or fire area, has now been dismantled. Also, at least four large trucks now appear at the site. One of these trucks appears to be a large open bed truck possibly dedicated to the removal of rubble and debris. Overall, the shape and size of these trucks are consistent with those of either fire or debris removal trucks.

**Figure 1.** Airbus imagery dated October 9, 2014 showing the Parchin military complex, in its entirety, four days after a reported explosion.

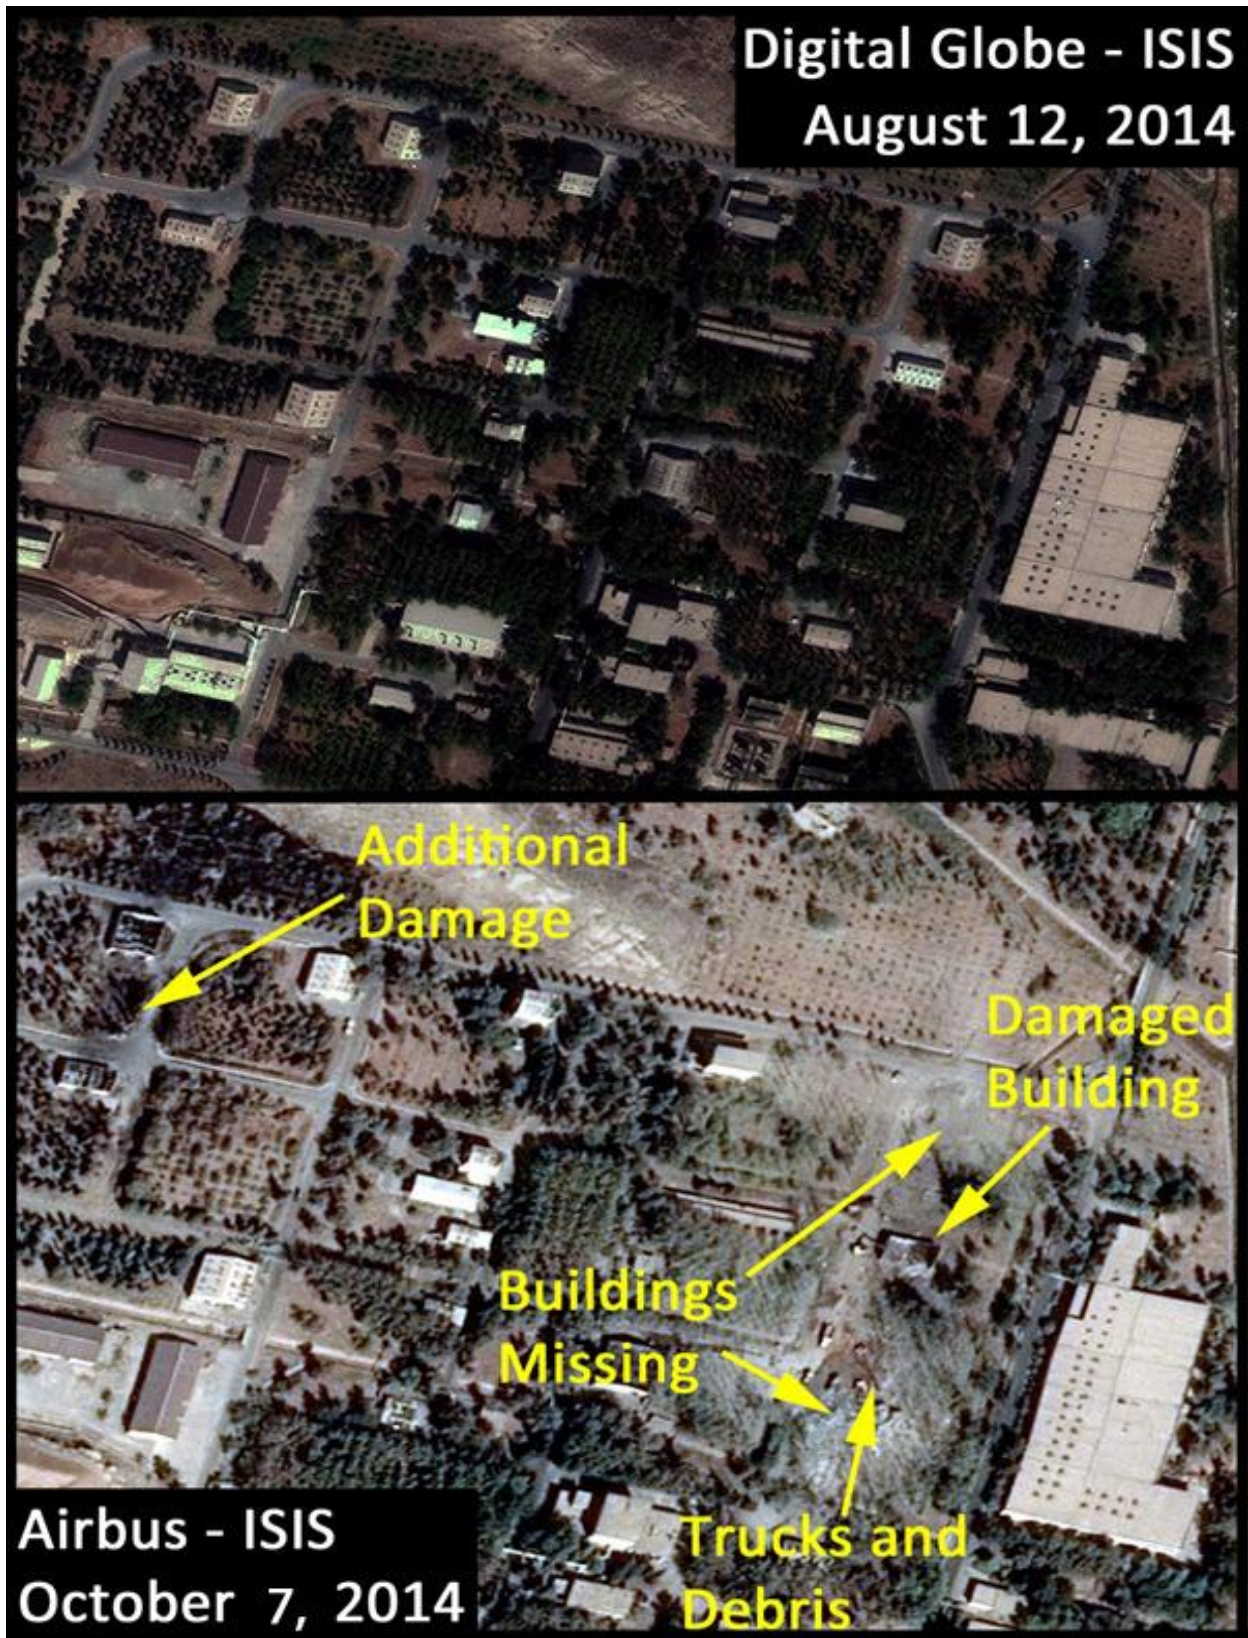
An October 7 image, the first image ISIS purchased after the reported explosion, already showed several signatures that coincided with those expected from an explosion. As figure 3 shows, two buildings that were present in August 2014 were no longer there, while a third building appeared to be severely damaged. In total at least six buildings appeared damaged or destroyed. Several trucks were already present at the site. The irregular line and color of the vegetation strongly suggested that an explosion, with a resulting fire and scattering of debris, occurred. Additionally, a layer of grey colored dust and debris was visible at the center of the probable explosion area and was scattered throughout the surrounding vegetation. Although the large building east of the main explosion area appears to present a wavy roof line, suggesting damage, as pointed out to us by an observant reader, ISIS assesses that this is an optical illusion and not an indication of any structural damage caused by the blast. The waviness is caused by a combination of the processing of the satellite image, a discrepancy with the underlying elevation data used in the image processing, the "look angle" of the satellite, and by the fact that the structure appears to be built into a hillside.

**Figure 3.** Before and after imagery of a possible site of the reported explosion. Digital Globe imagery from August 12, 2014 and Airbus imagery from October 7, 2014.
