# Update of Key Activities at North Korea's Yongbyon Nuclear Site

By David Albright and Serena Kelleher-Vergantini

January 13, 2016

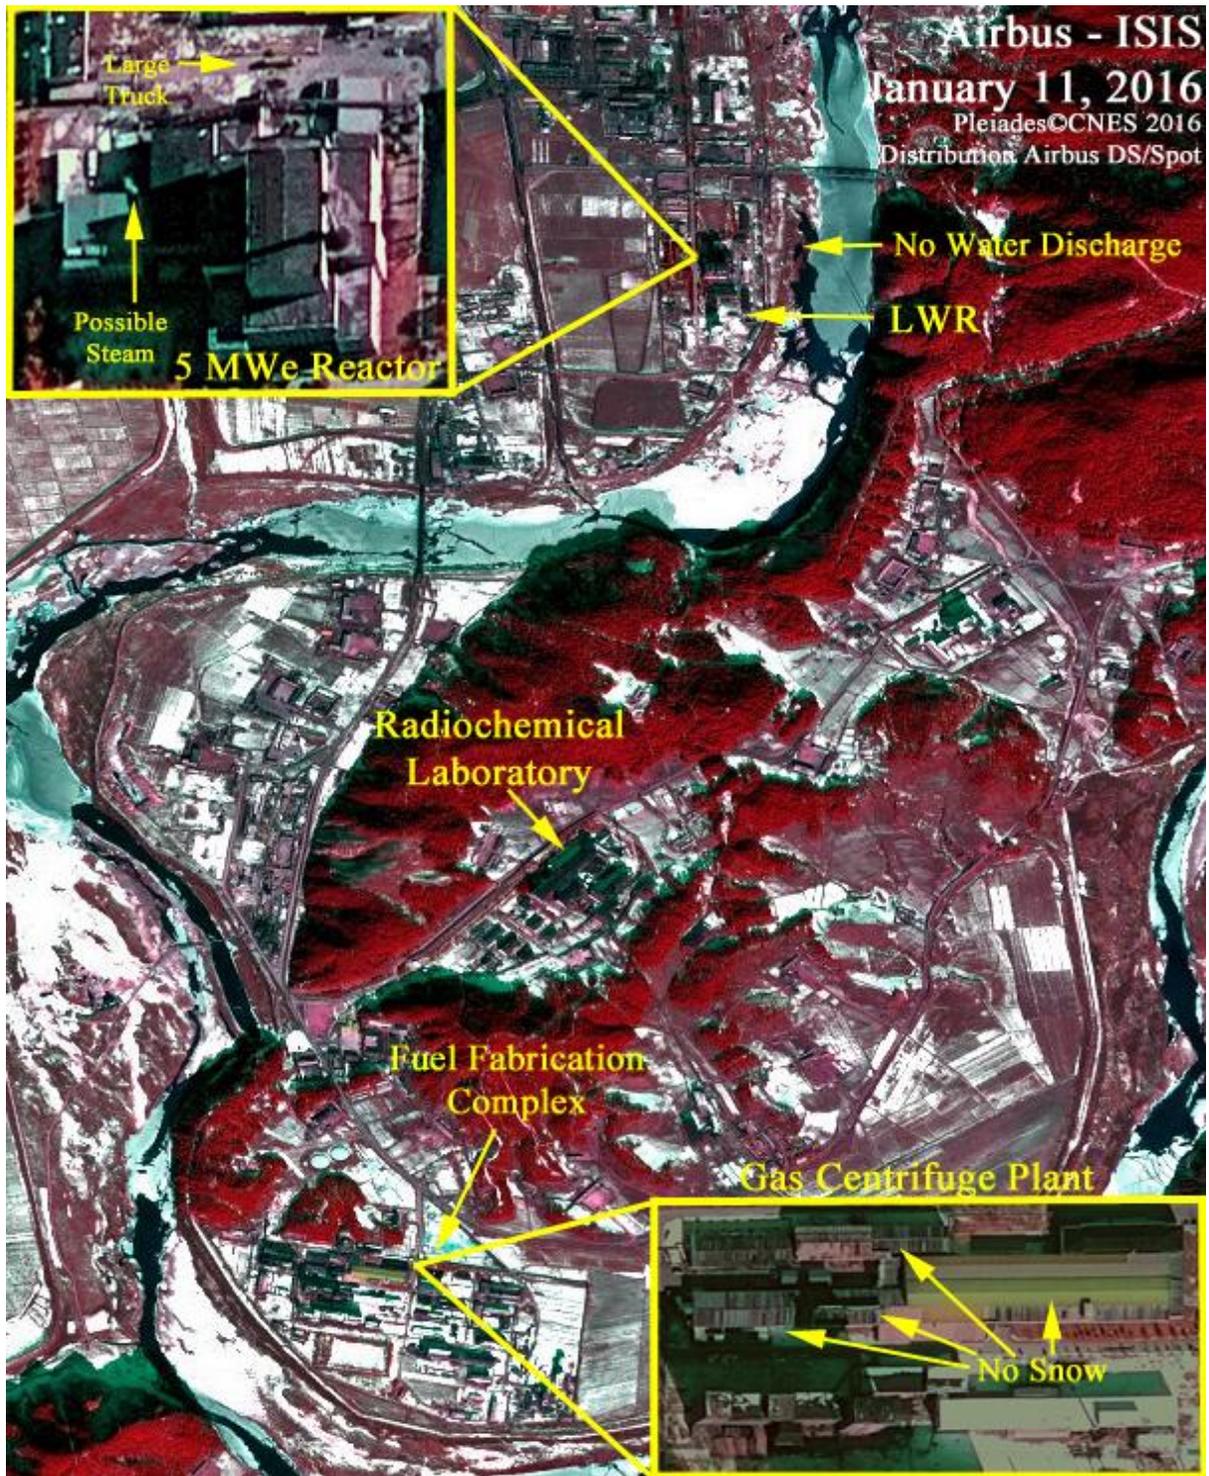
Consistent with on-going intermittent operation, Airbus imagery dated January 11, 2016, acquired and analyzed by ISIS, shows what appears to be the emission of steam from the 5 MWe reactor's turbine building. This is a signature of turbine activity which, in turn, indicates that the reactor is operational, although possibly at low power. Additionally, a very large truck is visible at the entrance of the reactor.

No new activities have been observed at the experimental light water reactor (LWR). As figure 1 shows, light snow is present on both the dome of the reactor and on the roof adjacent to the reactor. This is likely an indication that the reactor is not operational, although nothing suggests that construction has stopped.

**Figure 1.** Airbus imagery showing North Korea's Yongbyon Nuclear Complex on January 11, 2016. This is a false color image in which healthy vegetation appears red.
