IMAGERY BRIEF

Update on North Korea's Reactors, Enrichment Plant, and Possible Isotope Separation Facility

February 1, 2016

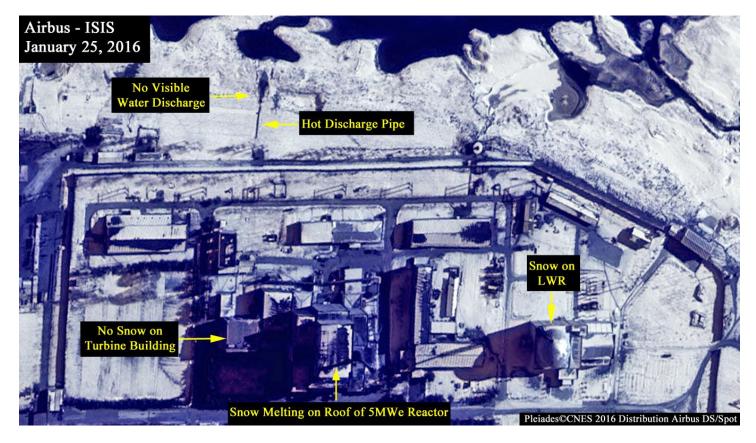
Analysis of recent satellite imagery dated January 25, 2016 is consistent with ISIS's <u>previous</u> assessment that the 5 MWe reactor is operational. Signatures such as snow melting on the roof of the 5 MWe reactor and no snow present on the roof of the turbine building are consistent with the reactor operating at low power or intermittently. The reasons for this type of operation are still unknown.

An additional signature suggesting operation is visible in this January 25th image. As figure 2 shows, although the river shore is covered in snow, the snow directly above the 5 MWe reactor's discharge pipeline has melted. This indicates that the pipe is warm either because it discharged warm water before this image was taken or because it is discharging smaller amounts of water that are not visible via commercial satellite imagery.

The January 2016 image does not show new activities at the experimental light water reactor (LWR). Snow is still visible on the dome of the reactor and on the adjacent building. Some snowmelt is visible but is believed to be caused by the sun, not by heat originating from inside the building. These are strong indications that the reactor is not operational.

Figure 2. Airbus imagery showing the status of North Korea's 5 MWe and LWR reactors on January 25, 2016.

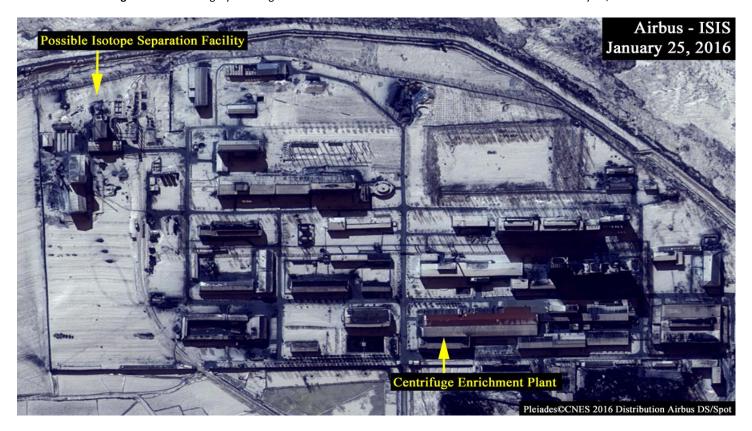
North Korea's gas centrifuge enrichment plant is located at the fuel fabrication complex in the southern corner of the Yongbyon nuclear site (see figure 1). The January 25, 2016 image does not show any new

signs of external activity at this site, except for the absence of snow on several roofs, including the roof of the main centrifuge building, indicating that the Yongbyon gas centrifuge plant is operational.¹

Figure 3. Airbus imagery showing the status of North Korea's centrifuge enrichment plant at the fuel fabrication facility on January 25, 2016.
