## North Korean Reprocessing Campaign May Have Taken Place

By David Albright and Sarah Burkhard

June 5, 2018

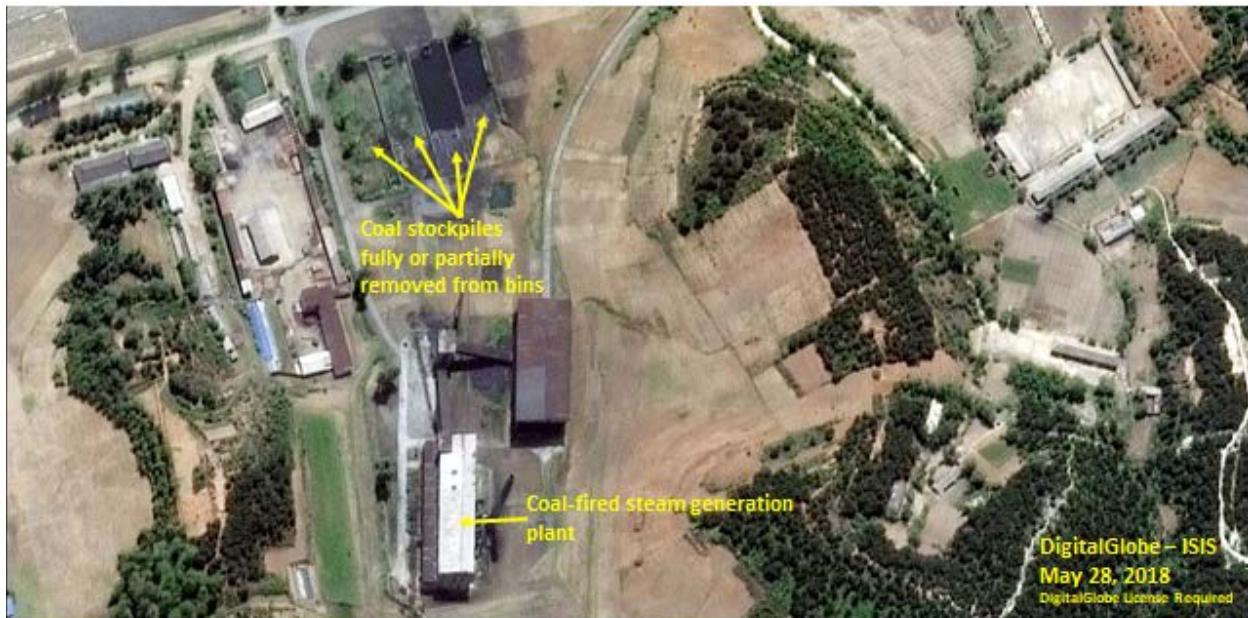
Figure 1, a recent DigitalGlobe image acquired by the Institute, shows the coal-fired steam generation plant at Yongbyon, which, via an above ground pipeline, supplies the Radiochemical Laboratory with steam. The plant seems to have been active in May, since at the beginning of May, a small exhaust plume was observed coming from the smokestack, and at the end of May, coal stockpiles outside the plant seem significantly reduced (figure 1). The most recent imagery shows no signs of current activity, which indicates that the operational period may have ended.

**Figure 1.** Compared to a May 6, 2018 DigitalGlobe image published and annotated by 38North, it appears that coal at the coal-fired thermal plant has been fully or partially removed from the individual stockpiles. No smoke is coming from the stack, indicating that the reprocessing campaign may have ended or been completed. The coal-fired plant supplies steam for operations at the Radiochemical Laboratory where reprocessing occurs.

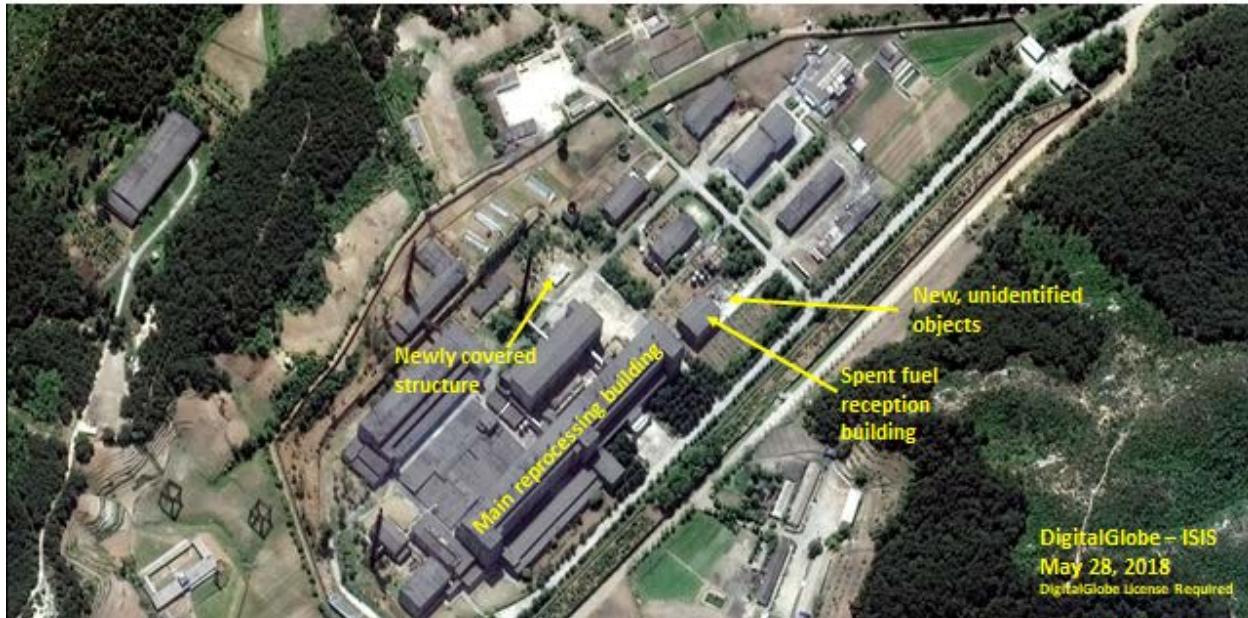
The Radiochemical Laboratory is where North Korea chemically processes discharged irradiated fuel from the 5 MWe reactor and separates plutonium for nuclear weapons. The steam from the thermal plant is used for waste processing activities following the separation of plutonium from irradiated fuel. Figure 2 shows no major current visible activity at the Radiochemical Laboratory, which indicates that the reprocessing campaign may have ended. The Institute estimates that North Korea could have separated enough plutonium during this campaign for a few to several nuclear weapons.

**Figure 2.** The Radiochemical Laboratory shows no major signs of activity.

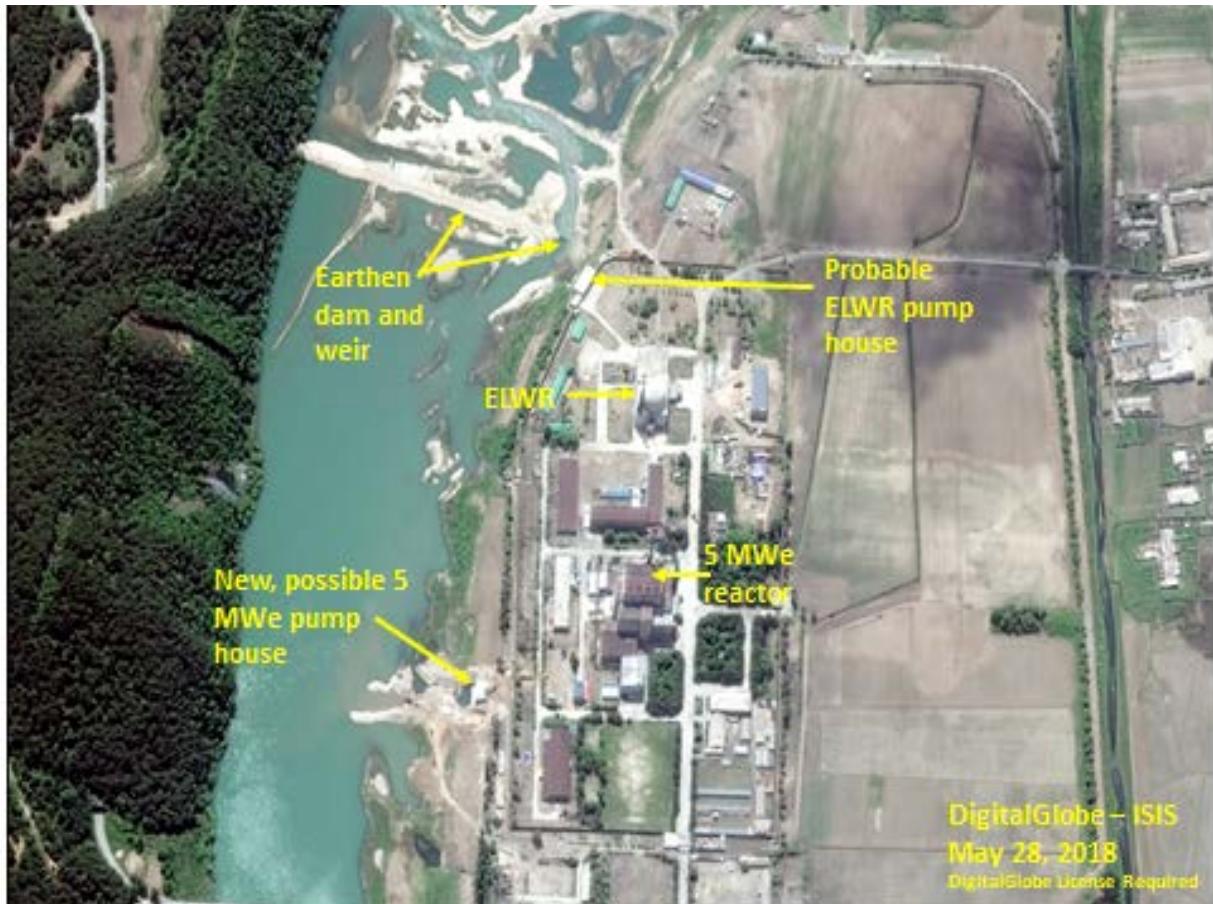
Figure 3, a May 28, 2018 commercially available satellite image, gives an overview of the site hosting the two reactors. The riverbed of the Kuryong river has changed significantly over the past months, as documented by several Institute satellite imagery reports. It has become more and more evident that the recent changes were undertaken by North Korea to improve the secondary cooling systems for both the ELWR and the 5 MWe reactor. Figure 3 shows the probable ELWR pump house for which river access was broadened, and an earthen dam and a weir which are likely designed to channel water flow and control water levels by the pump house. Construction further upstream around the 5 MWe reactor water discharge pipe is ongoing, but it appears that North Korea is building a pump house similar to the one for the ELWR (see figure 3 and 4). Figure 4 shows more clearly that North Korea is broadening river access to the building and is possibly working on piping connecting the new construction to the 5 MWe reactor. Some piping leading from the 5 MWe to the river was already in place, where, in the past, water discharge into the river was observed.<sup>2</sup>

**Figure 3.** A recent satellite image indicates that the changes made at the Kuryong river bed likely serve the purpose of improving the two reactors' cooling systems.

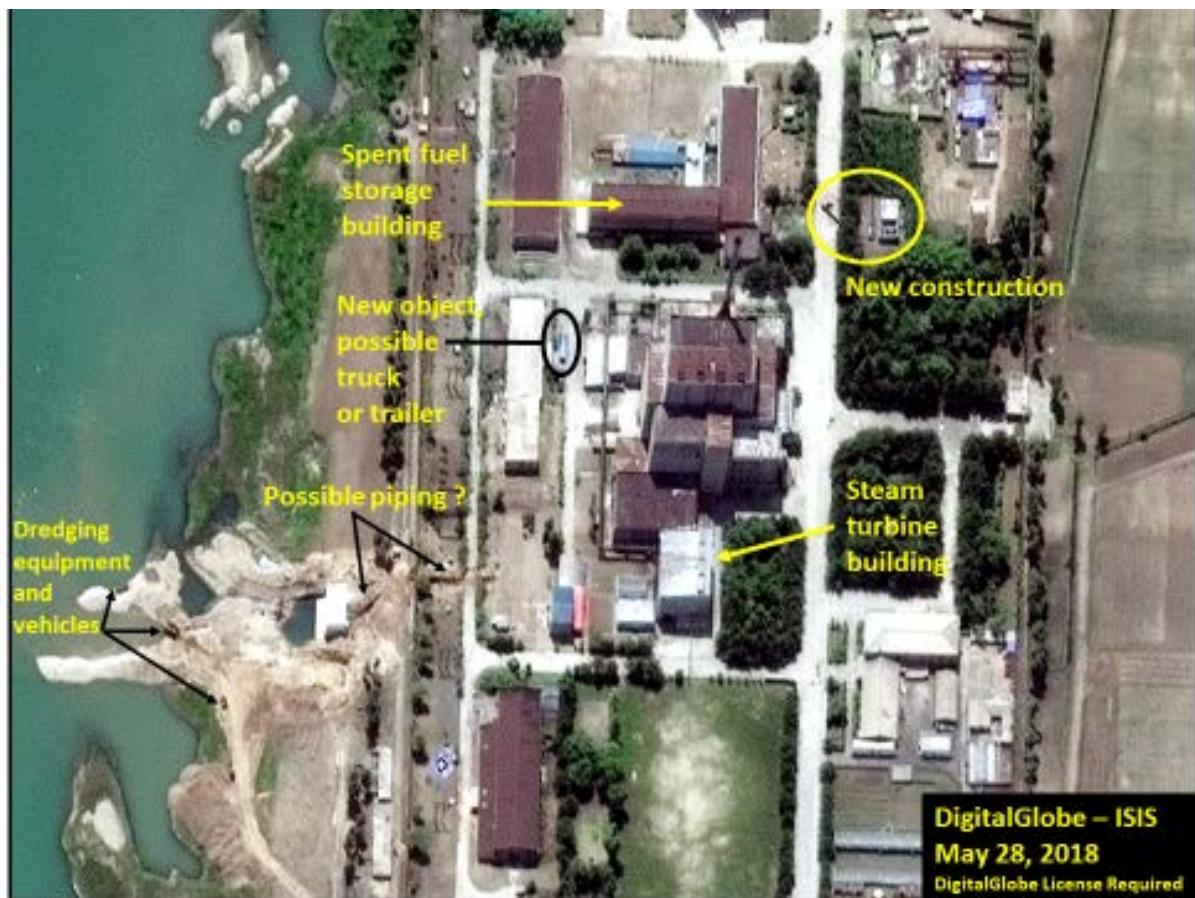
**Figure 4.** Construction around the 5 MWe water discharge pipe is on-going and seems to serve the addition of a pump house.

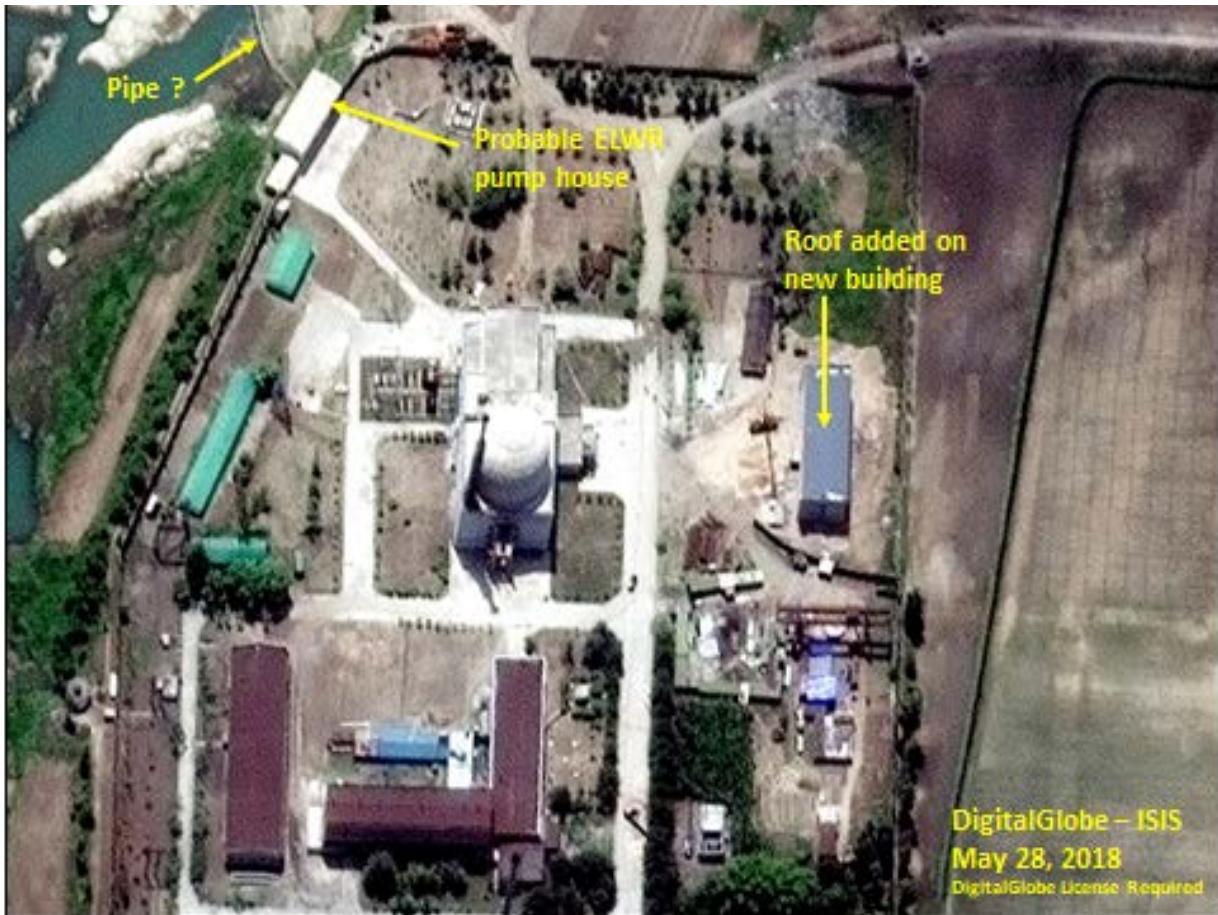
Outside the ELWR's main entrance, where construction has been occurring, the exterior of a new building seems almost complete (see figure 5).

**Figure 5.** A new building added outside the ELWR's main entrance seems to be near external completion.

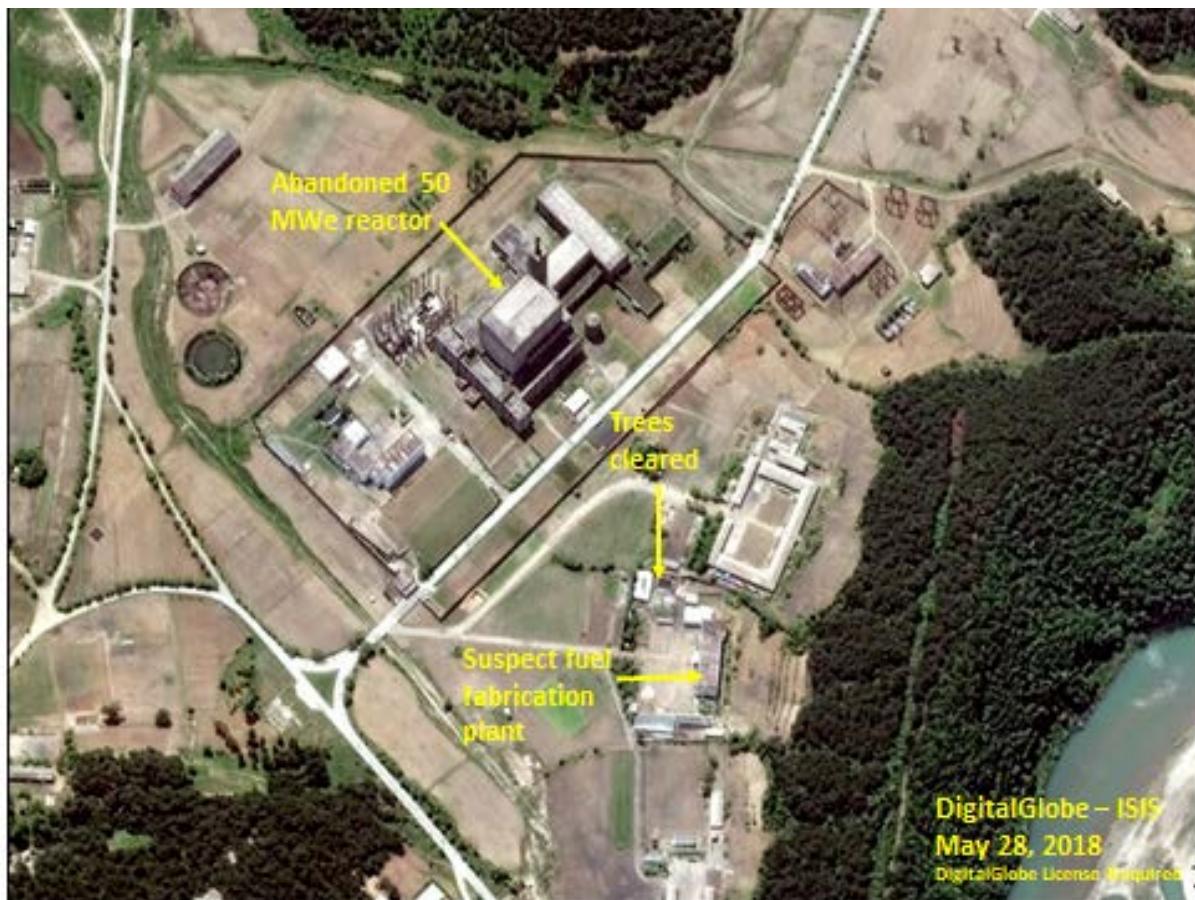
**Figure 6.** Trees seem to have been cleared around a possible waste water pond near the suspect fuel fabrication plant.

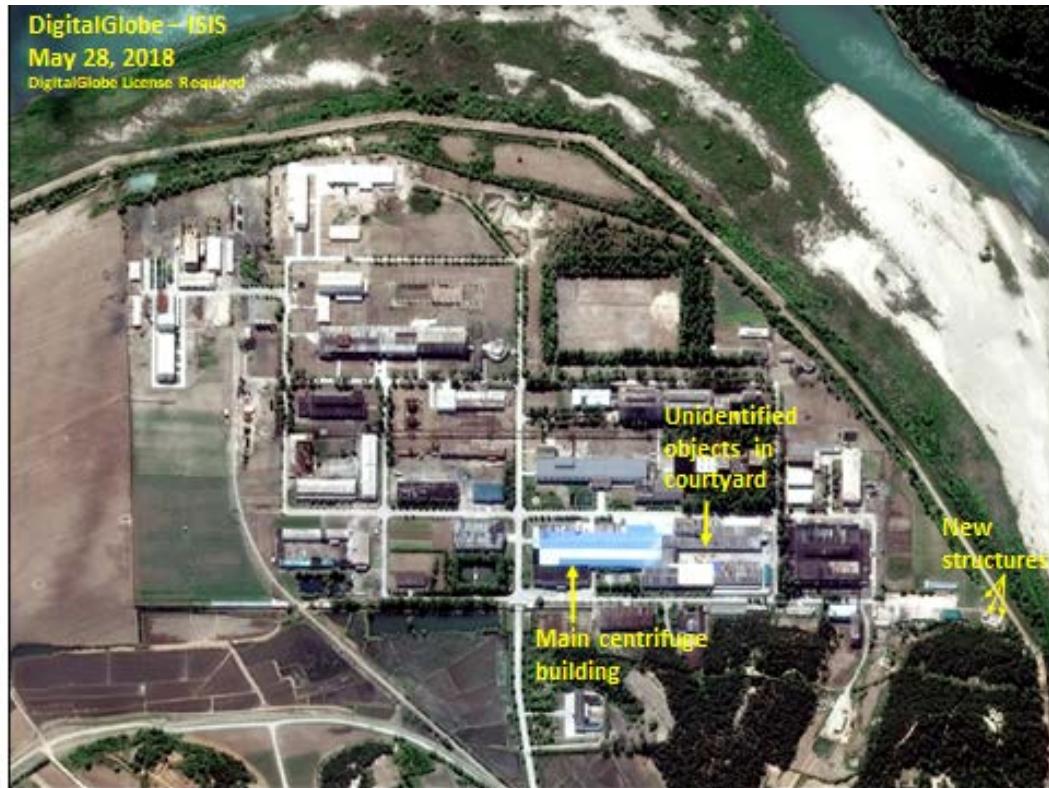
**Figure 7.** The fuel fabrication facility hosts the main centrifuge building.

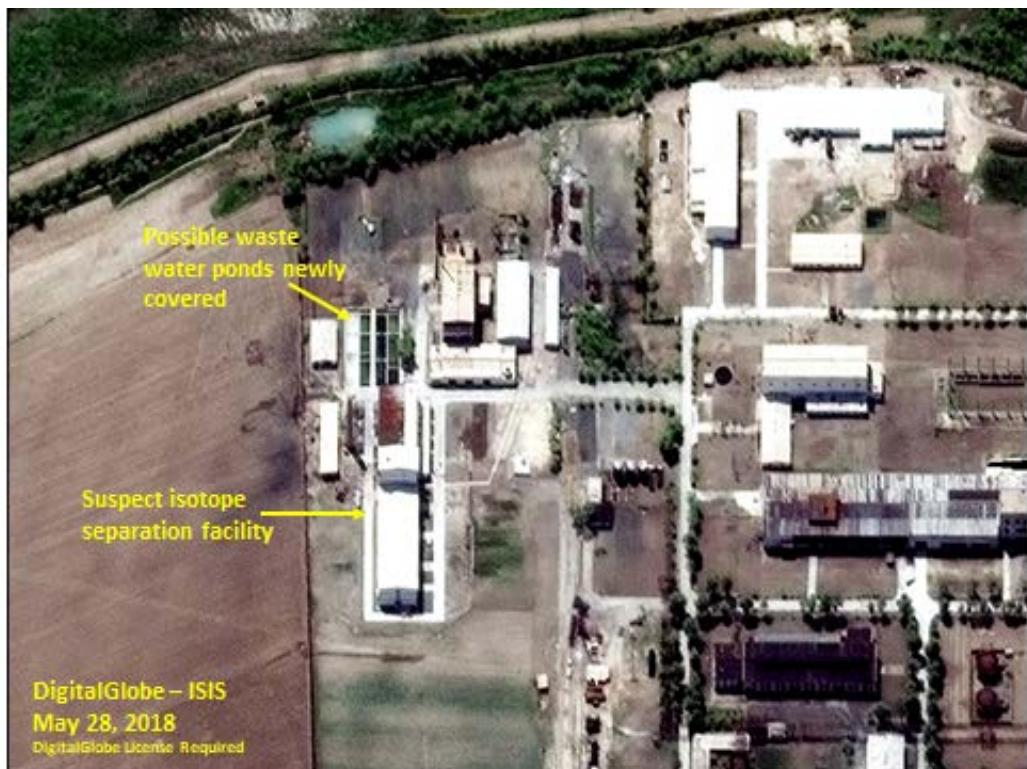
**Figure 8.** The suspect isotope separation facility shows no major signs of activity.
