January 30, 2013

Day after Alleged Sabotage at Fordow: Hardly the Expected Emergency Response

By David Albright, Robert Avagyan, and Andrea Stricker

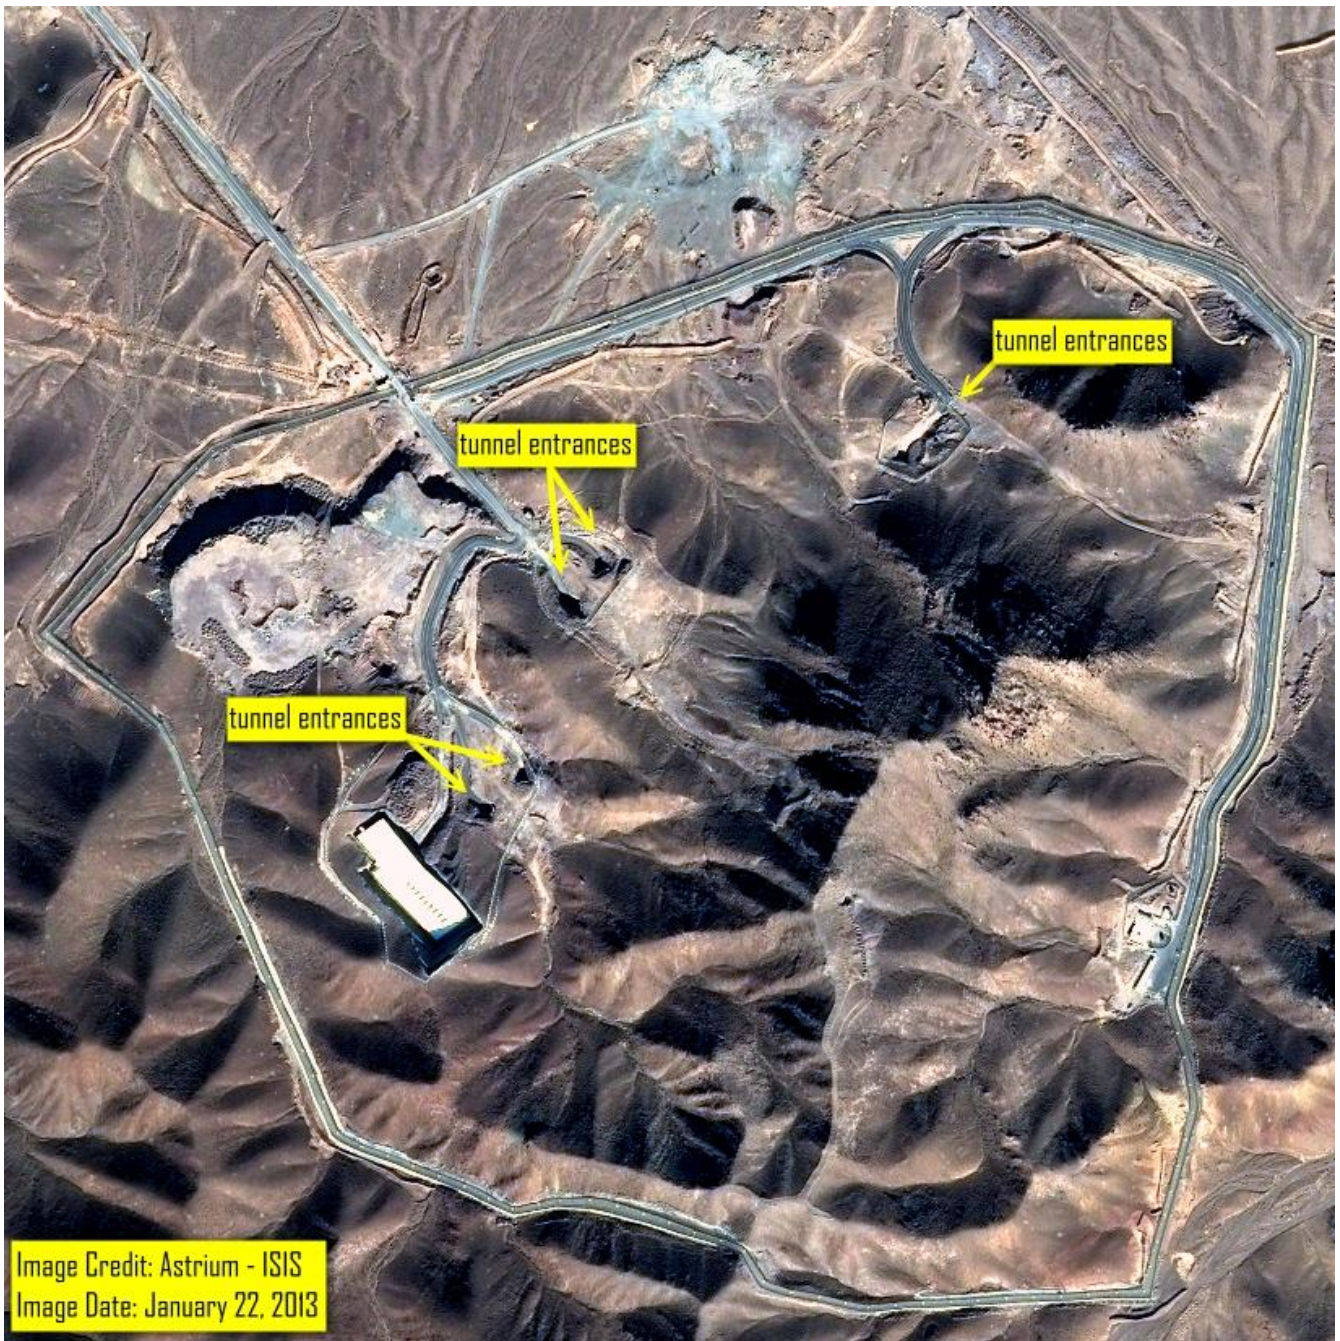
Figure 1. Satellite imagery of the Fordow fuel enrichment site from January 22, one day after a report of an alleged explosion that caused major damage to the site. The imagery shows no damage to the exterior and no apparent signs of emergency vehicles or activity at the tunnel entrances.
