February 23, 2011

Satellite Image Shows Suspected Uranium Conversion Plant in Syria

David Albright and Paul Brannan

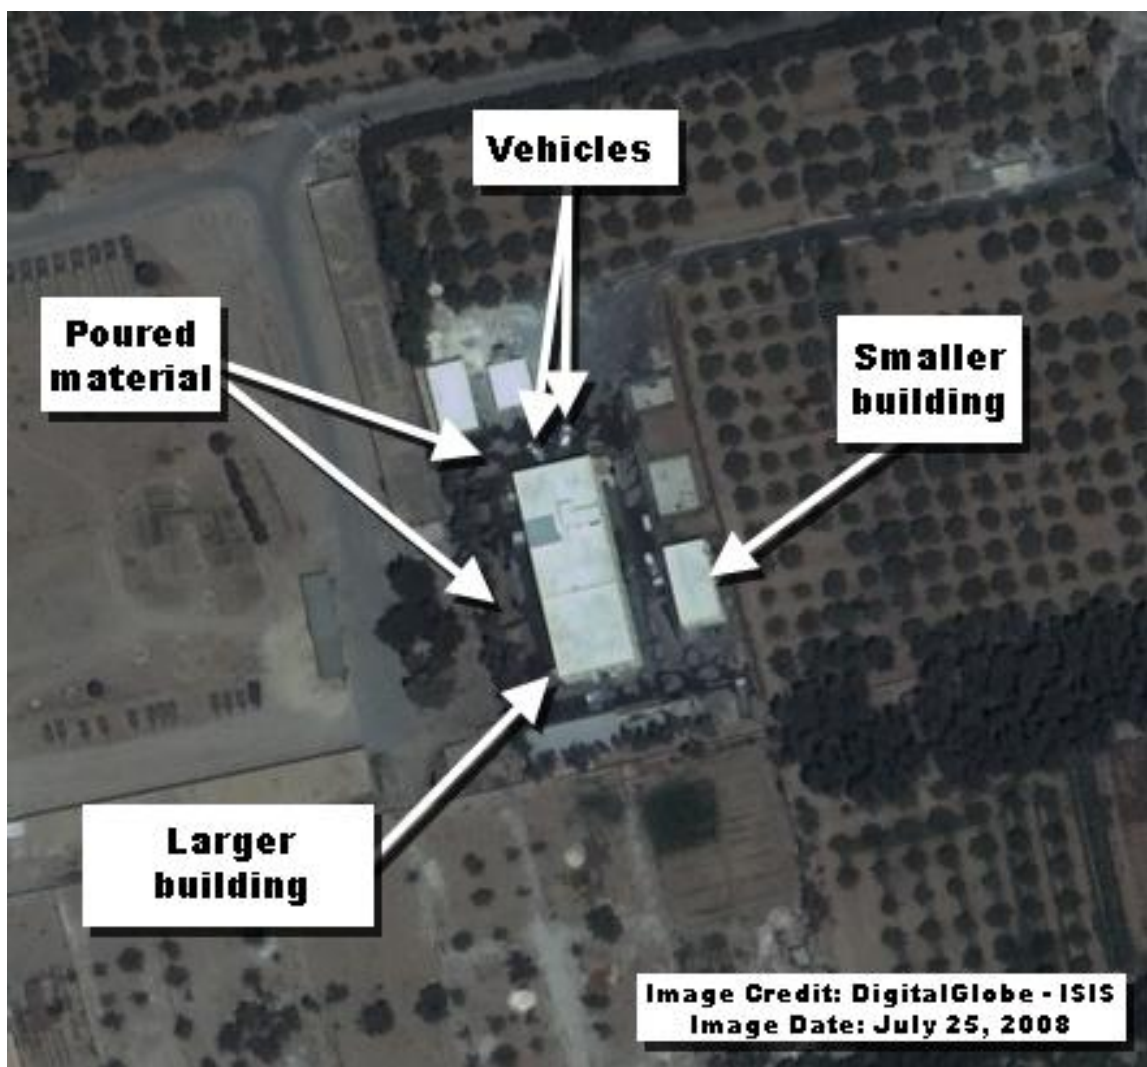
Figure 2. A close-up view of the two main process buildings. Something appears to have been poured on the ground surrounding the larger building. There also appear to be vehicles present which may be involved in this operation. This activity may represent an effort to lay down a new foundation surrounding this building. The IAEA noted in a November 2008 report that it saw in satellite imagery landscaping activities as well the removal of containers shortly after it requested access to these sites in May 2008. Pouring a new foundation may be an effort to defeat IAEA environmental sampling in the event of a visit.

A commercial satellite image of this site near Marj as Sultan, acquired by ISIS, shows considerable activity taking place on July 25, 2008 (see figure 2).¹ The activity seen in the July 25, 2008 image appears to involve pouring a material on the ground surrounding the larger building. There also appear to be trucks and other vehicles present that may be involved in this operation. This activity may represent an effort to lay down a new concrete or asphalt foundation around the building.

¹ ISIS acquired a clearer version of the July 25, 2008 DigitalGlobe image that is currently available on Google Earth. Figure 2 is this clearer version of this image. The version on Google Earth can be seen by utilizing the historical imagery viewer tool inside the application.

A reader commented to ISIS that the substance seen on the grounds around the buildings in the July 25, 2008 image in Figure 2 appears more like piled wet gravel or water. While the activity remains suspicious, ISIS acquired imagery in order to narrow the timeline during which Syria began paving the area around the buildings. An image from July 2, 2008, three weeks before the July 25 image, shows new pavement (see figure 4). An image from January 6, 2008, however, shows that the area has not yet been paved as of that date (see figure 5). Syria paved or repaved the grounds surrounding the suspect buildings sometime after the January 6, 2008 image date—after Israel bombed the reactor construction site at al Kibar in September of 2007. This paving at the suspect Marj as Sultan site and the paving of the grounds surrounding the buildings at the Masyaf site after the bombing of the reactor site are consistent with the landscaping activities reported to have taken place at the suspect sites and could be intended to defeat environmental sampling in the event of an IAEA visit.

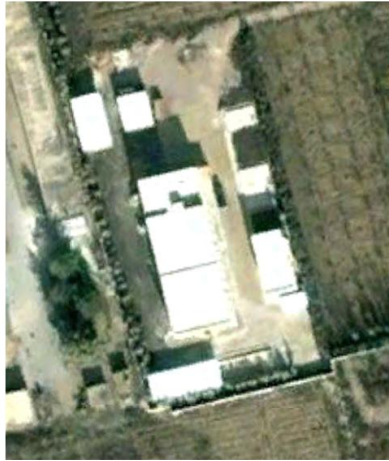
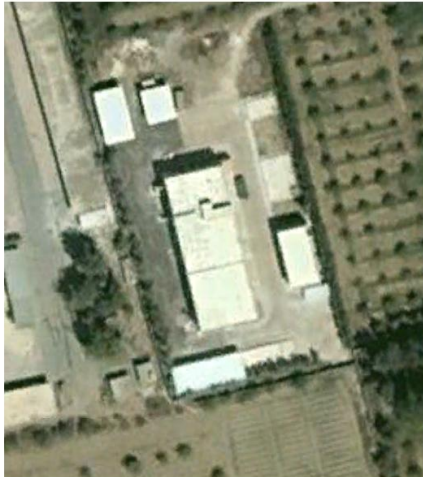
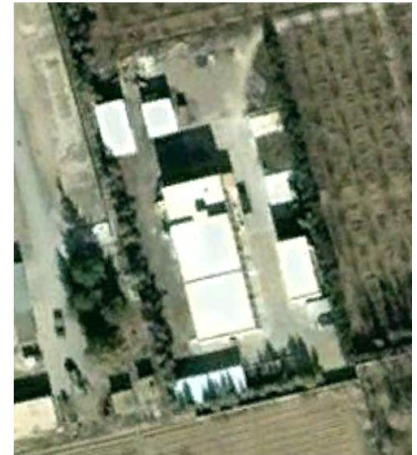
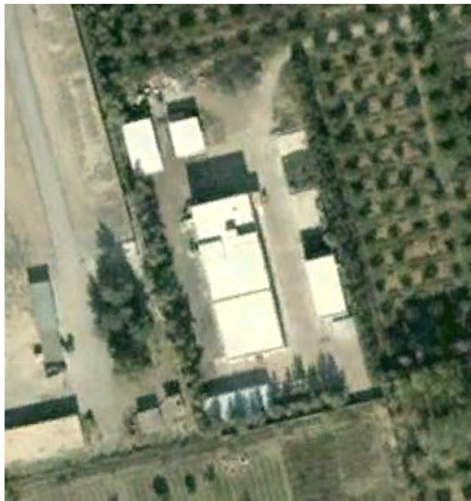
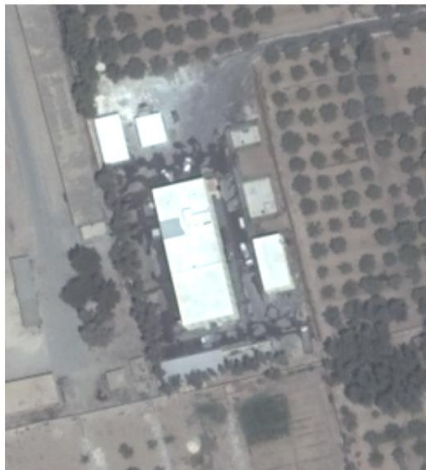
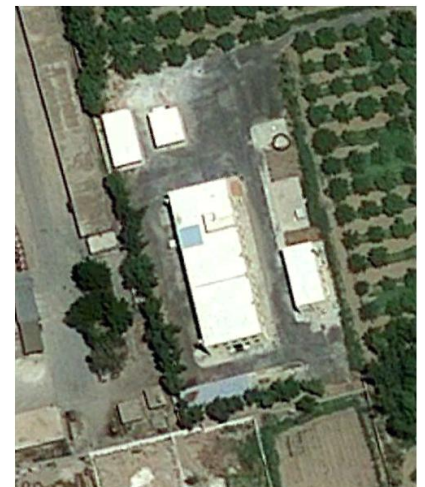
Figure 3. A comparison of the buildings and the surrounding area over the last seven years. The level of activity seen near the larger building in the July 25, 2008 image stands in stark contrast to the other image dates.

A comparison of commercial satellite images of this site over time highlights the level of activity seen on July 25, 2008 (see figure 3). Little activity is seen in the other images over nearly seven years. The level of activity seen near the larger building in the July 25, 2008 image stands in stark contrast to the other image dates.

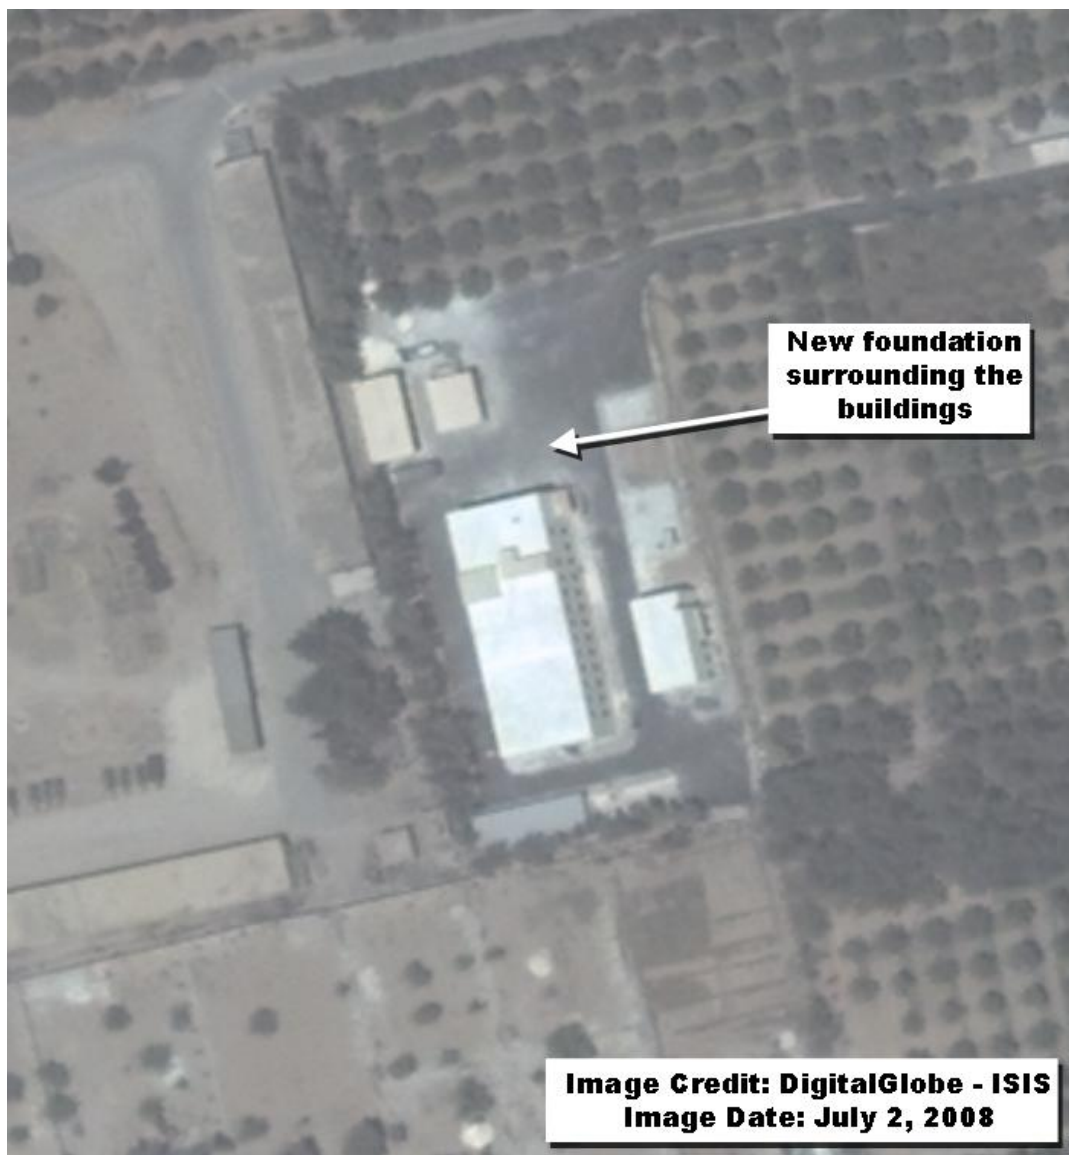
Figure 4. Image taken on July 2, 2008 shows the new foundation laid around the buildings.

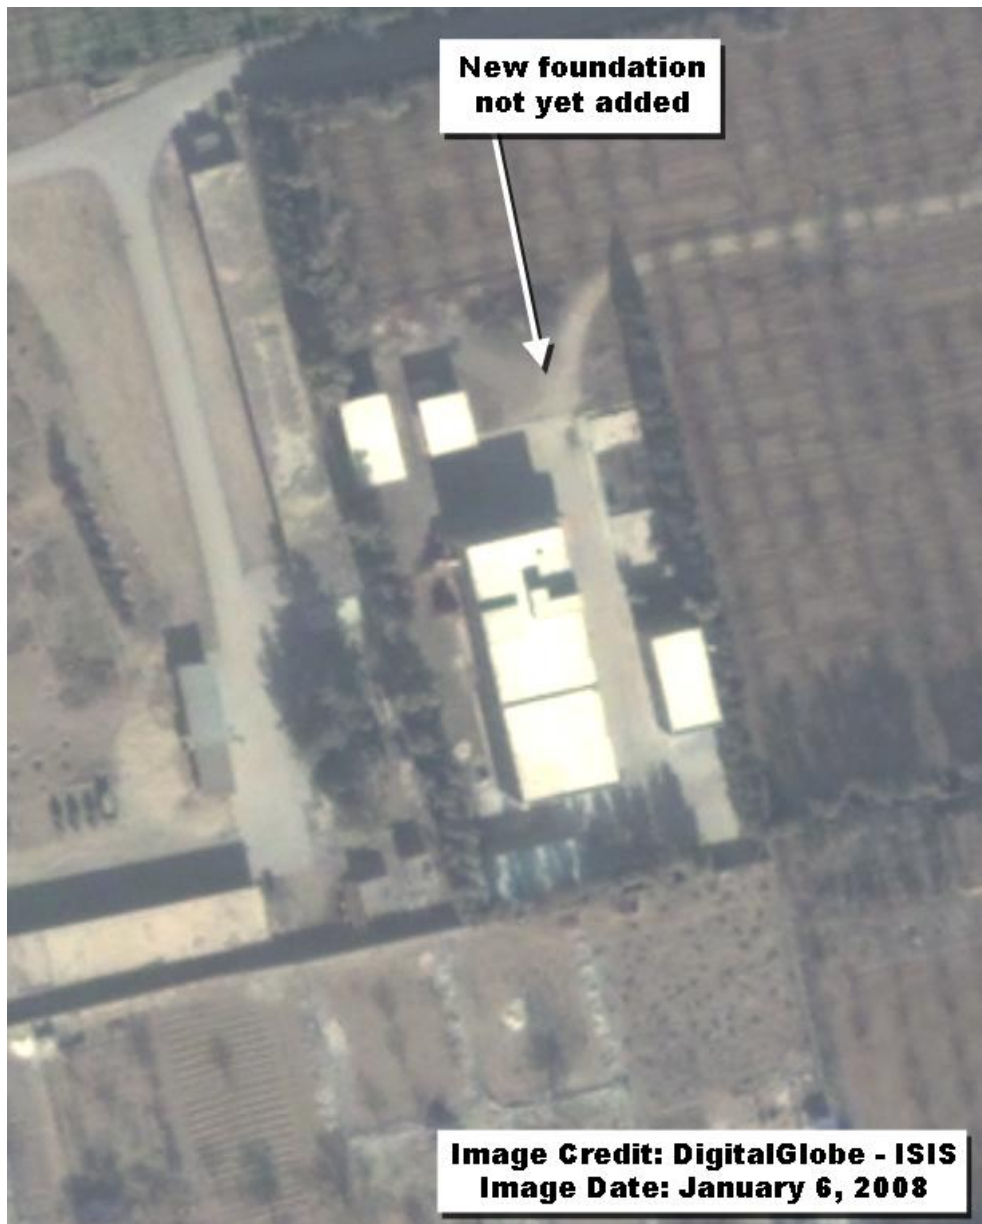
Figure 5. Image from January 6, 2008 shows that the new foundation has not yet been laid around the buildings as of this date. Syria paved the area surrounding the buildings sometime after this image date. Israel bombed the covert reactor construction site in early September 2007.

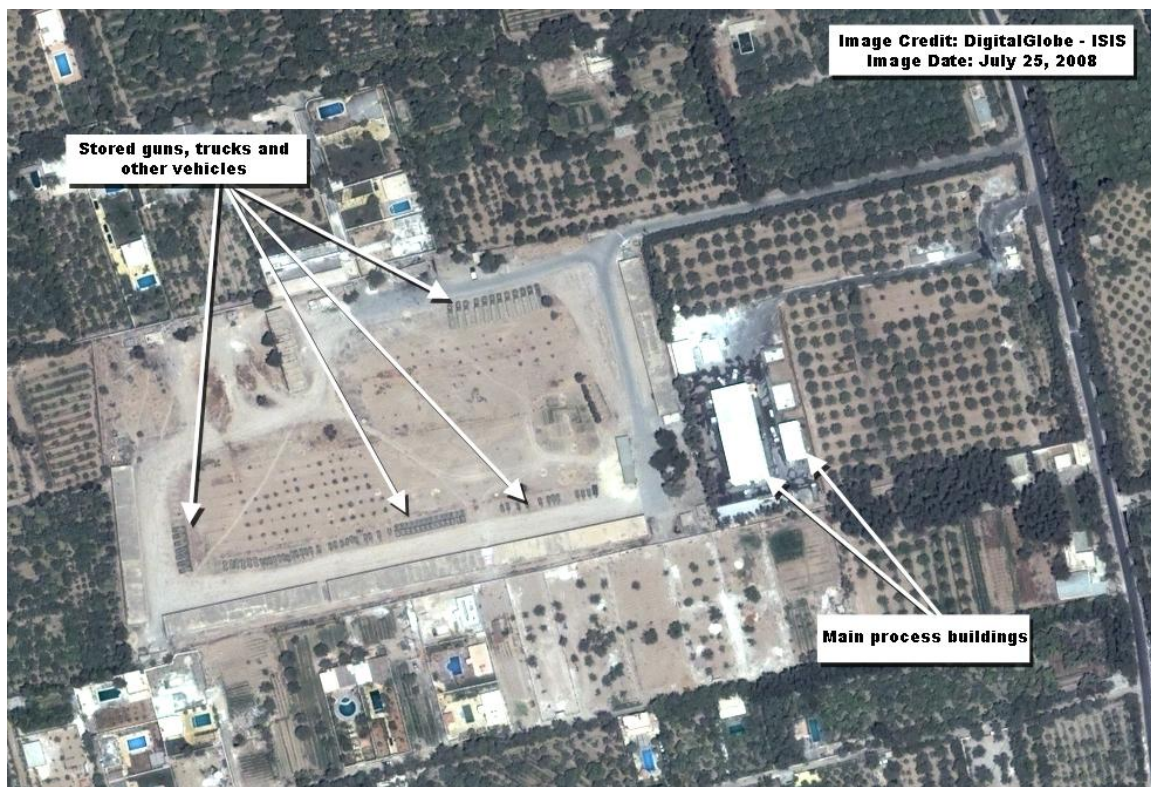
Figure 6. A wider view of the Marj as Sultan site. The main process buildings are seen located at the same site that appears to be a military storage depot. Large guns, trucks, and other vehicles can be seen stored outside.

As with the [site near Masyaf](#), the site near Marj as Sultan also appears co-located on a military storage depot, with stored military vehicles, trucks and large guns (see figure 6). Syria also laid a new foundation around the buildings at the suspect site near Masyaf, which can be seen by comparing commercial satellite imagery from before and after the May 2, 2008 request for access by the IAEA (see figure 7).

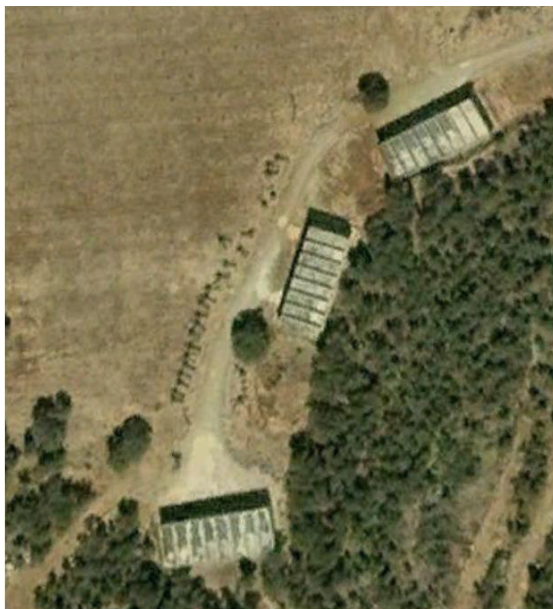
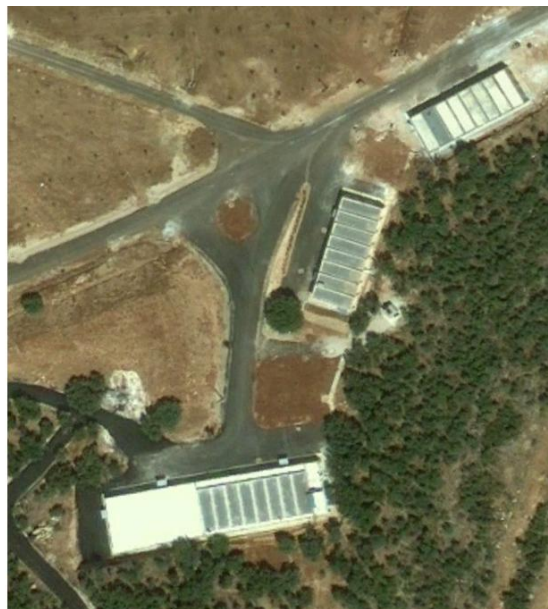
Figure 7. Image of one area of the Masyaf site from two different dates. The image shows a new foundation surrounding what appear to be storage buildings. The IAEA reported in November 2008 that it noticed in satellite imagery landscaping activities at the other suspect sites shortly after it requested to visit in early May 2008. Such landscaping activities could be aimed at defeating environmental sampling that the IAEA may carry out in the event of a visit.
