## April 2016: Monitoring Activities at Yongbyon Nuclear Site

By David Albright and Serena Kelleher-Vergantini

April 29, 2016

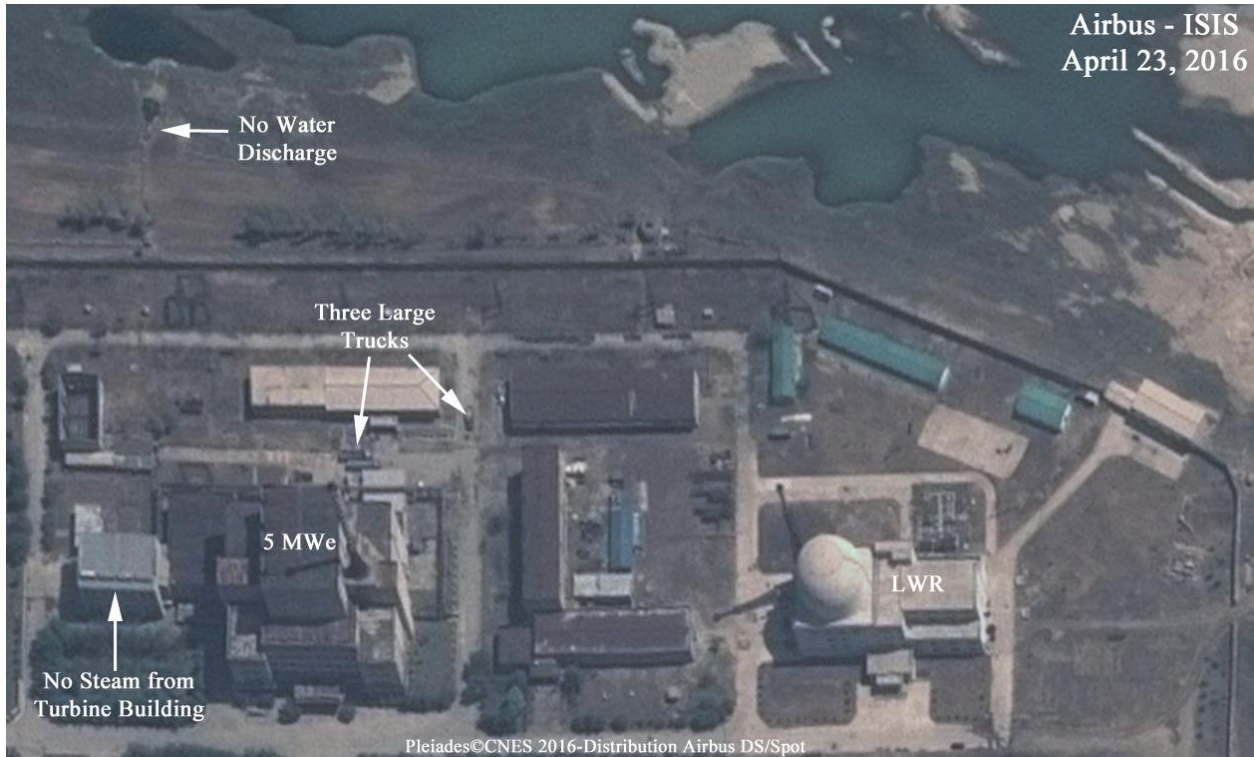
Airbus satellite imagery purchased and analyzed by ISIS shows no clear indicators that the 5 MWe reactor is operating at full power on April 23, 2016. As figure 1 shows, no water is visibly being discharged from the reactor's discharge pipeline and no steam is venting from the turbine building beside the reactor. However, the absence of these two indicators does not mean that the reactor is shutdown. ISIS estimates that the 5 MWe reactor has been operating intermittently or at low power since mid-2014.<sup>1</sup>

Nonetheless, the presence of three large trucks, two of which are very large open bed trucks parked in front of the reactor, implies that some sort of activity is taking place at the reactor building. However, the nature of this activity is unknown.

No significant external activities are visible at the site of the Experimental Light Water Reactor (LWR).

**Figure 1.** Airbus imagery showing North Korea's 5 MWe and LWR reactors on April 23, 2016.

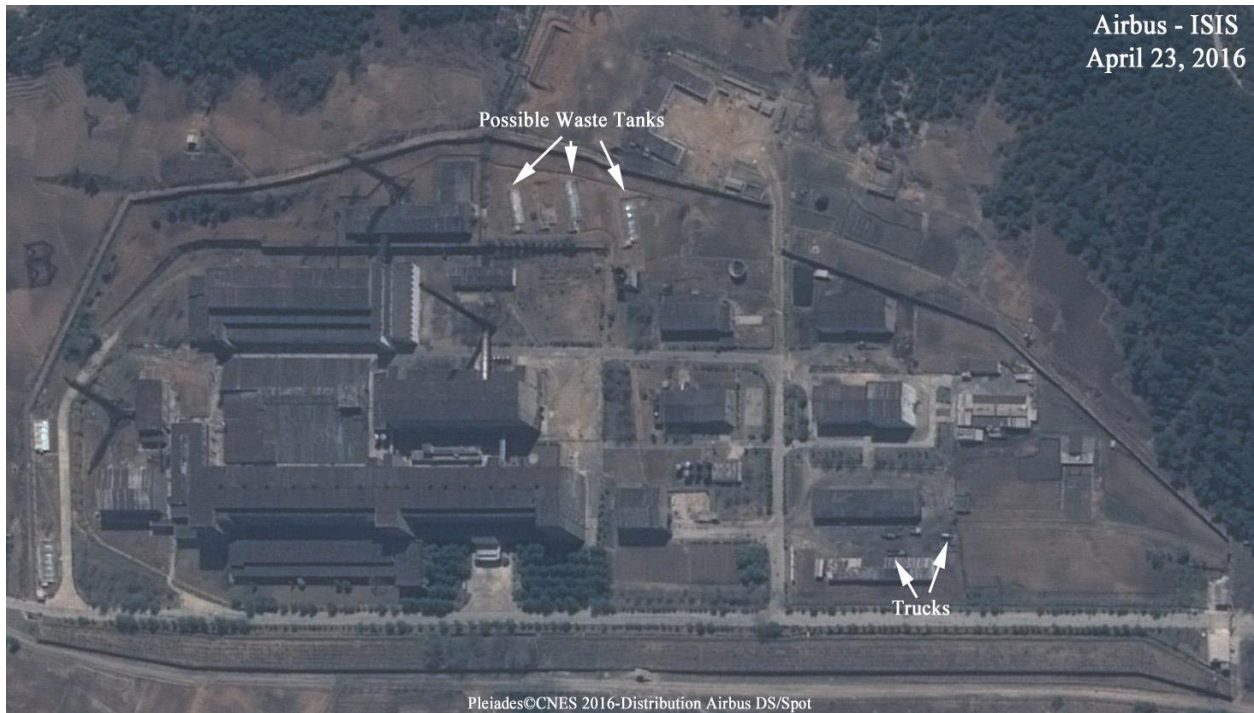
The Radiochemical Laboratory is the site where North Korea chemically processes newly discharged irradiated fuel from the 5 MWe reactor and separates plutonium for nuclear weapons. No external activity linked to the operational status of the reprocessing building is visible on April 23, 2016 (see figure 2).

However, there are two indicators of other external activity: three open bed trucks are visible at the site, while the three structures that had been previously [identified](#) by ISIS as possible waste tanks are being covered with soil. These structures are located at a site known to house underground nuclear waste tanks. In fact, it is possible that these structures are in fact waste tanks that were known to be

buried in this approximate location.<sup>2</sup> Therefore, North Korea may have uncovered these aged waste tanks. Although the reason for this activity is unknown, the excavation activities started in the fall of 2014, just after the 5 MWe reactor stopped full power operation, which had lasted from about August 2013 to June 2014. This could suggest that North Korea was renovating its nuclear waste disposal facilities at the Radiochemical Laboratory, possibly in anticipation of additional plutonium separation activities from irradiated fuel from the 5 MWe reactor that would generate more nuclear waste. Alternatively, the tanks may have required maintenance due to leaks or age.

**Figure 2.** Airbus imagery showing North Korea's Radiochemical Laboratory on April 23, 2016.

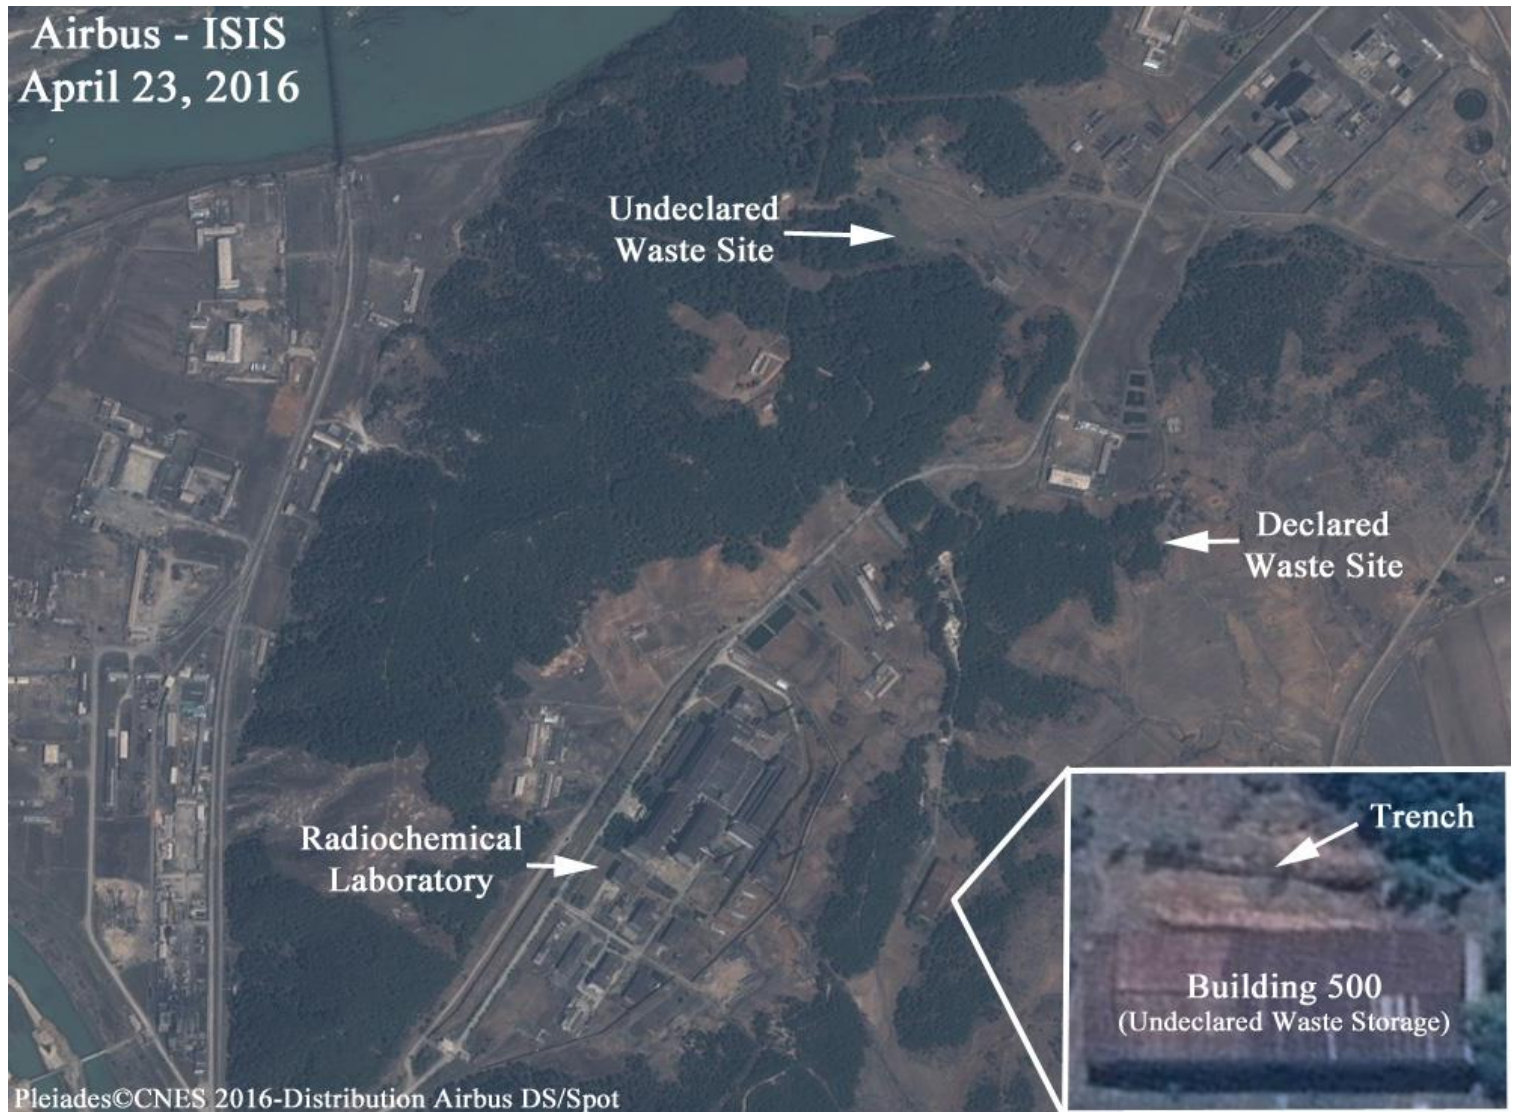
In April 2016, activity has been detected at one of North Korea's waste buildings. Figure 3 shows three nuclear waste sites within the Yongbyon nuclear complex, two of which were not declared to the IAEA. One of them is an undeclared waste storage building, also known as "Building 500," located on a hill immediately south of the Radiochemical Laboratory. This building was built in 1991 and has a vault in the basement divided into four pits for liquid waste storage tanks and six smaller compartments for storage of solid wastes. As figure 3 shows, between March 15 and April 4, 2016 a trench was dug next to this building. The purpose of this activity is unknown, but it raises many questions: is North Korea trying to create an access point for the waste stored in the basement vaults? If so, why? Are they renovating this waste storage facility? Are they trying to store more waste? Is it possible that after 15 years of storage the tanks and concrete cells are leaking?

A road connects the main entrance of Building 500 to the Radiochemical Laboratory and other parts of the Yongbyon complex. However, a smaller dirt road breaks off to allow access to the southern side of the building. This smaller dirt road has been present since early 2000, but its visibility has varied based on use. Between March and April 2016, this small dirt road became more visible, likely because it was more heavily used, probably by vehicles used to excavate the trench.

However, this is not the only alteration that has been visible at Building 500. Satellite imagery shows that in 2010 the roof of Building 500 started to change color. Interestingly, this color change only affected the southern half of the roof. It is very unclear what this color alteration signifies. One possibility is that this uneven color alteration is from corrosion caused by substances or processes inside the building. In 2012, this color alteration became even more pronounced, possibly meaning that corrosion worsened. An alternative explanation is that in 2012, North Korea may have replaced some of the panels on the side of the roof that had been affected by earlier corrosion. This uneven coloring of Building 500's roof persists today. Additionally, a small building beside Building 500 was demolished between April 2004 and March 2005.

No activity has been detected at the other two waste sites. One of these sites is located east of the Radiochemical Laboratory and was declared by North Korea as a radioactive waste storage. This site is believed to store only solid wastes and is probably used as a repository of low and intermediate level solid wastes from the entire Yongbyon nuclear complex.<sup>3</sup> Over the years, only the movement of some construction material has been spotted at this site, which is often covered by light vegetation. North of

this site is an undeclared waste site that may have been used earlier for storage of wastes from the reprocessing of targets from the IRT reactor. This site originally housed an above ground waste storage facility that North Korea covered in about 1992. The facility originally had vaults containing two large liquid waste tanks and several compartments for storing solid waste. Evidence associated with the recovery of small amounts of plutonium produced in the IRT reactor is suspected of being buried here.<sup>4</sup> No activity has taken place at this site since 2003, when the roads leading to this site were heavily used. The site is often covered with light vegetation.

Figure 3. Airbus imagery showing three waste facilities on April 23, 2016.

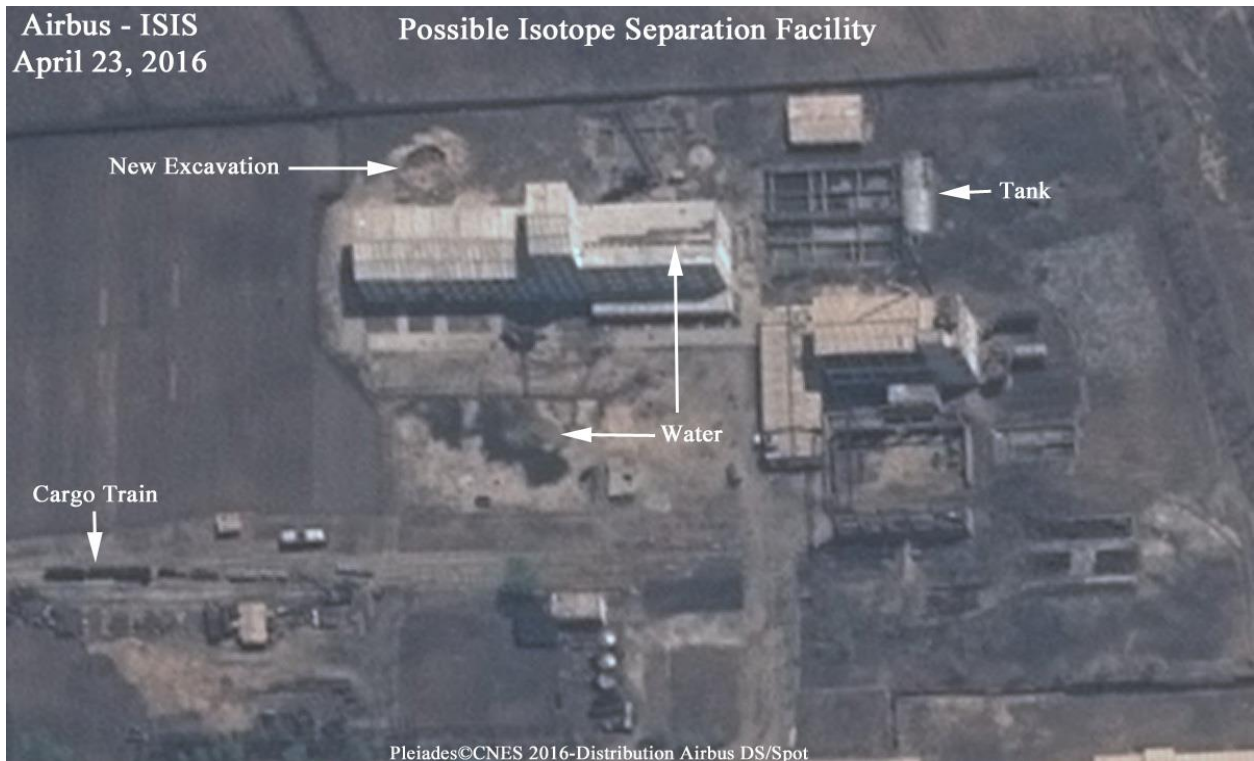
As of April 23, 2016, several signatures of external activity are visible at a site ISIS identified as a possible isotope separation facility, located east of the Yongbyon fuel fabrication complex. Additional water discharge is visible in front of, and on top of, the main building at the site (see figure 4). Additionally, circular-shaped excavation is taking place next to the main building. Its purpose is unknown.

This site presents signatures consistent with an isotope separation facility, including tritium separation.<sup>5</sup>

**Figure 4.** Airbus imagery showing the possible isotope separation facility at Yongbyon on April 23, 2016.

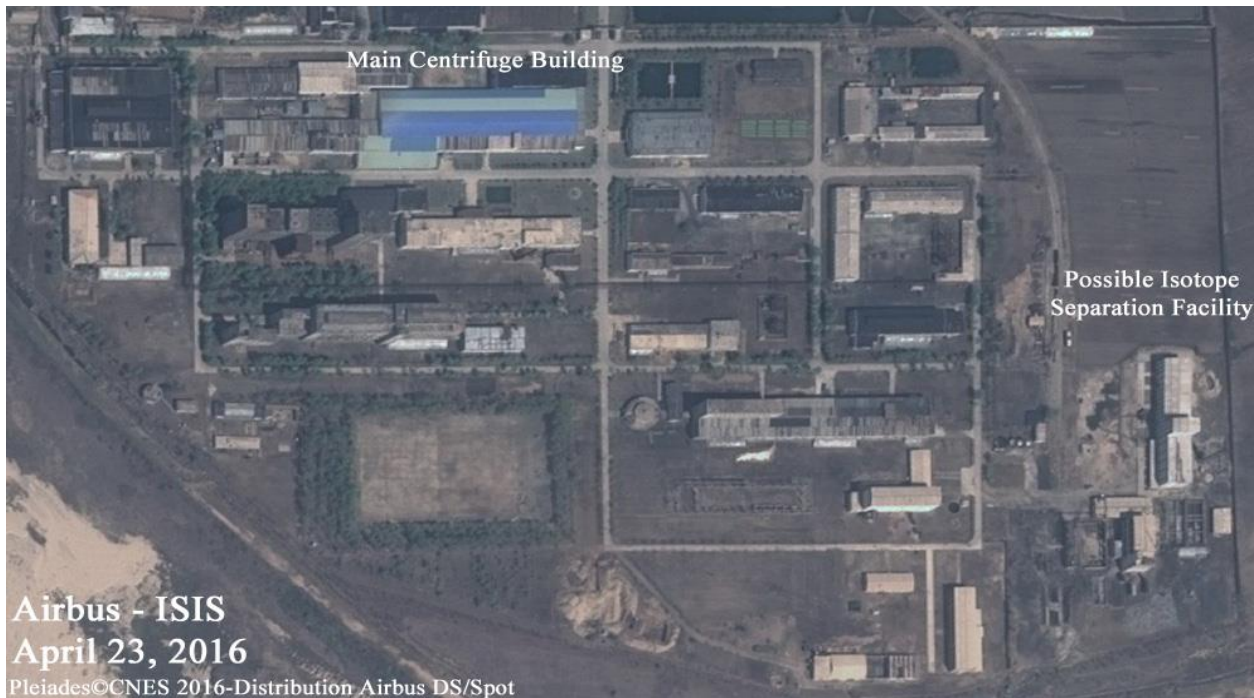
No significant external activity is taking place at North Korea's uranium enrichment facility.

**Figure 5.** Airbus imagery showing North Korea's fuel fabrication facility and centrifuge enrichment building on April 23, 2016.
