# Monitoring Developments at North Korea's Yongbyon Nuclear Site

By David Albright and Serena Kelleher-Vergantini

March 4, 2016

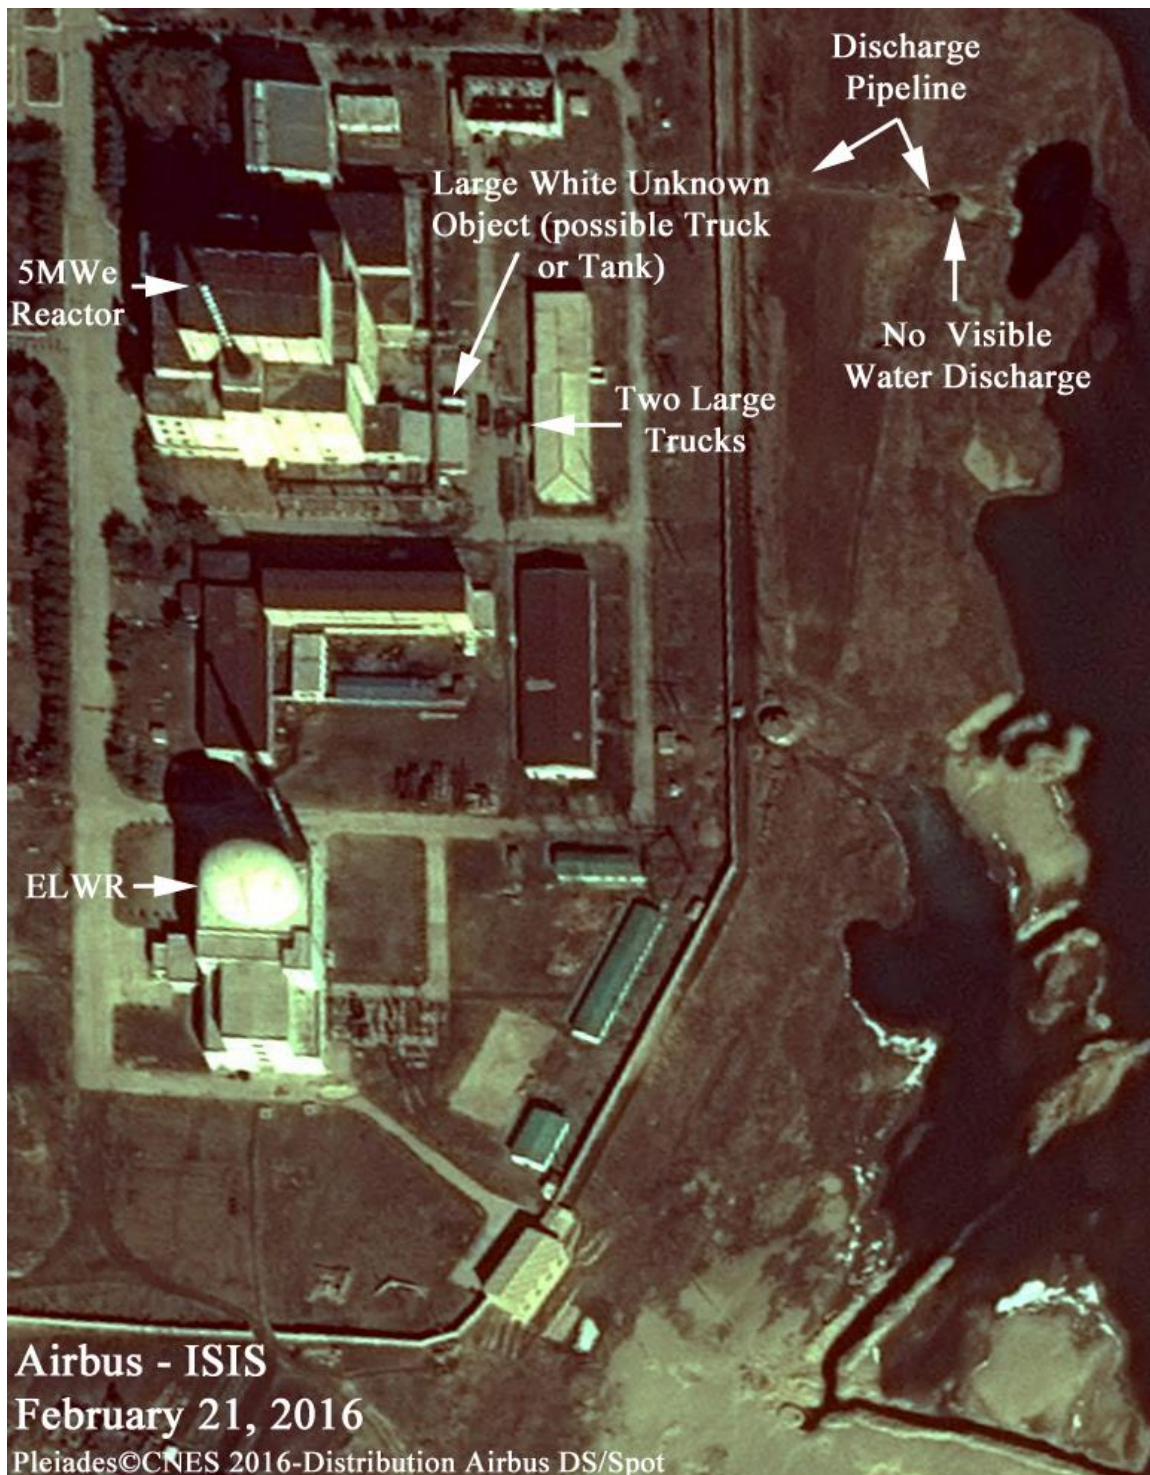
Analysis of recent Airbus satellite imagery dated February 21, 2016 shows that no water is visibly being discharged from the 5MWe reactor's discharge pipeline, and no steam is venting from the turbine building (see figure 1). Thus, there are no clear indicators in this image that the reactor is operating at full power. However, the absence of these two indicators is in line with ISIS's previous assessments that the reactor has been operating intermittently or at low power (see [here](#)). On some dates, there has been evidence of steam venting or small amounts of water discharge (visible in snow melt), and on other dates, no such evidence.

The image shows the movement of large vehicles and objects at the 5 MWe reactor (see figure 1). Two large trucks and a large 6 meter by 2 meter rectangular-shaped white object, which is either a truck or a tank, are visible at the entrance of the 5 MWe reactor. The purpose of the trucks could not be determined.

**Figure 1.** Airbus imagery showing the status of North Korea's 5 MWe and ELWR reactors on February 21, 2016.

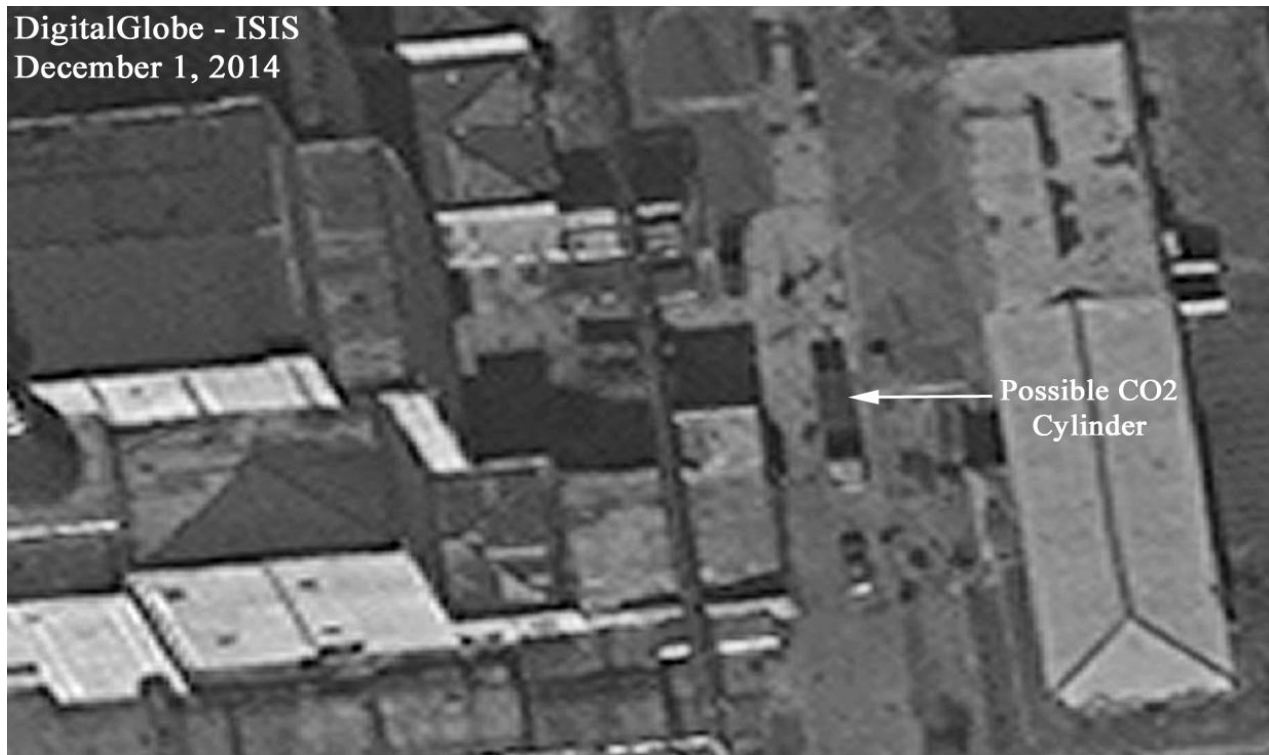
The reactor is cooled by carbon dioxide (CO<sub>2</sub>) gas, which needs periodic replenishment. Figure 2 shows a possible carbon dioxide tank on a truck next to the reactor on December 1, 2014 (see report [here](#)). The carbon dioxide is believed to be produced at a nearby facility that makes a number of gases for the nuclear program. Figures 3 and 4 show a possible site of this gas plant that is about 10.5 kilometers south of the 5 MWe reactor. This is a new site identification and comments are welcome. We are still unable to identify the method North Korea uses to make carbon dioxide.

**Figure 2.** Digital Globe imagery showing North Korea's Yongbyon 5 megawatt-electric (MWe) reactor and a truck carrying a possible CO<sub>2</sub> cylinder on December 1, 2014.

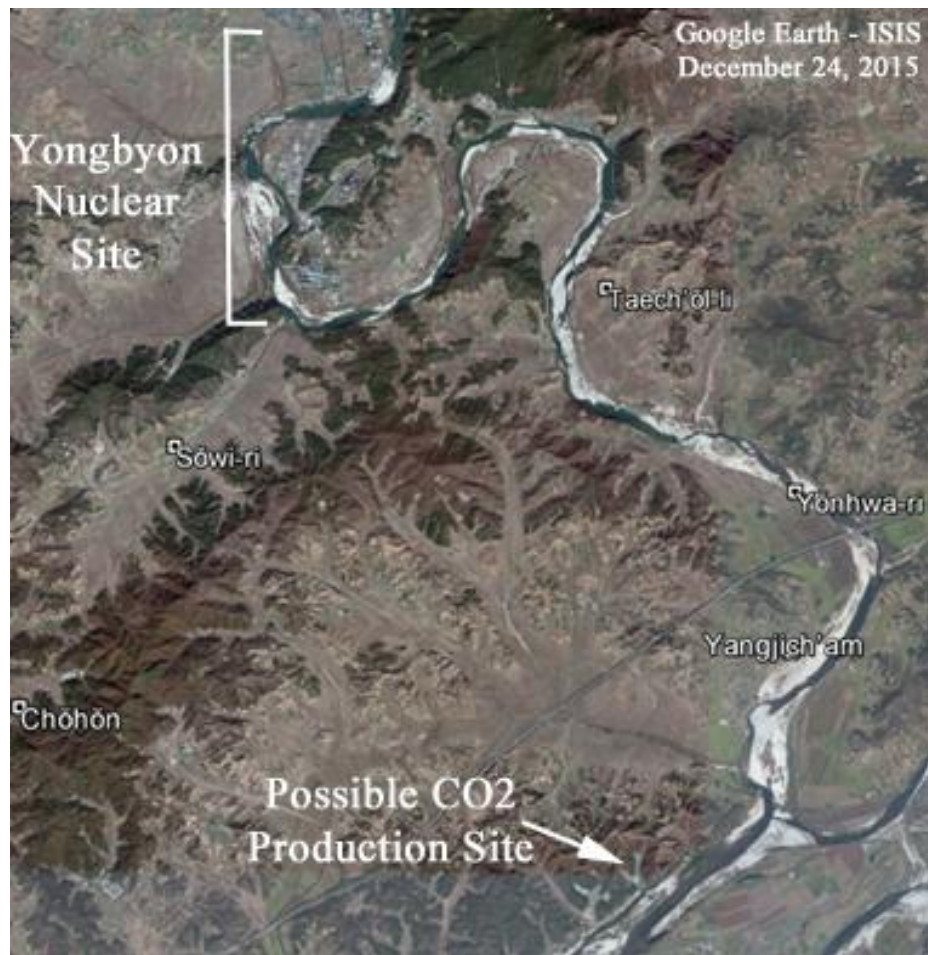
**Figure 3.** Google Earth imagery showing the possible location of North Korea's CO<sub>2</sub> production plant in reference to the Yongbyon Nuclear Site.

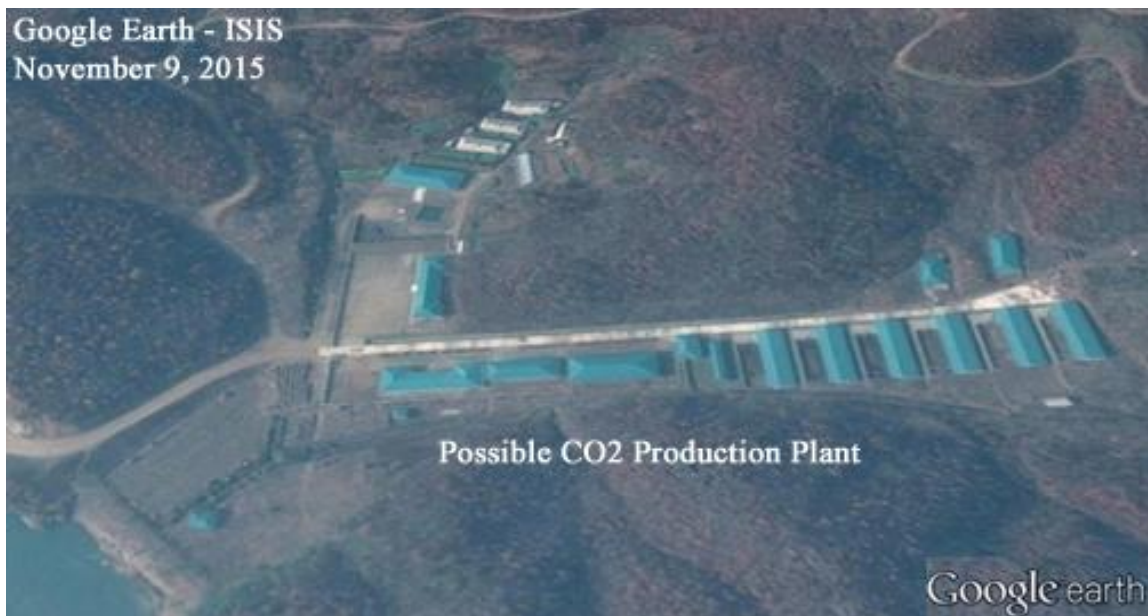
**Figure 4.** Google Earth imagery showing the possible location of North Korea's CO<sub>2</sub> production plant.

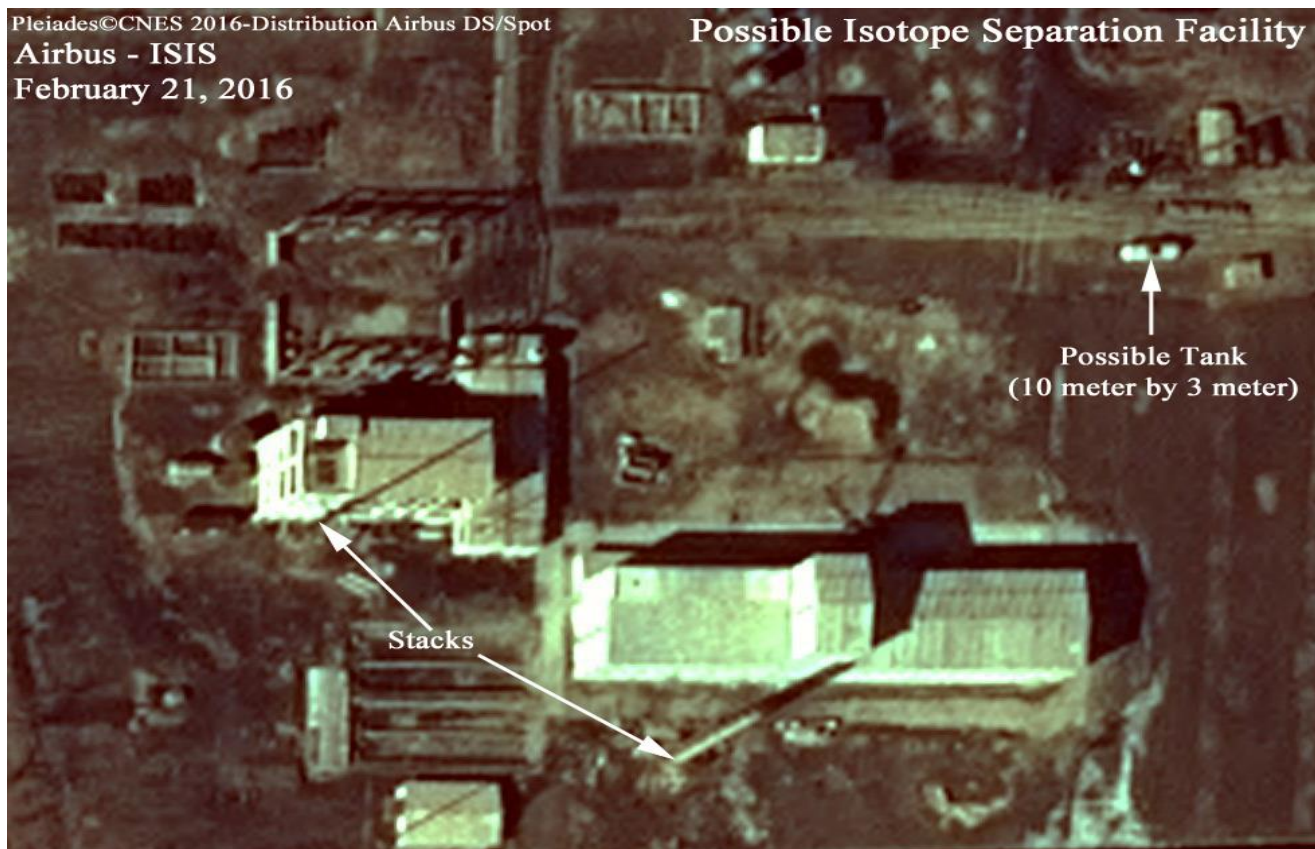
ISIS has assessed that a site, which is close to the Yongbyon fuel fabrication complex, presents signatures consistent with an isotope separation facility, including tritium separation (see earlier studies in [April](#) and [September 2015](#)). The February 21, 2016 image also shows that construction activity has continued at the site. The new imagery shows that external construction and clean-up activities continue, and a large 10 meter by 3 meter rectangular-shaped white object is present near the train tracks adjacent to this site (see figure 5). This object presents signatures consistent with a large tank.

**Figure 5.** Airbus imagery showing the status of North Korea's possible Isotope Separation Facility on February 21, 2016.

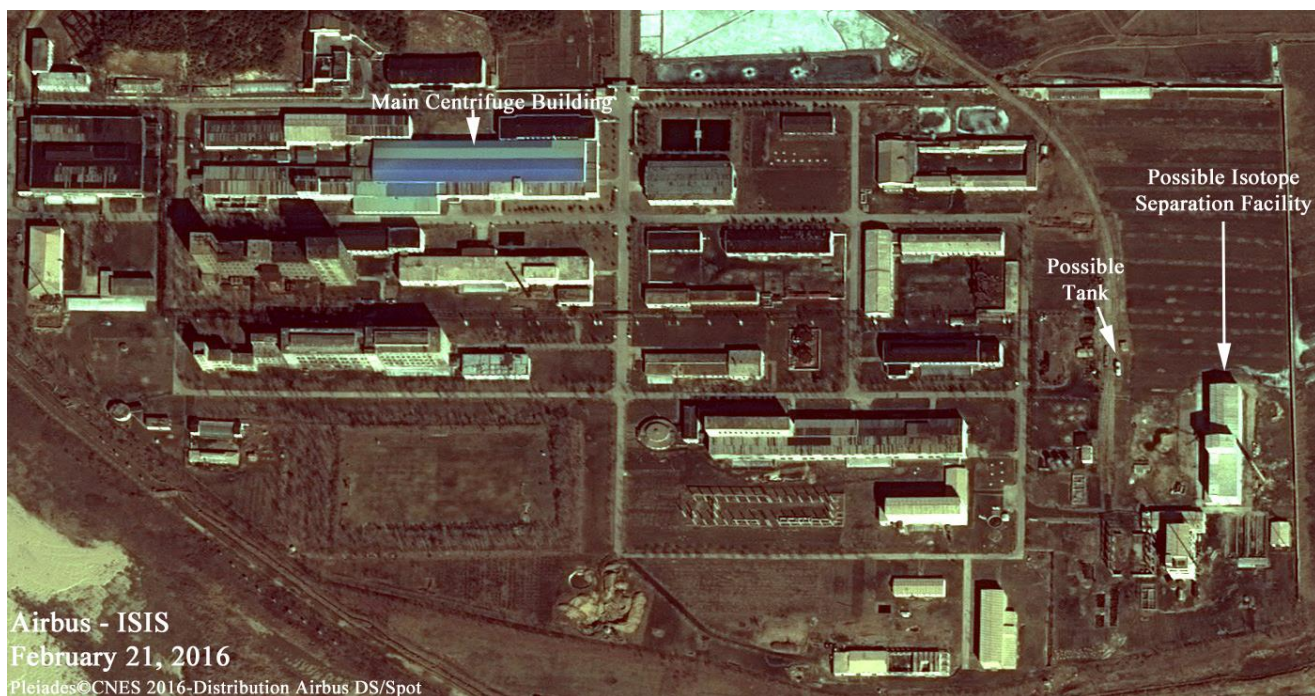
**Figure 6.** Airbus imagery showing the status of North Korea's Fuel Fabrication Facility and possible Isotope Separation Facility on February 21, 2016.
