January 28, 2010

## Exploring Claims about Secret Nuclear Sites in Myanmar

By Robert Kelley, Andrea Scheel Stricker, and Paul Brannan

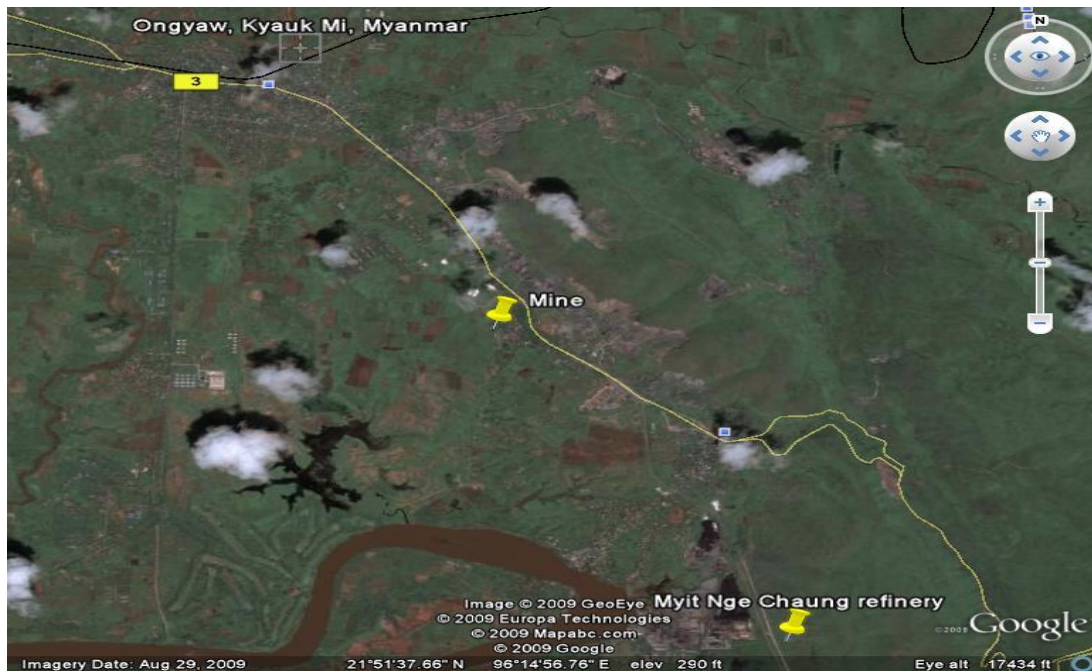
**Figure 1: Google Earth image from August 29, 2009 showing the location of the Myit Nge Chaung facility, the associated mine, and the town of Ongyaw, Kyauk Mi. DictatorWatch claims that the Myit Nge Chaung facility is a uranium refinery.**

promoting democracy in Burma and China, and later supported by Desmond Ball and Phil Thorton in an August 2009 *Sydney Morning Herald* report.<sup>2</sup> The refinery, or mill, lies on the Myit Nge River 14.5 miles southeast of Mandalay and 17.7 miles northeast of Kyaukse, hereafter referred to as the Myit Nge Chaung site. The mine is located about 1.5 miles to the northwest of the refinery. The closest village is Ongyaw to the north of the mine (see figure 1). Examination of the images and comparison to open source information makes it very unlikely that it is a uranium mining and refining operation.

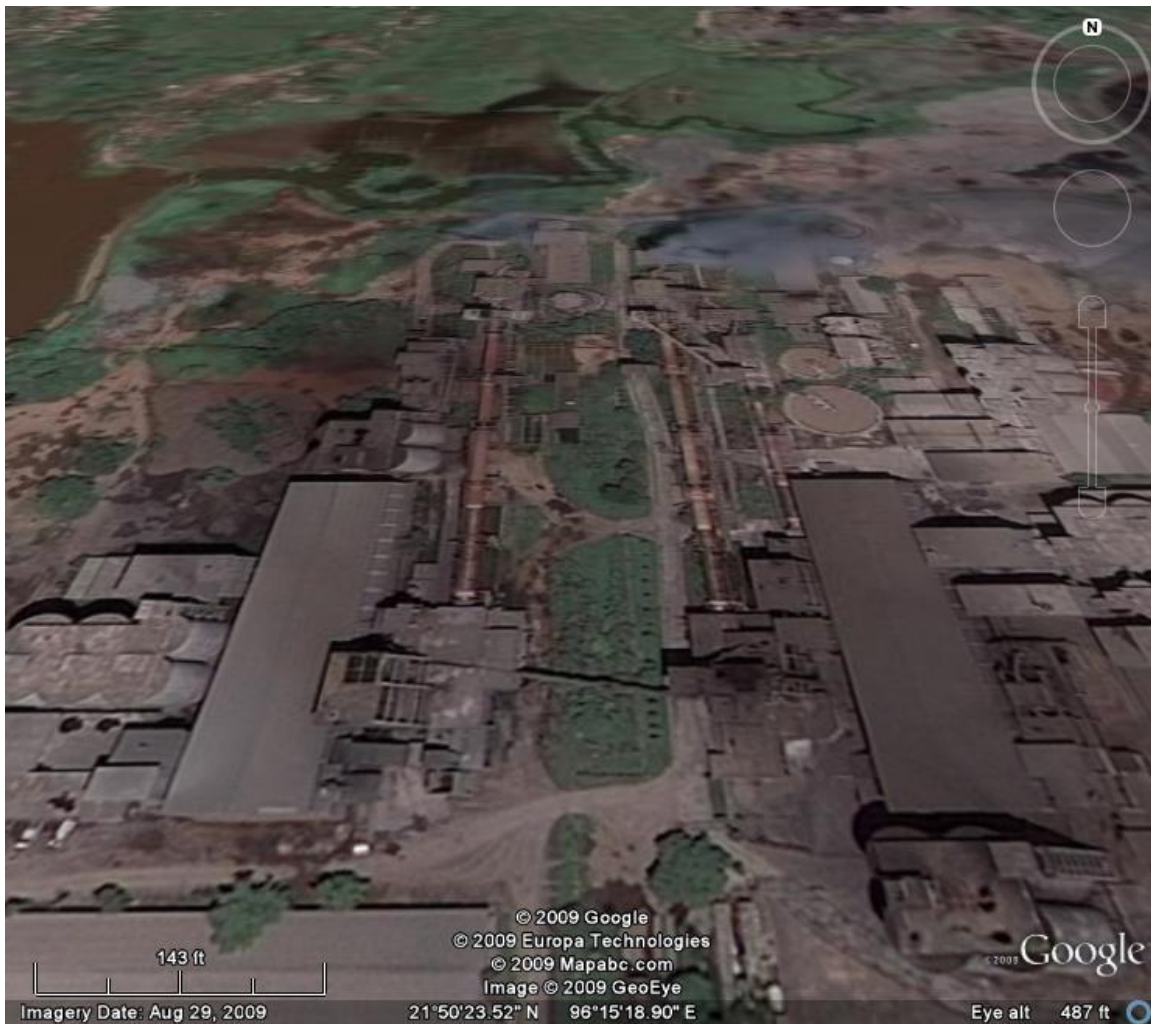
**Figure 2: Close-up of Google Earth image of the Myit Nge Chaung facility from August 29, 2009. It shows distinctive characteristics of a cement plant**

ISIS assesses that the Myit Nge Chaung refinery is a cement plant on the Mandalay to Pyin Oo Lwin road, National Highway 3 (see figure 2). The plant is very large for any small clandestine uranium operation in Burma. The mill is also typical of a cement plant in several key ways. It has very large rotary kilns, which are used to roast the limestone feed materials to produce cement. This is not done for uranium but is done for many other metals and cement preparation. There is a large pile of coal or coal ash north of the plant, which is probably the fuel used in the rotary kilns. The site also has many vertical bulk silos. Silos are used for handling solid powders in industrial operations.

A uranium mill extracting uranium from rock ore would have many more signatures of liquid processing, such as crushers, thickeners, solvent extraction columns and a prominent liquid waste pond. These signatures are absent. Uranium can be extracted from phosphates in fertilizer operations. This is clearly not a phosphate fertilizer plant.

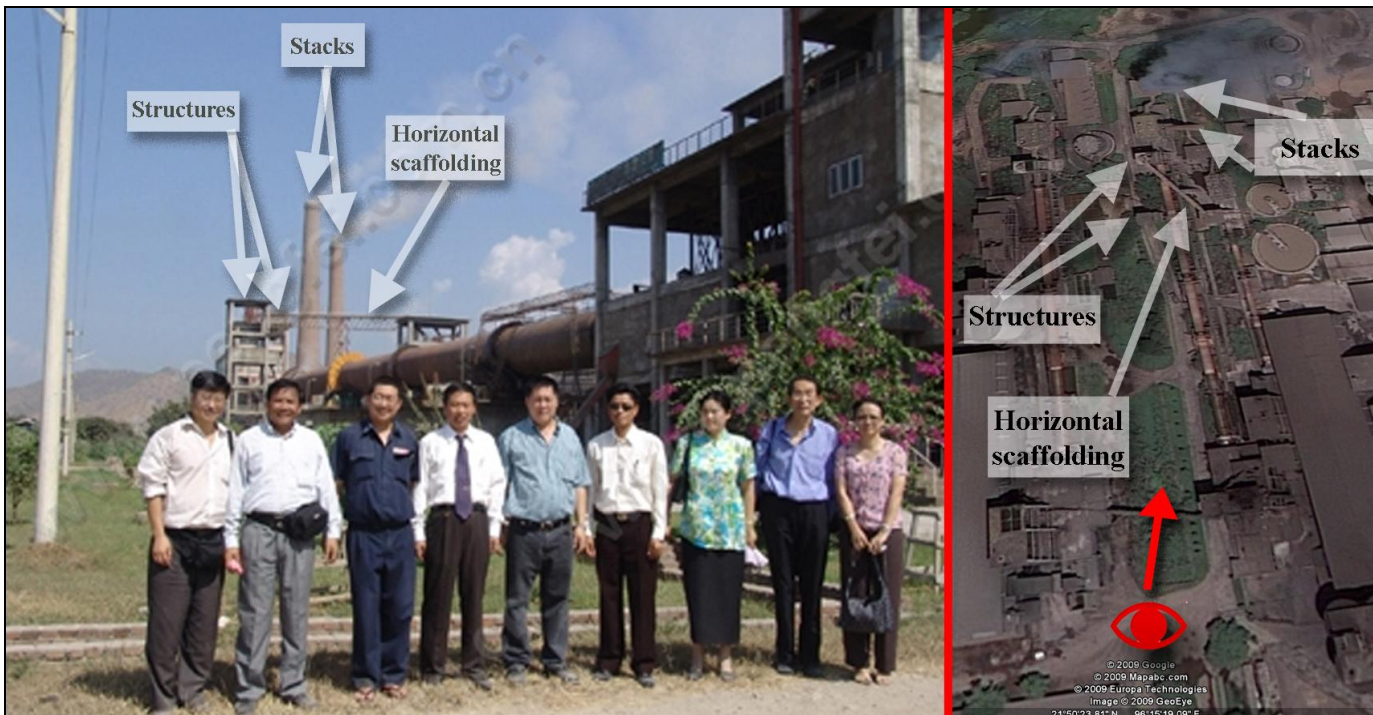
Figure 3. On the left, a ground photograph of the AAA Cement Plant in Myanmar<sup>3</sup>. On the right, a GoogleEarth satellite image of the Myit Nge Chaung site. The location of stacks, piping and structures appear to correspond between the two images.

In addition, the mill matches characteristics in a ground photograph of the AAA Cement Plant, also called the Triple A Cement Plant (see figure 3). Piping, structures, scaffolding and stacks appear in the same positions between the two pictures.

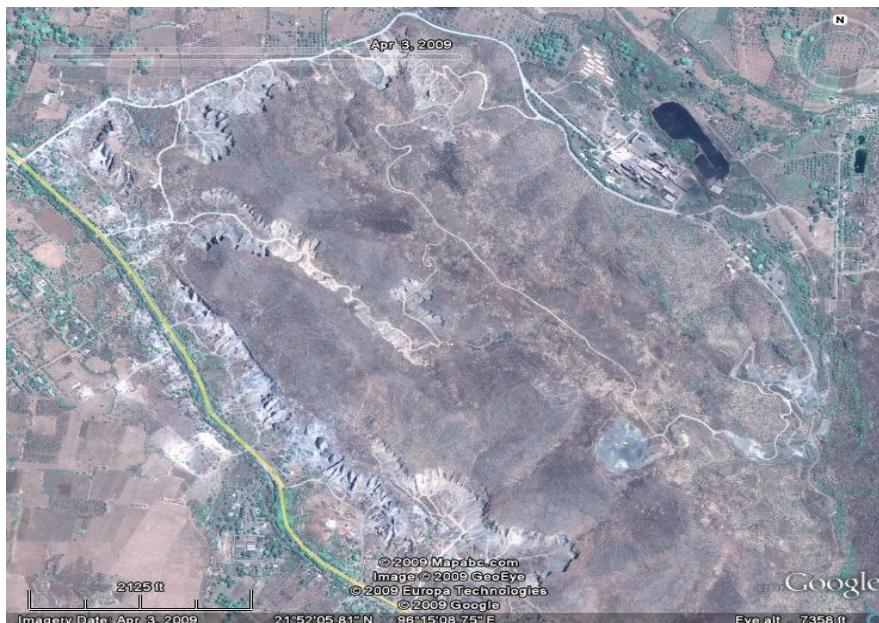
Figure 4: Google Earth image from April 3, 2009 showing the large mining operation 1.5 miles northwest of the Myit Nge Chaung site.

ISIS also assesses that the mine north of the Myit Nge Chaung site is not likely a uranium mine (see Figure 4). It is not possible to conclusively identify the ores being mined from the overhead photo signatures. Nevertheless, the mine looks more like a quarry where bulk material is identified by its general characteristics and removed by diggers and buckets. The light colored material could easily be limestone.

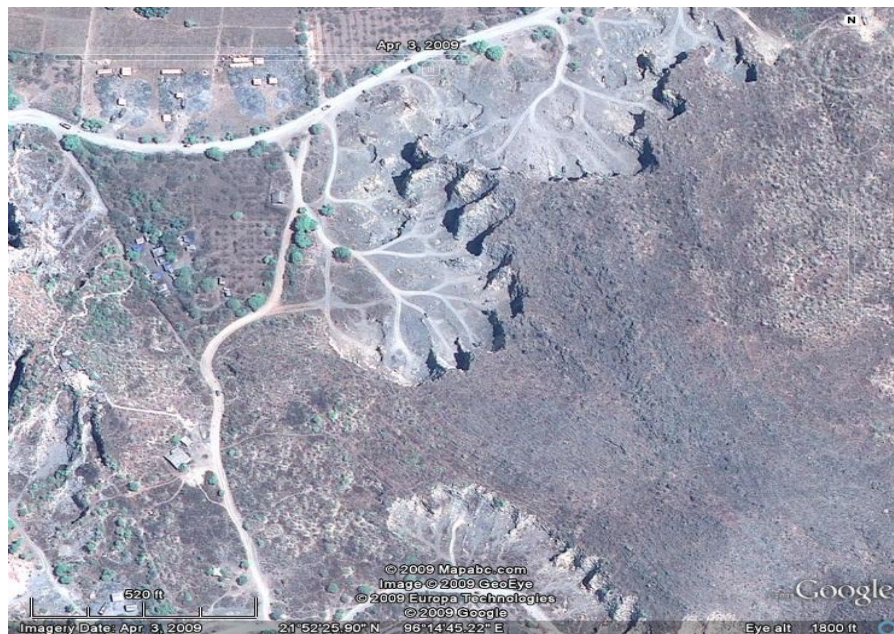
Figure 5: Google Earth close-up of the same area from April 3, 2009 showing the simplistic piecemeal mining technique not characteristic of uranium mining.

The mountain where mining is taking place is apparently homogeneous and is being mined from all sides (see Figure 5). This has resulted in the mountain being scraped away piecemeal at all sides rather than by modern open pit mining techniques--which is one type of technique expected at a uranium mine.
