## **What is North Korea building in the area of the destroyed cooling tower? It bears watching.**

By David Albright and Paul Brannan

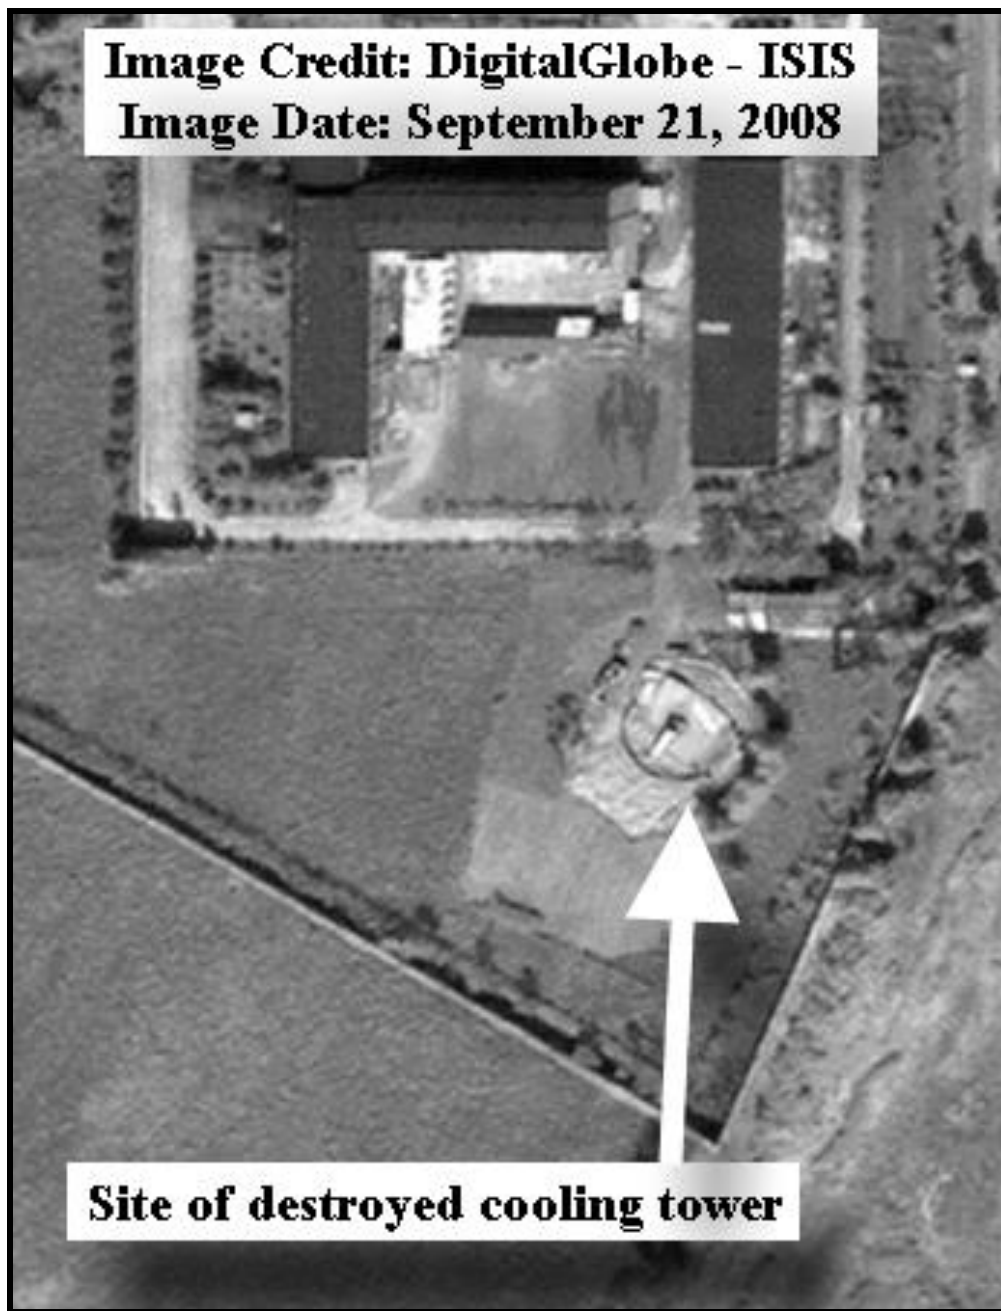
Figure 2. September 21, 2008 DigitalGlobe satellite image of the same site. Only the remaining foundation of the destroyed cooling tower can be seen.

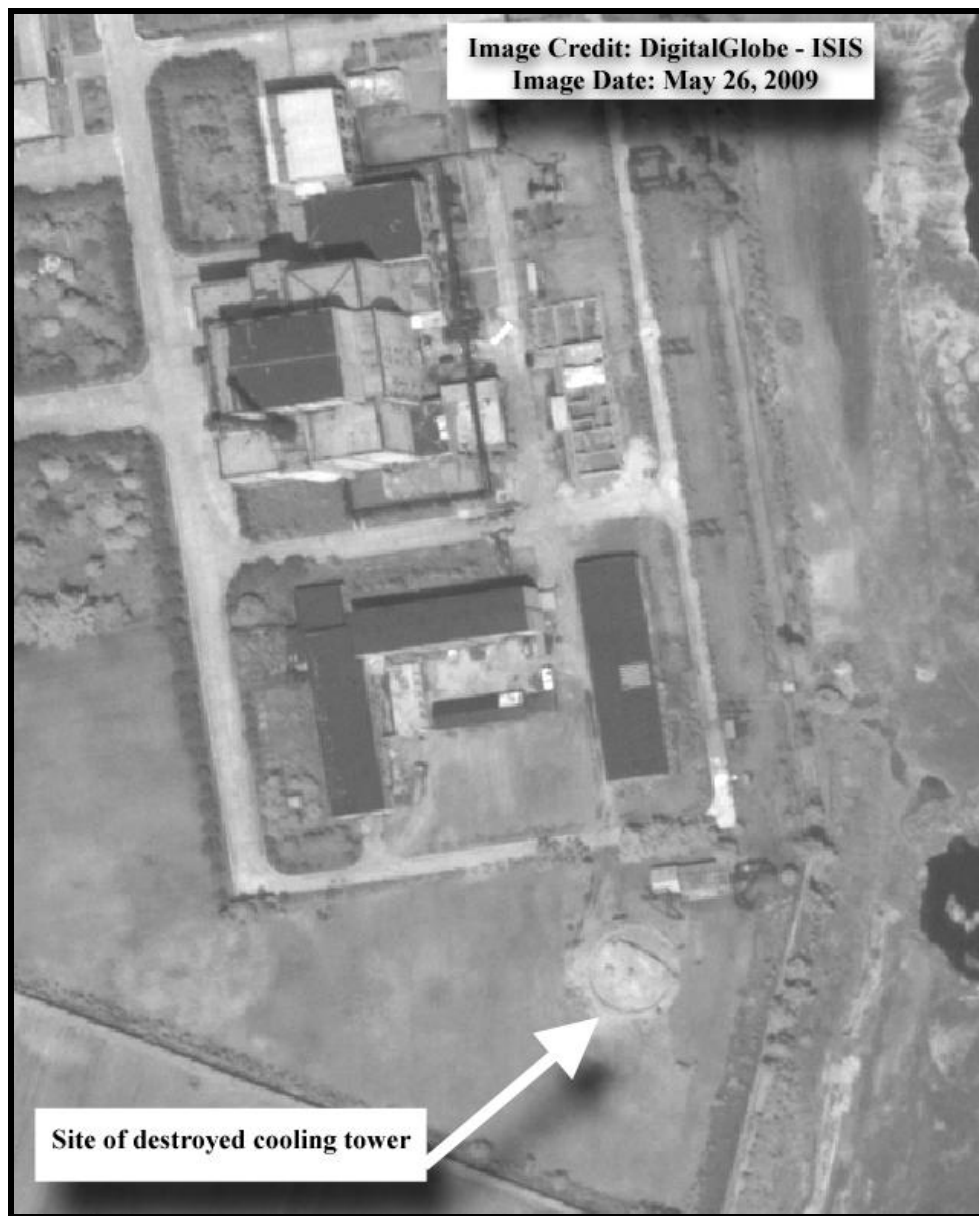
Figure 3. May 26, 2009 DigitalGlobe satellite image of the same site. Only the remaining foundation of the destroyed cooling tower can be seen.

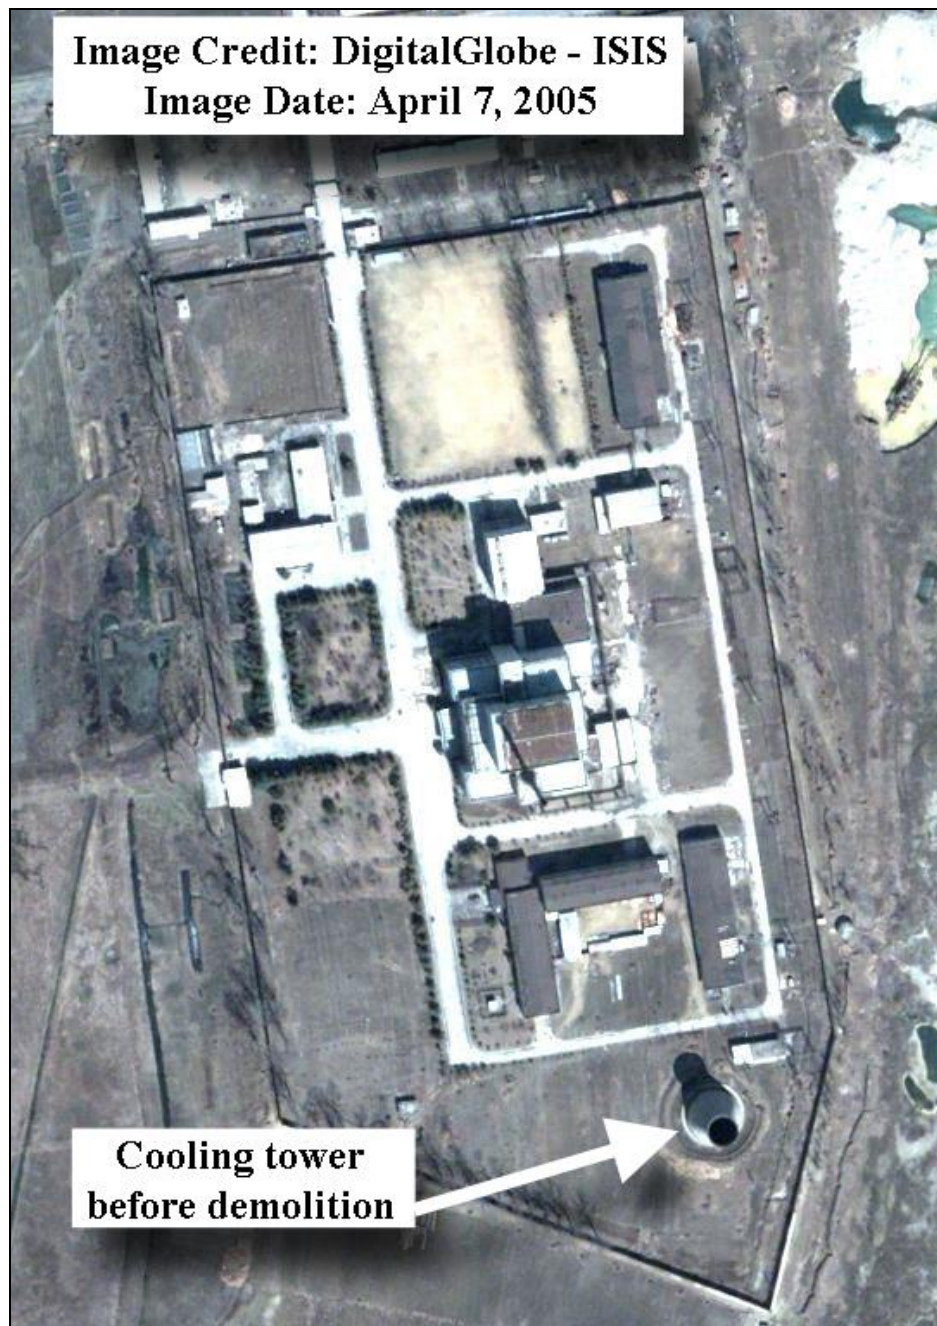
Figure 5. April 7, 2005 DigitalGlobe satellite image of the reactor site before the cooling tower was demolished
