New Satellite Imagery of Iranian Nuclear Sites on Google Earth

October 11, 2011

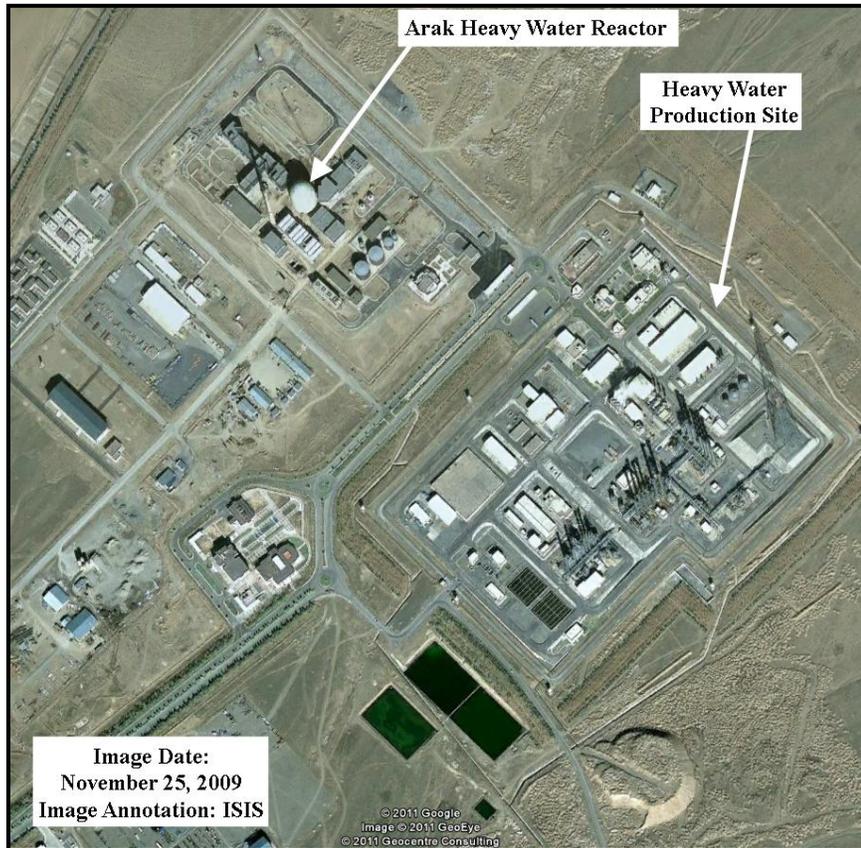
Figure 1. The Arak reactor and heavy water production site in November 25, 2009.

Over the last several months, Google Earth has posted updated commercial satellite imagery over Iran which includes several nuclear sites. [New imagery](#) from June 22, 2010 covers the Arak heavy water reactor and heavy water production facility. Compared with [earlier imagery](#) from November 2009, also available on Google Earth, there do not appear to be major external changes at either the reactor site or the heavy water production facility—though construction continues inside the buildings (see figures 1 and 2). Assorted construction activity at heavily guarded sites along the mountainside adjacent to the Arak site, such as [here](#) and [here](#), continues.

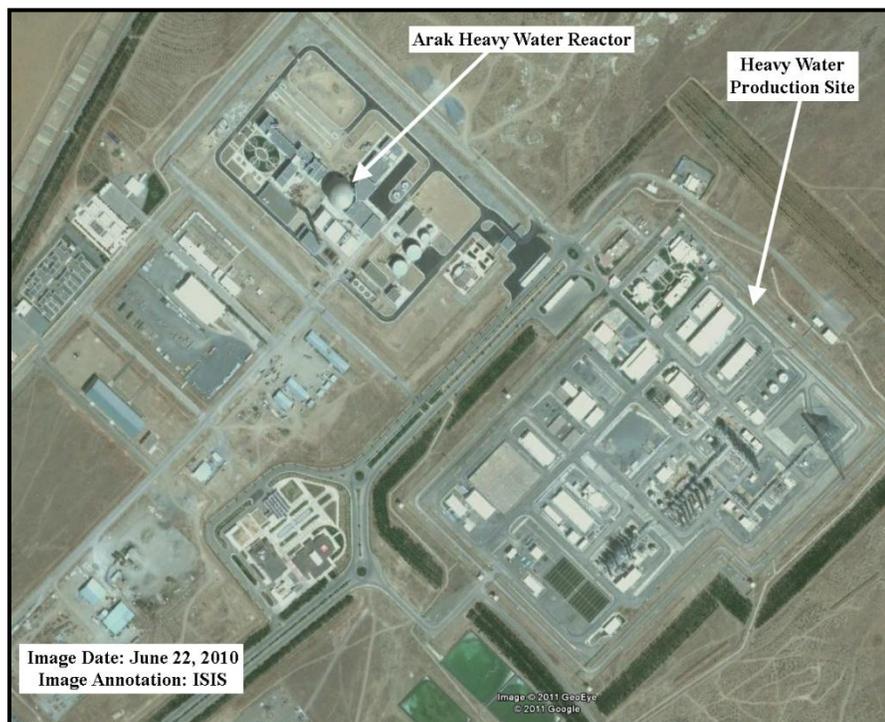
Figure 2. Arak reactor and heavy water production site in new Google Earth imagery June 22, 2010. There do not appear to be major external changes to the site—though construction inside the buildings is ongoing.

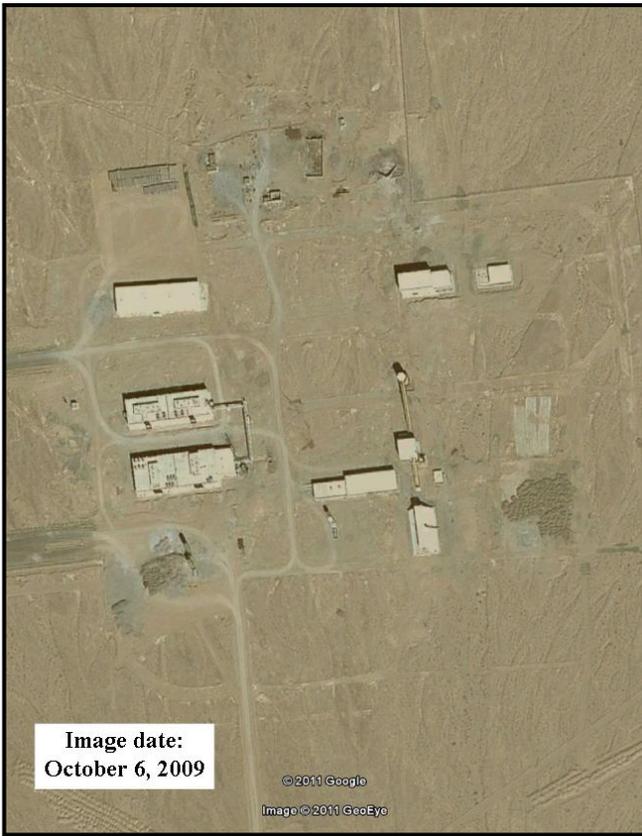
Figure 5. Ardakan yellowcake production facility under construction in this October 6, 2009 satellite image.

In August 2011, Google Earth added imagery from March 6, 2011 of the [Ardakan yellowcake production plant](#). The facility is being constructed very slowly, with few buildings added each year. Comparing the new imagery to a picture from October 2009, a few more buildings have been constructed (see figures 5 and 6). Two large square excavations can be seen [here](#) (see figure 7). One or both of these excavations could be for a tailings pond. A building towards the south of the site, under construction in previous imagery, now [appears to be a hardened facility](#) (see figures 8 and 9).

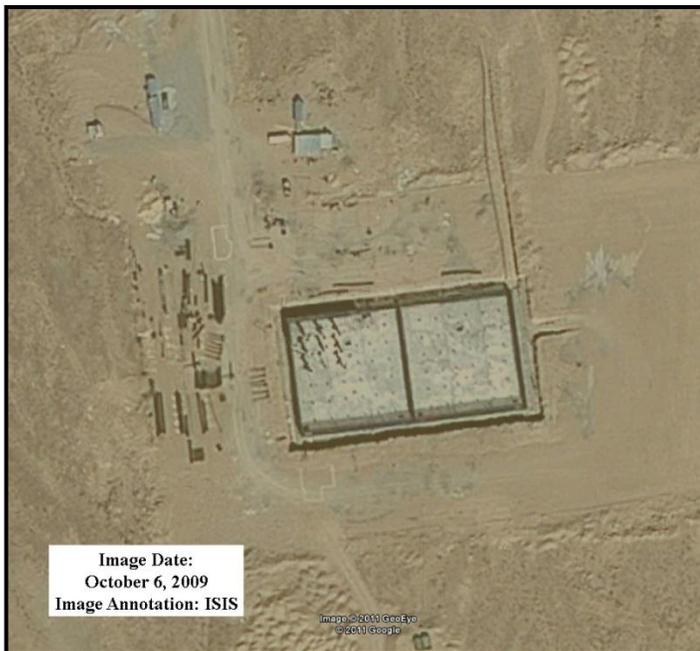
Figure 8. October 6, 2009 satellite image shows building under construction at southern end of Ardakan site.

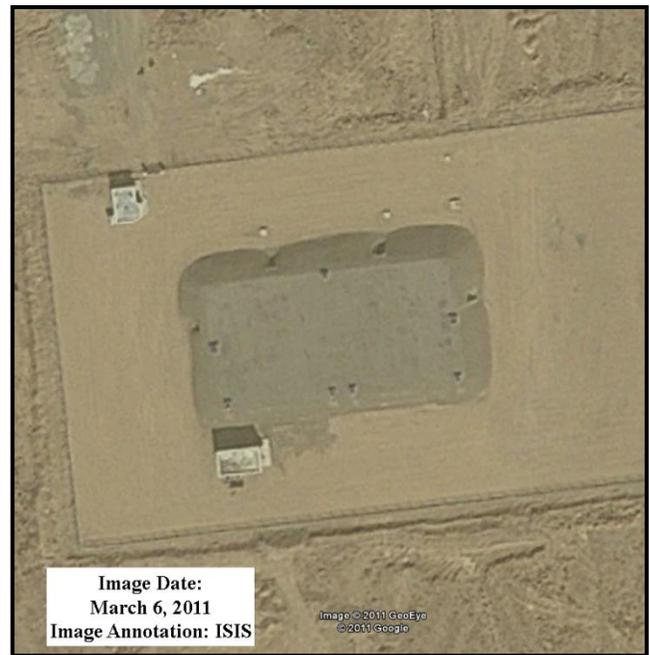
Figure 9. March 6, 2011 satellite image showing the hardened facility.
