June 20, 2012

### **Suspected Clean-Up Activity Continues at Parchin Military Complex: Considerable Dirt Movement Near Suspect Building**

by David Albright and Robert Avagyan

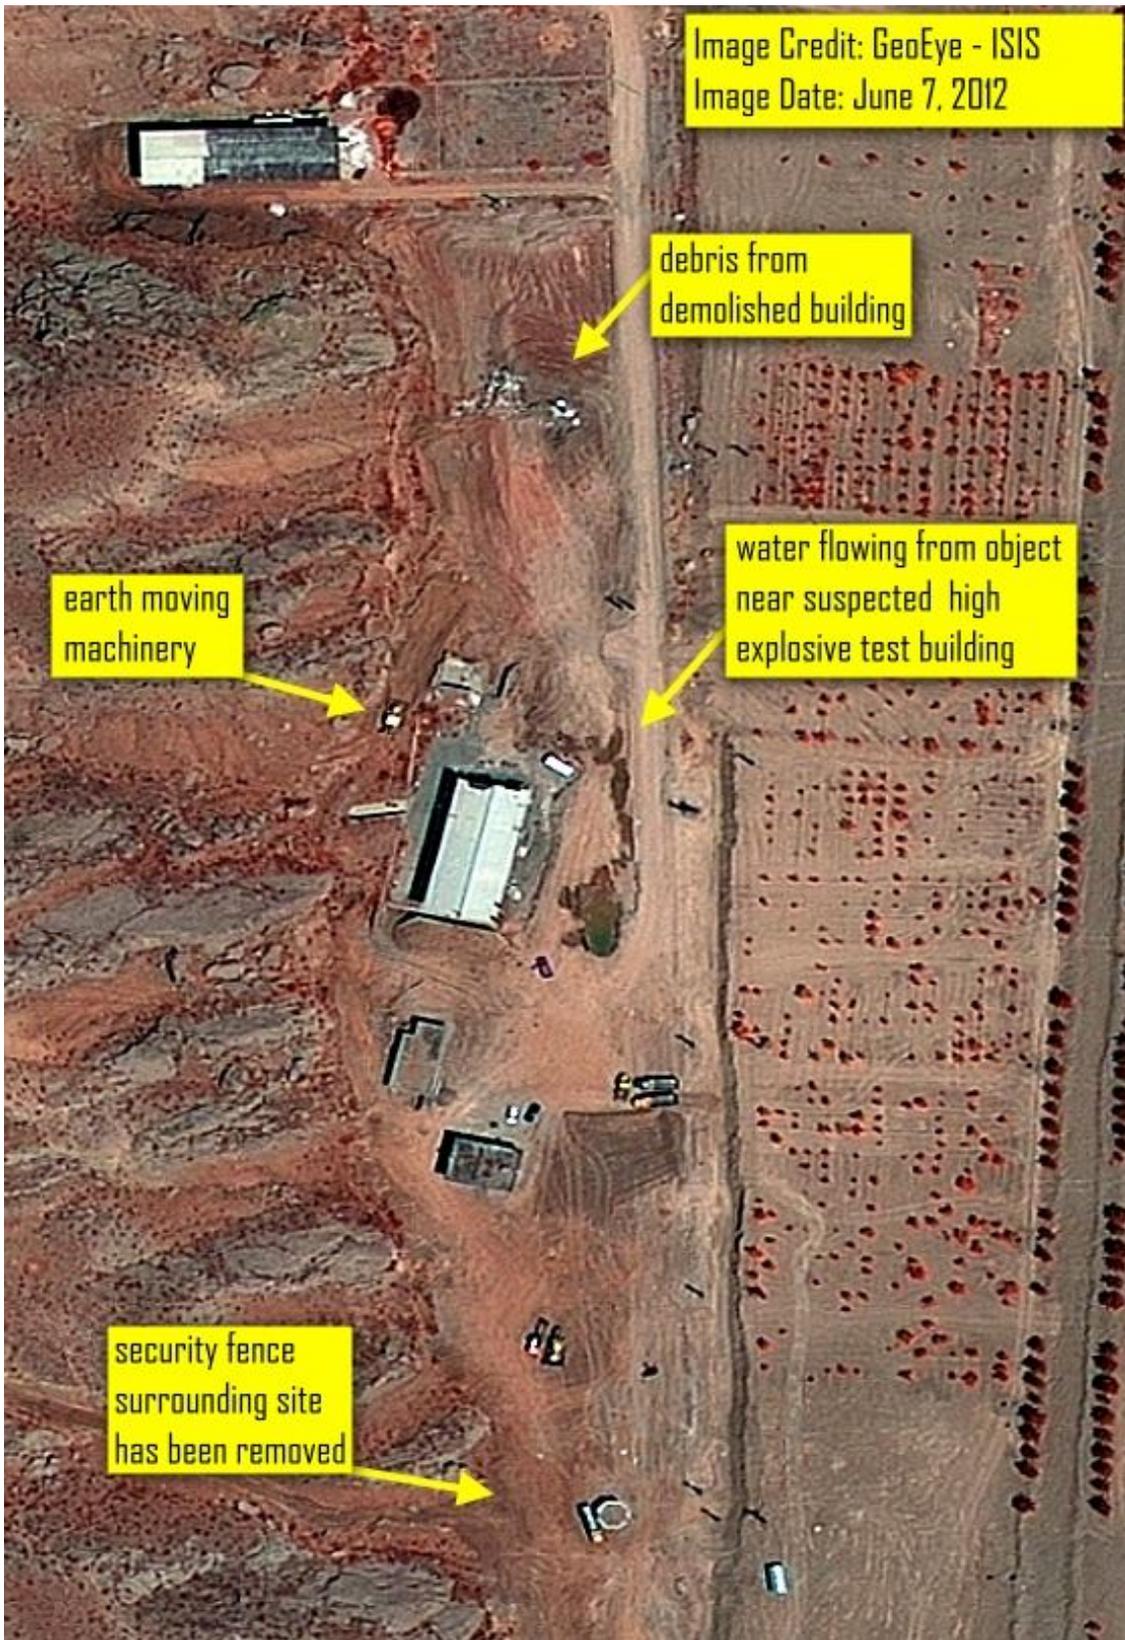
The latest satellite imagery from June 7, 2012 shows continued activity at the site where the International Atomic Energy Agency (IAEA) suspects Iran may have conducted high explosive compression related to the development of nuclear weapons. The image shows heavy machinery tracks and earth displacement throughout the site. The debris from one of the razed buildings visible in the imagery from May 25, 2012 has now been consolidated into piles just north of the site of the former building (figure 1). There is evidence of earth moving machinery and excavation activity near the second demolished building north of the building suspected to contain the high explosive testing chamber.

Figure 1. Satellite imagery from June 7, 2012 showing considerable vehicle and earth moving activity near the building at the Parchin complex that the IAEA suspects was used in high explosive tests related to nuclear weapons development.

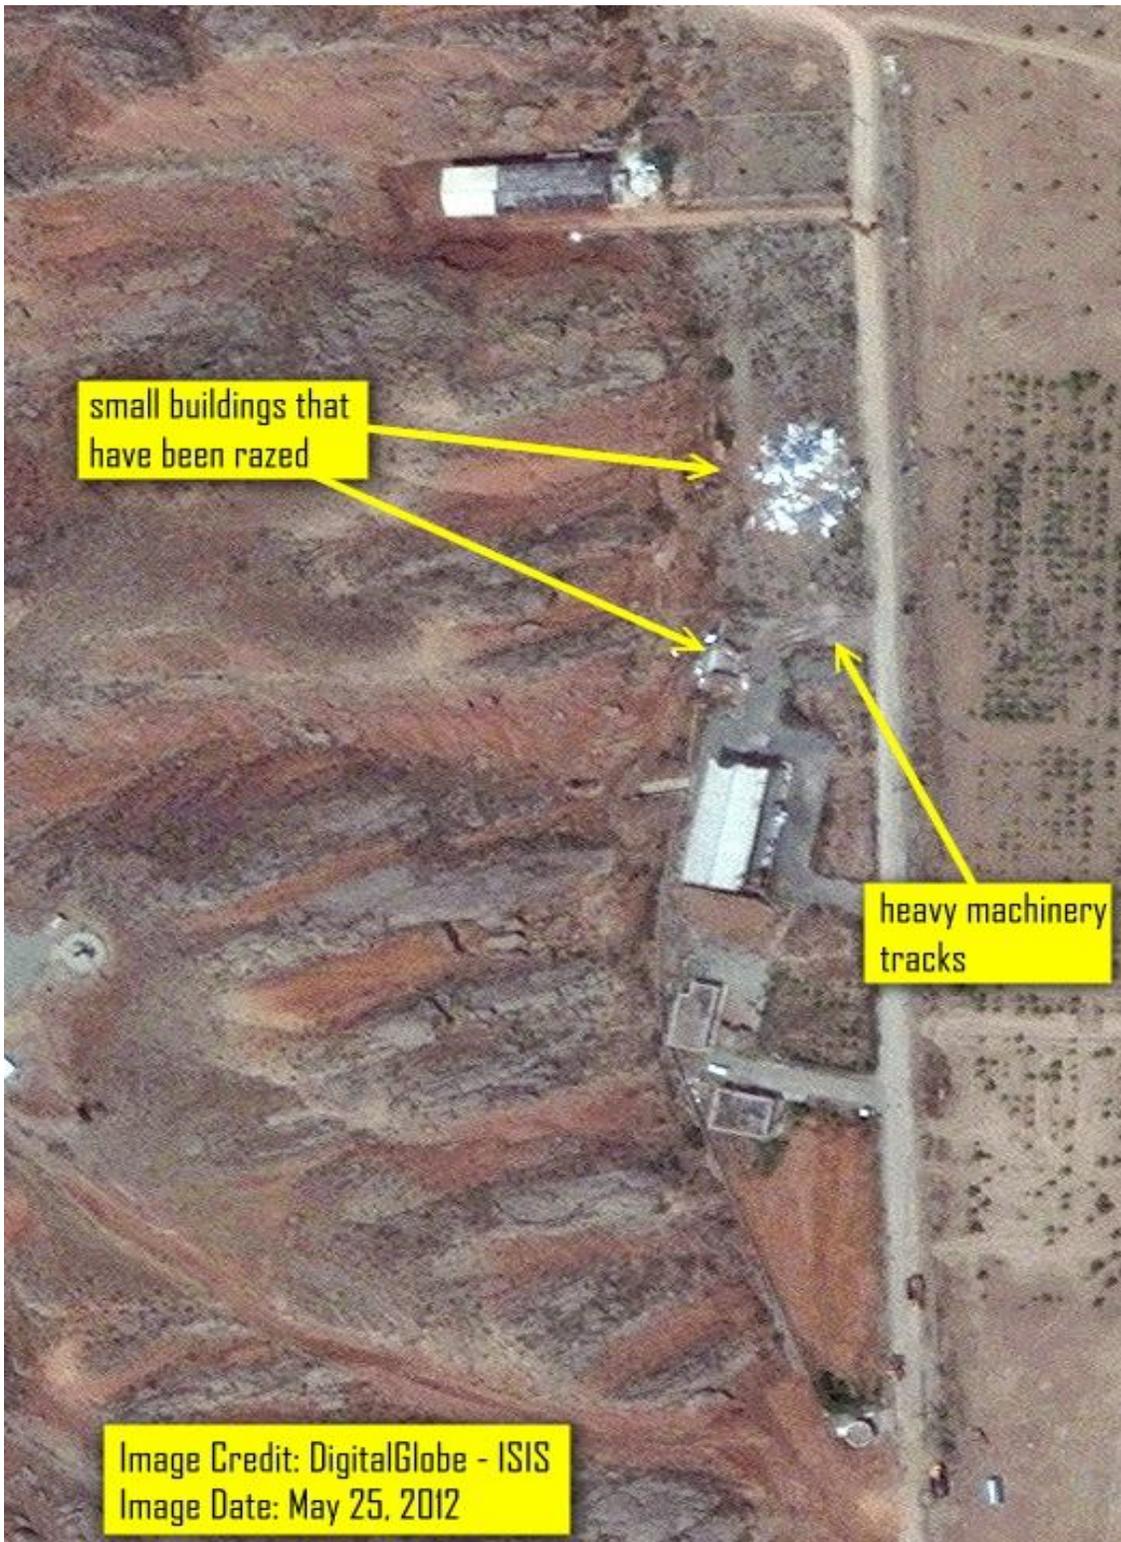
Clearly defined roads that previously led to several of the buildings (figures 2 and 3) are no longer discernible due to machinery traffic or earth removal. The security barrier that previously ran along the perimeter of the site has also been removed. Areas close to the suspect building that contained access roads and vegetation now appear to have been bulldozed or disturbed by machinery (compare figures 1, 2, and 3).

Figure 2. Earlier imagery from May 25, 2012 showing demolished buildings near the suspected high explosive testing building.

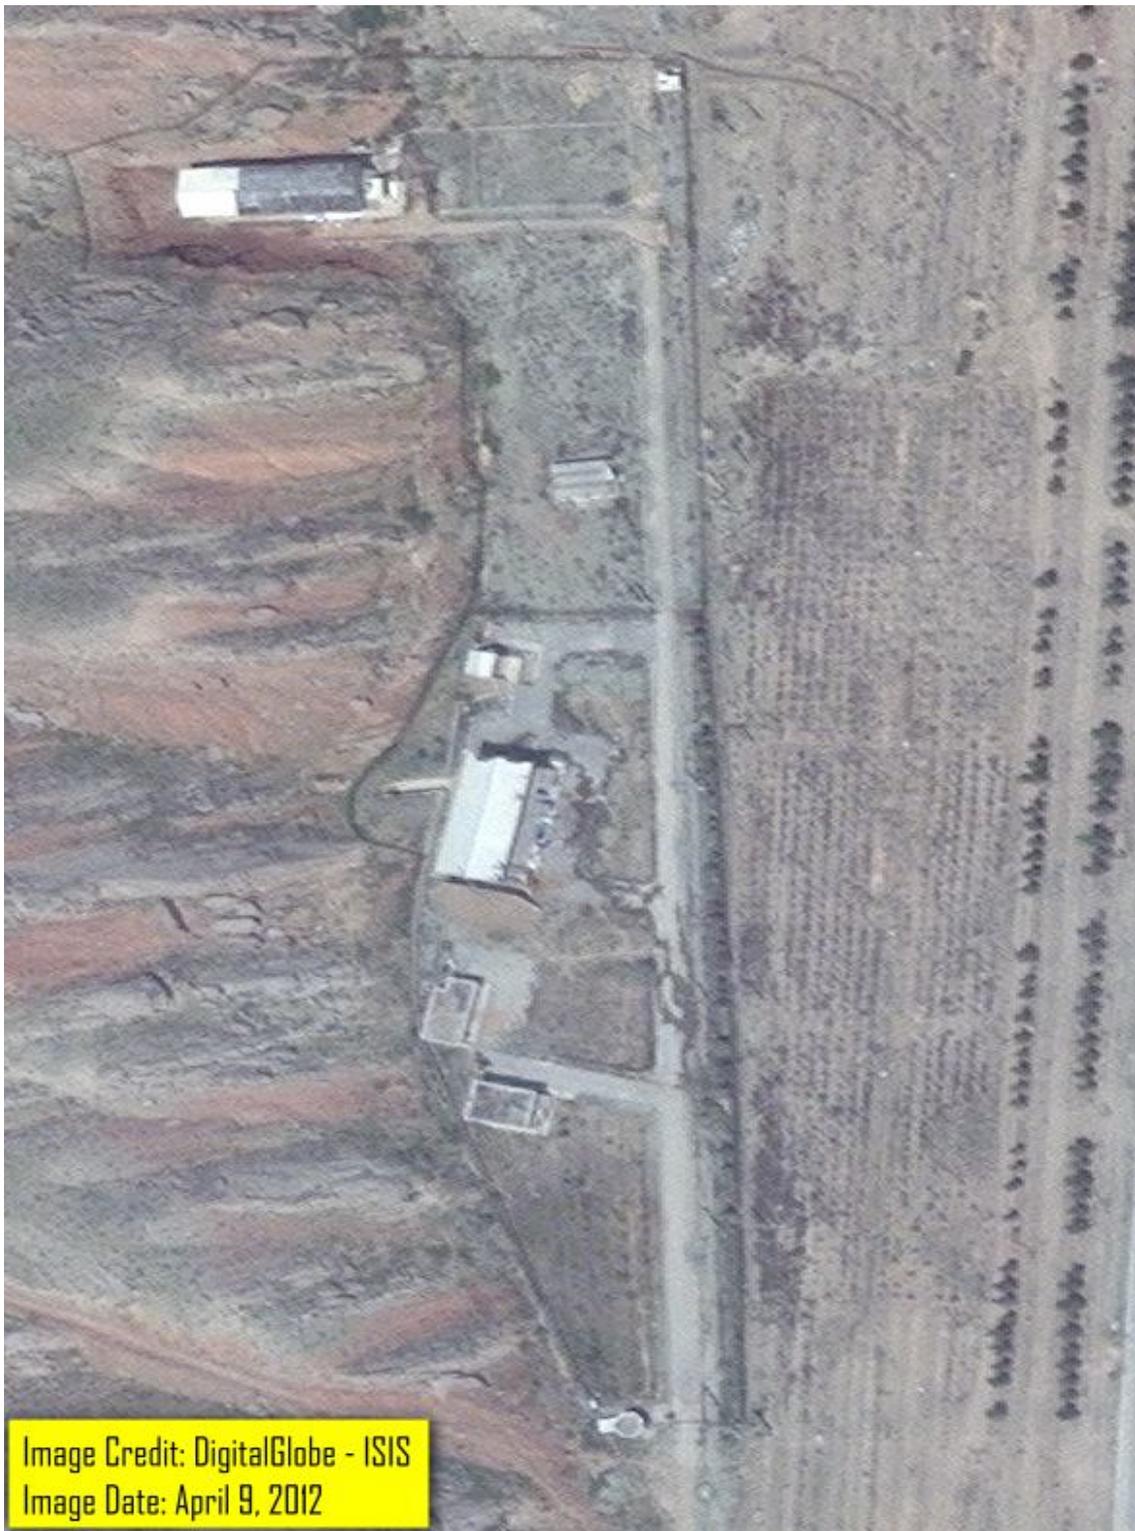
The latest imagery also shows a notable amount of water flow from nearby an object placed next to the alleged high explosive testing building. It is hard to distinguish what the object is or the purpose of the water. The water flows into areas that have seen considerable activity due to heavy machinery traffic or earth removal, activities which appear likely to persist.

Figure 3. Earlier imagery from April 9, 2012 showing water flowing from the suspected high explosive test building. As seen in the June 7<sup>th</sup> imagery (figure 1), the areas where the water flowed in this image are altered due to earth displacements.
