The Al Kibar Reactor: Extraordinary Camouflage, Troubling Implications

David Albright and Paul Brannan
May 12, 2008

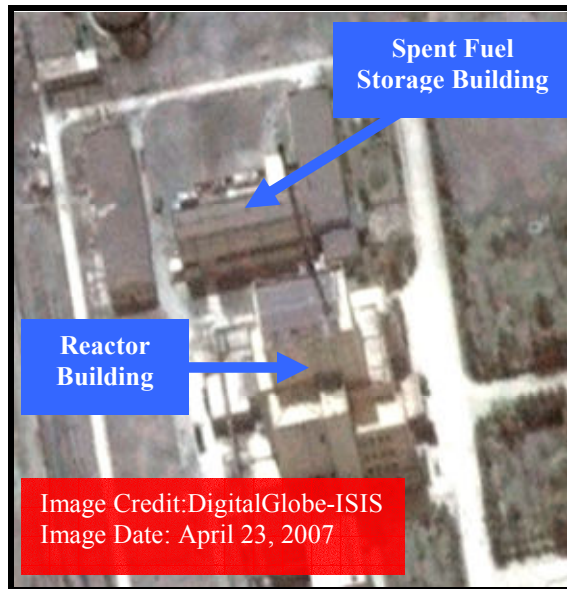
Figure 3. North Korea's Yongbyon reactor with separate spent fuel storage building.

The U.S. intelligence community assessed that the reactor’s spent fuel pond was on the eastern side of the building (see figures 1 and 2). The spent fuel pond for Yongbyon’s reactor is located in a separate building (see figure 3).

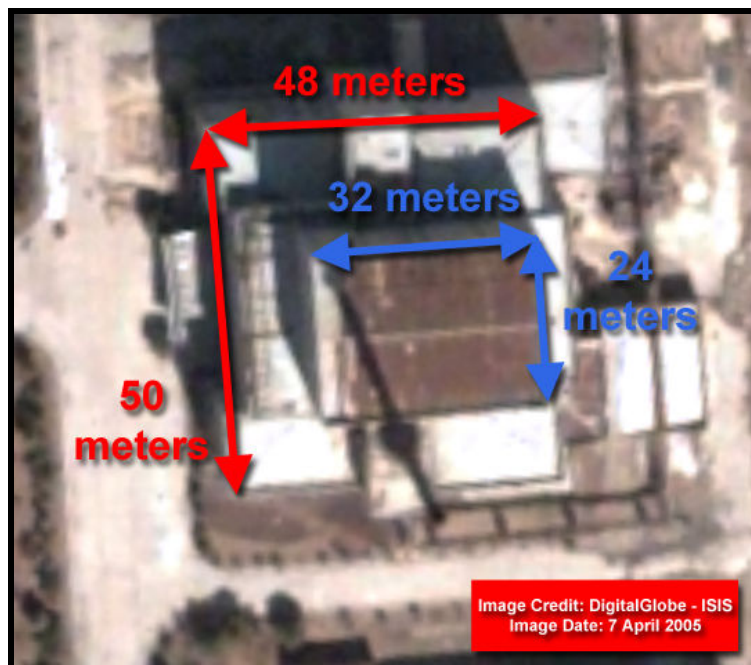
Figure 10. The five megawatt electric reactor building at Yongbyon, North Korea.

The building modifications did not hide all indications of the original building. When ISIS measured the footprint of the altered building in October 2007, it was virtually the same as that of the Yongbyon reactor. Furthermore, the discrepancy between the false outer roof and the actual reactor hall roof created faint yet distinct lines on the roof. ISIS measured these lines and found that the dimensions of the inner square were similar to those of the Yongbyon reactor,

leading ISIS to report that this building had dimensions consistent with the North Korean reactor (see figures 9 and 10).

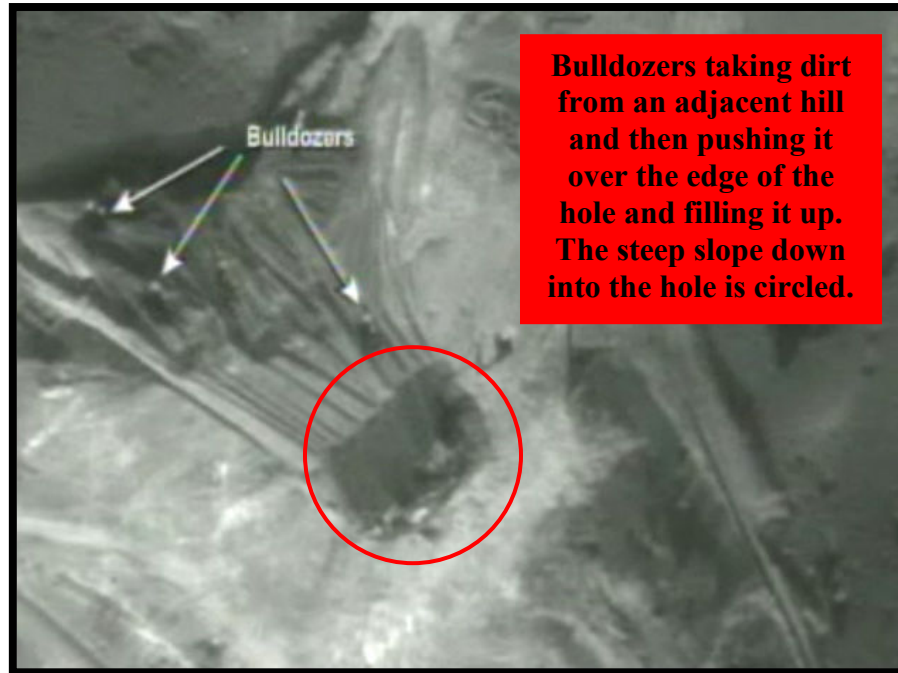
Figure 11. Bulldozers taking dirt from an adjacent hill and pushing it over the edge of the hole and filling it up.

A significant percentage of the Al Kibar reactor building was underground. After demolition of the reactor building on October 10, 2007 and removal of the heavy reactor structures, Syria filled in the resulting hole. Figure 11 shows that this hole was quite deep. According to U.S. government experts, the depth of the hole was several tens of meters. In contrast, the Yonybyon five megawatt-electric reactor was built essentially from the ground upwards.

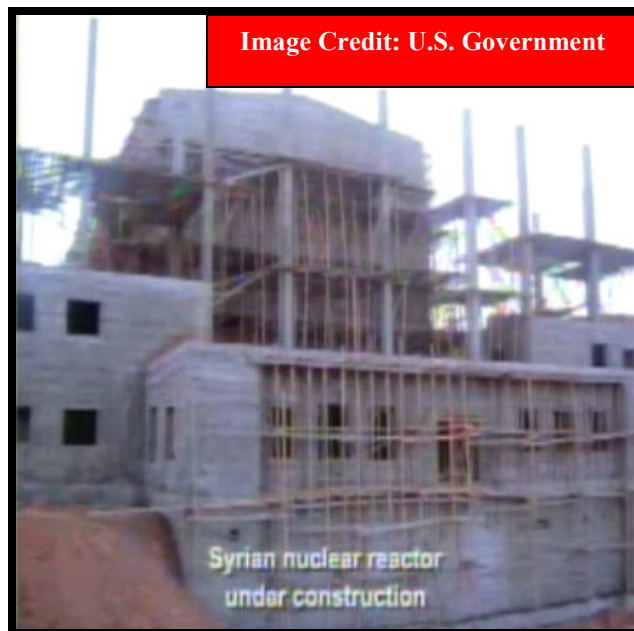
Figure 12. Ground photograph of Syrian reactor before construction of false upper walls and roof. Portions of the underground construction are visible; compare to figure 13. Photo taken prior to 2003.

Figures 12 and 13 show the Syrian reactor building before and after the false roof and upper walls were constructed. The west-facing façade can be seen in Figure 13, and then it is partially buried below ground level in figure 14. Figure 13 shows part of the underground structure.

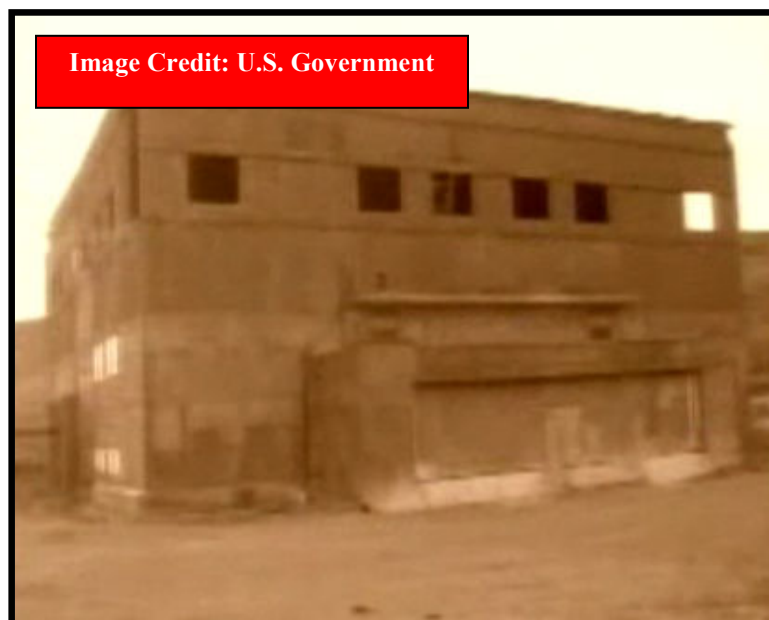
Figure 13. Ground photograph of Syrian reactor after transformation into a box. The windows have been covered by a wall, and the underground portion visible in figure 12 is also covered. Date when photo taken is unknown, but likely after 2003.

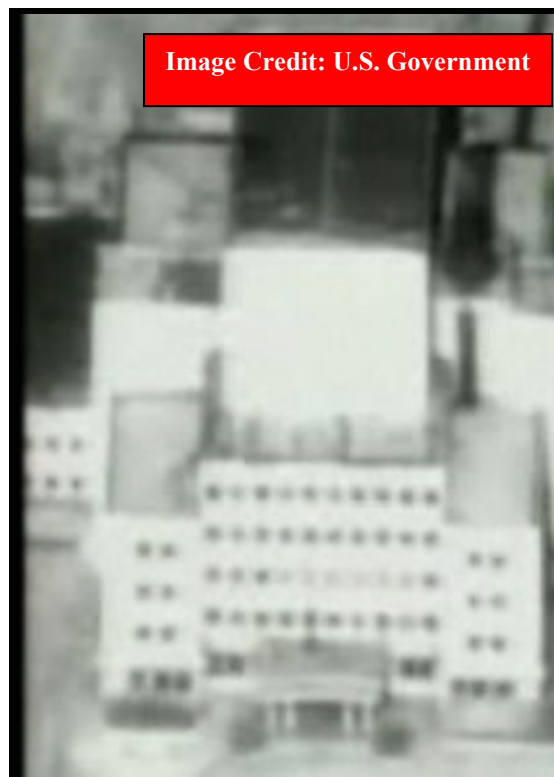
Figure 15. Yongbyon's 5MW-electric reactor. The Syrian reactor is similar to the Yongbyon reactor, but this reactor is taller than the Syrian reactor which has several levels below ground.

The front façade of the Yongbyon reactor is taller than that of the Al Kibar reactor, again implying that much of the Syrian reactor is underground (Figures 14 and 15).

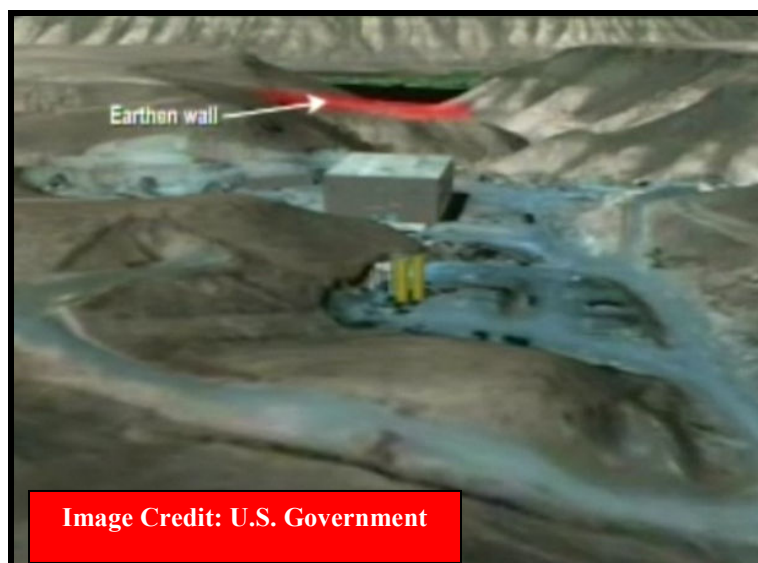
Figure 17. Location of an earthen wall on top of ridgeline.

Syria built the reactor at the bottom of a canyon, affording the site a considerable degree of natural isolation. To further increase the site's privacy, Syria created a series of earthen walls at key points around the reactor that would block the view of anyone traveling nearby (see figure 16). These walls were constructed by repeatedly dumping large mounds of dirt in a line and then pushing them from either side with a bulldozer to create a ridge. Some of these walls were created near ridgelines, a difficult feat to accomplish (see figure 17).

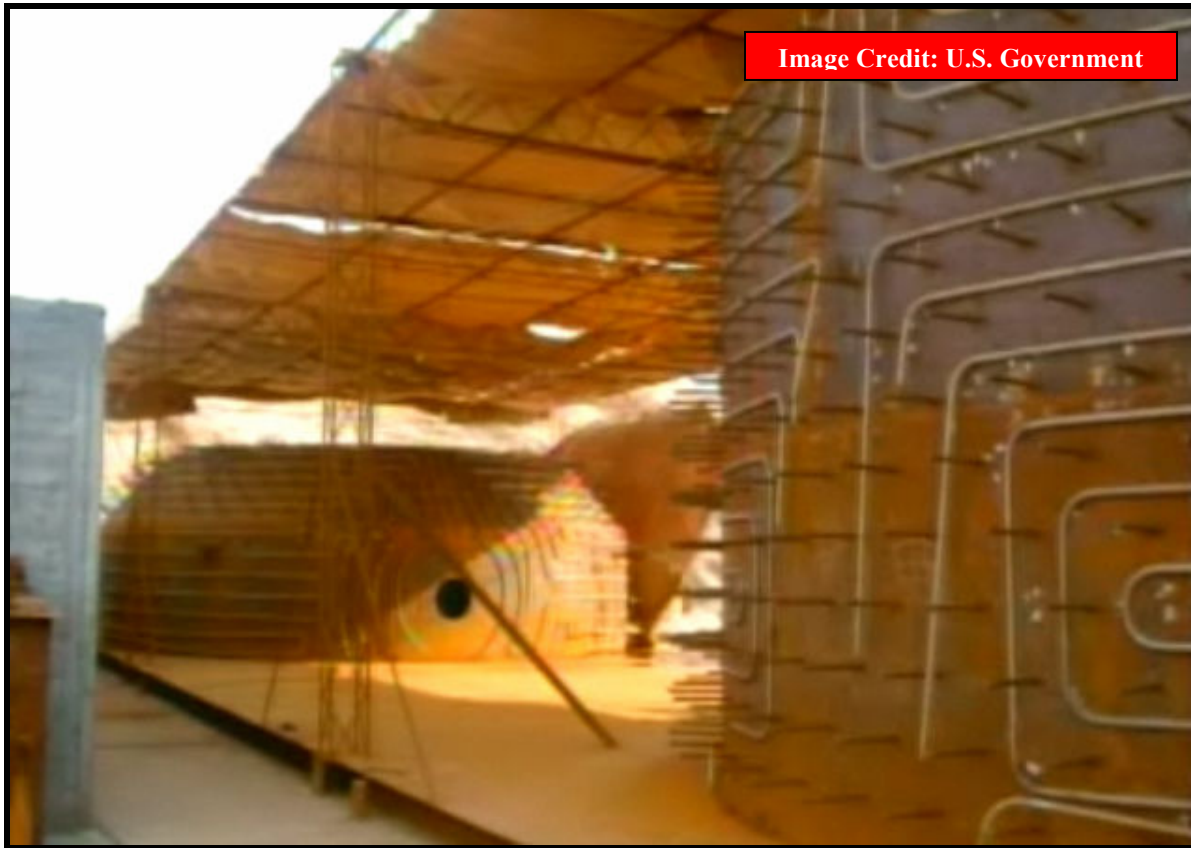
Figure 22. Syrian reactor vessel under tarps.

The construction of a special transport system is not necessary for this type of reactor. Large internal components do not need to be assembled elsewhere and shipped to the site. In about 2002, Syria assembled the steel reactor liner or vessel at or near the site under a tarp to hide it from overhead surveillance, according to U.S. government experts (see figure 22). It was placed inside the building before installing the roof, perhaps at night. The thin sheets of steel and water piping used in the vessel could have easily been transported to the site in trucks. Other components were probably likewise assembled at the site from easily transportable subcomponents.

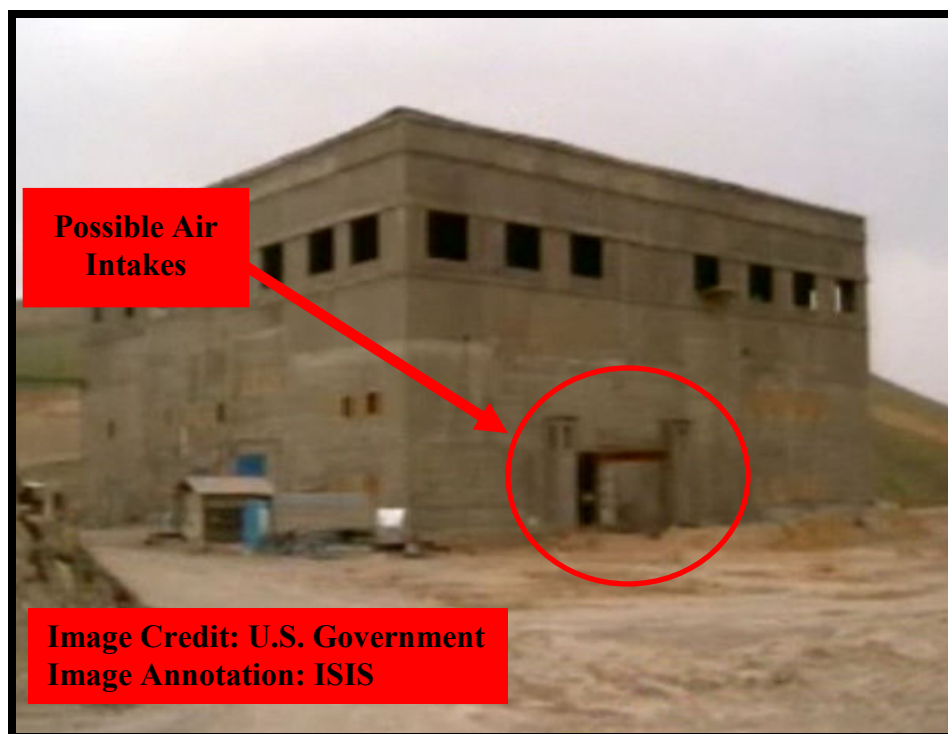
Figure 23. The air intakes for the Syrian reactor.

According to U.S. government experts, the reactor's ventilation system was carefully hidden. The air intakes of the ventilation system are assessed to be along one wall of the building, according to these experts (see figure 23). They noted that two rectangular structures located against the wall have louvers at the top through which air can enter.

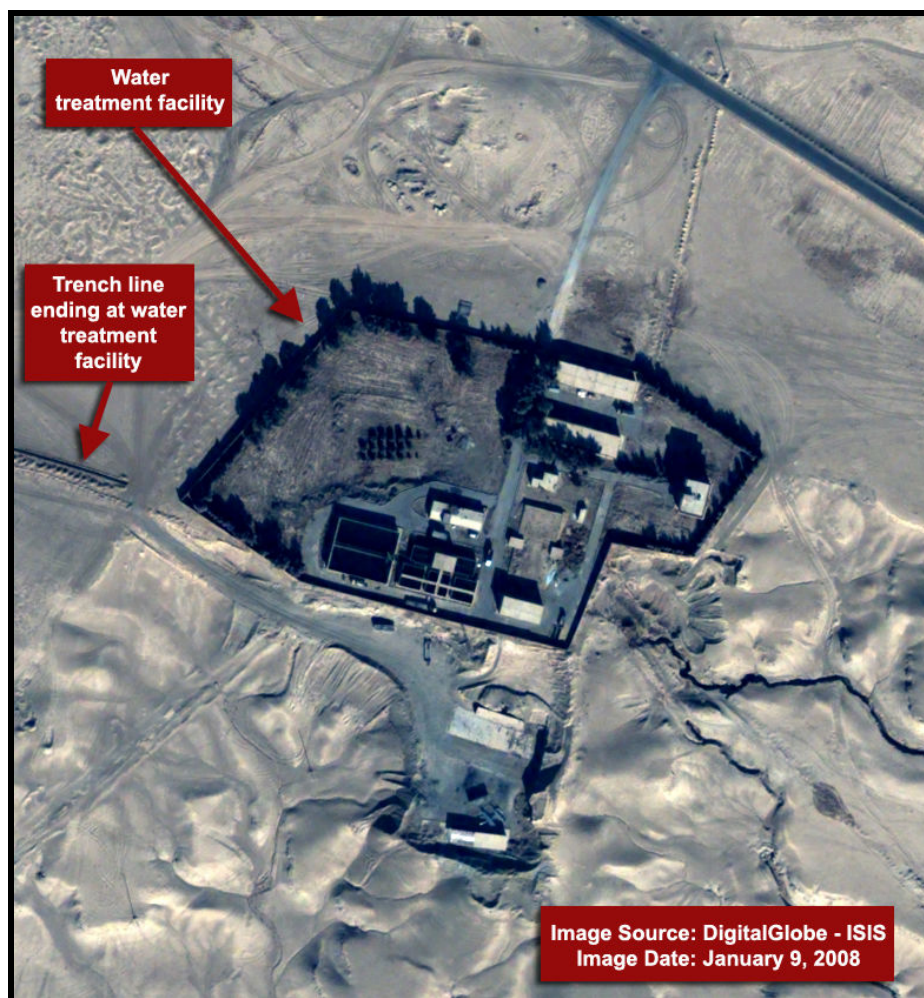
Figure 26. Image of water treatment facility after the reactor was destroyed.

In the case of this reactor, the U.S intelligence community assessed that the power lines originated at a water treatment plant that is connected to the local electrical grid (see figure 26). The power lines were likely placed in conduits running underground from the treatment plant to the reactor building (see figures 27 and 28).

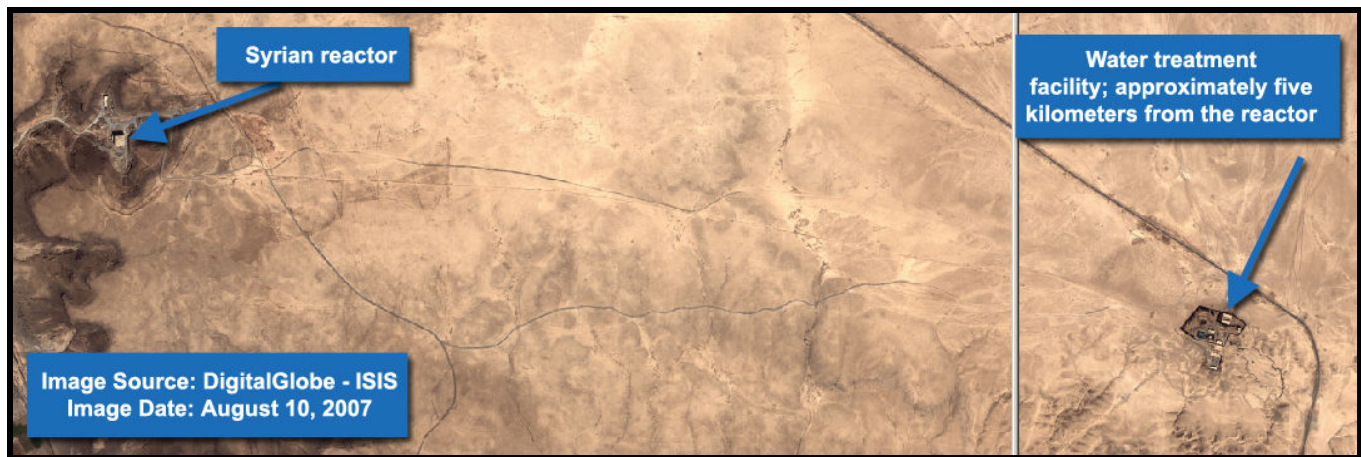
Figure 27. Pre-strike wide image of reactor and water treatment facility. A line is visible in the image between the reactor and the treatment plant.

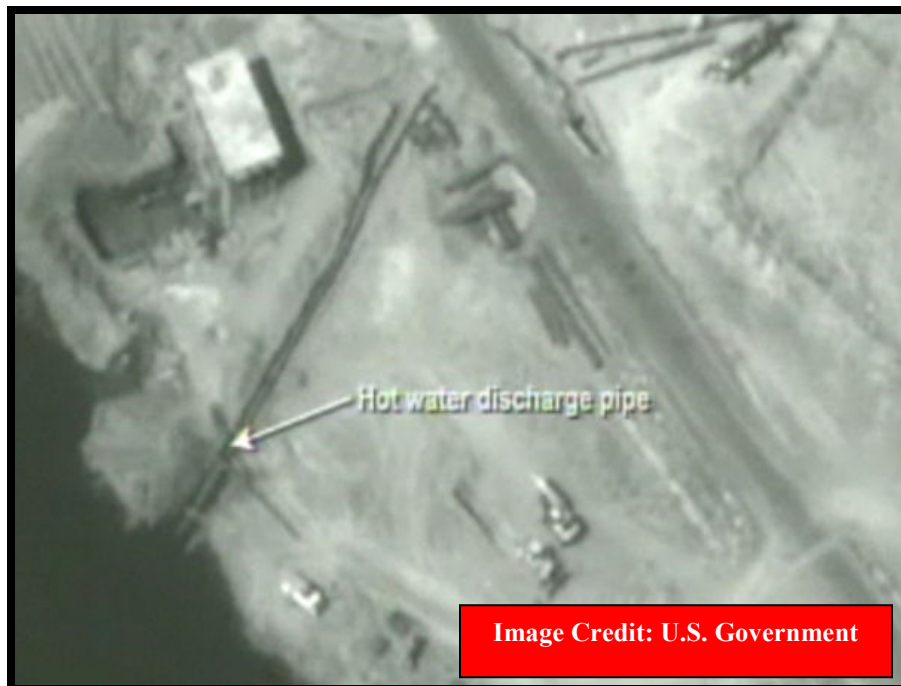
Figure 34. Buried hot water discharge pipe. According to U.S. government experts, this piping ends under water.

Syria decided not to use a cooling tower, which is readily apparent in satellite imagery, but instead planned to dump the heated water back into the river. According to U.S. government experts, the water is pumped from the river through two pipelines leading to the reactor compound (see figure 32). The water then goes into what the intelligence community has assessed was a buried reserve water storage tank as well as into the reactor building. The purpose of the storage tank could be to provide an emergency supply of water in case of an interruption of the reactor's operation. According to U.S. government experts, Syria may still have intended to install another pumping station between the buried water storage tank and the reactor building to increase the water pressure as it entered the heat exchangers in the reactor building (see figure 33). As noted earlier, the heat exchangers transfer the heat from the gas to the water. This heated water then exits the reactor building through a single discharge pipeline that extends down toward the river. The warm water pipeline discharges into the river under water, making identification of the discharge pipe more difficult (see figure 34).
