Update on Natanz: Construction Progresses Towards Large-scale Tunnel Complex

By David Albright, Sarah Burkhard, and Frank Pabian

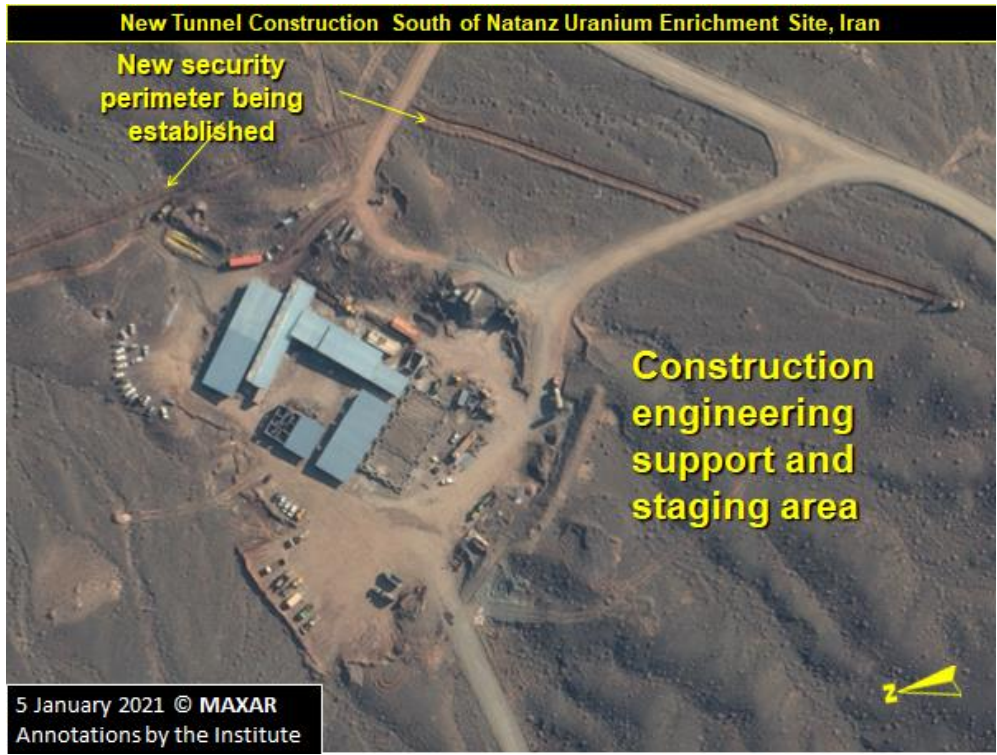
Figure 2. In addition to construction equipment, the construction staging area features several buildings and a partly-established security perimeter.

Figure 2 shows a close-up of the current construction staging area and future engineering support site. A security perimeter is being added, in addition to several buildings constructed in the past months, further indicating that this area will eventually host administration and engineering offices, and possibly serve as a security access control area.

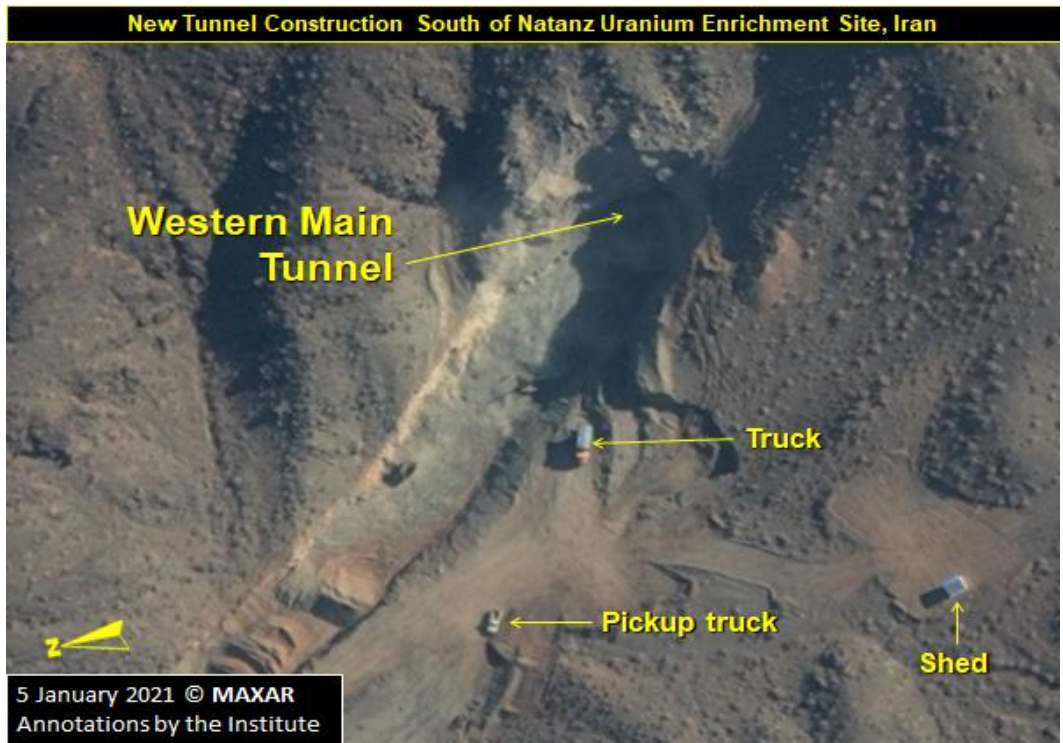
Figure 6. A close-up of the western main tunnel entrance.

Figure 5 provides an overall view of the western tunnel entrance area. Figure 6 shows excavation at the western main tunnel entrance leading into the large mountain. Two trucks and a shed can be identified in the cleared area. The spoil pile appears to be roughly the same size for this one entrance as it is for the two eastern entrances combined. Nearby is an explosive storage area, most likely for use in tunnel excavation. Another branch of the access road leads to the mountain at the previously identified potential tunnel entrance, but that area remains undeveloped at this time. Figure 7 shows the western tunnel associated explosives storage area consisting of four revetted explosives storage buildings.

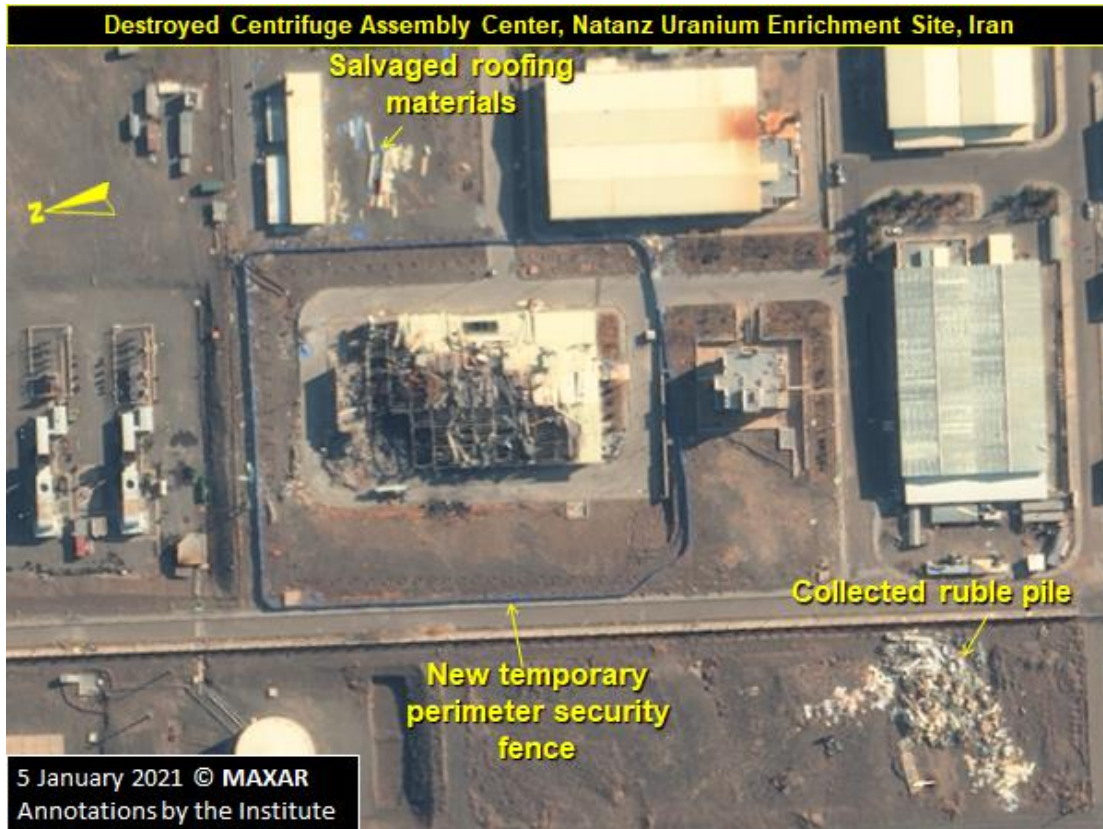
Figure 8. The remains of the original Iran Centrifuge Assembly Center (ICAC), destroyed by an explosion in early July 2020, are now secured by a perimeter fence.

The construction progress to date indicates a large-scale tunnel facility, connecting a small mountain ridge with a large mountain ridge, with enough room to harbor a facility larger in size than the original centrifuge assembly facility. Figure 8 shows the remnants of the destroyed assembly facility at the Natanz enrichment site. The area around the facility has been thoroughly cleared of blast debris and is now encompassed by a single perimeter security fence. The current state of the facility is unclear; whether it is being dismantled, albeit very slowly, further investigated, or preserved for a symbolic value or political purpose. In any case, our assessment is that the most likely location for the new assembly facility is best-protected, centered underneath the large mountain, far away from tunnel entrances. The tunnel will likely host additional security structures and blast traps, but could also include additional facilities, laboratories, storage, etc.
