## Video Walk-Through of Iran's New Interim Centrifuge Assembly Center

By David Albright and Sarah Burkhard

### **Assembly Facility Areas Shown in the Video**

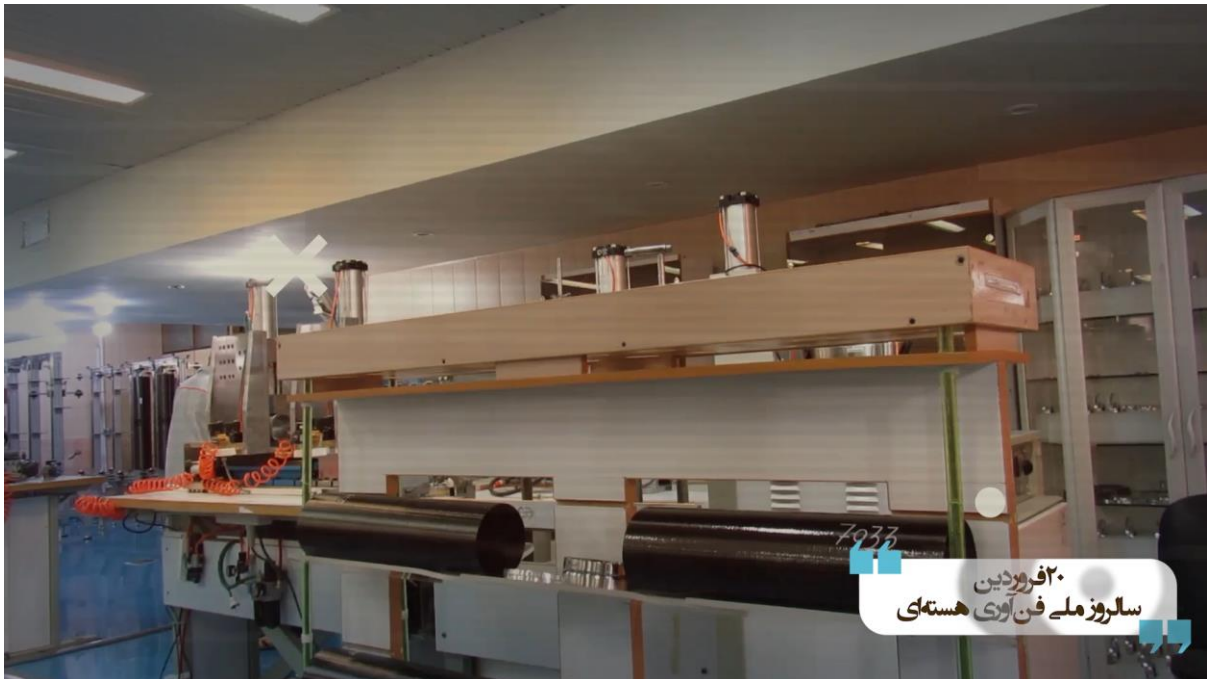
**Figure 3.** In same room as in Figure 2, two carbon fiber cylinders awaiting assembly. Between them is possibly a metal bellows, most logically made of maraging steel because of the relatively high speeds achieved by the advanced centrifuges.

Despite Iran’s past difficulties to procure maraging steel, the video shows what appear to be IR-6 bellows in storage cabinets that appear silver rather than black grayish, indicating metal instead of carbon fiber. Maraging steel is a logical candidate for these bellows given the speed requirements of Iran’s deployed advanced centrifuges, claimed to reach tangential speeds of up to 600 meters per second. This is partially confirmed by IAEA reporting. On January 23, 2021, the IAEA verified that Iran had started manufacturing metal bellows for IR-6 centrifuges for testing, which Iran plans to reinforce with carbon fiber.<sup>8</sup> It is possible that the new bellows use a lower quality maraging steel, requiring carbon fiber reinforcement, or use another metal other than maraging steel, also necessitating carbon fiber support.

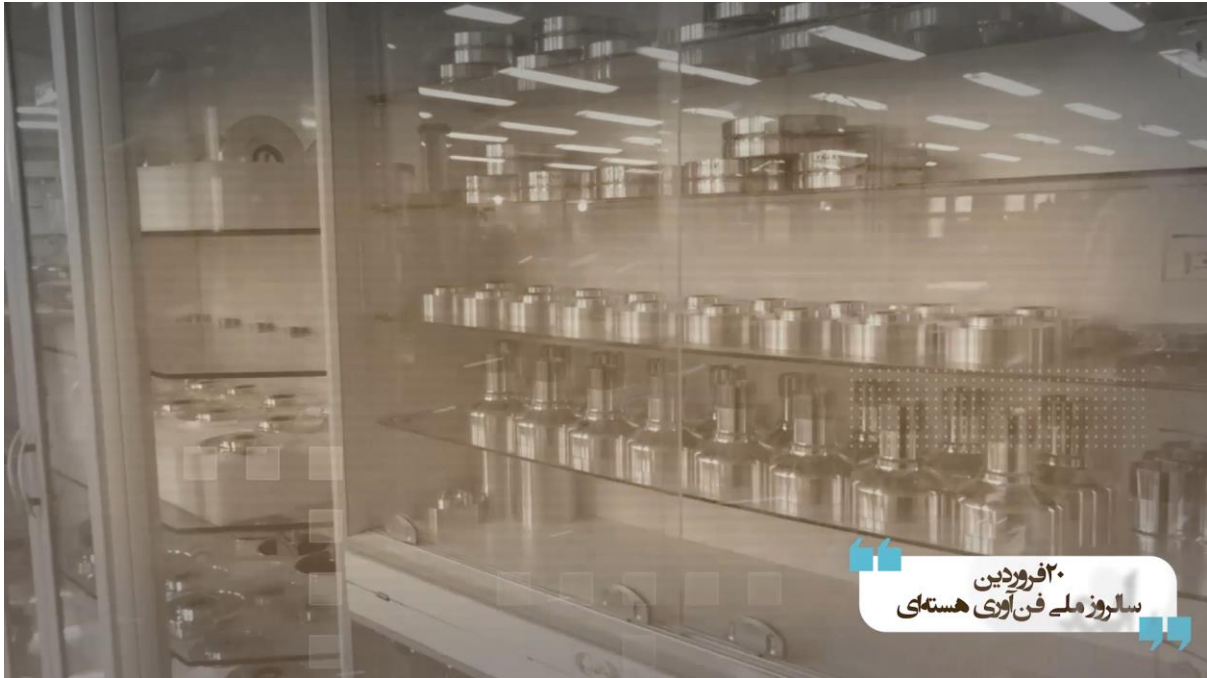
**Figure 4.** Two component storage cabinets. In the cabinet on the right side, on the upper two shelves are more metal bellows, again possibly made of maraging steel although high strength aluminum cannot be excluded. The lower two shelves also hold subcomponents, which have diameters slightly smaller than the bellows. One shelf may hold top cap metal inserts that hold the rotating magnet and catch the top end of the rotor when unintended rotor vibrations occur during startup and rotor failure. The other shelf may hold bottom cap metal inserts for holding the rotating elements of the drive and bottom bearing pin and ball. These subcomponents could be of high strength aluminum alloy or maraging steel. All of these components appear to have been degreased and cleaned, hence stored in a closed cabinet.

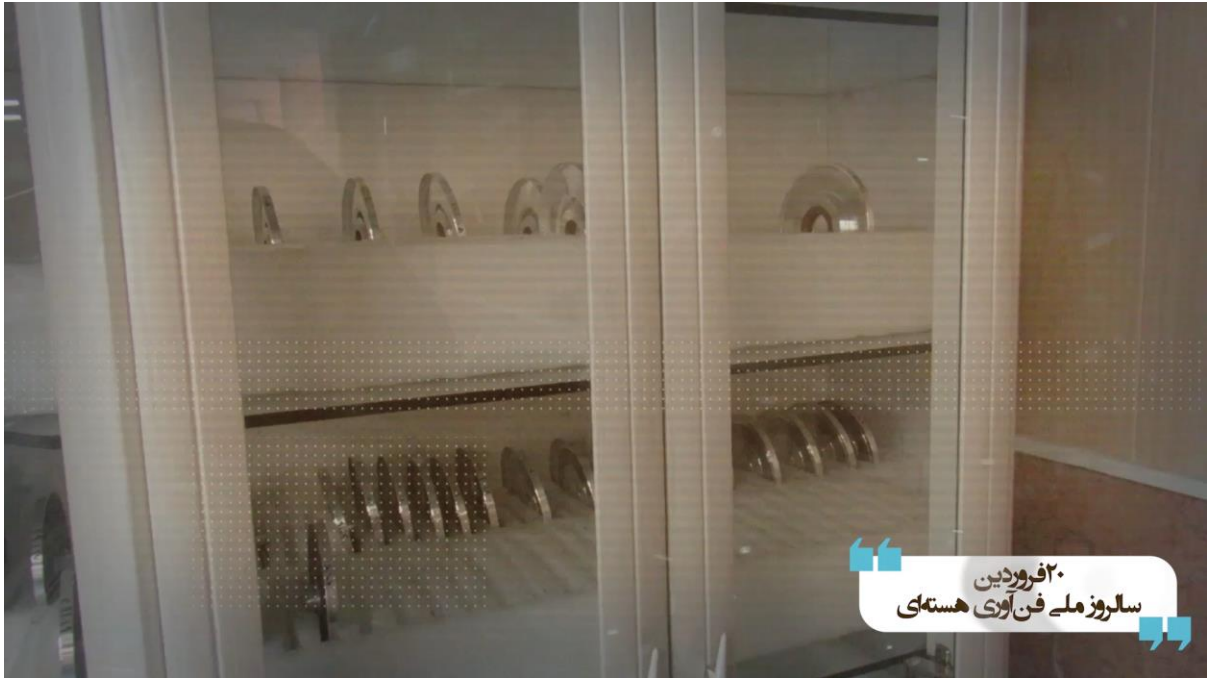
**Figure 5.** This cabinet contains a stock of centrifuge subcomponents. At first glance, they look like baffles made from metal rather than carbon fiber. Baffles are inserted in the rotor to create the counter-current gas flow and to isolate the top scoop extraction chamber. Note that the subcomponent is made of metal and not a carbon composite, and is likely made of maraging steel or high strength aluminum. They could also be end caps made out of high strength aluminum, where they are inserted inside the carbon fiber rotor tube, providing strengthening.

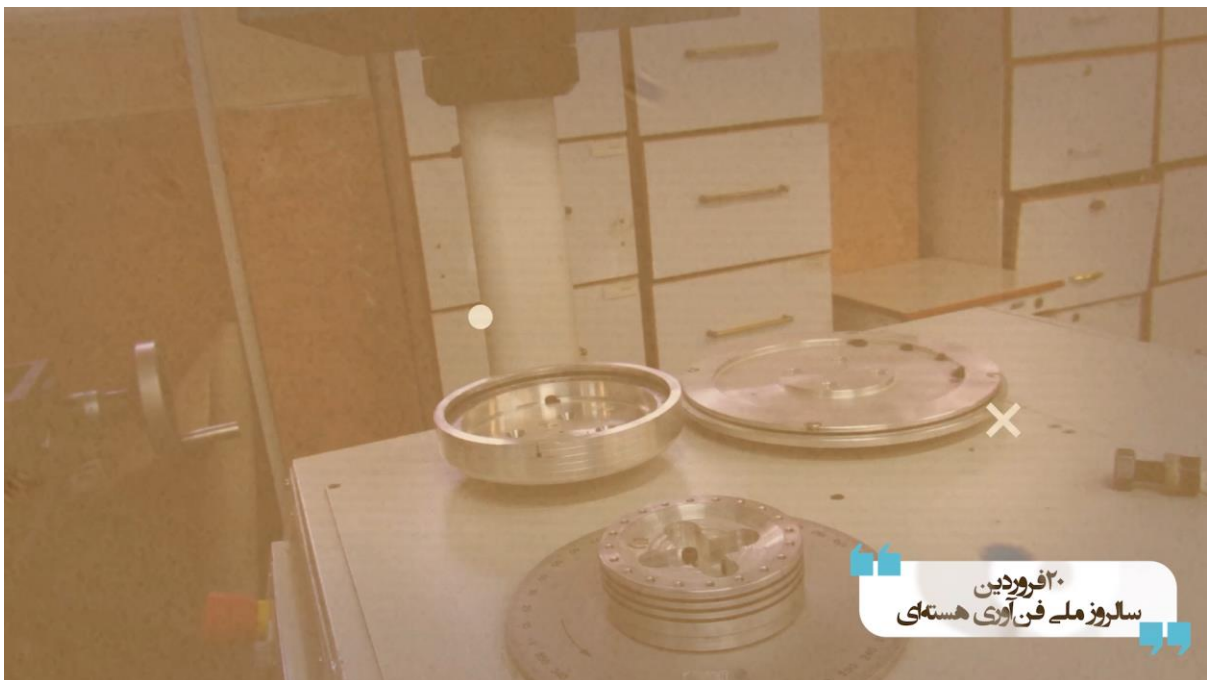
**Figure 6.** A photo with possible top and bottom end flanges of the outer casing, also known as the recipient.

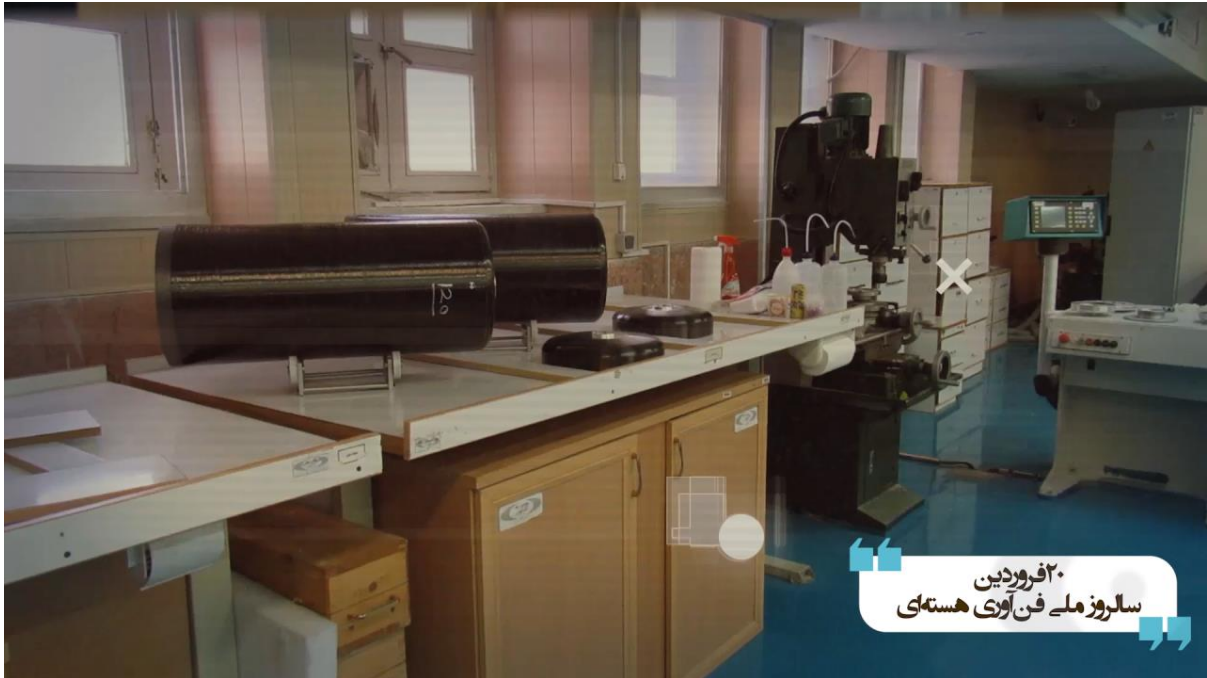
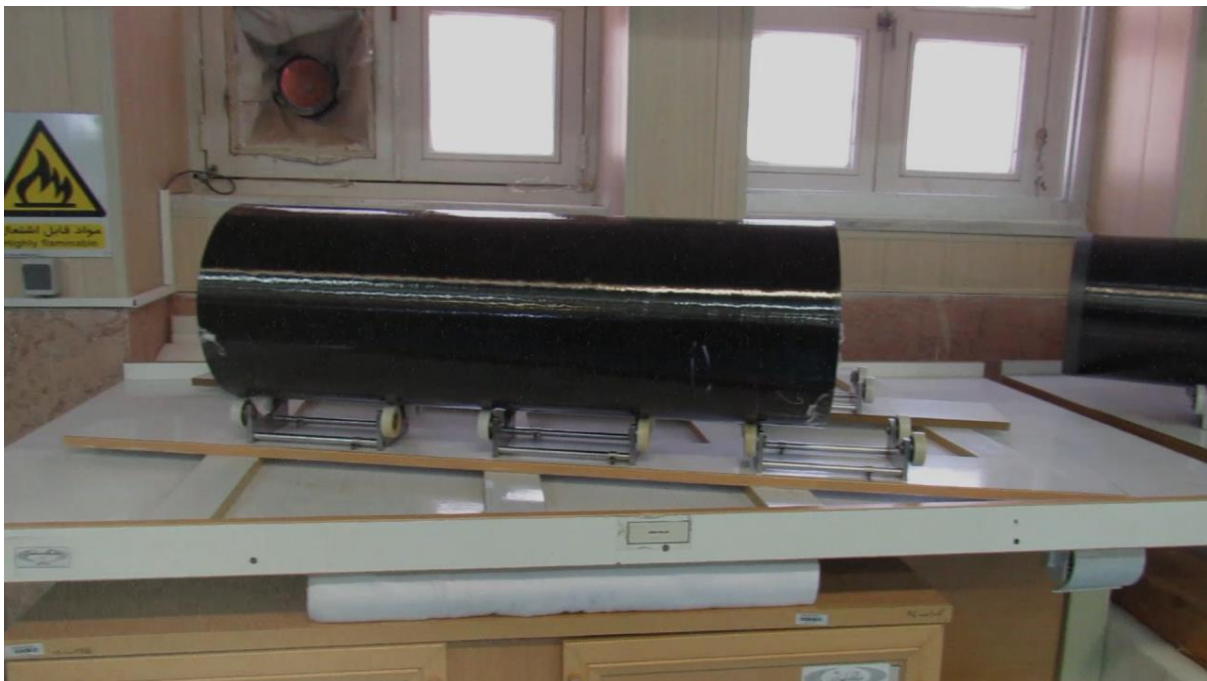
**Figure 8.** IR-6 rotor tubes on two adjacent work surfaces shown in consecutive freeze frames, panning from right to left. The top photo shows that the end of one rotor tube has been partly machined, likely for fitting purposes, and the other end holds a domed end cap (the machined end can also be seen in the partial rotor tube on the right side of the bottom image.) Accepting that the cylinder diameter is 200 millimeters then one can roughly measure the length from the photo as about 600 millimeters, as expected). Note that in the top image there are two domed top caps on the table awaiting to be fitted onto the cylinders. The caps appear to be made from carbon fiber and have a metal insert. The windows are consistent with being in a half-basement, such as found in the Natanz administration building (see text).

The video suggests that parts of the IR-6 design have changed since 2015, perhaps indicating ongoing problems in these centrifuges. The video shows domed end caps rather than flat ones.<sup>7</sup>

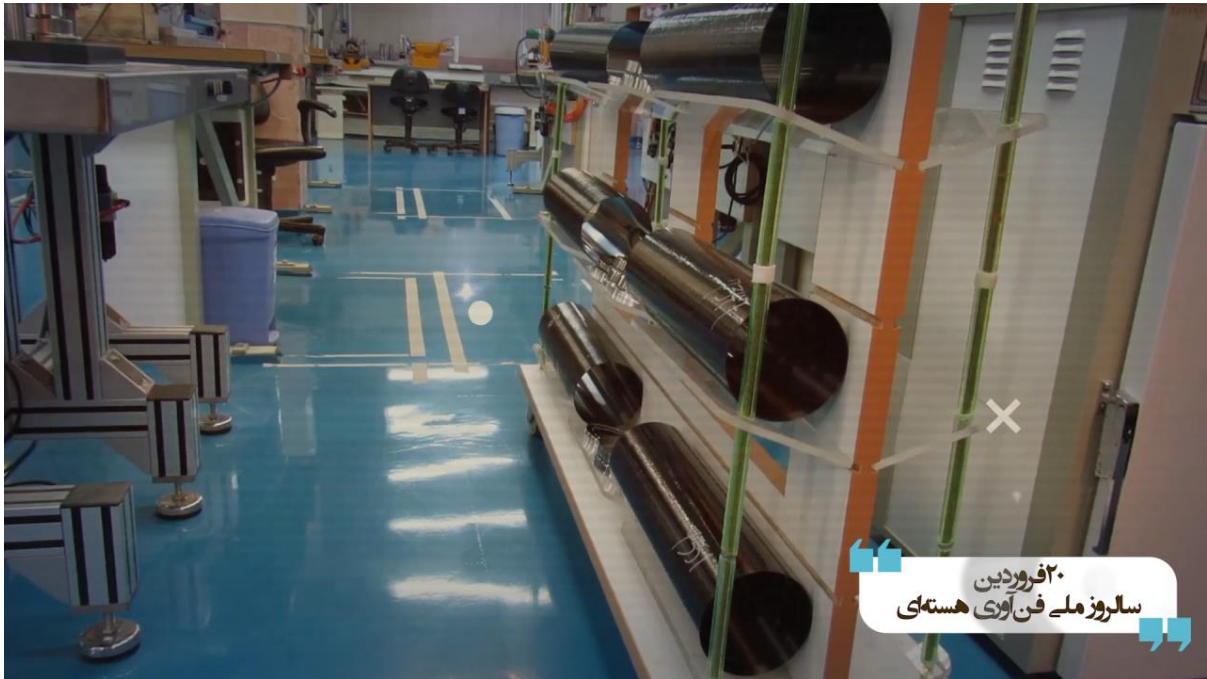
**Figure 9.** Photos showing how the cylinders are handled and moved around a subassembly shop.

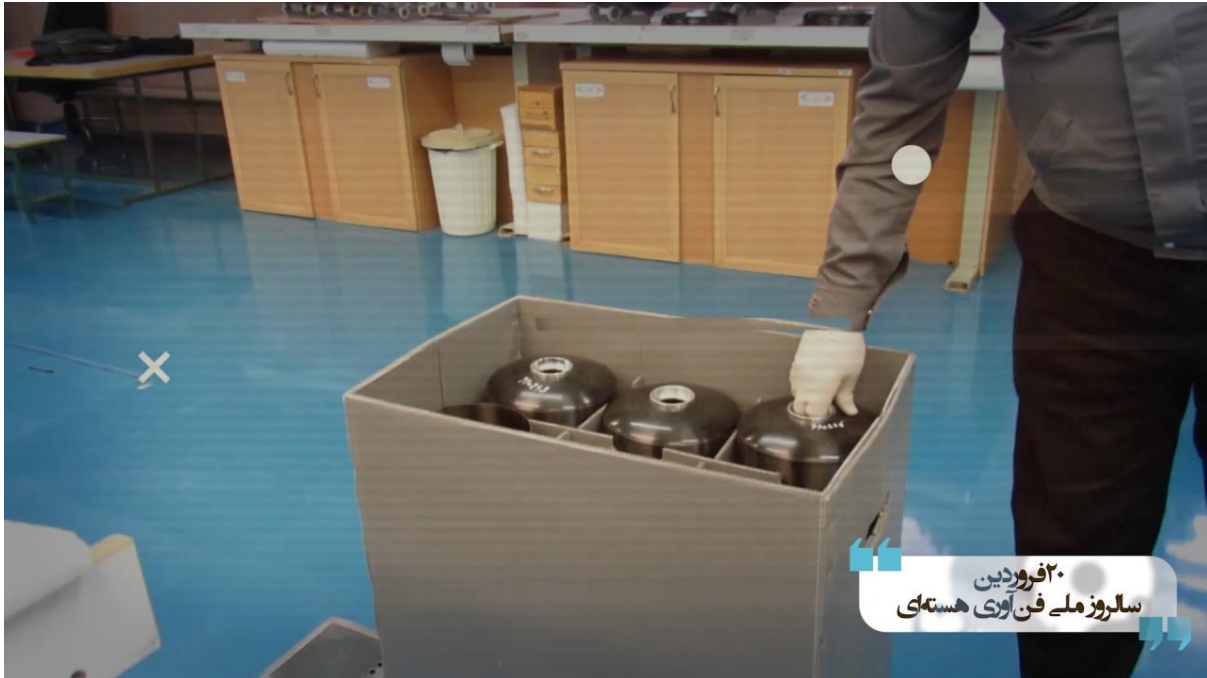
**Figure 10.** Visible is a carton box large enough for containing IR-6 rotor tubes and top caps. The top caps are domed with a flat section in the middle. Using the man's leg as a guide, the box appears to be about 800 millimeters in depth. Note that the end caps do not have rotating magnets installed at this point, although they look like they have a metal insert to hold the magnet. (The magnet holder, absent the magnet, may be used to hold the rotor vertically while checking its balance and straightness (see below.))

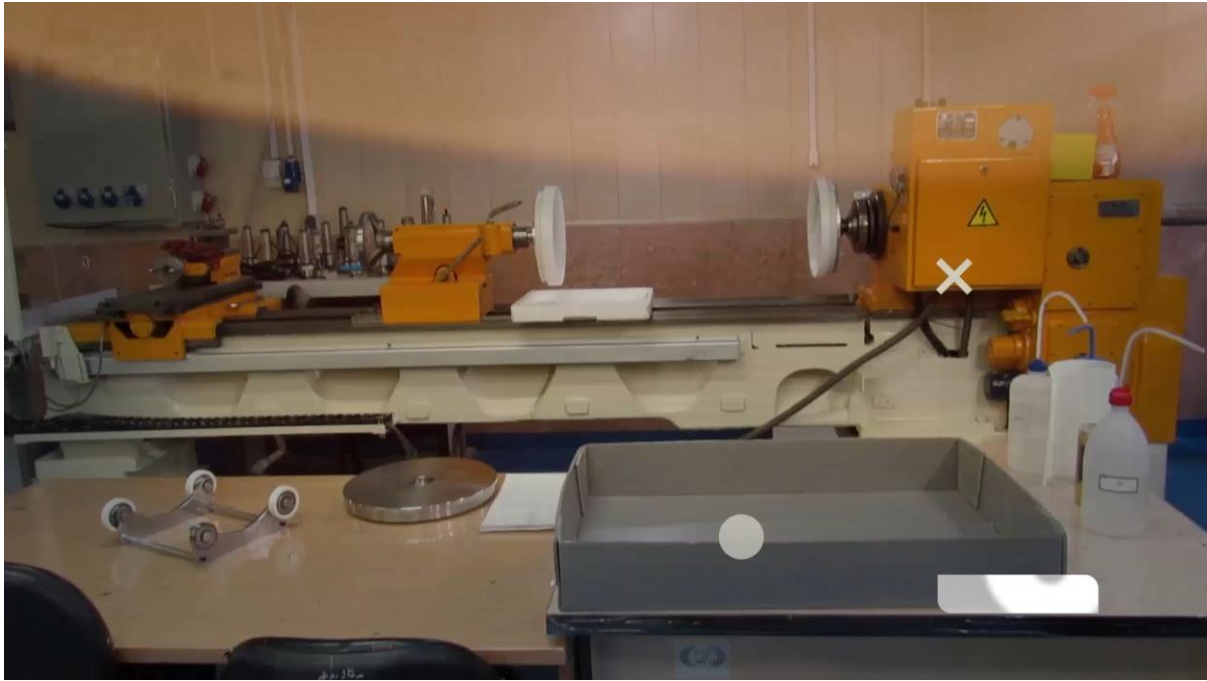
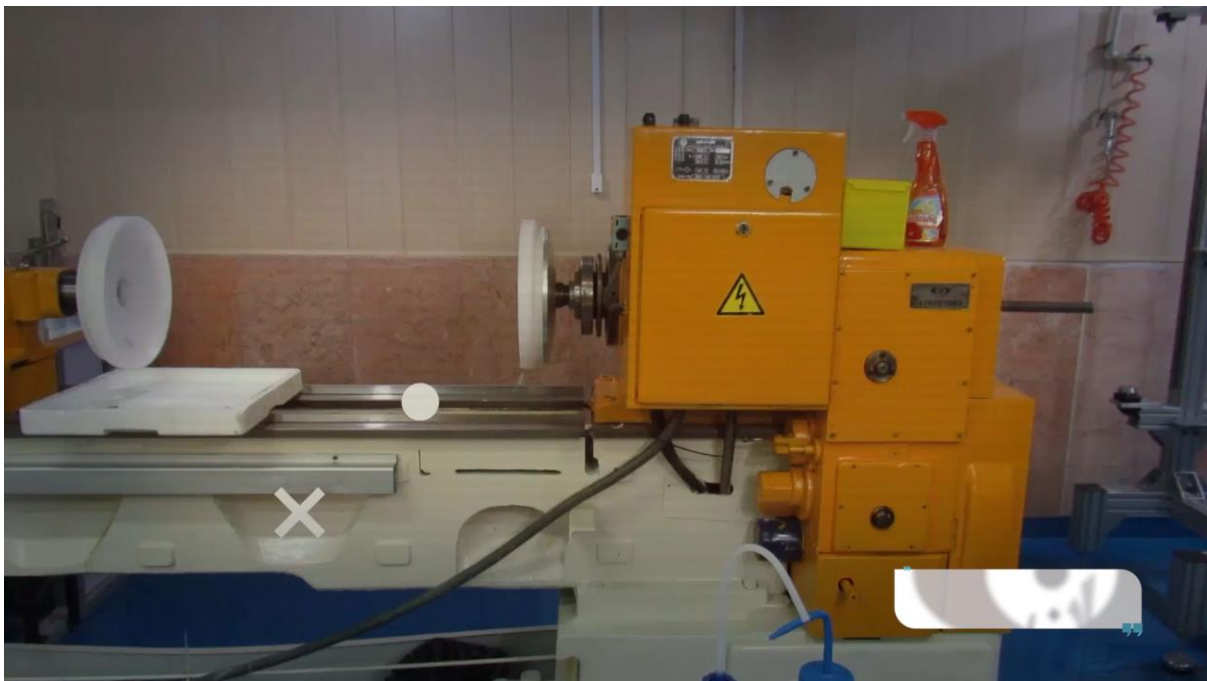
**Figure 11.** Measuring and balancing equipment used to quality check incoming rotor tubes and other components. It can hold a rotor tube horizontally to check its dimensions, such as length, diameter, ovality, and straightness, and also ensure it is balanced.

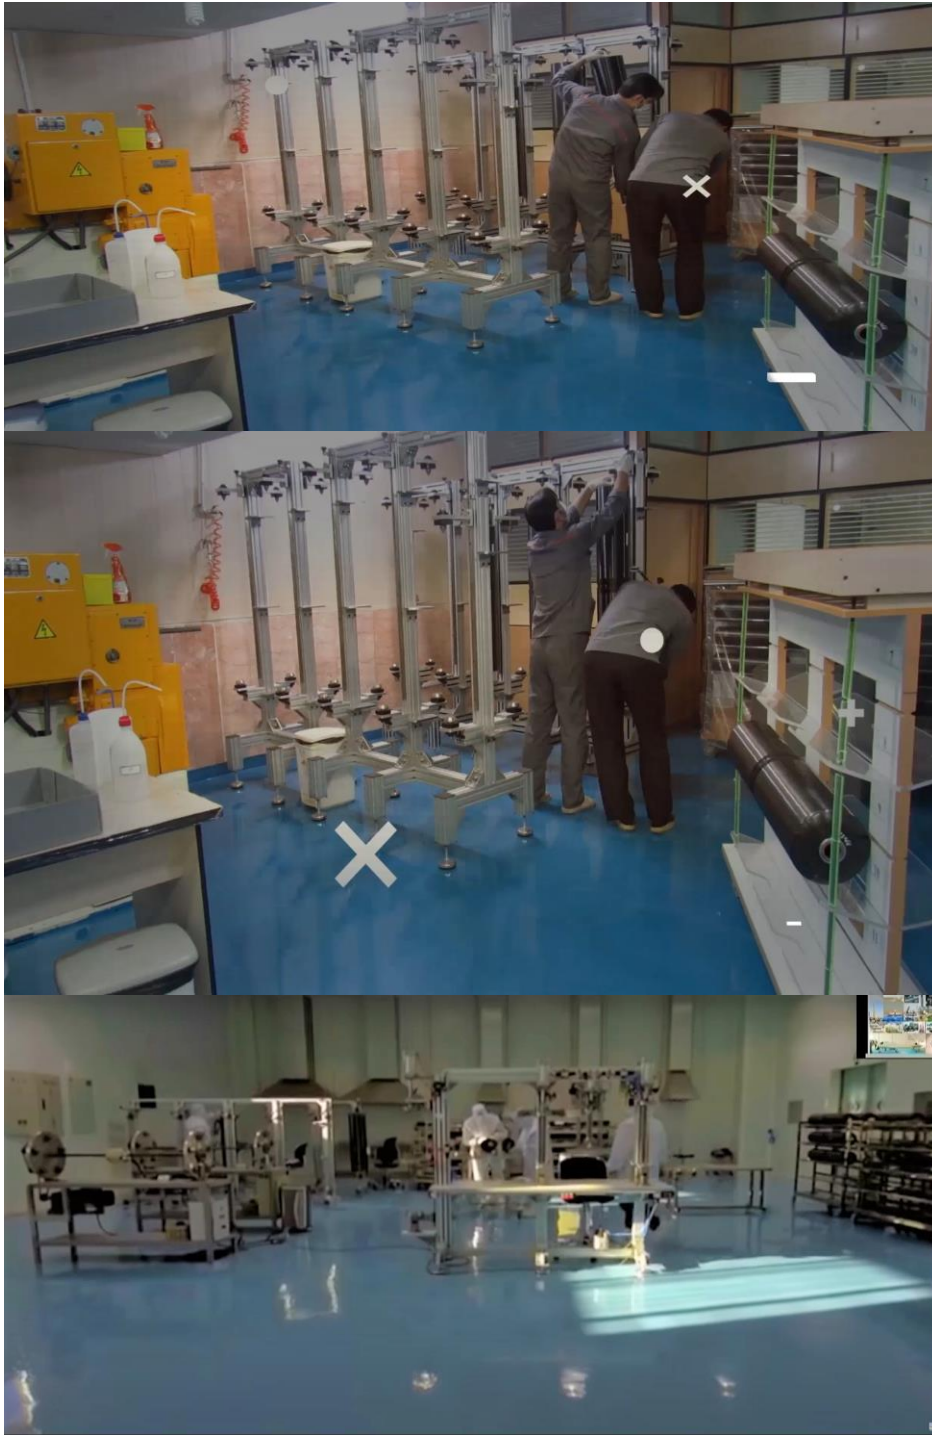
**Figure 12.** The top two photos show two workers loading an IR-6 assembled rotor vertically into a rotor straightening and balancing rig. Three or four rotor assemblies are visible in the photo. There are 20 rigs in total, some with different heights. The two personnel may be working with more than one rig at the same time. The workers must ensure that the rotor assembly is straight, which can be done by slowly rotating the assembly, while using probes and simple adjustments. For comparison, the bottom photo is of a similar, albeit far larger, room in the destroyed Iran Centrifuge Assembly Center, showing straightening and balancing equipment and rigs, racks of rotor tubes, and workers in protective, sanitary clothing. Such clothing is absent from personnel in the video, perhaps consistent with staged activities conducted for the video.

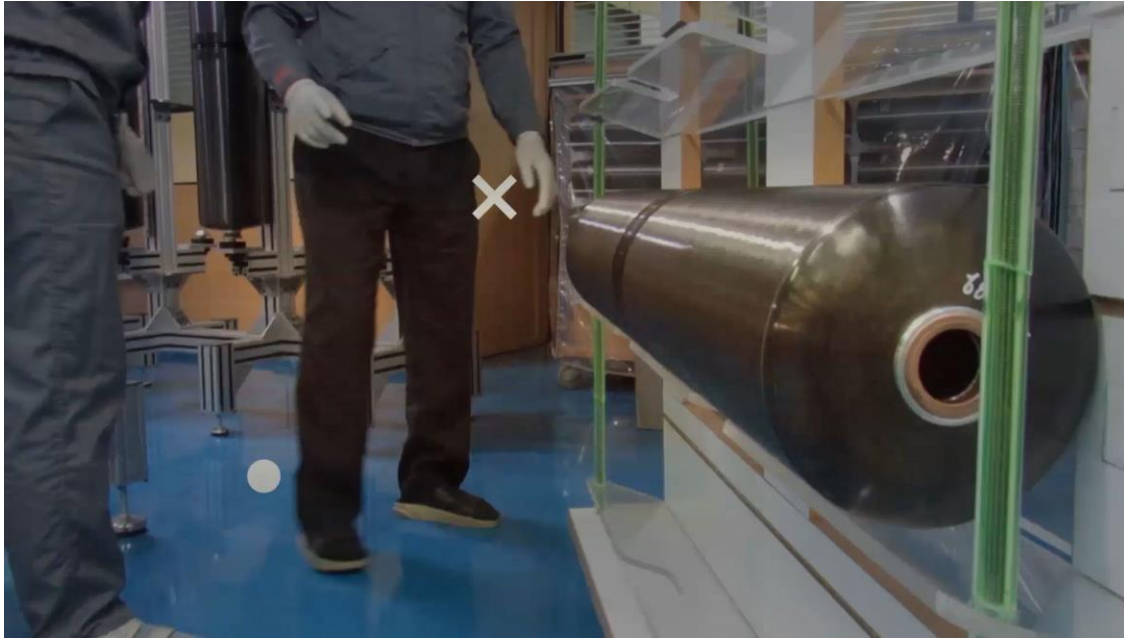
**Figure 13.** A close-up of an assembled IR-6 rotor assembly. Note that the rotating magnet, possibly made from cobalt samarium, is inserted into the metal insert of the top end cap. It is unclear if a bottom bearing pin and motor armature have been attached to the bottom of the rotor assembly. The bellows looks darker than those on the shelf made from metal, but the lighting complicates a determination of the bellows being made from carbon fiber instead of metal. However, perhaps these are carbon fiber strengthened metal bellows, e.g. overwrapped metal bellows, with the color of the carbon fiber overwrap.

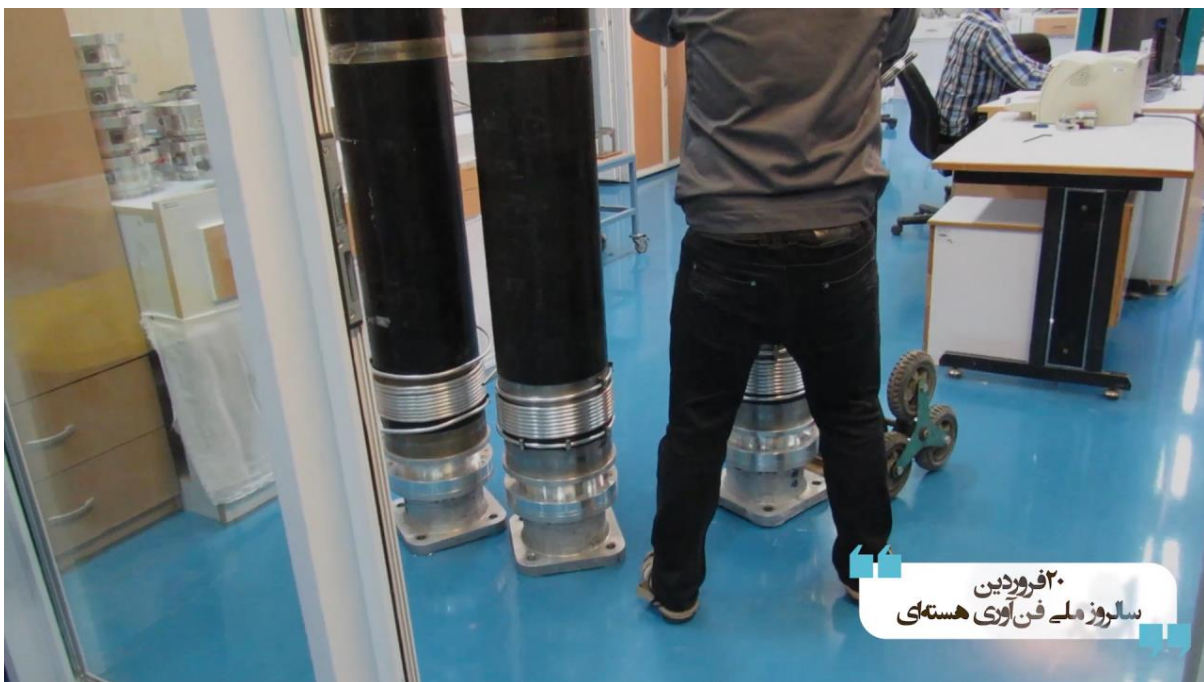
**Figure 14.** The image is a view of the bottom half of recipients and their base, showing the cooling water coils around the bottom of the recipient. The cooling is used to remove surplus heat from the rotor and to set up the temperature gradient along the rotor to stimulate the internal uranium hexafluoride gas flow. Stacks of motor housings may be visible in the left top of the top photo.

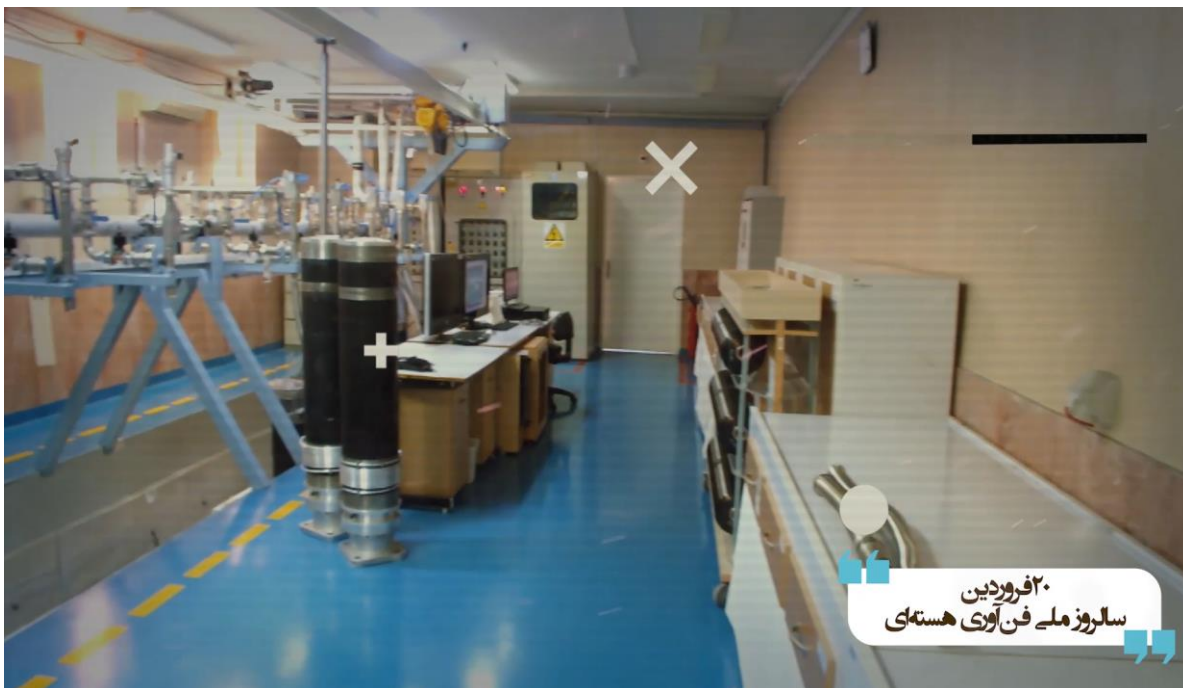
**Figure 15.** The video shows preparation for the installation of the centrifuge test stands in a testing pit. In the top photo, visible is the base flange of the centrifuge which will be bolted to the floor. The two IR-6 centrifuges in the bottom photo are awaiting lowering into the test pit, located to the left. Three rotor assemblies are visible along the right wall. The outer casings appear to be made of carbon steel rather than aluminum. Carbon steel casings have the advantage of being less expensive than aluminum ones, leading to frequent use in centrifuge programs, but carbon steel corrodes more easily, making aluminum preferable in Iranian enrichment plants.

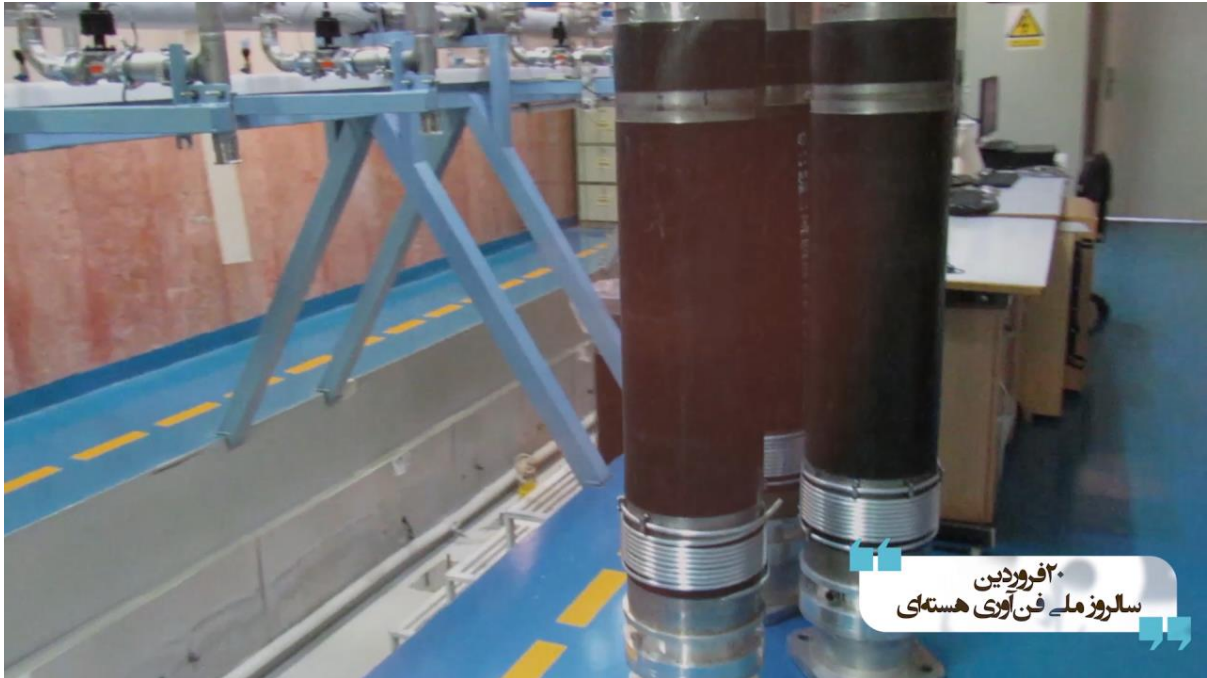
**Figure 16.** Three IR-6 test stands, with “case and base,” are awaiting to be lowered into a test pit.

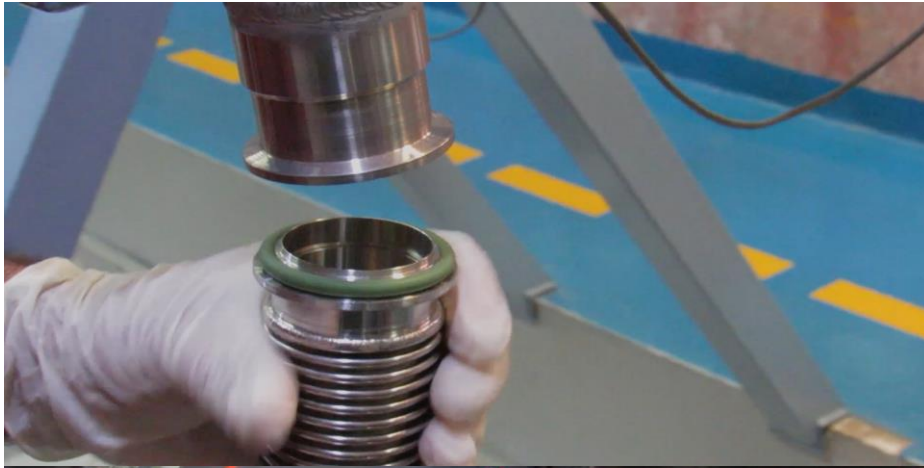
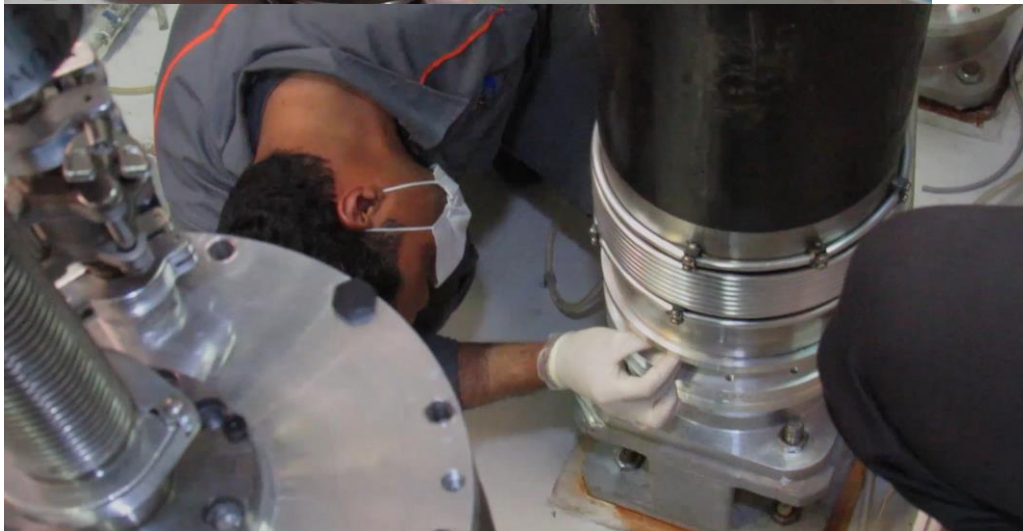
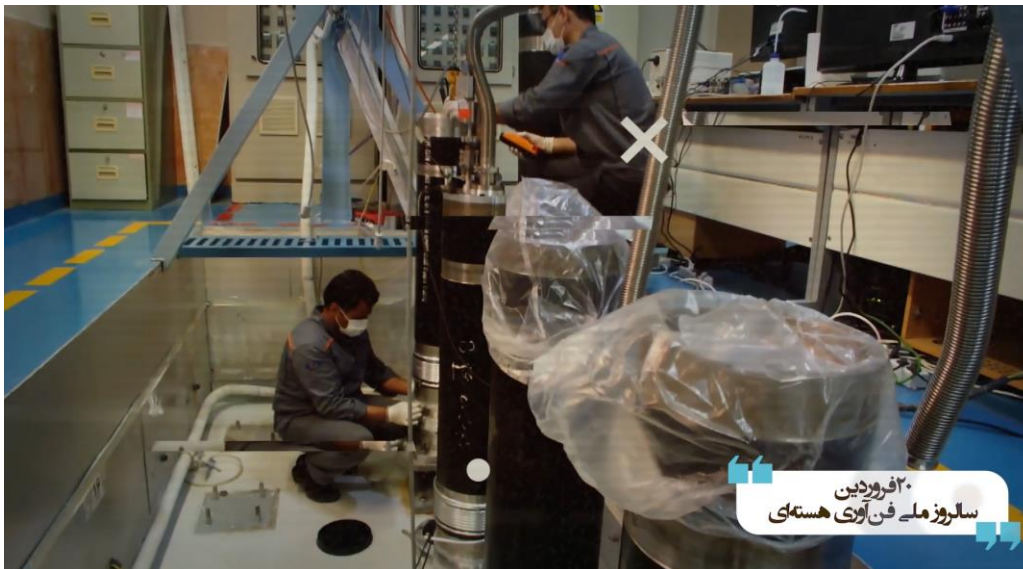
**Figure 18.** Installing the centrifuge case and base, including the outer casing, bearing housing, and motor drive housing, in a pit for mechanical testing or low speed spin tests related to quality control and assurance, likely for IR-6 centrifuges. The top photo shows the connection of the vacuum hose pipe to the top of the recipient, where a clamp is visible in a later image not included here. The middle and bottom photo shows the attachment of the motor drive unit to the bottom of the recipient.

assemblies. The video also shows the installation and operation of centrifuge test stands in at least three concrete, instrumented pits in the floor. Here, centrifuge rotor assemblies are spun under vacuum in fixed outer casings, also called recipients. As part of centrifuge assembly, a rotor is tested at various speeds inside a casing to ensure its quality. The testing is an important final step before the rotor assembly is deployed at an enrichment plant in outer casings already installed there. Modified or experimental rotor assemblies could also be tested in these casings, a process often referred to as mechanical testing.

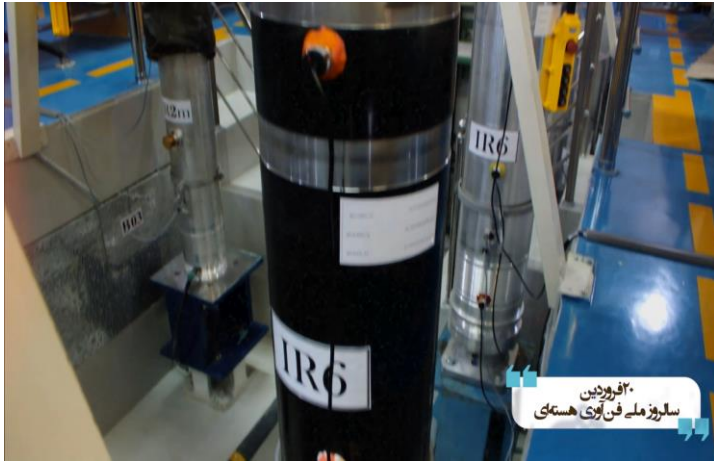
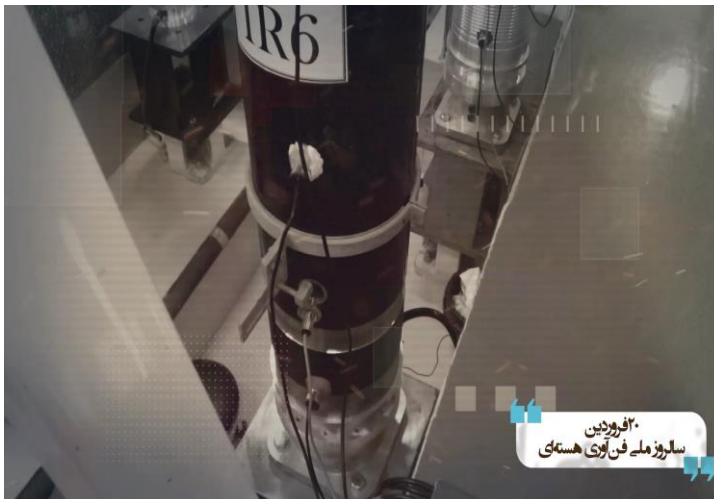
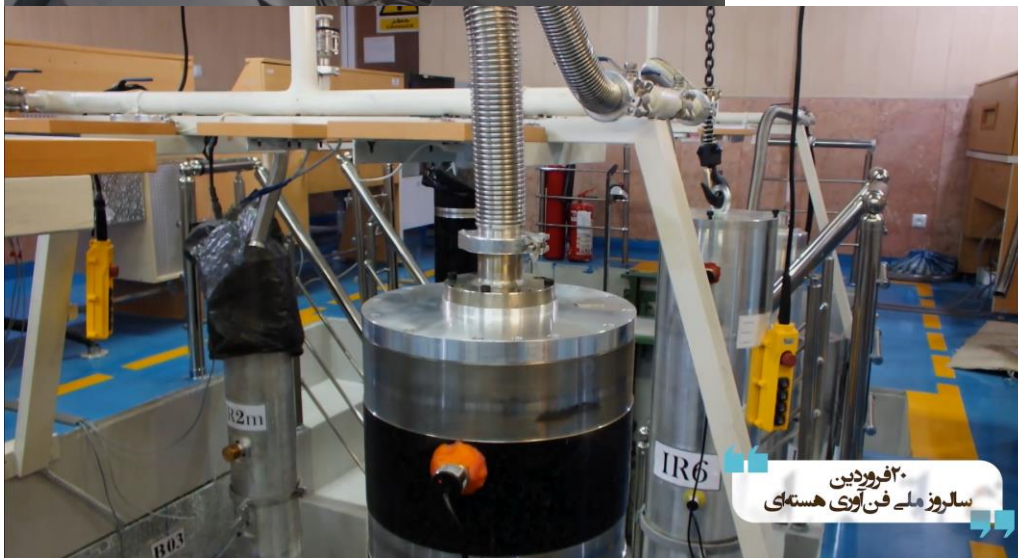
**Figure 19.** Top two images show close-ups of centrifuge test stands in a pit, labeled as the IR-6 centrifuge. Note that to the left of the IR-6 is an IR-2m machine test stand and to the right and slightly behind may be a version of an IR-6 machine with an aluminum outer casing rather than carbon steel. In the bottom photo, the IR-6 centrifuge is connected to vacuum piping and may be undergoing spin testing. The pit is marked B03, possibly related to location, and is not the same pit as in earlier images. In addition, the water coils appear to be missing. The labelling may reflect their use in other public videos released by the AEOL.

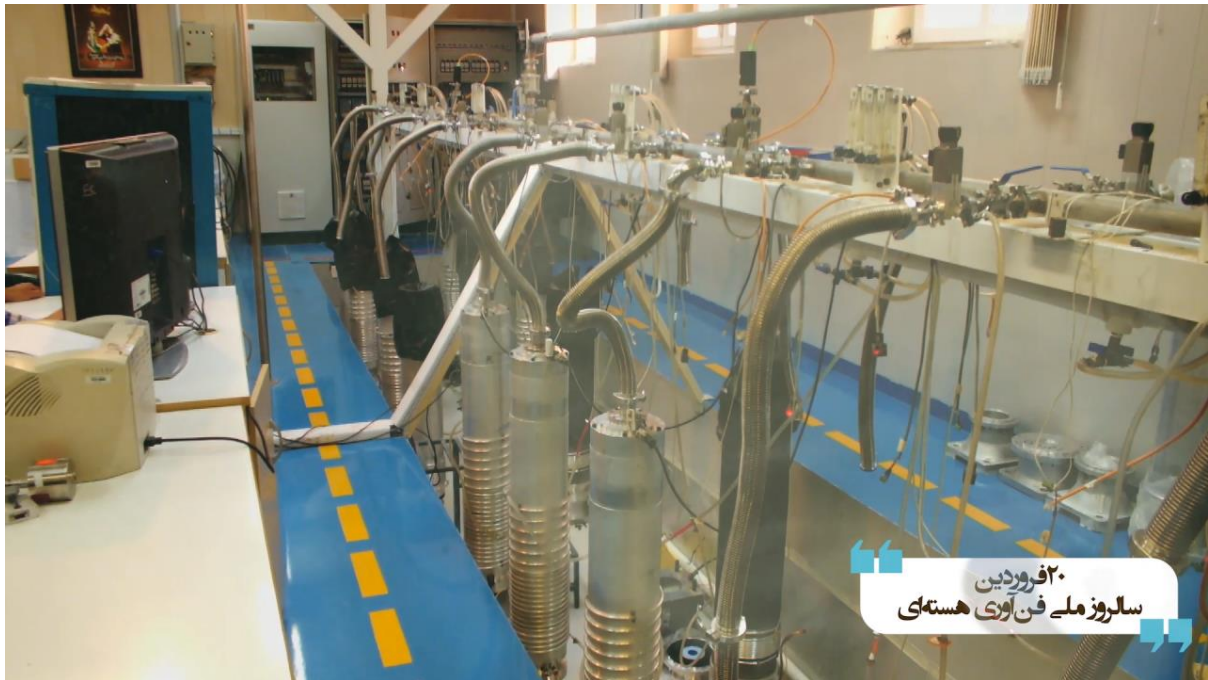
**Figure 20.** General views of advanced centrifuges in a pit, which looks different than the two discussed above. There are five or six IR-2m machines in the front row, all having metallic recipients and smaller in diameter. Several appear to be under vacuum and could be operating. Three others, with coverings, have the vacuum pipe unattached and may be on standby awaiting the insertion of new rotor assemblies. In the second row, visible is the possible installation and bolting of additional IR-6 centrifuge test stands. A motor housing with a motor inserted may be visible in the bottom photo on the bottom right. Stands of different diameters are visible in the lower right of the top photo and upper right of the bottom photo. Hand-operated vacuum valves are visible in the top image. The top photo has at least five sets of measuring or regulating devices, possibly for the water in the cooling cables.

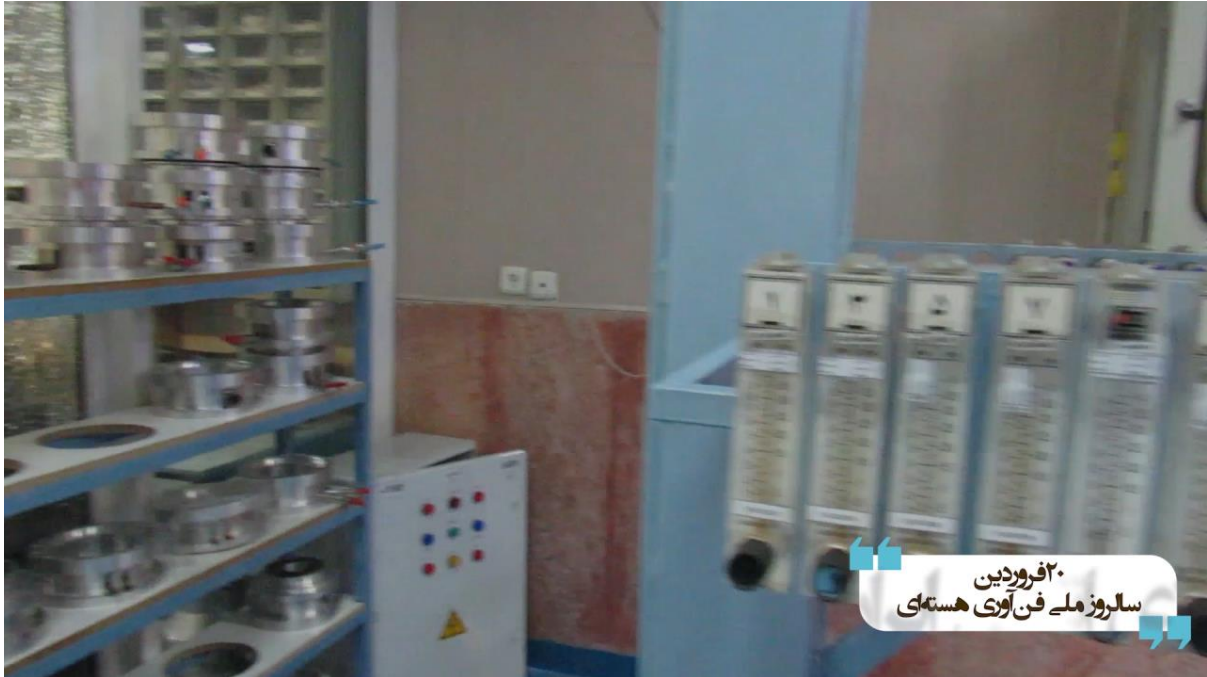
**Figure 21.** Visible are a number of components and subassemblies in the racks on the shelf. They may be motor housings, some with motors inserted. A pit may be visible behind the five monitoring or regulating devices
