Video Walk-Through of Iran's New Interim Centrifuge Assembly Center

By David Albright and Sarah Burkhard

June 29, 2022

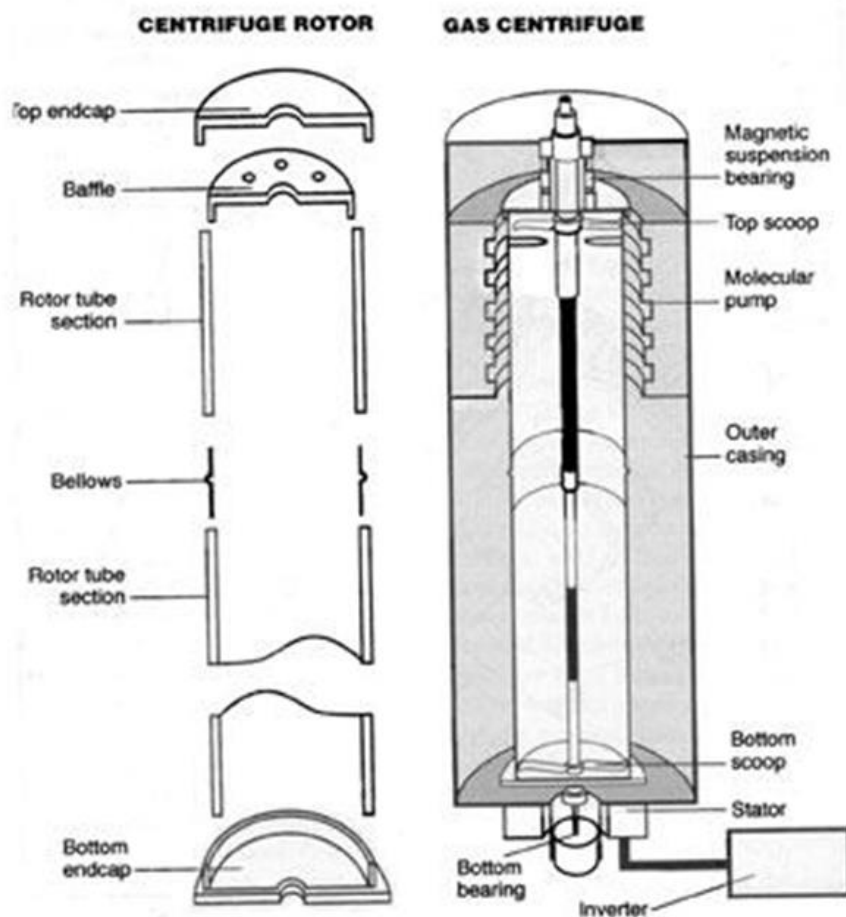
Figure 1. Schematics showing a supercritical Zippe-type centrifuge with two-rotor tubes and one bellows, a design with similarities to the IR-6 centrifuge. The type of bellows in the schematic, with an outward pointing convolution, is not the same as found in Iranian bellows, which have an inward pointing bellows, as can be seen in the video.

Many components of centrifuges are visible in the video, including whole rotor assemblies, rotor tubes, end caps, possible top and bottom cap inserts, motor housings, bottom stands, and baffles (see Figure 1 for a centrifuge schematic.) Several components and aspects of centrifuge assembly are missing in the video, including top and bottom bearing assemblies, balancing rooms and associated equipment for individual centrifuge components, motor assembly, and clean rooms necessary for assembling the top and bottom bearings.

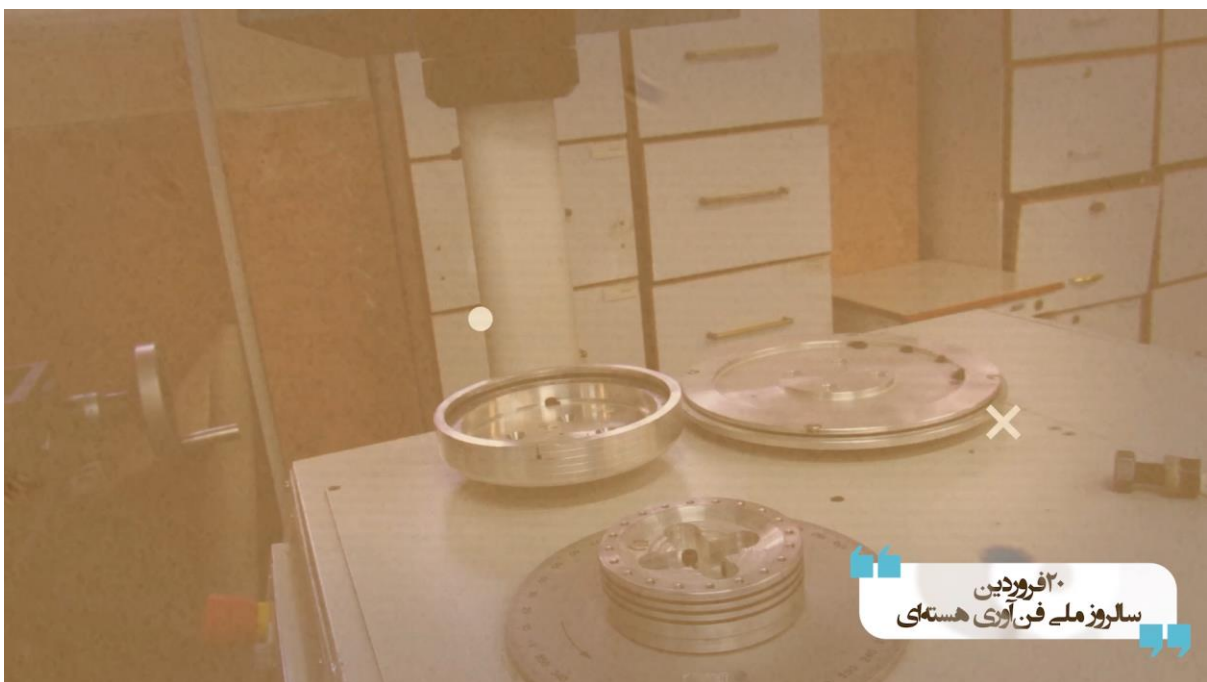
Figure 6. A photo with possible top and bottom end flanges of the outer casing, also known as the recipient.

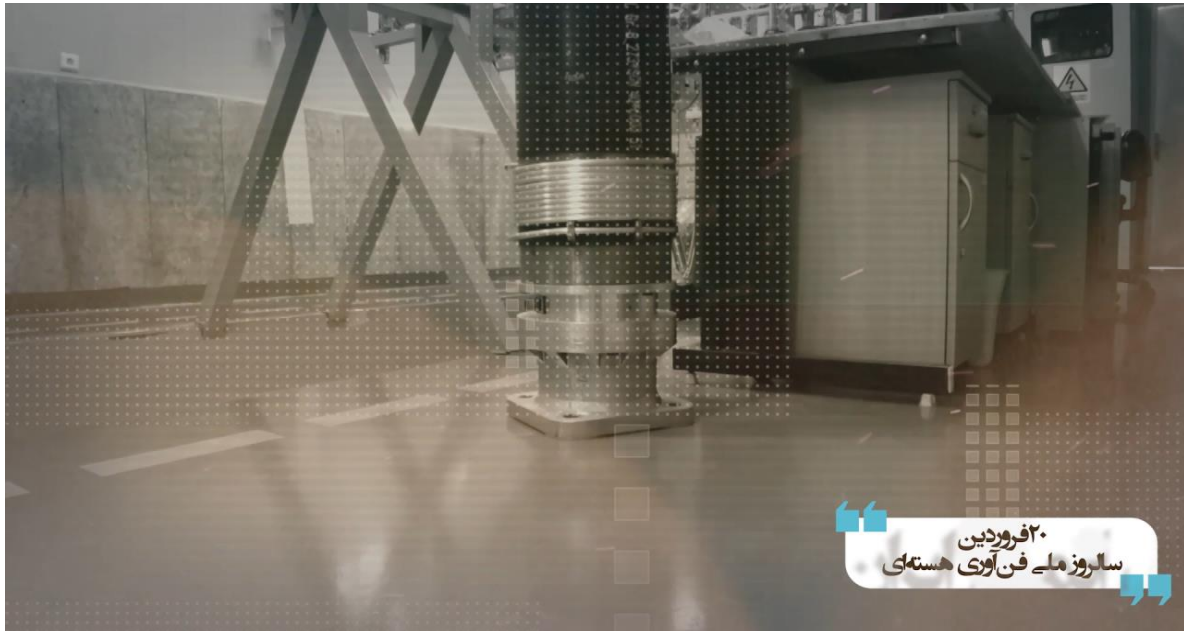
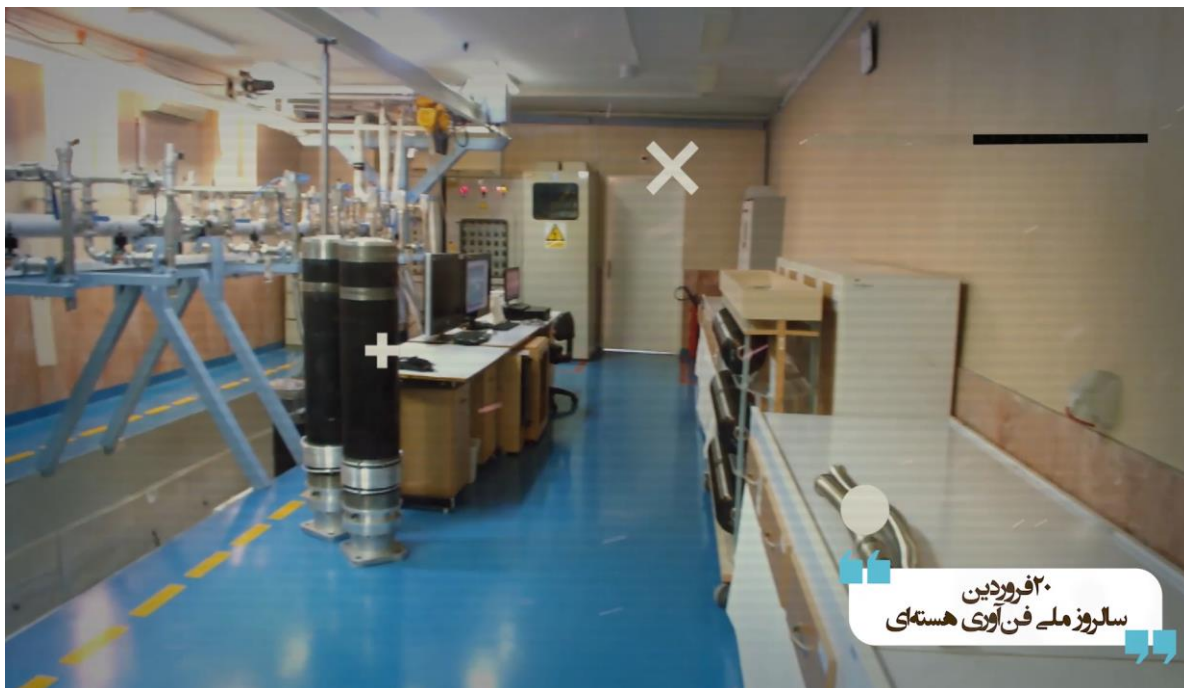
Figure 15. The video shows preparation for the installation of the centrifuge test stands in a testing pit. In the top photo, visible is the base flange of the centrifuge which will be bolted to the floor. The two IR-6 centrifuges in the bottom photo are awaiting lowering into the test pit, located to the left. Three rotor assemblies are visible along the right wall. The outer casings appear to be made of carbon steel rather than aluminum. Carbon steel casings have the advantage of being less expensive than aluminum ones, leading to frequent use in centrifuge programs, but carbon steel corrodes more easily, making aluminum preferable in Iranian enrichment plants.

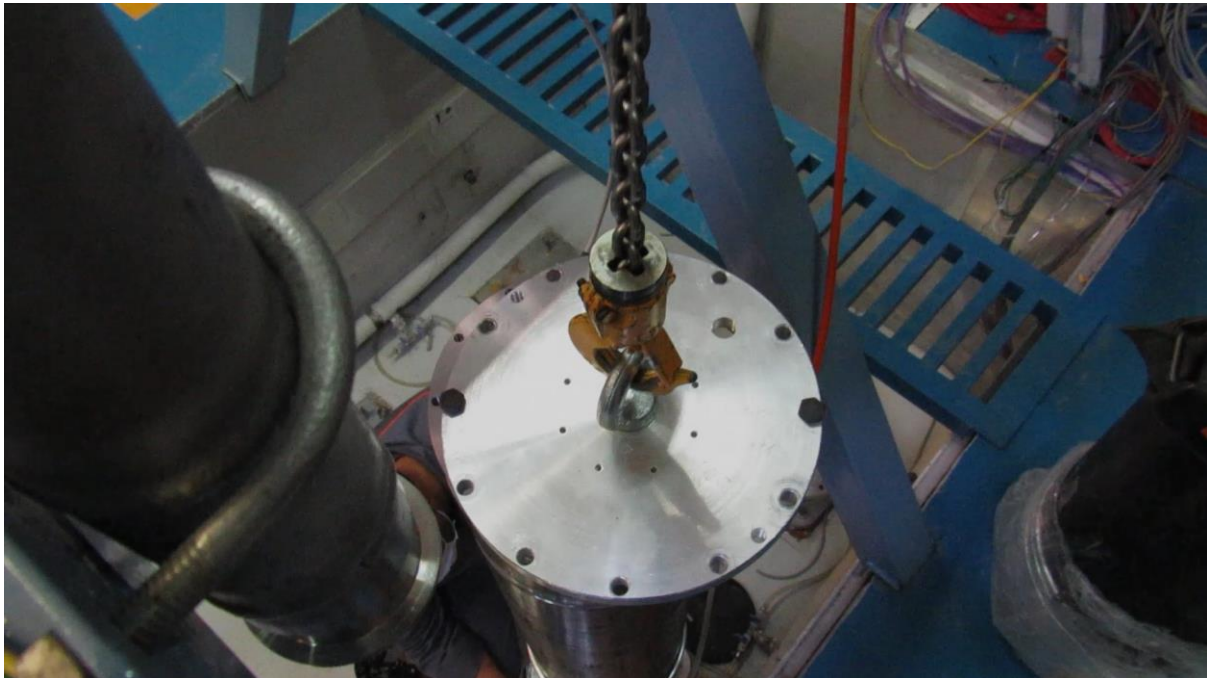
Figure 17. A close-up of the equipment used to lower the centrifuge test machines into the test pit.

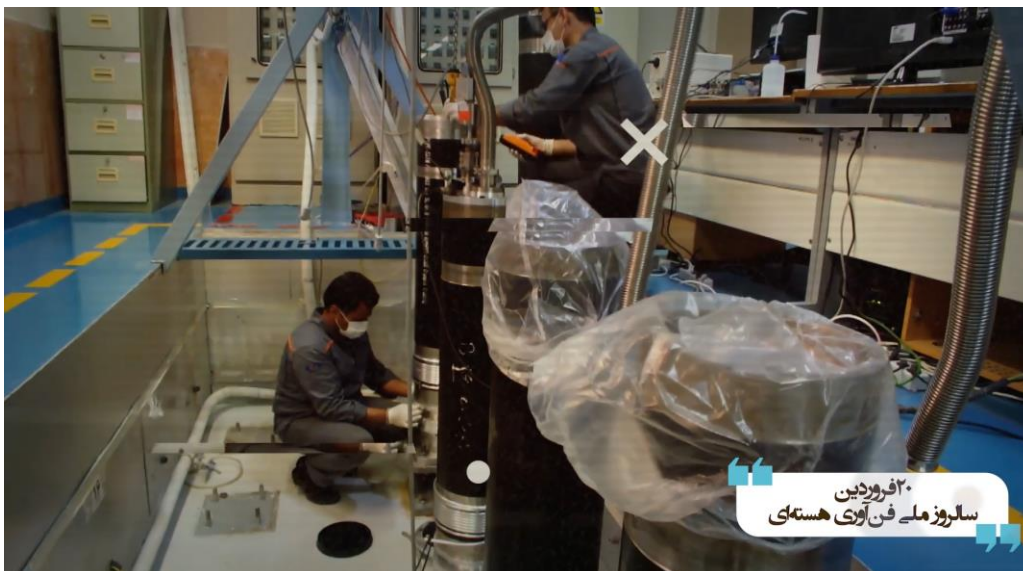
Figure 18. Installing the centrifuge case and base, including the outer casing, bearing housing, and motor drive housing, in a pit for mechanical testing or low speed spin tests related to quality control and assurance, likely for IR-6 centrifuges. The top photo shows the connection of the vacuum hose pipe to the top of the recipient, where a clamp is visible in a later image not included here. The middle and bottom photo shows the attachment of the motor drive unit to the bottom of the recipient.
