Increased Activity at the Yongbyon Nuclear Site

By David Albright and Serena Kelleher-Vergantini

December 5, 2013

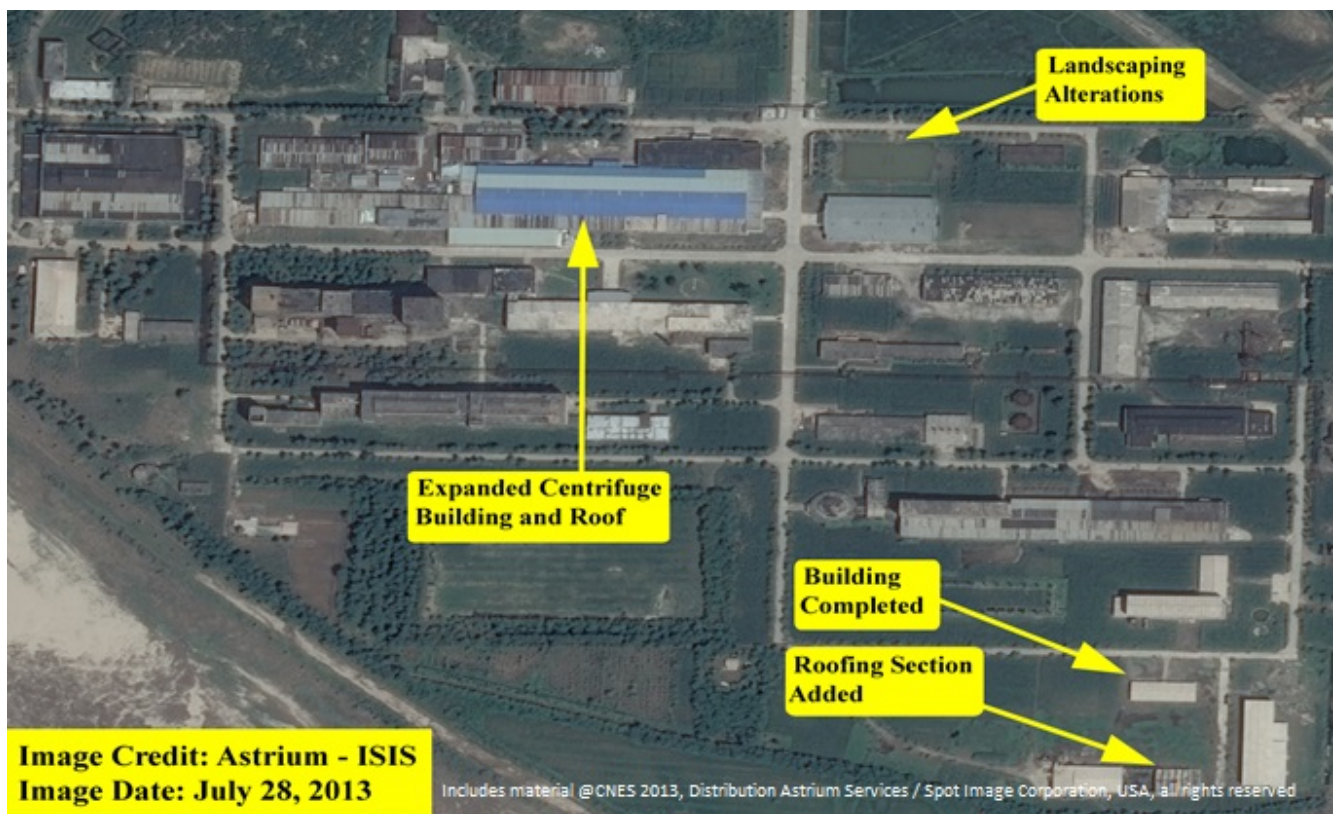
In the July 28, 2013 commercial satellite image, there were signs of construction or landscaping in an area adjacent to the centrifuge plant. A previously empty lot was cleared and converted in what seems to be a pool although it is not clear if this activity is functionally related to the expansion of the centrifuge plant building or to the fabrication of fuel (figure 1 and 2). In the December 2 image, the new area appears more finished but it still cannot conclusively be identified. However,

it looks like a pool, since it appears below grade, based on evaluating shadows in the image, and the pool appears to have some type of wall along its perimeter. The suspected pool's function and that of the adjacent building is not known.

Figure 2. Astrium imagery showing the status of North Korea's Yongbyon Fuel Fabrication Complex and Uranium Centrifuge Plant on July 28, 2013.

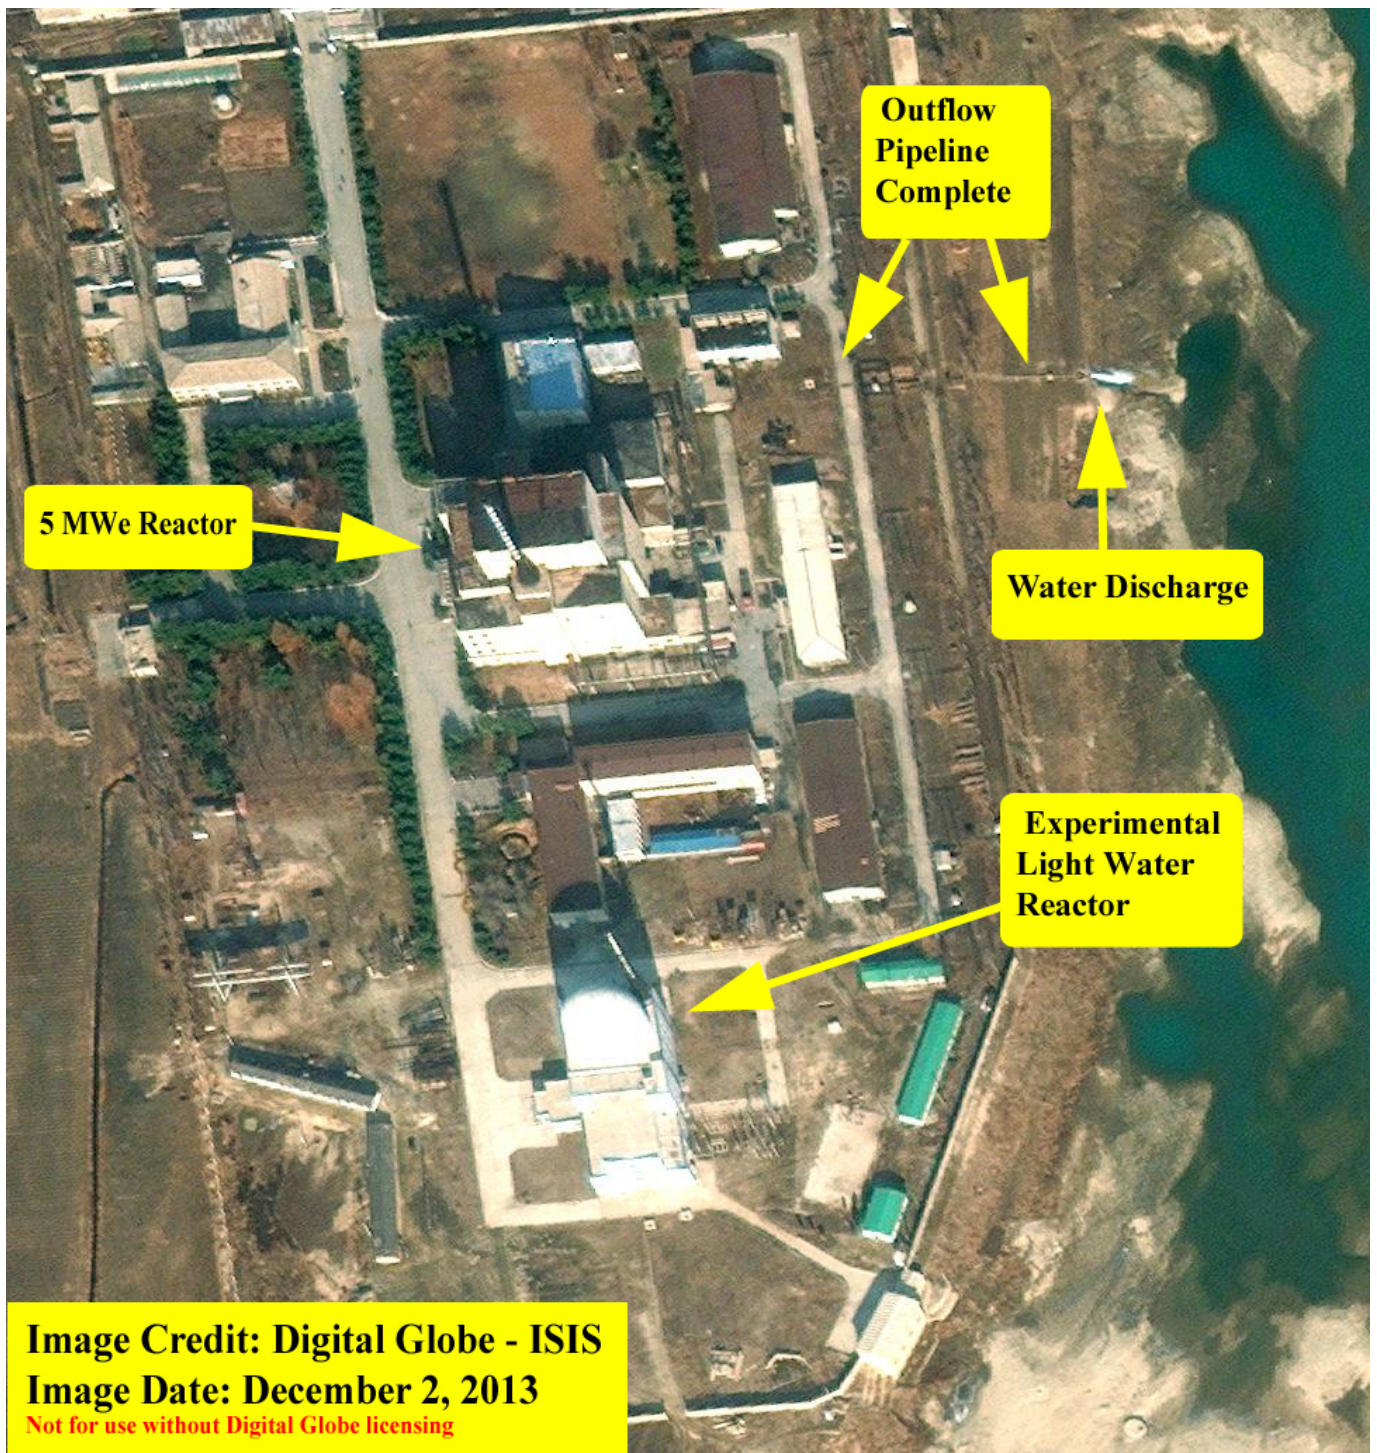
Water is being discharged near the 5 MWe reactor, according to the December 2, 2013 commercial satellite imagery (see figure 3). The outflow pipeline east of this reactor building has been successfully completed, according to [analysis](#) by 38North. A November 3, 2013 Astrium commercial satellite image shows water discharge as well, as does an August 31, 2013 Digital Globe image. Collectively, the various imagery suggests that the 5 MWe reactor has restarted and is operating.

This discharge point into the river serves the 5 MWe reactor. The most likely explanation of the water discharge is that this water is used as part of a secondary cooling system to cool the carbon dioxide gas from the 5 MWe reactor core and its presence signifies testing or on-going operation of the 5 MWe reactor. However, no steam is seen originating at this reactor, so this conclusion results from an assessment.

Figure 3. Digital Globe imagery showing the status of North Korea's Yongbyon 5 megawatt-electric and experimental light water reactors on December 2, 2013.

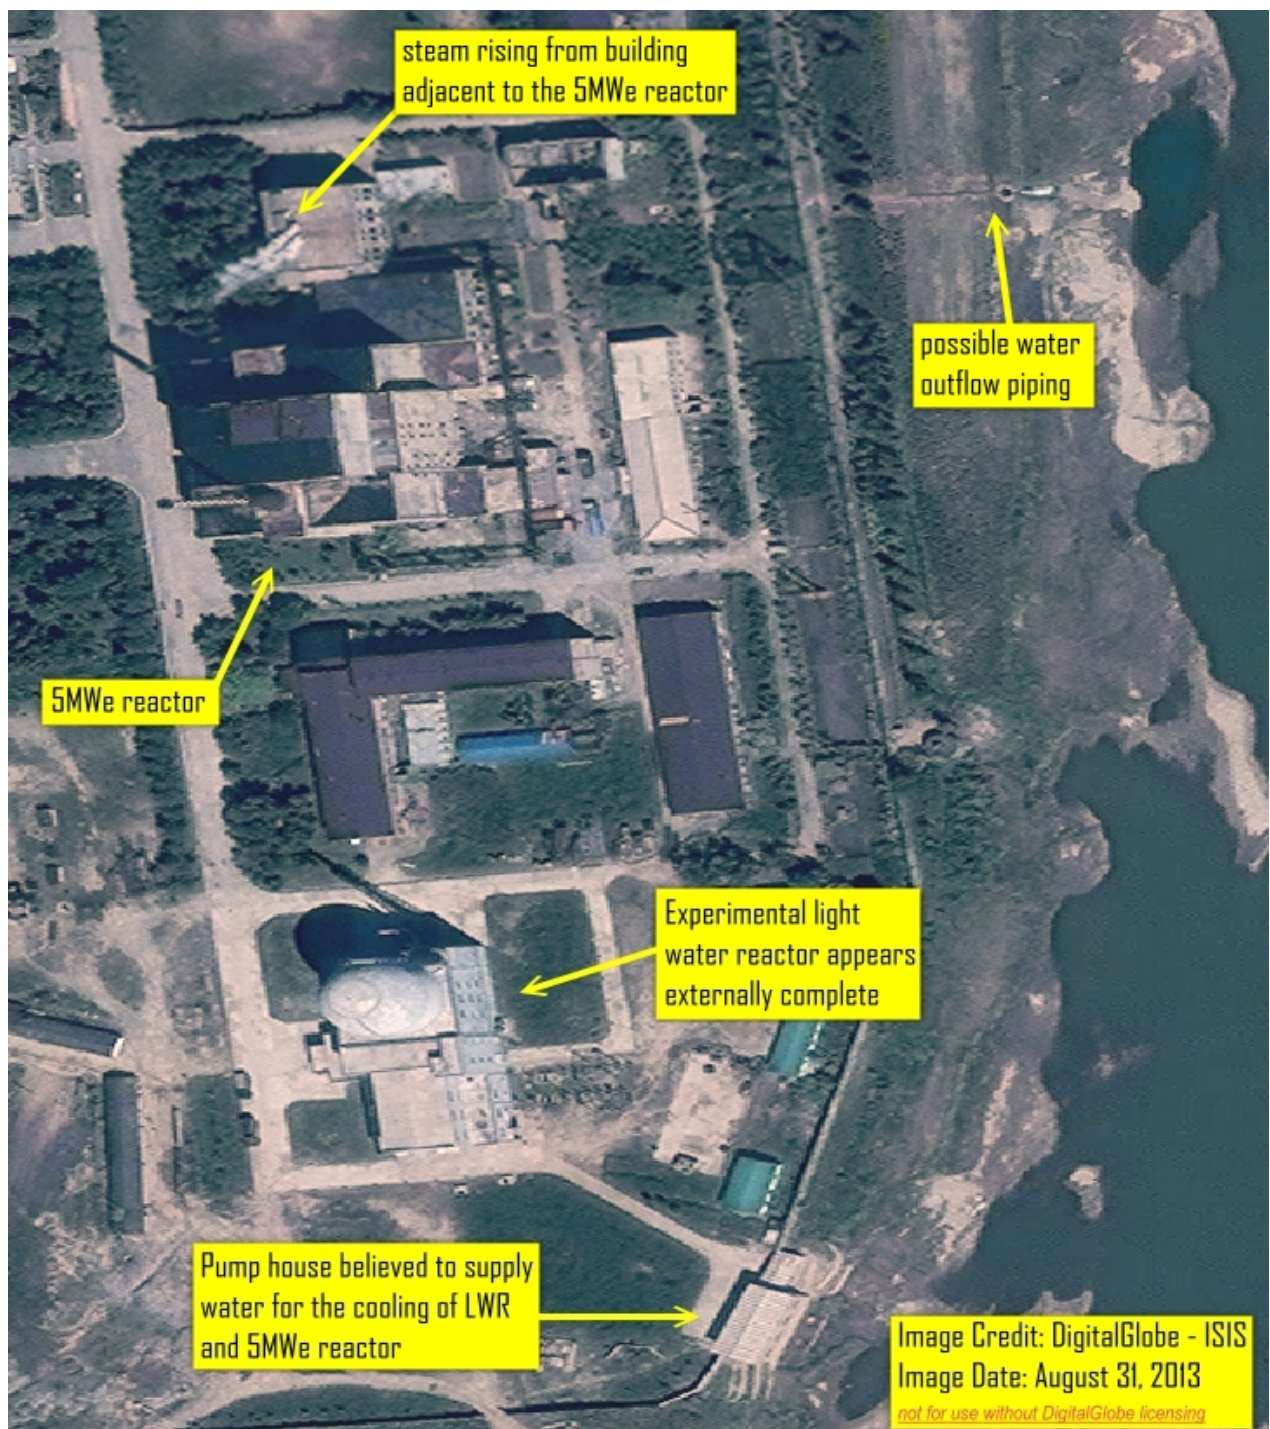
In a previous [ISIS Imagery Brief](#), commercial satellite imagery dated August 31, 2013 showed two columns of steam rising from a building adjacent to the 5MWe graphite-moderated reactor (figure 4). This could have been connected to the testing or operation of the 5 MWe reactor.¹ No such steam was seen in two images from November and December 2013.

Figure 4. Digital Globe imagery showing the status of North Korea's Yongbyon 5 megawatt-electric and experimental light water reactors on August 31, 2013.
