## ISIS IMAGERY BRIEF

September 4, 2009

### No Reconstruction at the Yongbyon Reactor Site

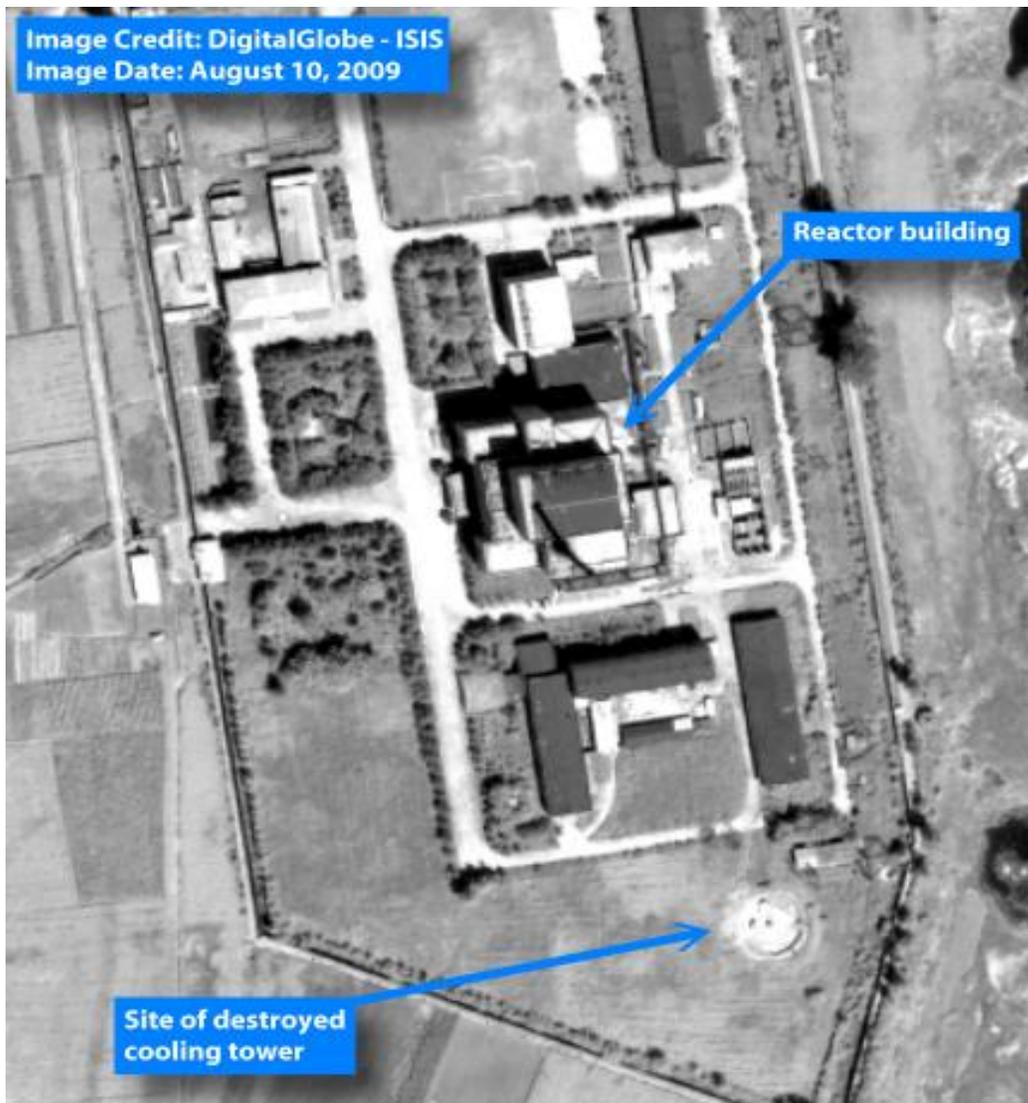
(Fig. 1) August 10, 2009 DigitalGlobe image of the reactor at the Yongbyon nuclear site in North Korea. No construction activity is visible near the disabled cooling tower.

ISIS has obtained commercial satellite imagery from DigitalGlobe of the disabled reactor at the Yongbyon nuclear site in North Korea. Based on an analysis of imagery, there do not appear to be any reconstruction efforts at the reactor site (see figure 1). The cooling tower was destroyed in 2008 and the Yongbyon nuclear reactor was disabled as part of the disablement steps agreed upon in the Six Party Talks. As seen in figure 1, there is no reconstruction of the reactor's cooling tower and no additional construction is visible in the immediate area of the reactor site.
