## Evidence that the Yongbyon 5 Megawatt-Electric Reactor Remains Operational

By David Albright and Sarah Burkhard

February 2, 2018

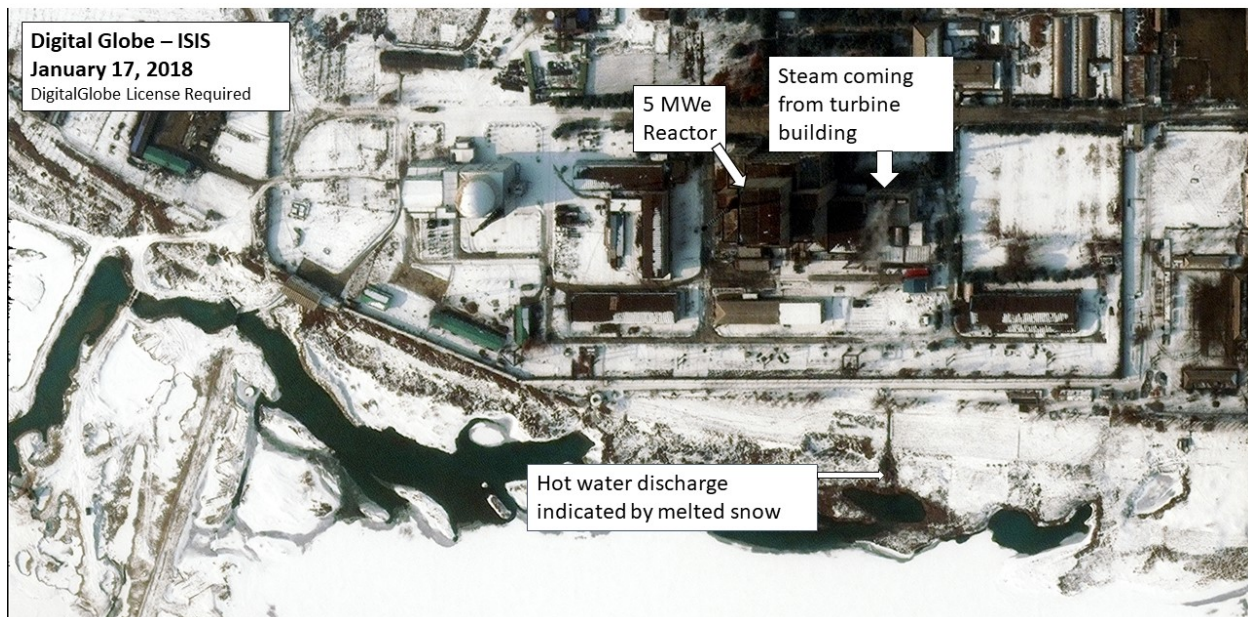
**Figure 1.** January 17, 2018 Digital Globe image of the Yongbyon 5 MWe reactor, with steam visible from the reactor's turbine building, implying the reactor is operational.

North Korea's 5 megawatt-electric reactor at the Yongbyon nuclear center remains operational, producing plutonium for nuclear weapons. In a Digital Globe January 17, 2018 image, steam is visible coming from the reactor's turbine building, and hot water appears to be melting snow at the discharge pipe for this reactor (see figure 1).

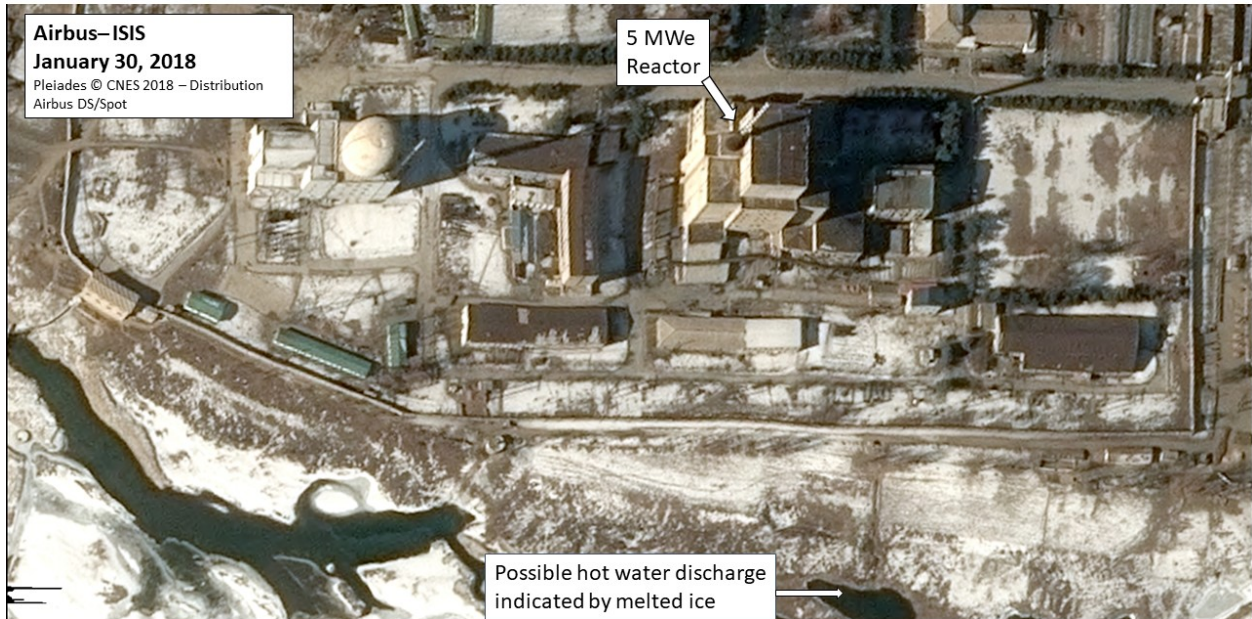
**Figure 2.** Yongbyon 5 MWe reactor on January 30, 2018.

In a January 30, 2018 Airbus image, no steam is visible but hot water may be coming from the discharge pipe (see figure 2).
