**May 27, 2009**

**Commercial Satellite Imagery of Yongbyon Nuclear Site from May 26, 2009**

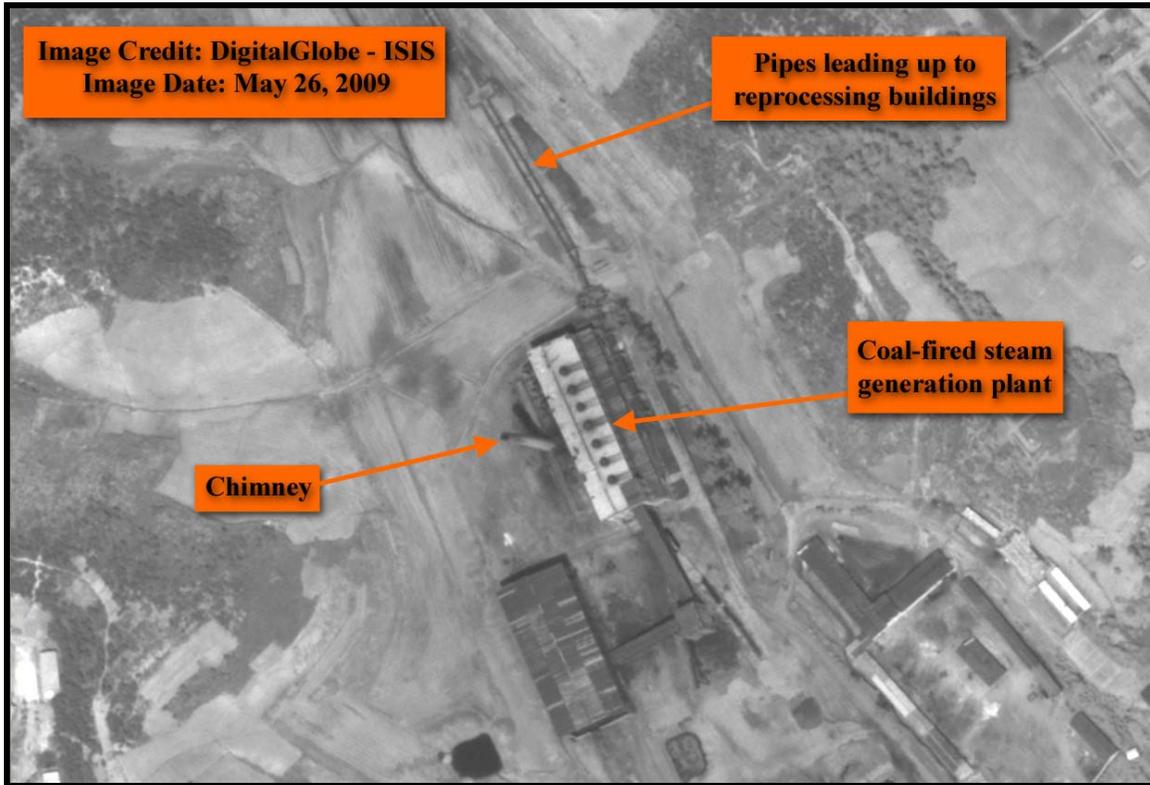
**Figure 1. May 26, 2009 DigitalGlobe image of the coal-fired plant at the Yongbyon nuclear site in North Korea. The coal-fired plant is used to generate steam for several processes at the adjacent reprocessing plant, including plutonium separation. There does not appear to be any smoke coming out of the chimney in the May 26 image. There also does not appear to be any steam emitted from the piping leading to the reprocessing plant.**

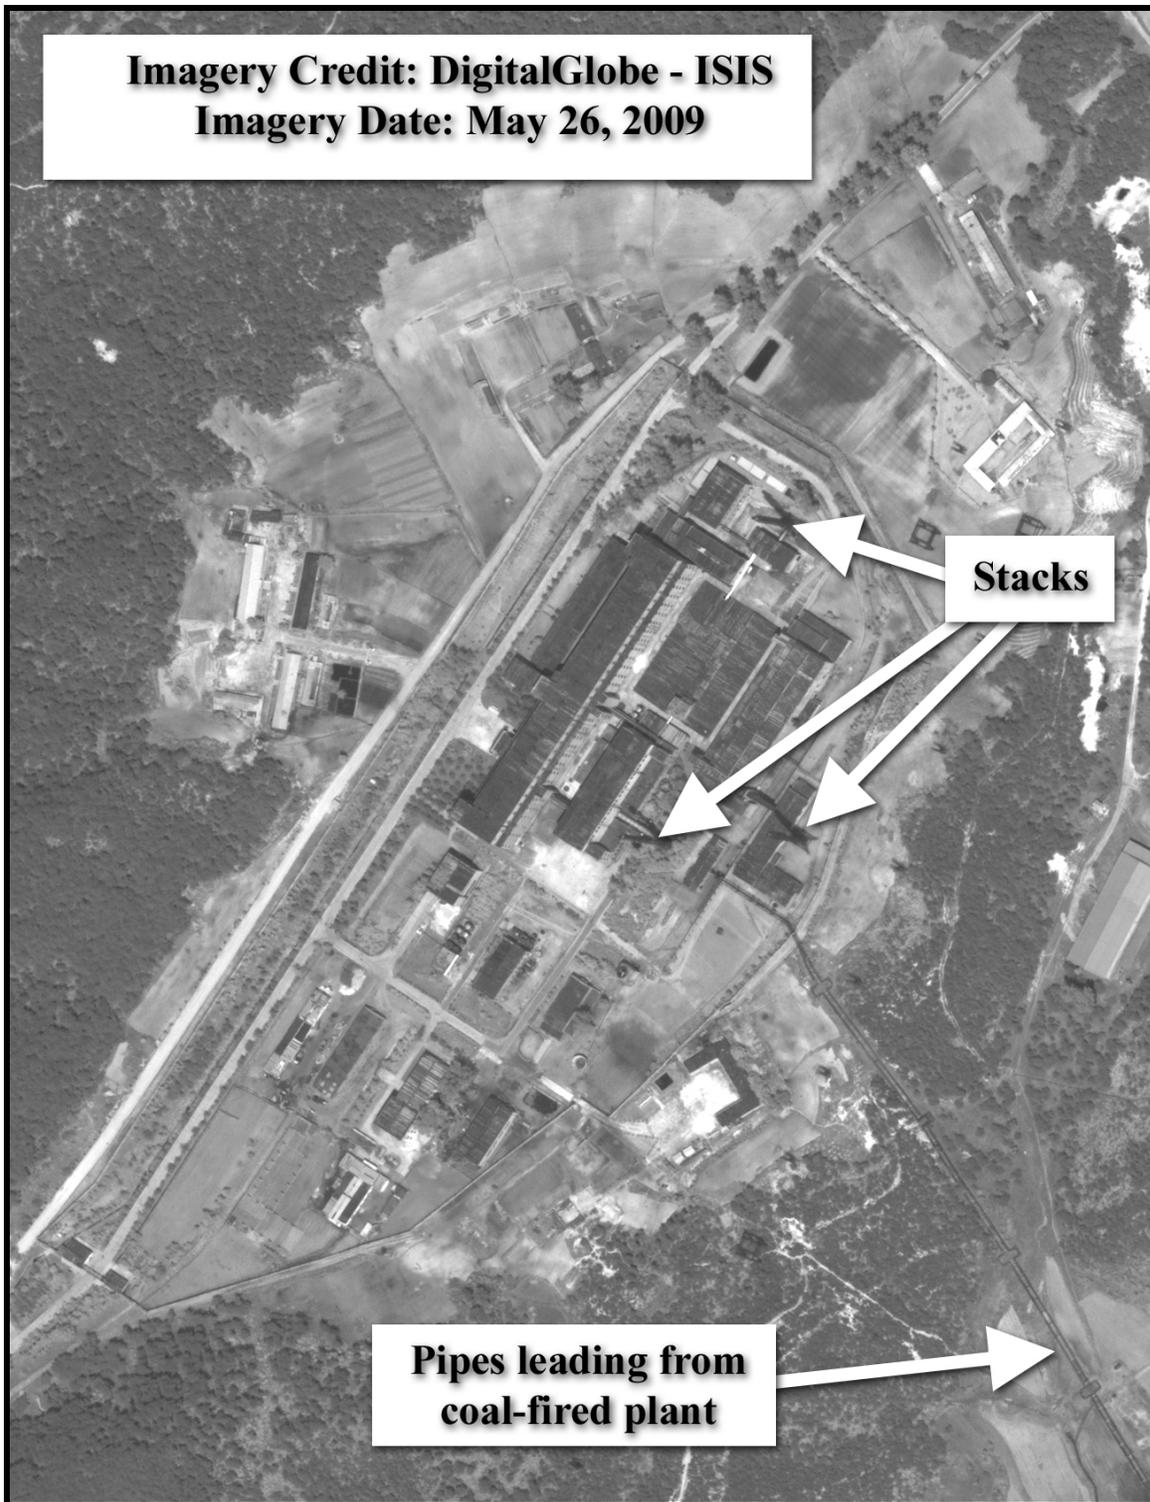
**Figure 2. May 26, 2009 DigitalGlobe image of the reprocessing buildings at Yongbyon. There does not appear to be any plume coming from the stacks at this facility. There also does not appear to be any steam emitting from the pipes leading from the coal-fired steam generation plant to the reprocessing buildings.**

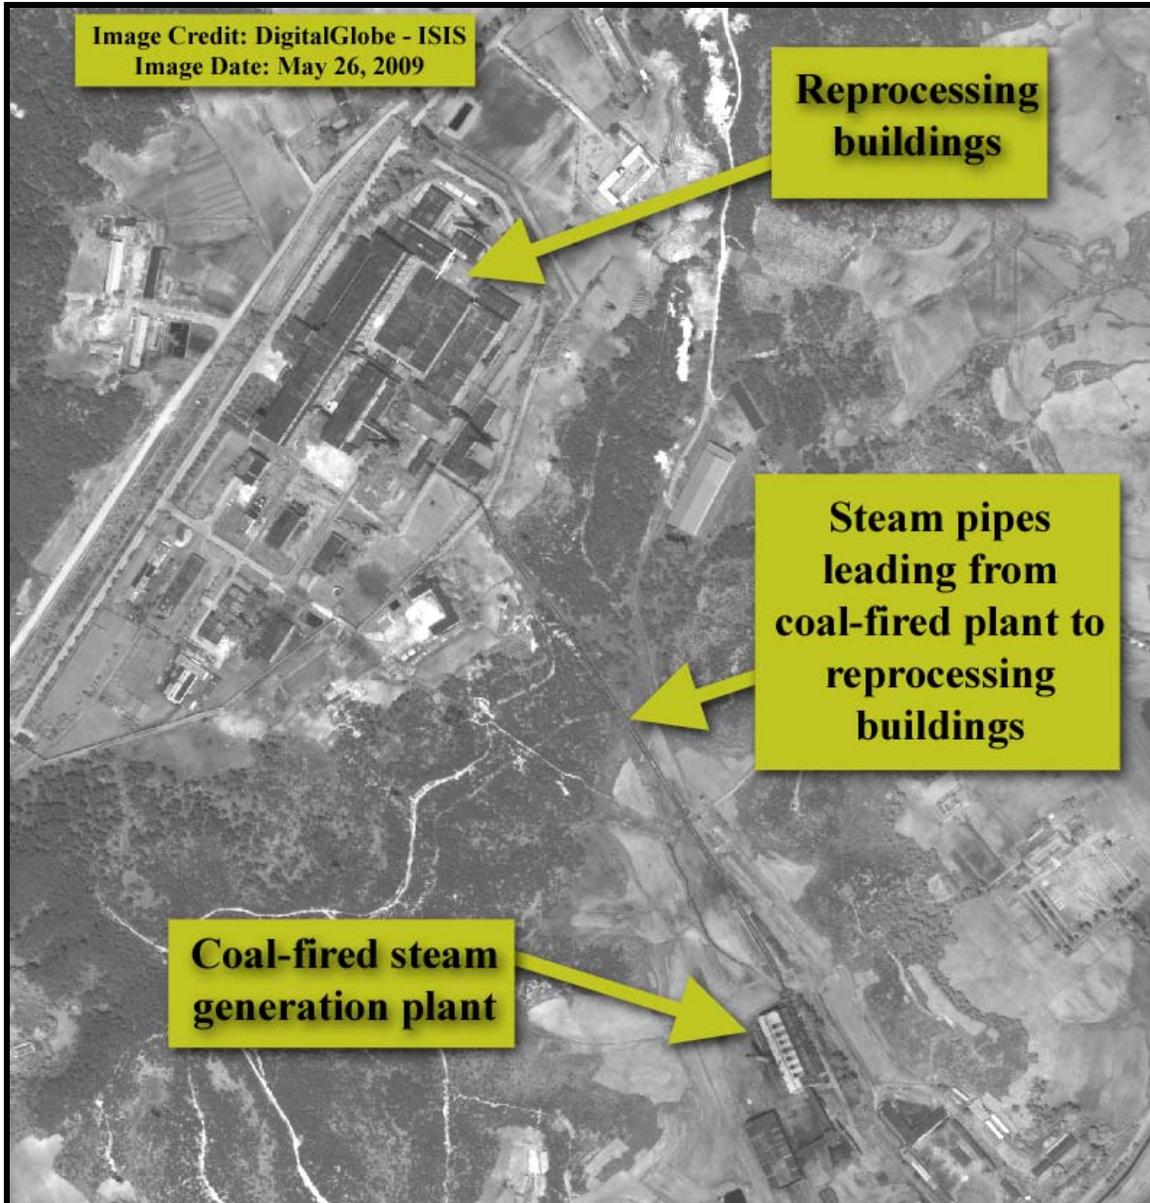
Figure 3. May 26, 2009 wide area view showing location of the reprocessing buildings, the coal-fired steam generation plant, and the pipes connecting the two compounds.

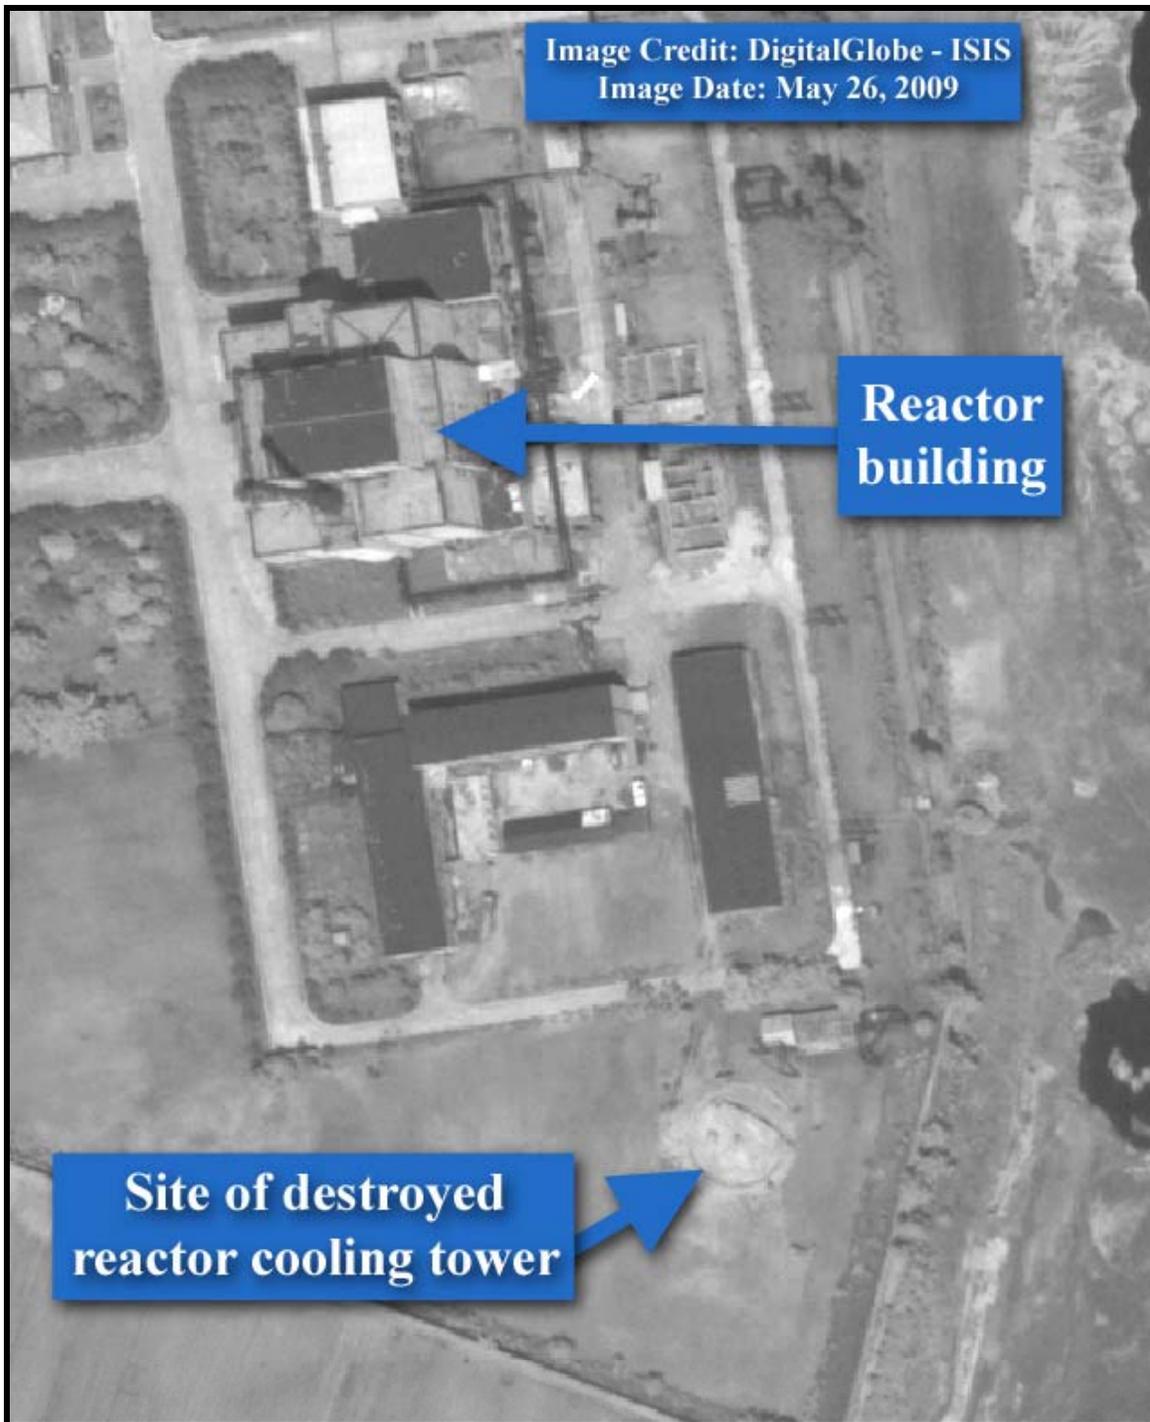
There also does not appear to be any construction activity at the site of the destroyed cooling tower for the 5MW reactor at Yongbyon (see figure 4). North Korea had disabled the cooling tower in a dramatic implosion in June of 2008.

**Figure 4. May 26, 2009 DigitalGlobe image showing the site of the destroyed cooling tower. There does not appear to be any construction activity near where the cooling tower had previously stood. North Korea imploded the cooling tower in June 2008 as a disablement measure.**
