Chongsu Nuclear-Grade Graphite Production Plant? North Korea may be proliferating controlled nuclear goods

By David Albright

April 20, 2018

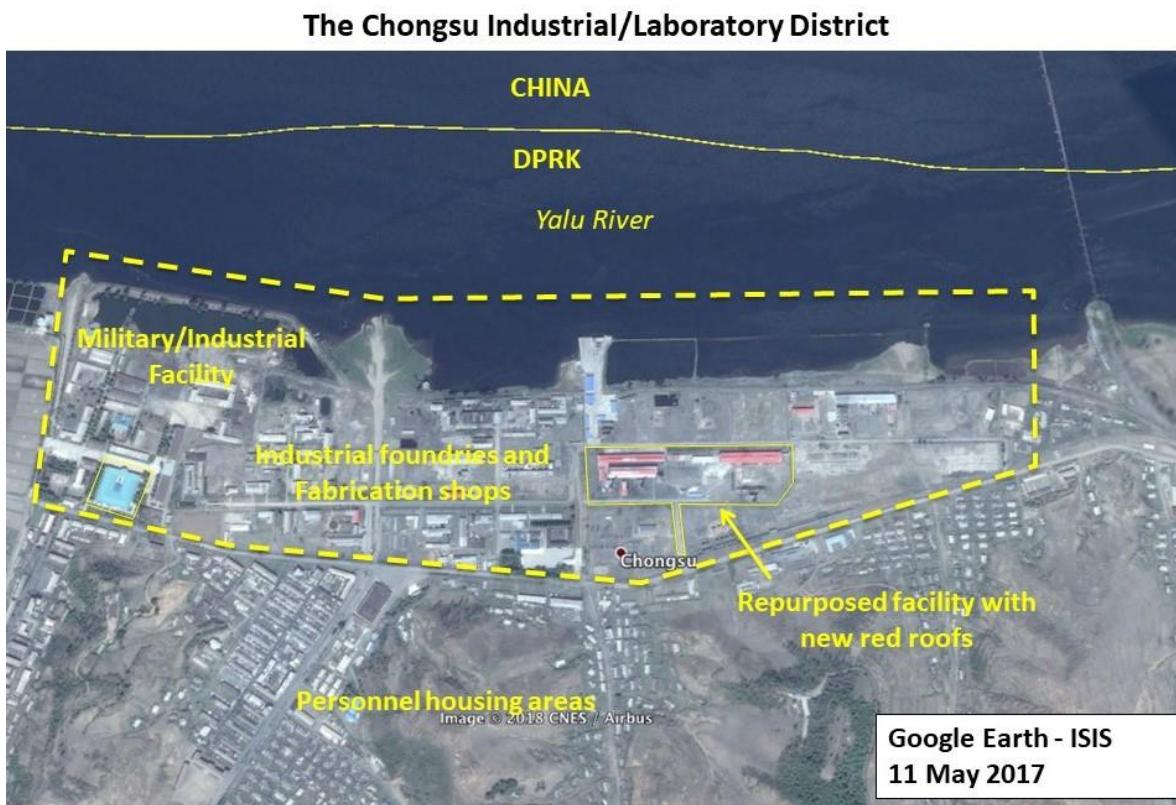
Figure 1. Complex at Chongsu suspected to contain a nuclear-grade graphite production facility.

Figure 1 shows a Google Earth image of a complex at Chongsu on May 11, 2017, which the Institute is calling the Chongsu Industrial and Laboratory District. Japanese Wikimapia labeling identifies the area of interest at Chongsu as the "Shing Pong Laboratory District." The suspect facility can be identified by new red roofs seen in figure 2.

There is also a new large building located at the south end of this industrial and laboratory district (see figure 1). This large building, located in a secured military industrial facility, was completely dismantled and rebuilt as an entirely new building with new, more modern architecture and a new blue roof (see figures 7-9). Its function could not be determined since there do not appear to be clearly observable functional signatures.

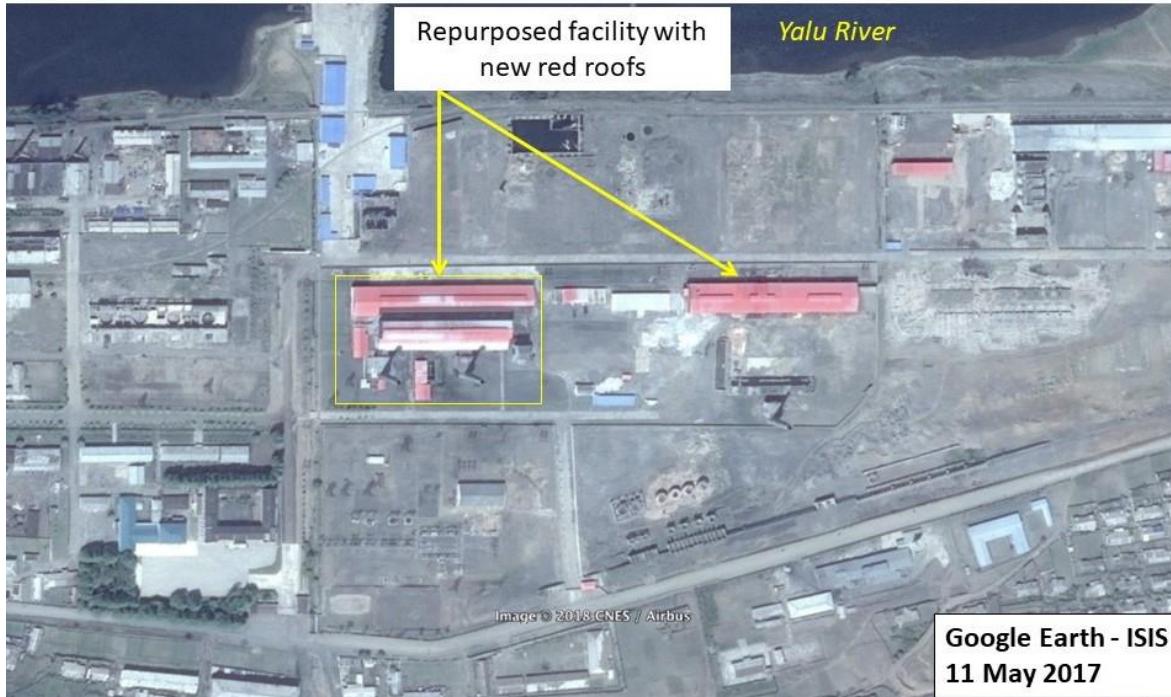
Figure 2. Close-up of suspect nuclear-grade graphite production facility.

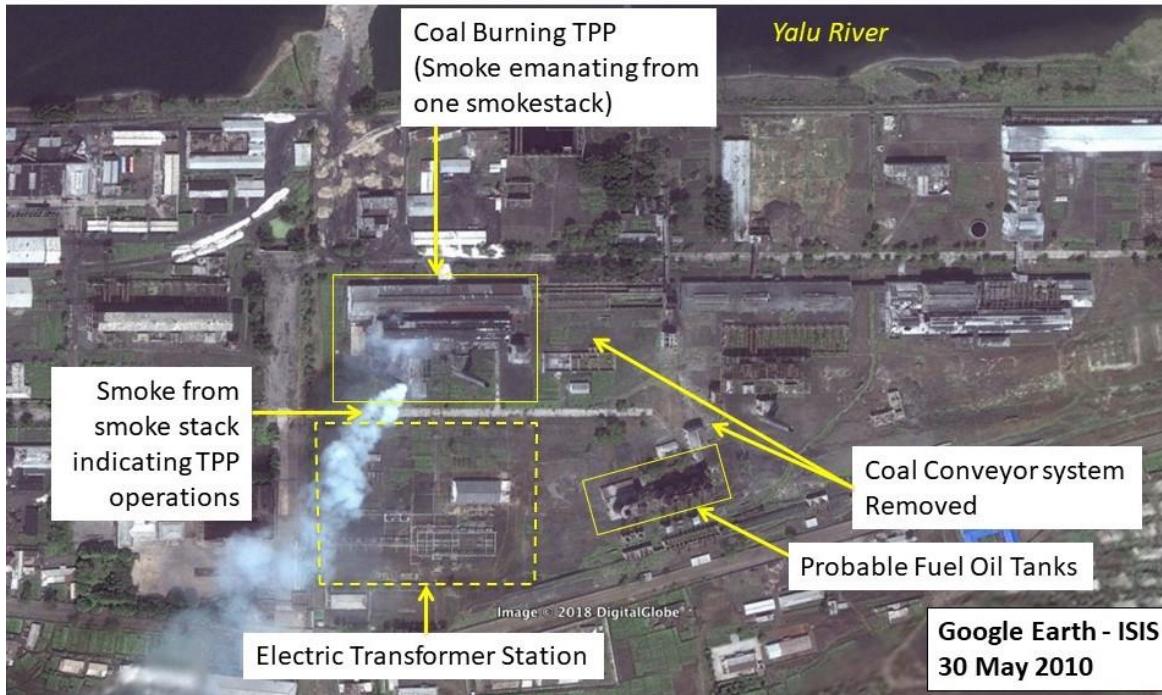
Figure 3. Coal-fired thermal power plant at Chongsu site in 2010, prior to extensive modification, with smoke visible.

This facility appears to be a repurposed coal burning thermal power plant (TPP). Figure 3 shows the facility on May 30, 2010, where smoke can be seen emanating from one of two stacks and a coal conveyor system is visible. Figure 4 shows the facility in 2006.

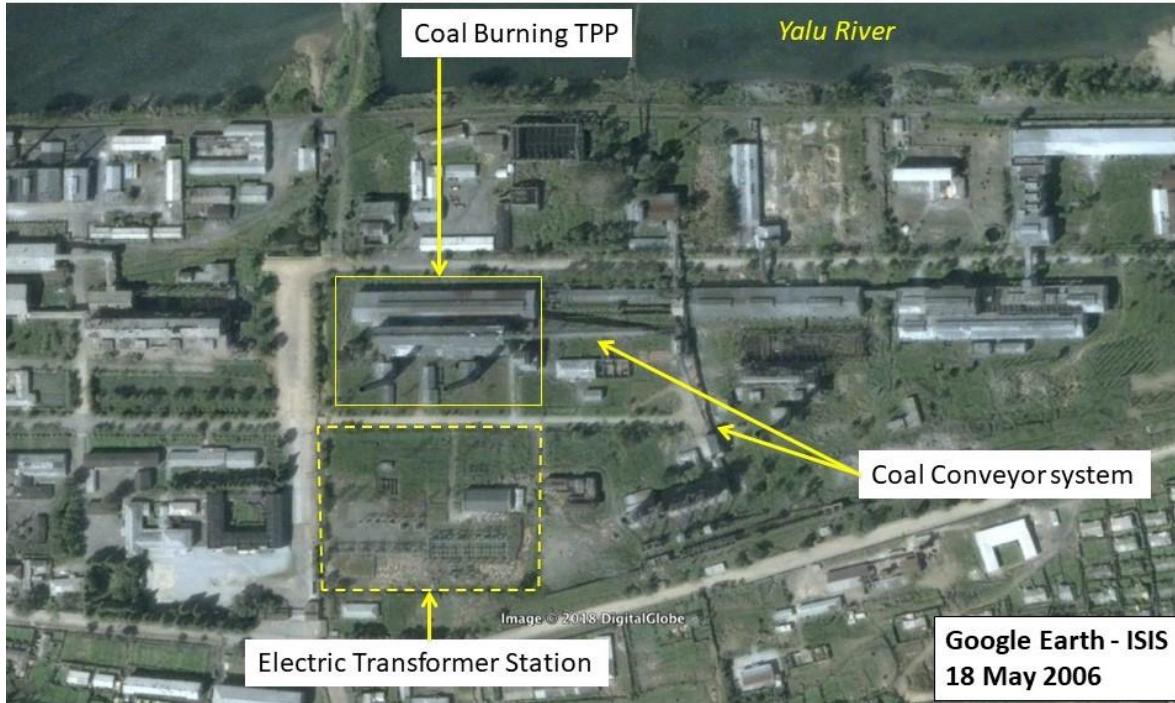
Figure 4. Coal-fired power plant at Chongsu in 2006.

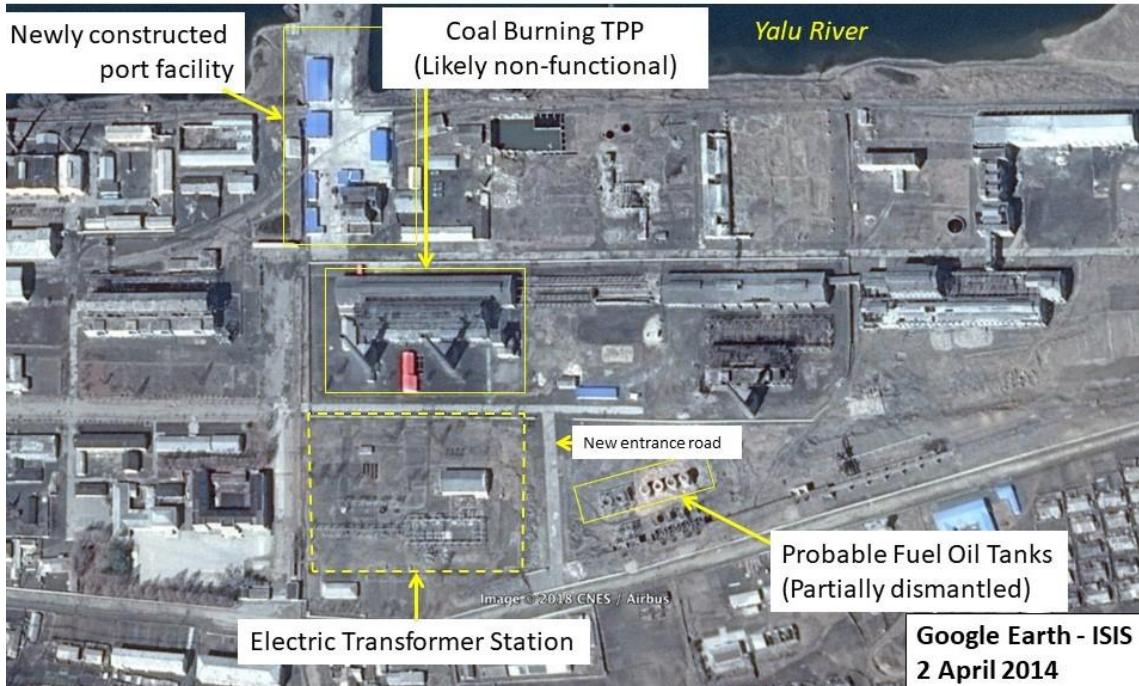
Figure 5. Modification of the coal-fired coal plant and associated facilities in 2014, showing extensive changes.

Figures 5 and 6 show construction progress at this site from 2014 to 2016, showing extensive renovation of the coal burning thermal power plant. The renovation of the plant and adjacent area included the addition of red roofs and improved security. Figure 5 is from April 2, 2014

and shows the powerplant as likely no longer functional. Figure 6 shows the site on May 18, 2016. A significant part of the electrical substation was dismantled. The entire coal conveyor system of the TPP was also dismantled. There may have been an attempt to convert the plant to fuel oil several years ago. The repurposed facility has a new entrance road and is surrounded by a new security perimeter wall with a security checkpoint building at the front gate (see figure 6).

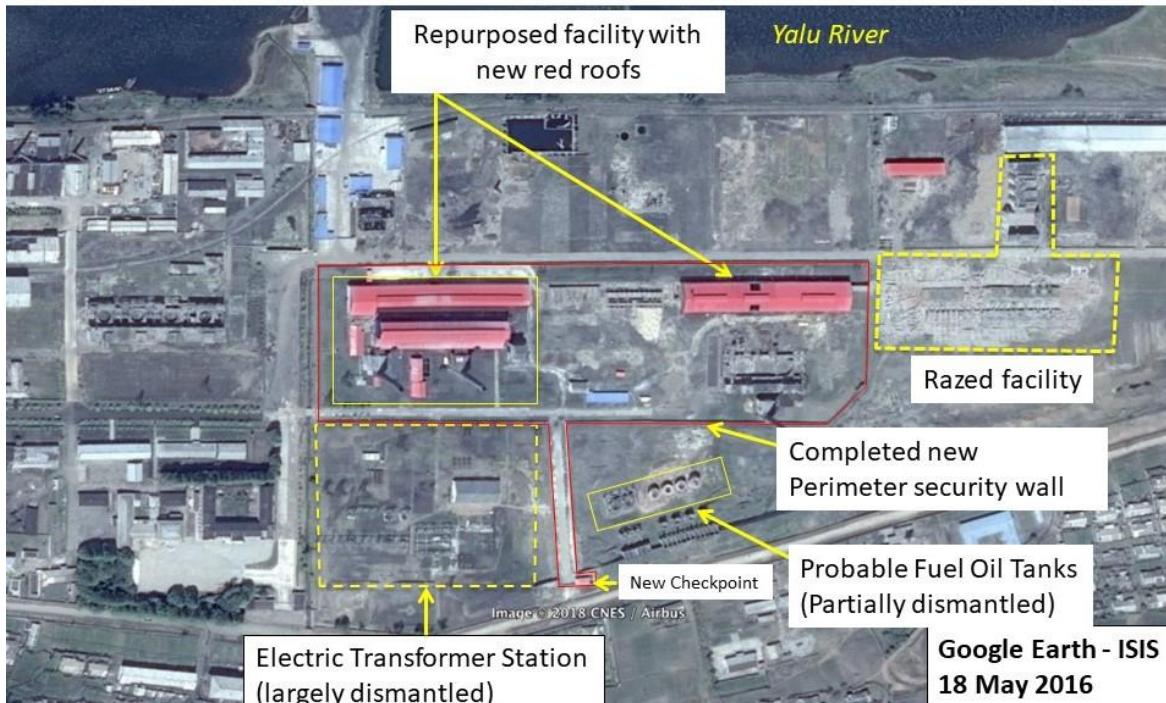
Figure 6. Modified coal-fired plant in 2016.

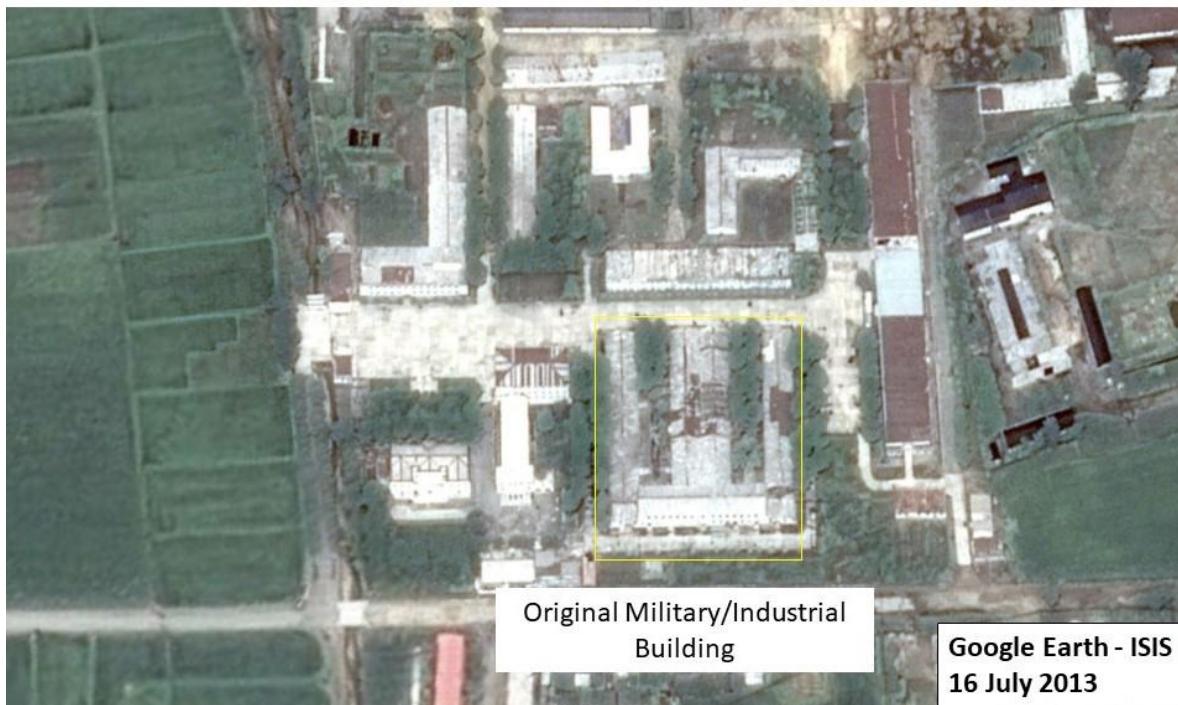
Figure 7. Original military or industrial facility at the Chongsu site, 2013.

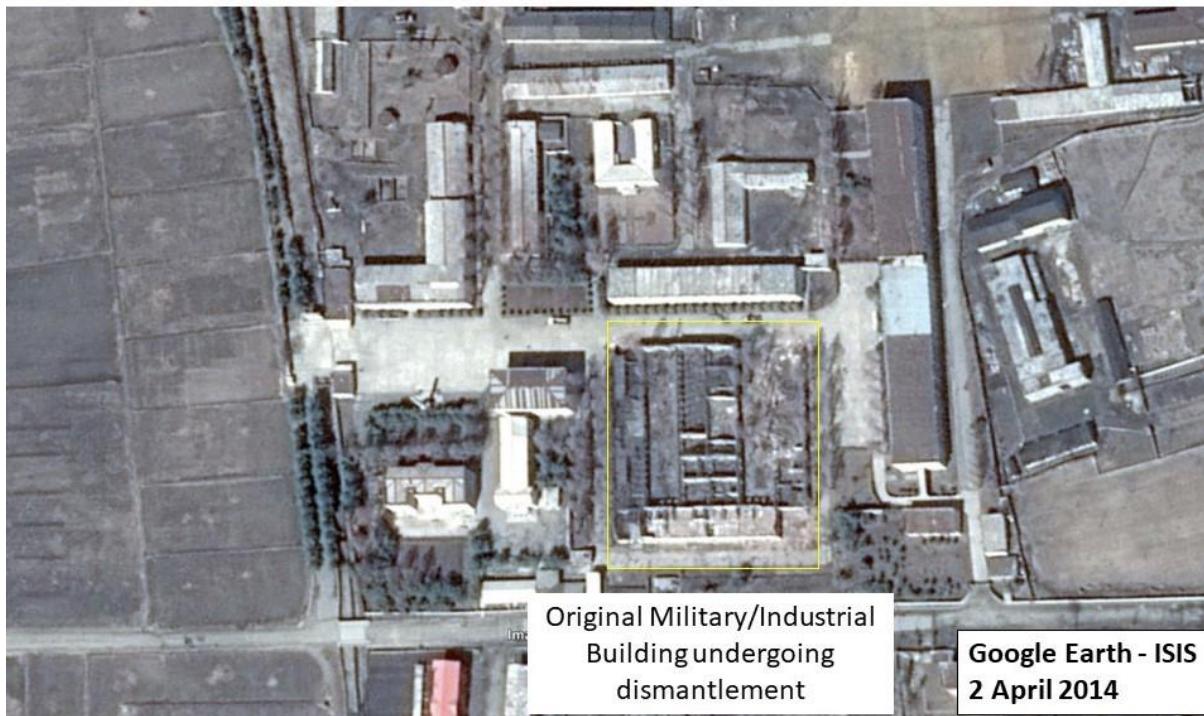
Figure 8. Military or industrial facility undergoing demolition at the Chongsu site in 2014.

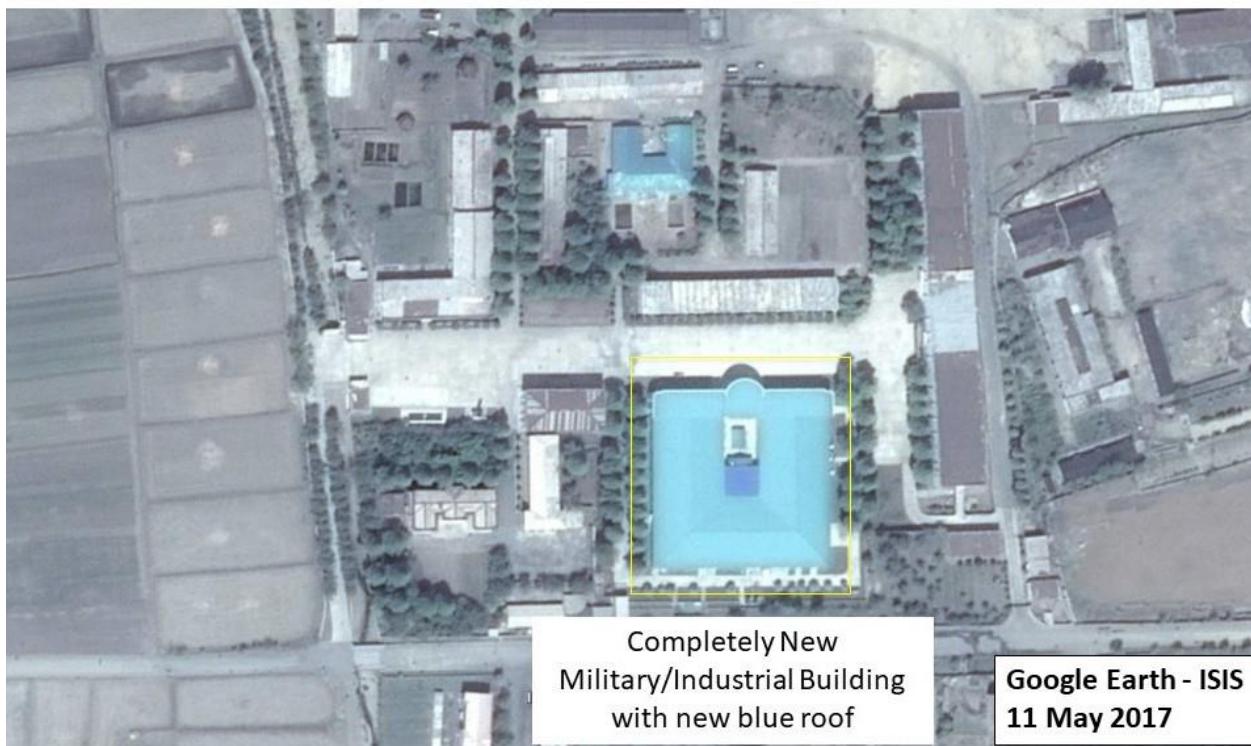
Figure 9. New building with blue roof at the Chongsu site, 2017.
