## Continued Activity Identified at Al-Qusayr

By David Albright, Sarah Burkhard, Spencer Faragasso

April 12, 2023

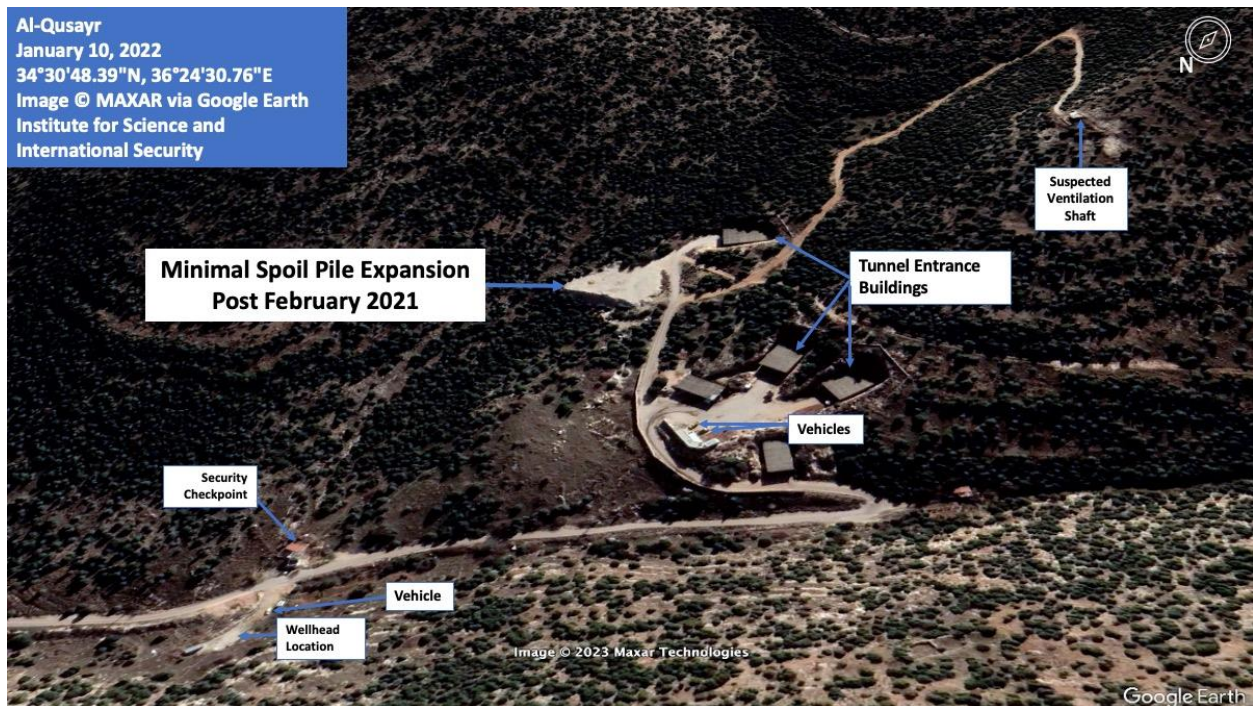
**Figure 1.** An overview of the Al-Qusayr site as of January 10, 2022.

The Institute has reviewed satellite imagery of the site, where available imagery on Google Earth is sufficient in resolution and temporal frequency to monitor changes from January 2019 to January 2022. A new phase of underground excavation was apparent between mid 2019 and early 2021. More recent, commercially-available imagery indicates that no significant changes have occurred since then, but the site remains active. Figure 1 provides an overview of the site as of January 2022. The image shows the road leading to the three main buildings suspected to house the tunnel entrances. Along the road is a security checkpoint, with a wellhead located across the street. Near the tunnel entrance buildings, two support buildings and vehicles are visible. A suspected ventilation shaft is further up the hill.

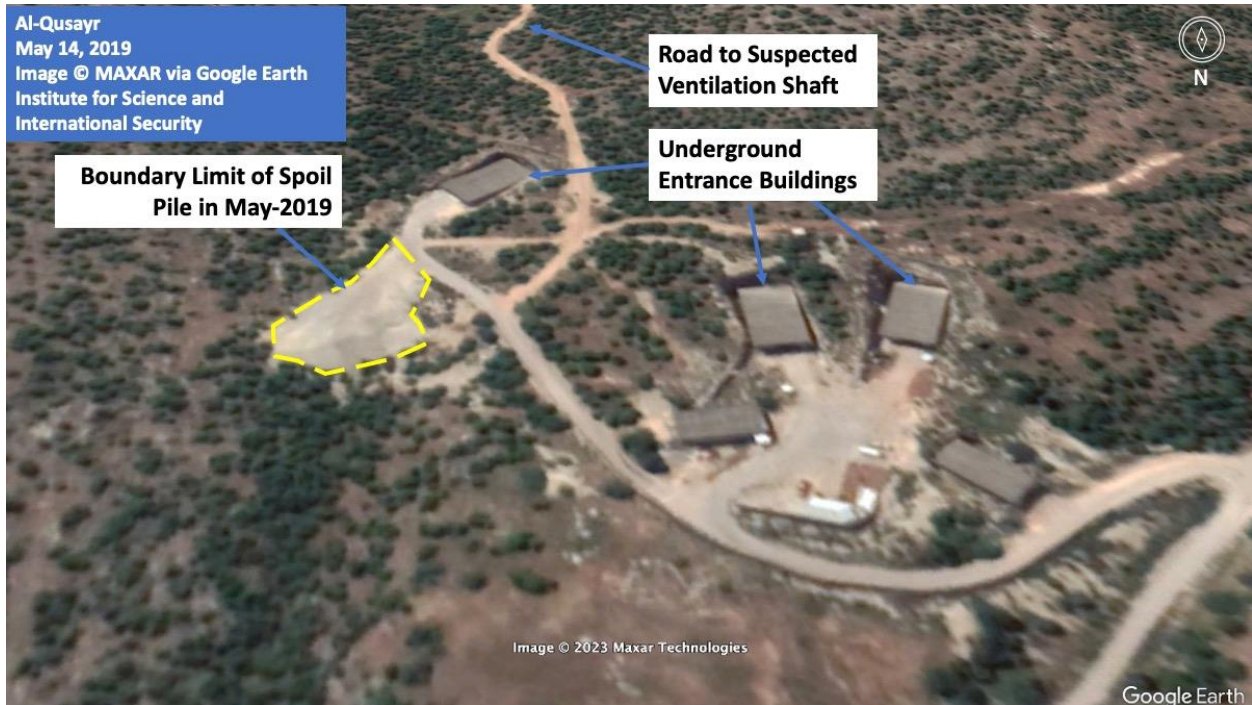
**Figure 2.** This shows the size of the spoil pile that is near the upper tunnel entrance building in May 2019.

The most notable change since 2018 is the limestone spoil pile outside of the suspected upper tunnel entrance, which has significantly grown in size. In May 2019, the spoil pile covered roughly 925 square meters at its top (see Figure 2). By February 2021, the spoil pile had grown to about 1100 square meters at its top and had begun to expand further down the hill along the road (see Figure 3). By January 2022, the pile may have grown about 80 square meters more at most, but more debris had been added and shifted along the road (see Figure 4). The image further shows that multiple trees or shrubs were buried by the spoil pile growth. Debris that had fallen down the hill may have been removed and transferred to other areas of the pile or along the road. It is clear from the past leveling of the top of the spoil pile that heavy equipment moved the material, perhaps to create room for additional spoil taken from the internal construction and to prevent the pile from cascading down the hill any further.

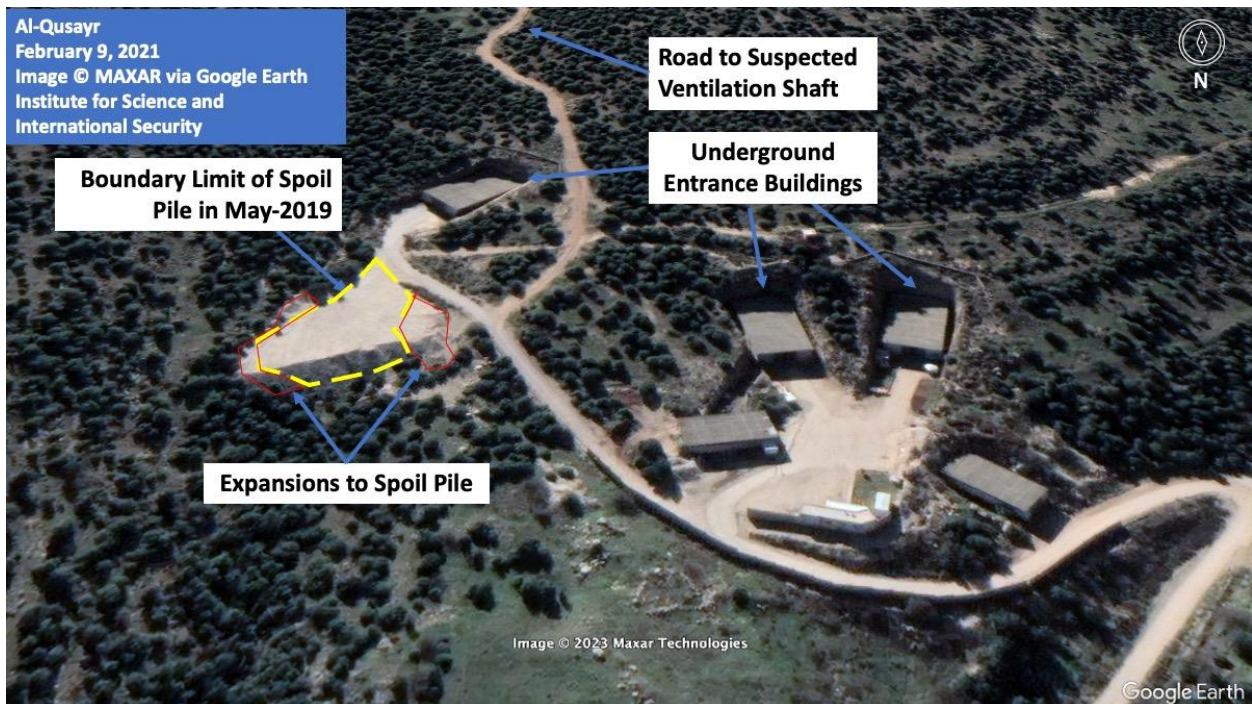
**Figure 3.** This shows the size of the spoil pile in February 2021. The spoil pile grew most noticeably in the areas outlined in red.
