December 8, 2011

No Visible Evidence of Explosion at Esfahan Nuclear Site; Adjacent Facility Razed

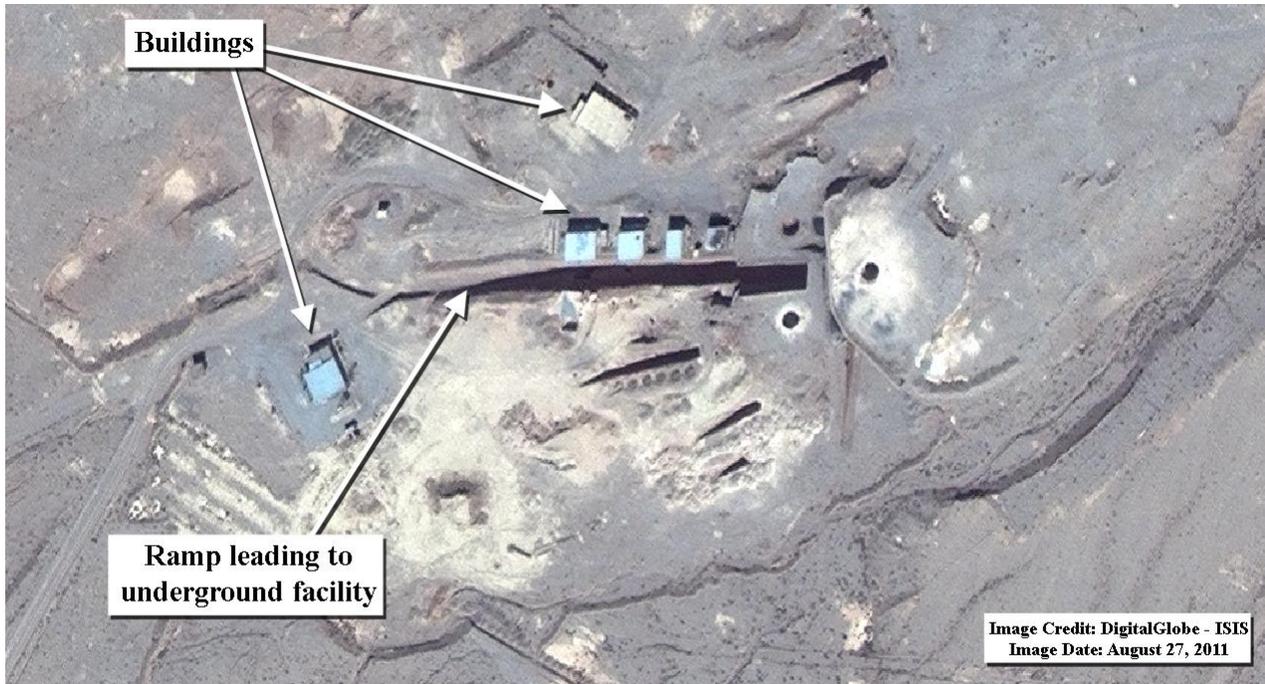
Figure 3. August 27, 2011 satellite image showing the facility before a November 28, 2011 explosion reportedly heard throughout Esfahan.

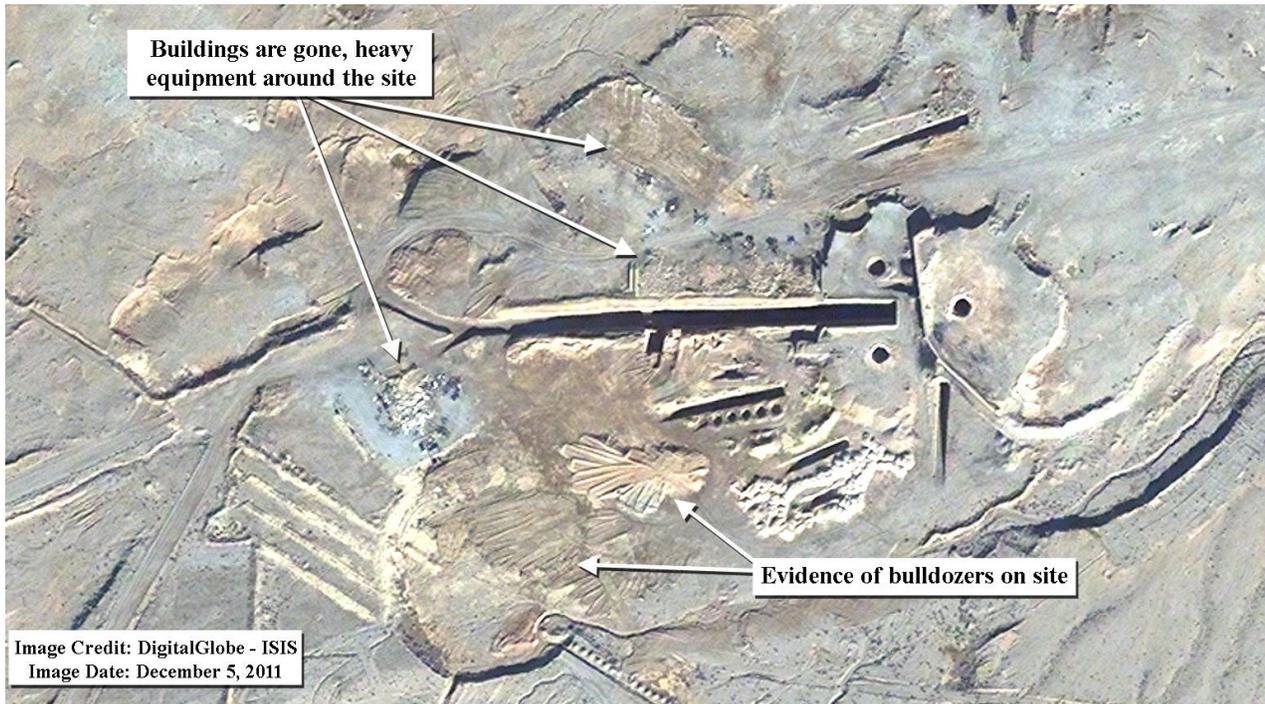
Figure 4. December 5, 2011 satellite image showing the facility after a November 28, 2011 explosion was reportedly heard throughout Esfahan. The buildings on the site are gone. Large equipment and evidence of bulldozers on the site can be seen in the image. It is unclear how and why the buildings are no longer present at the site
