New Extension to the Chashma Plutonium Separation Facility

By Neil Hyatt¹ and Sarah Burkhard

November 30, 2020

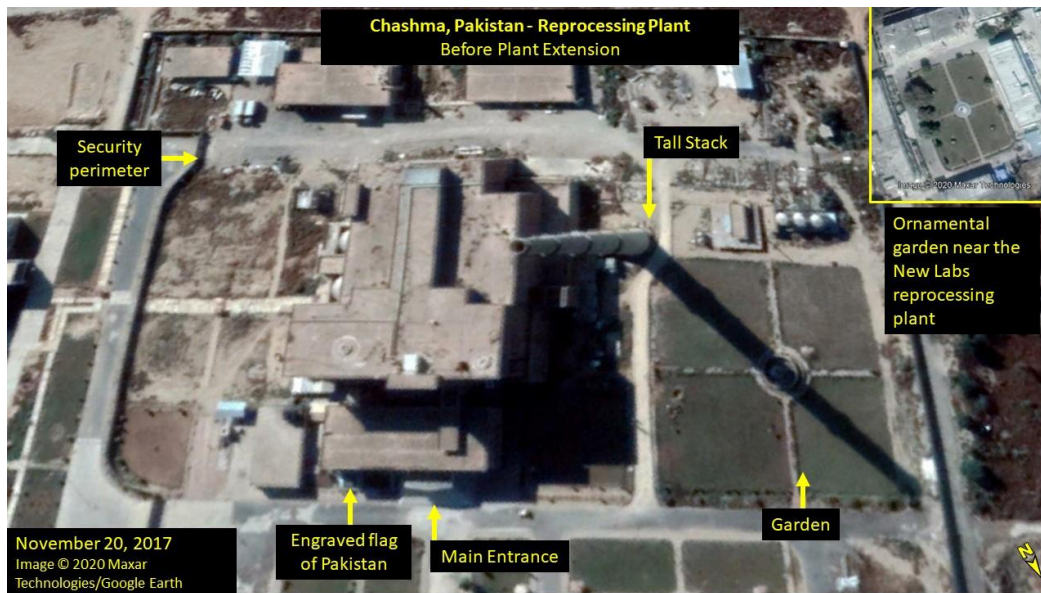
Figure 2 shows the reprocessing facility in 2017; a tall, windowless building of concrete construction, and an associated high stack. The building is contained within a security fence, which is further secured by three outer perimeter fences. These signatures are consistent with those expected of such a facility, and open source information locating a reprocessing plant at Chashma¹⁴, as previously reported by ISIS.¹⁵ Of note is a 5 x 3.5 meters engraved flag of Pakistan at the front personnel entrance to the Chashma facility, first apparent in imagery dated 21 November 2017, which evidently communicates the national significance of the facility. The site further features an ornamental garden, similar to one near New Labs at PINSTECH (see inset in Figure 2). The garden is one of several visible parallels between the two sites.

Figure 2. The Plutonium Separation Facility in 2017, before visible work on the extension began.

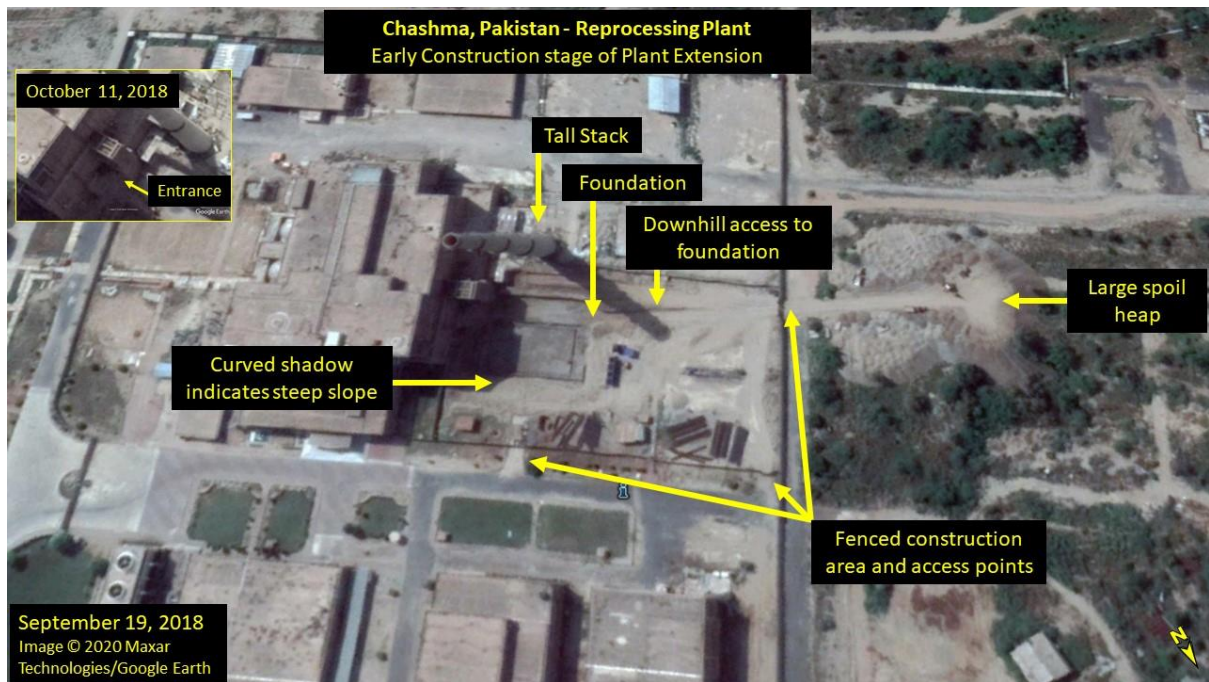
Imagery shows that construction of the extension started at some point between April and September 2018. Figure 4, dated 19 September 2018, shows the ornamental garden and the paved road adjacent to the reprocessing facility have been removed, and foundations for the new extension, covering an area of approximately 30 x 30 m, have been laid in concrete, with development of exterior and interior walls. The area had been cleared and levelled beforehand, with large amounts of dirt removed and stockpiled across the street. It is evident by the steep slope on the north side, the ramp-like access to the foundation, the staggered levels of earth on the south side, and the amount of dirt piled outside of the construction area that at least part, if not the majority, of the building are designed to be underground.

Figure 4. The construction of the extension to the Plutonium Separation Facility at an early stage in September 2018.

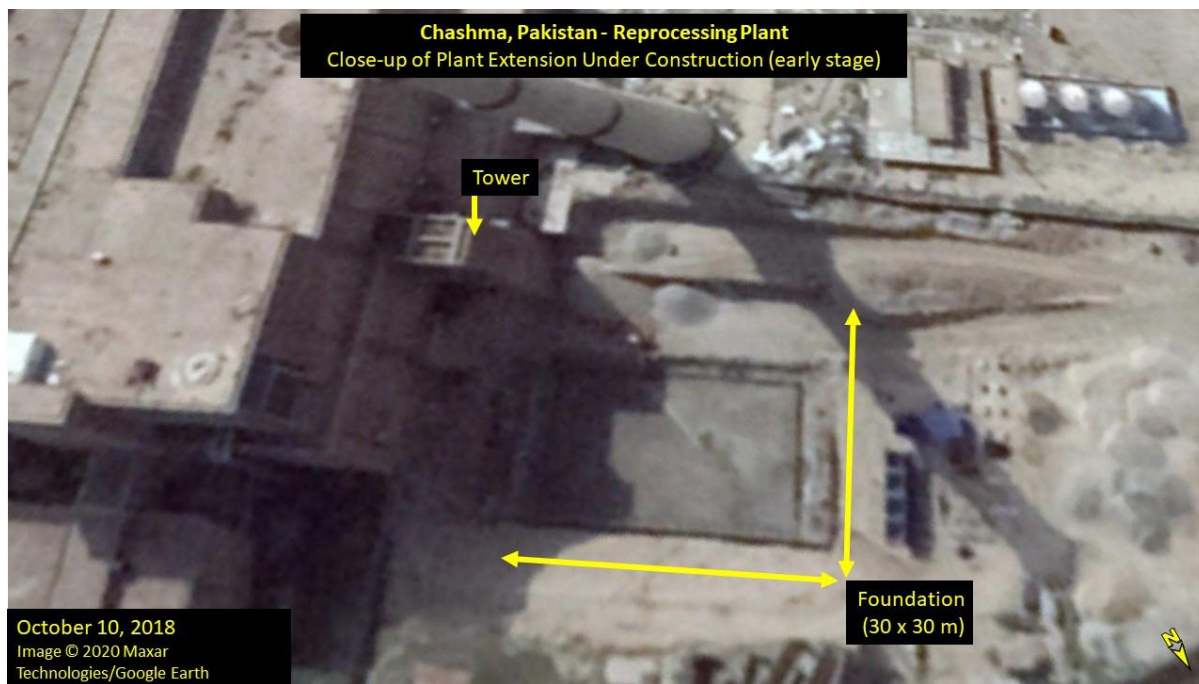
The construction area has been enclosed by a new fence with two vehicle access points; a vehicle access point to the construction area has also been created in the perimeter security fence. Within the enclosed construction area, a canopy shelter, steel reinforcements, and building materials are visible. A possible connection or entrance to the main reprocessing building on the east face is apparent on magnification, which is more clearly visible in the subsequent Google Earth image dated 10 October 2018 (see inset to Figure 4). Figure 5, the full 10 October 2018 image of the facility, shows that construction had not progressed significantly.

Figure 5. By October 2018, a 30 x 30 m foundation for the extension below ground level is visible in Google Earth imagery.

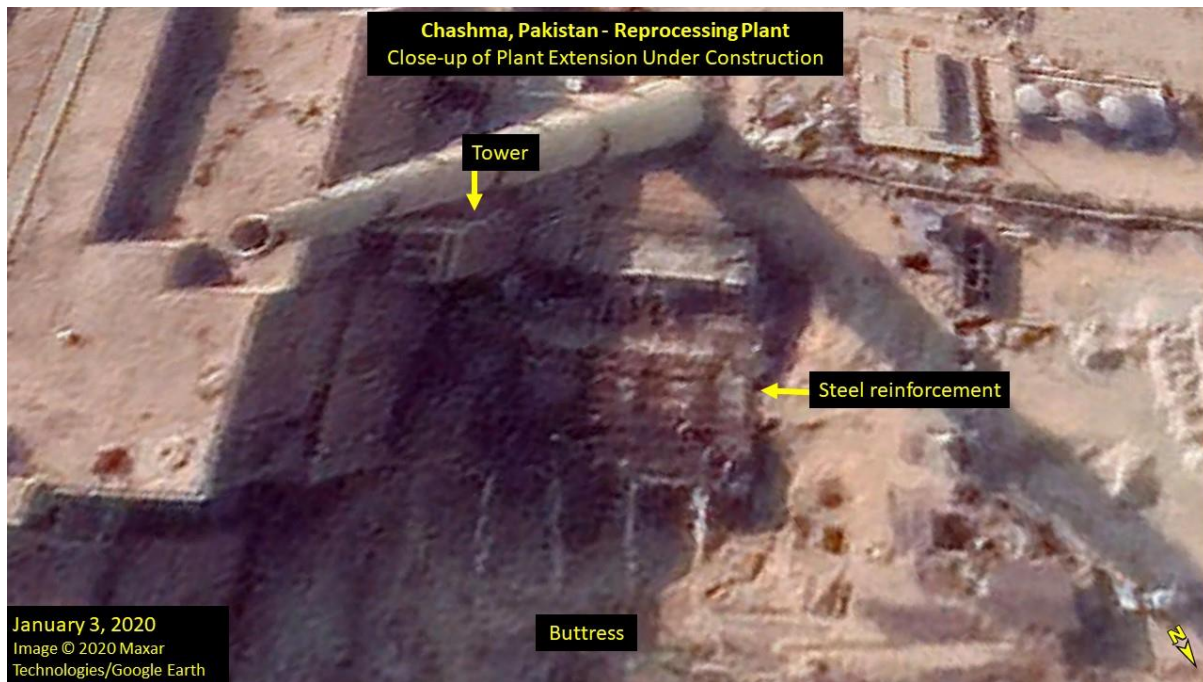
Over a year later, Figure 6, dated 3 January 2020, shows the development of exterior walls to the extension, which are supported by buttresses. Steel reinforcement is observable within the interior of the extension which appears to define three large compartments.

Figure 6. More than a year later, in January 2020, construction of the extension has progressed in height with steel reinforcement.

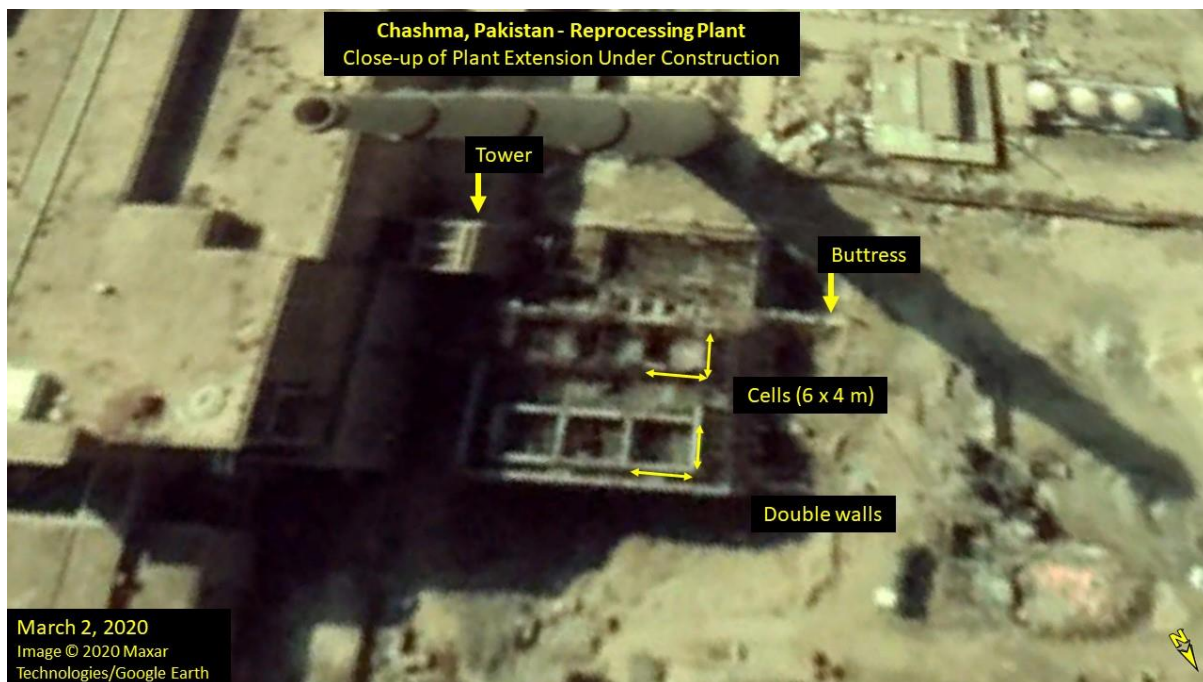
In the following two months, construction of the extension progressed rapidly, as shown by Figure 7, dated 2 March 2020. The exterior walls of the building have been established, as well as an upper floor, which contains two sets of three cells separated by an access way running the length of the extension. The exterior walls, and interior compartment walls, are estimated to be 0.8 m thick and of apparent concrete construction, consistent with a purpose that requires shielding. A Google Earth image dated 9 May 2020 (see Figure 3 and Figure 8) shows further development of the above-ground portion of the extension building, which covers the compartments previously observed. Additional wall structures are visible, which could plausibly be mechanical and electrical plant rooms. On the north side of the extension appear to be three large access ports, which align with the three internal compartments identified in earlier imagery. Figure 9, the most recent Google Earth image, dated 13 September 2020, shows that the exterior and roof of the extension has been completed and the fencing around the construction area has been removed.

Figure 7. In this March 2020 Google Earth image the layout of one of the upper stories is visible: six cells with double concrete walls, and a hallway.

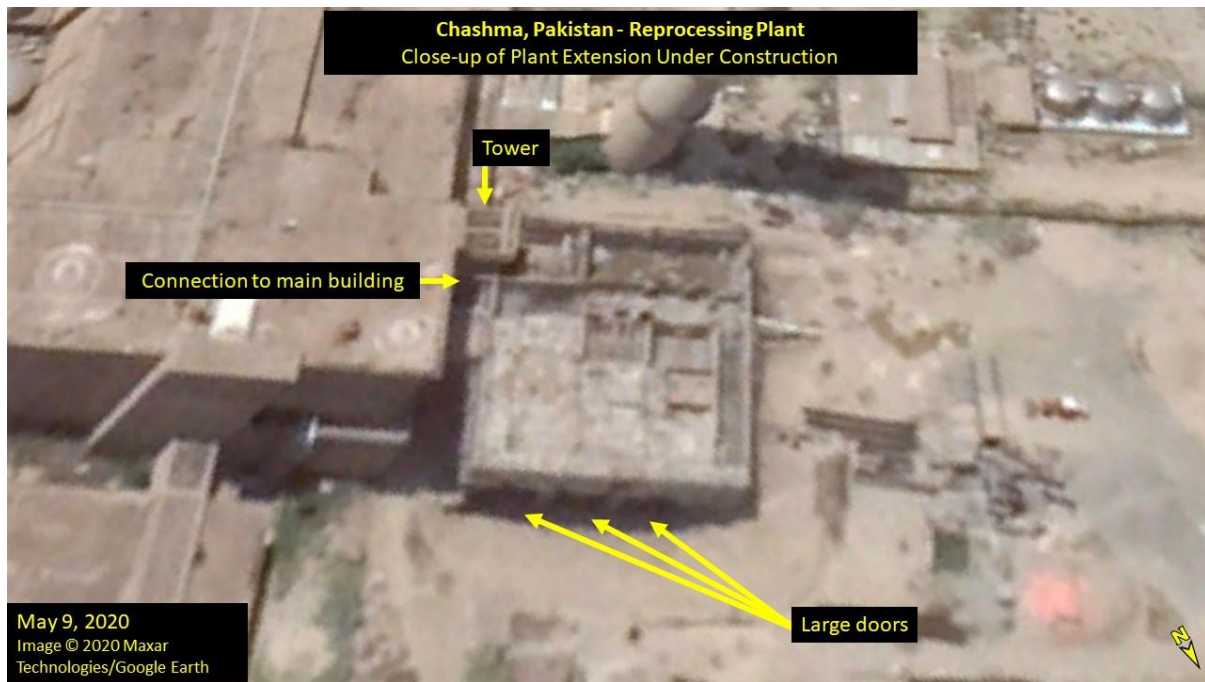
Figure 8. The extension is near external completion in May 2020, with a roof structure covering roughly half of the extension.

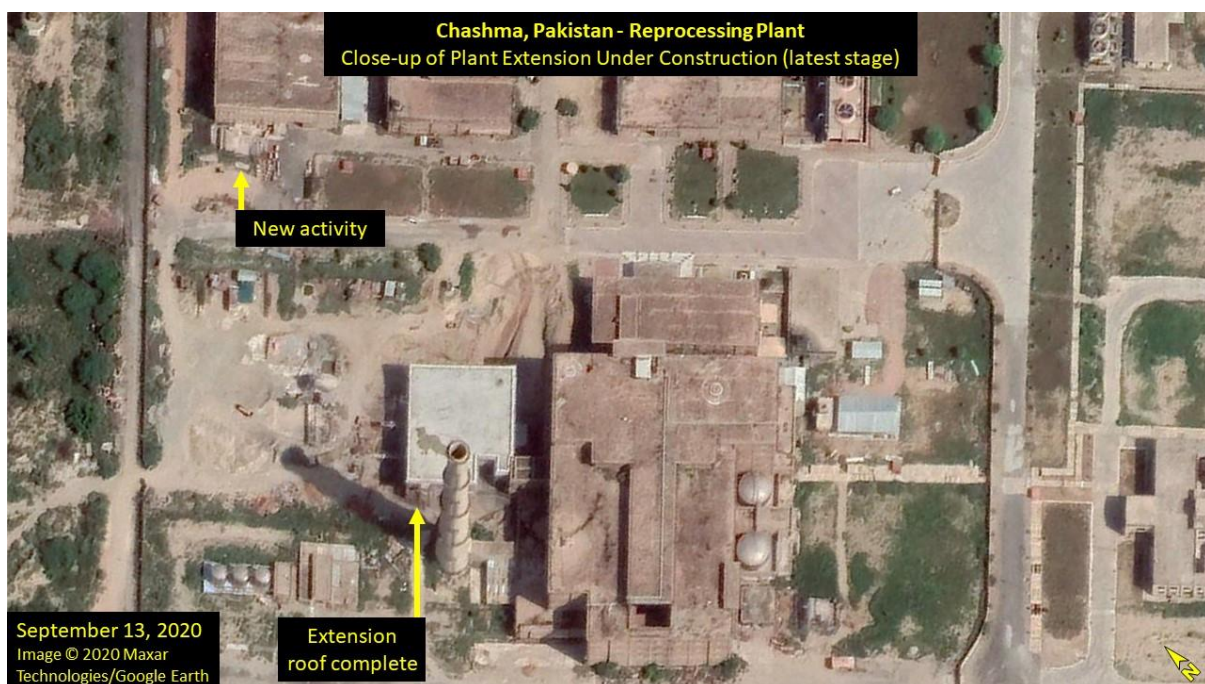
Figure 9. The extension is externally complete in September 2020.

The new extension has evidently been carefully designed and constructed to assimilate with the main reprocessing facility building, suggesting that it has an integral function. The interior compartments and moderately thick concrete walls suggest the purpose of the extension is to facilitate handling of high dose rate materials, such as spent nuclear fuels or radioactive wastes within shielded containers. The three large access points, and the fact that the extension appears to adjoin an existing access point to the main reprocessing facility building, suggest that the new extension could function to receive and unload

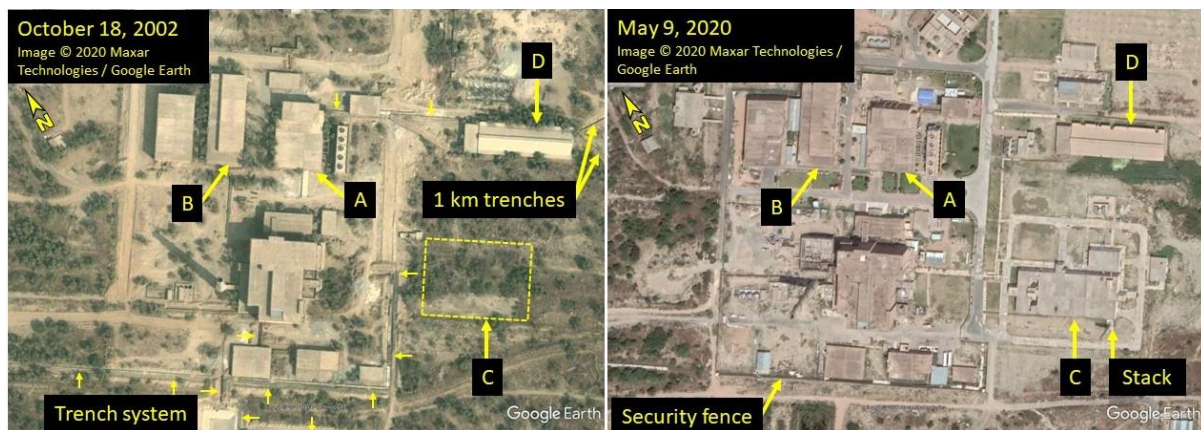
Figure 11 compares the reprocessing area in 2002 and 2020, highlighting co-located buildings which appear to be primarily of concrete construction and which may have a support function, given the external signatures and connection to the reprocessing plant via a network of trenches, identified by ISIS in 2015.¹⁶

Figure 11. A comparison of the buildings associated with the Plutonium Separation Facility in 2002 and 2020. Three of the four key buildings appear to have been part of the original design of the site; the fourth was added to the site in 2007-2009.

Within the secure area is a building (labelled Building A, 58 x 45 m) which is co-located with a bank of five external cooling fans, to which it appears to be connected by a system of piping, as shown in Figure 11 and 12. This building is observed to have three small stacks mounted to the north face, which is at least one story greater in height than the main building. These signatures are consistent with the need to provide cooling for heat generating activities within the building, the reprocessing facility, or the adjacent structures. The small size of the building relative to the cooling fans seems more consistent with a support function. Alternatively, the building could possibly function as a fissile material store, for which recent modifications to the west face, including a new white roofed structure which could function as an access control point. The adjacent building (B, 82 x 32 m) has a double height section covering most of the footprint. The double height section and its aspect ratio, roof mounted stacks, and large entrance on the east face, are plausibly consistent with a spent fuel storage facility, which would need to accommodate a crane gantry for movement of fuel skips. However, neither of these two buildings (A and B) shows clear external signatures of additional security measures that might be expected if used for storage of fissile materials, such as a further security fence and access checkpoint.

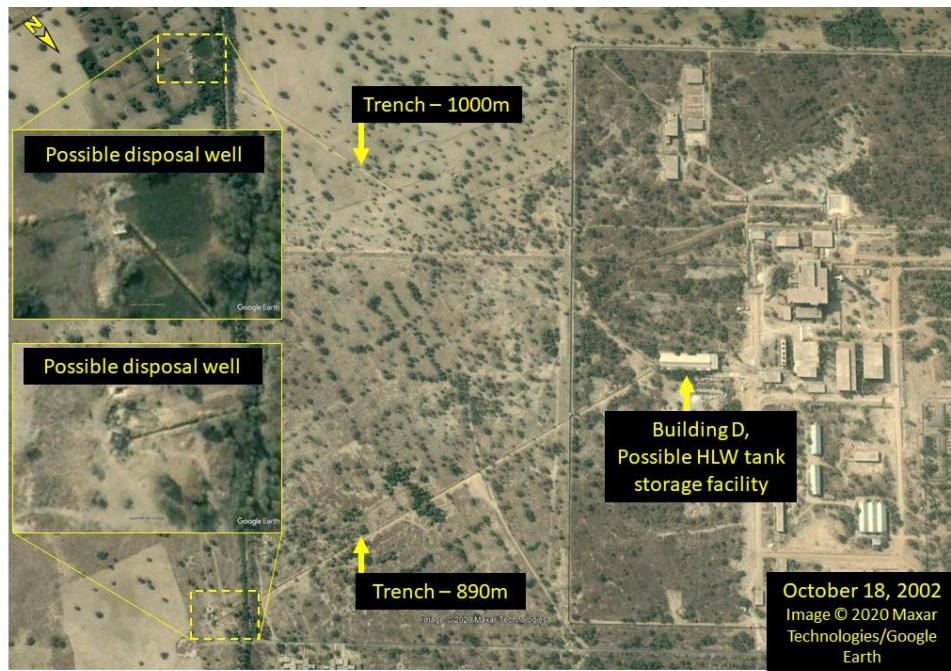
which requires active cooling to remove decay heat. Also of interest are two approximately one kilometre long trenches connecting this facility with two possible disposal wells beyond the outer perimeter fence, visible in October 18, 2002, imagery shown in Figure 14. These trenches are difficult to identify in more recent imagery, due to overgrowth and the shorter trench being obscured by new development. These trenches may signify an original intention to dispose of some higher activity liquid wastes by borehole injection to the subsurface, as was previously practiced in Russia, for example.

Figure 14. One of original buildings of interest (here shown in 2002) shows features consistent with a HLW tank storage facility.

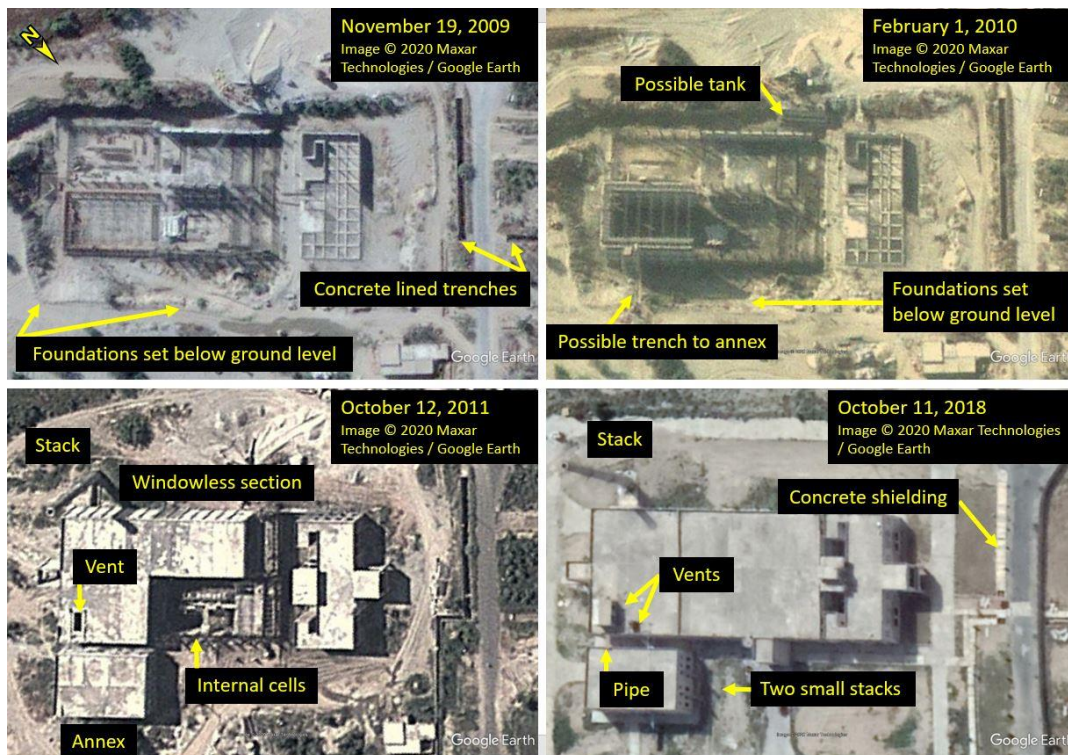
Construction of the tall concrete building (C) and stack was reported by ISIS in 2015, using commercial satellite imagery, at which time the exterior of the building was complete.¹⁷ Using historic imagery available in Google Earth, the construction of this facility can be analysed in new and revealing detail, as shown in Figure 15. The first available image showing construction of this facility is dated November 19, 2009; it shows the foundation for the building which is evidently constructed in two wings, each symmetrical about a central spine. The foundations appear to be set at basement level, as shown by the downward slope to the excavation area and shadow profile. The earliest image showing the facility to be externally complete is dated November 26, 2013. The front (west facing) wing of the building is shown in later imagery to have windows and small internal structures, which suggest the presence of shielded compartments at basement level (possibly for radioactive wastes). The rear wing contains at least one very heavily shielded section with external (0.8 m thick) and internal (1.3 m thick) walls, which may be utilised to the full height of the building. This section, uniquely, contains a roof vent, which interfaces with a roof mounted service building with two inlets or outlets; a small additional vent may also be present. This section appears to be connected to the neighbouring annex by underground pipes and an additional pipe to the roof mounted service building. The annex itself has two small stacks mounted on the west wall and exterior pipework is visible on the north wall which may connect to the four fans. Within the large rear wing, internal cells are visible within one of the larger forward sections, which could function as hot cells. Taken together, the external and internal signatures of the rear wing of the building are plausibly consistent with those of a high level waste vitrification facility, which would require: heavy shielding for operational activities; cooling for stored vitrified waste containers; a stack for release of volatile radionuclides (e.g. iodine, ruthenium) and gas emissions; and a buffer store of liquid HLW (located in the adjacent building with co-located cooling fans). The front wing of the building could plausibly accommodate process engineers, managers and support laboratories.

Figure 15. One of the buildings of interest was added to the site more recently; construction was first visible in Google Earth in 2009 imagery and external construction was largely complete by 2011. This figure shows the building from 2009 to 2018 (top left, top right, bottom left, bottom right).

Open source information documents a project by PAEC to procure vitrification technology for the immobilisation of high level radioactive wastes arising from nuclear fuel reprocessing, which was in progress during 2007. This information is consistent with Google Earth satellite imagery dated 17 August 2007, which appears to show ground clearance in preparation for construction of the possible vitrification facility, the foundations of which are present in the subsequent imagery dated November 19, 2009.

The scale of this facility deserves comment. If the footprint of the rear wing (40 x 67 m, or 2,680 m²) is assumed to include the vitrification plant itself and storage facility for vitrified HLW canisters (plausibly, the heavily shielded, ventilated, rear section), then it is comparable with the Tokai Vitrification Facility (TVF), Japan, for which these functions are accommodated in a plant occupying a footprint of 2,600m² (in a five storey building, including two basement levels).¹⁸ The TVF plant entered operation in 1992, to immobilise HLW from the Tokai Reprocessing Plant. The design capacity of the Tokai Reprocessing Plant was 90 thM / year (for LWR fuel), similar to the estimated 100 thM capacity of the Chashma plant (for PHWR fuel). Thus, the footprint of the possible vitrification facility is plausibly consistent with that required to support sustained operation of the Chashma reprocessing plant.
