## March 2016: Movement at North Korea's Yongbyon Nuclear Site

By David Albright and Serena Kelleher-Vergantini

March 23, 2016

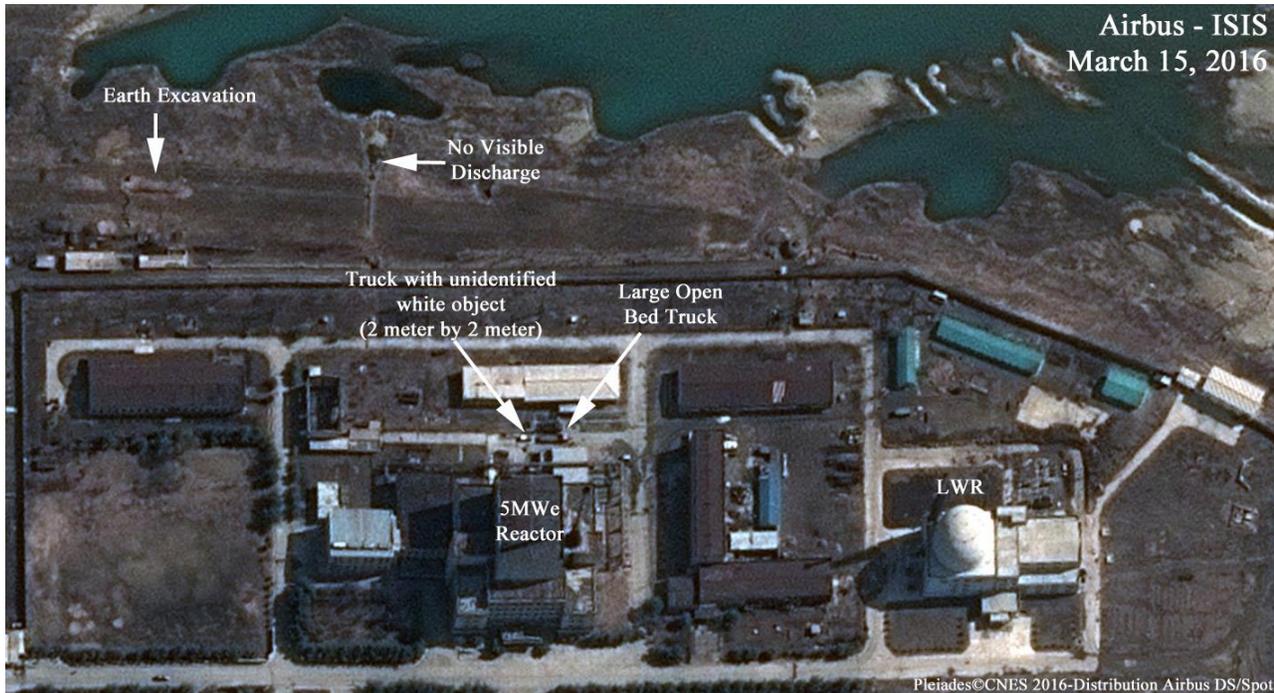
Analysis of recent Airbus satellite imagery dated March 15, 2016 shows no clear indicators that the 5 MWe reactor is operating at full power. No water is visibly being discharged from the 5 MWe reactor's discharge pipeline and no steam is venting from the turbine building (see figure 1). However, the absence of these two indicators is in line with ISIS's previous assessments that the reactor has been operating intermittently or at low power. Since mid-2014, the reactor appears to have operated at lower power and has been shut down at certain times. Before that, from mid- 2013 to mid-2014, the reactor appears to have operated at near full power.

However, other signatures of external activity are visible in the March 2016 image. First, two trucks are visible at the entrance of the 5 MWe reactor. One is a large open-bed truck which has been spotted at this location several times before. The other truck, however, is carrying an unidentified, white, 2-meter by 2-meter object. Although it is very difficult to assess with certainty the nature of this object, the shape and size are consistent with some type of reactor equipment, a container of fresh fuel for the reactor, or even a spent fuel cask. In the last case, such a cask would be in the wrong place, but it could be parked there temporarily. In all three cases, however, higher resolution imagery or other information is required to determine the nature of this object.

Additionally, North Korea seems to have started new earth excavation activities in the vicinity of the 5 MWe reactor's discharge pipeline. Similar activity was observed in October 2014 when North Korea dug a long trench in this area. However, the purpose of these excavation activities remains unknown.

**Figure 1.** Airbus imagery showing the status of North Korea's 5 MWe and LWR reactors on March 15, 2016

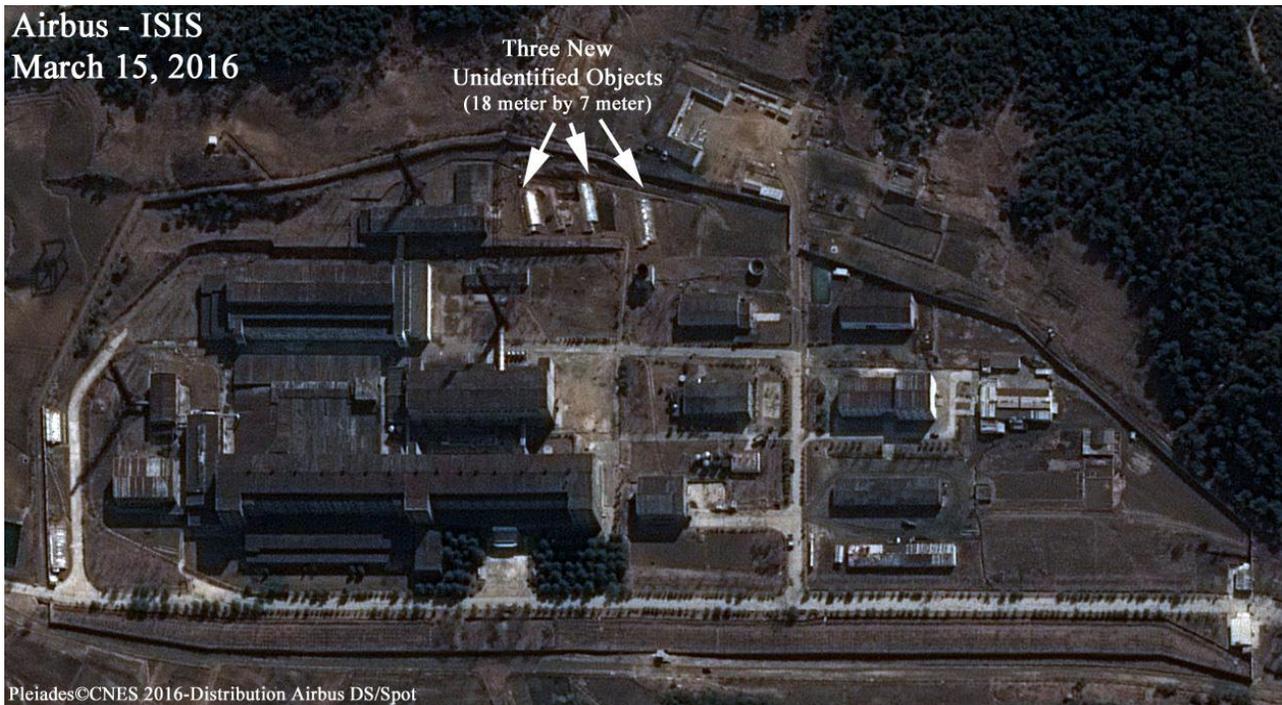
The recent image shows three new unidentified structures at the Radiochemical Laboratory site (see figure 2). Although the purpose of these structures is unknown, it is possible that they are used to store chemicals or water. They may alternatively be associated with nuclear waste disposal. The foundations were laid in the fall of 2014 while the three structures were built in November 2015. The fact that the foundations were laid just after the 5 MWe reactor stopped full operation in the summer of 2014 could suggest that North Korea's intent was to build additional storage structures to help with the processing of spent fuel from the 5 MWe reactor, which had been in full operation between August 2013 and June 2014.

Another potential signature of reprocessing operations is the status of the nearby coal plant that is associated with the Radiochemical Laboratory. This coal plant is the source of industrial steam for the plant. In the most recent image it is not operational. However, plutonium separation could still occur without the coal plant being operational.

**Figure 2.** Airbus imagery showing the status of North Korea's Radiochemical Laboratory on March 15, 2016

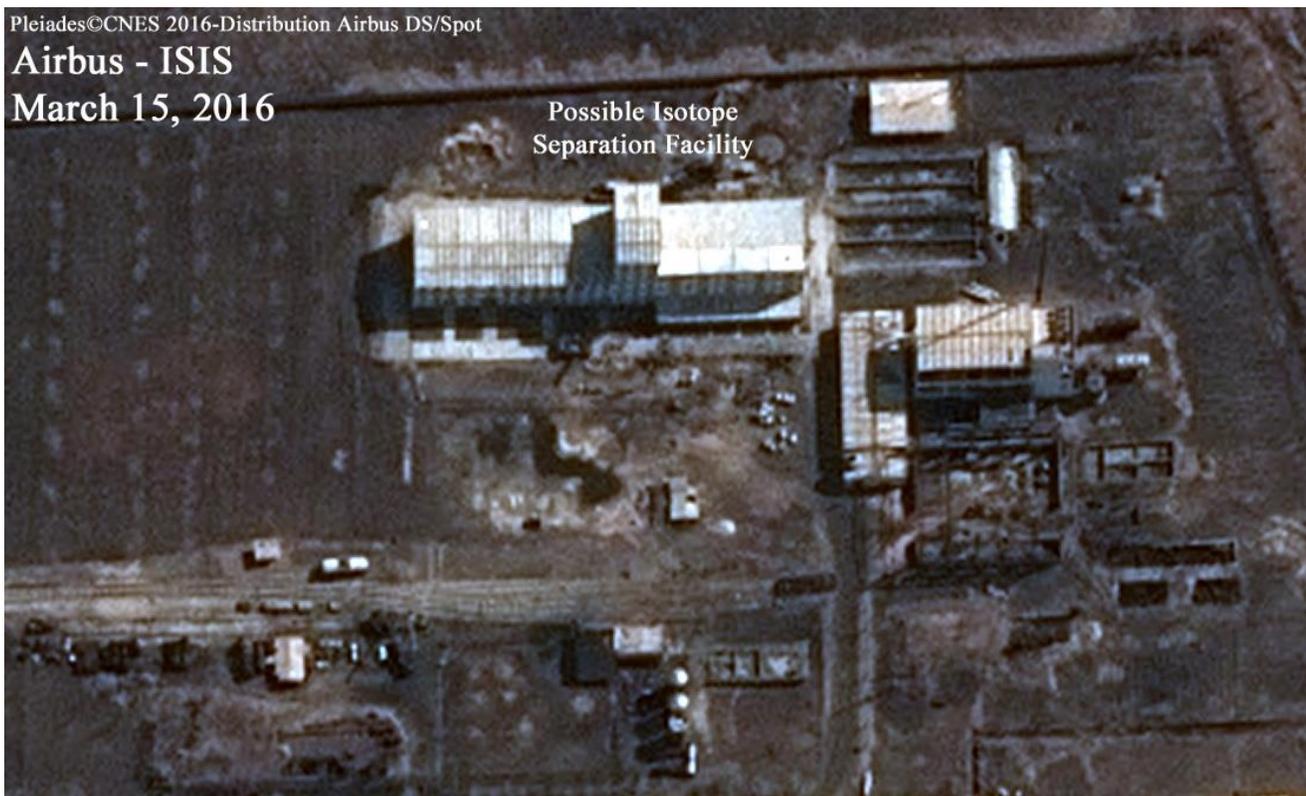
External movement of construction material and clean-up activities continue at a site ISIS has identified as a possible isotope separation facility (see figure 3). The site is close to the Yongbyon fuel fabrication complex and it presents signatures consistent with an isotope separation facility, including tritium separation (see earlier studies in [April](#) and [September](#) 2015). In [February 2016](#), a large 10 meter by 3 meter rectangular-shaped white object was present near the train tracks adjacent to this site. This

object presented signatures consistent with a large tank and continues to be present at the site as of March 15, 2016.

**Figure 3.** Airbus imagery showing the status of North Korea's possible isotope separation facility on March 15, 2016

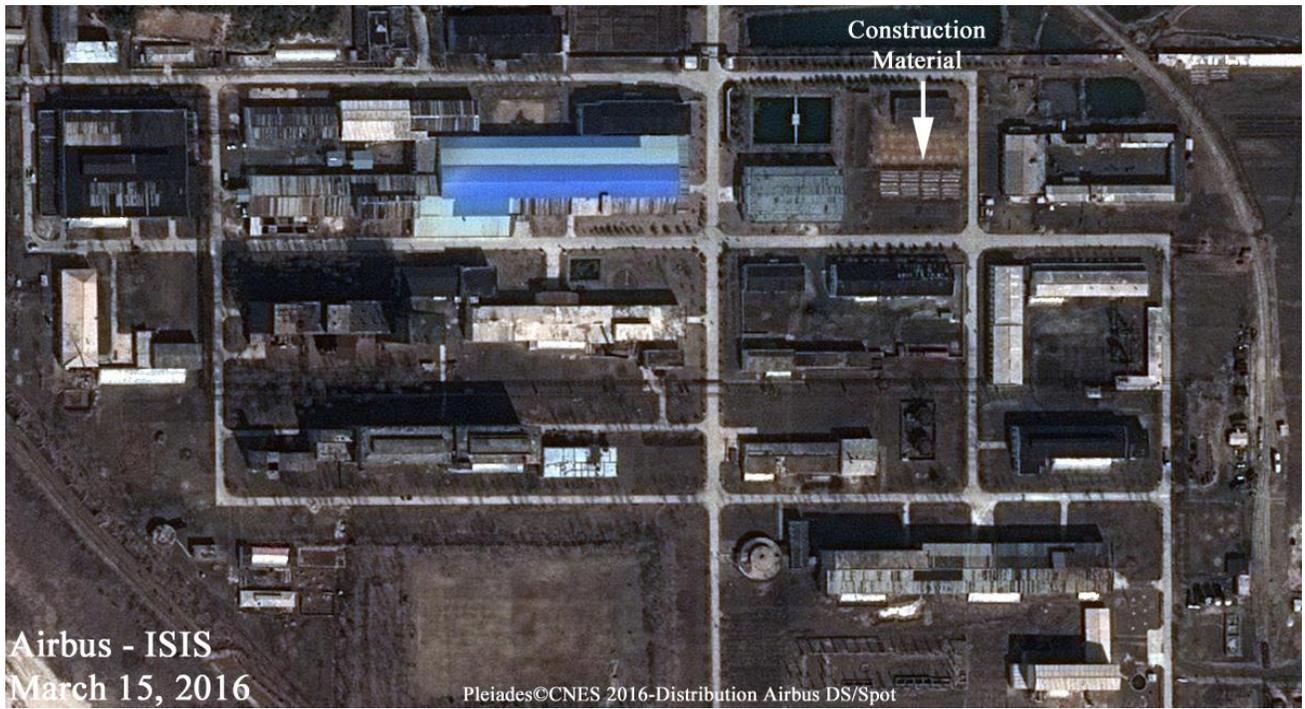
The only significant new activity visible at the centrifuge plant is the presence of construction material east of the main centrifuge building (see figure 4). This material has been spotted before and is believed to be used for the roof renovation activities taking place at the building adjacent to the main centrifuge hall.

**Figure 4.** Airbus imagery showing the status of North Korea's enrichment facility on March 15, 2016
