September 12, 2013

Syria's Past, Secret Nuclear Program Poses Proliferation Risks

By David Albright and Robert Avagyan

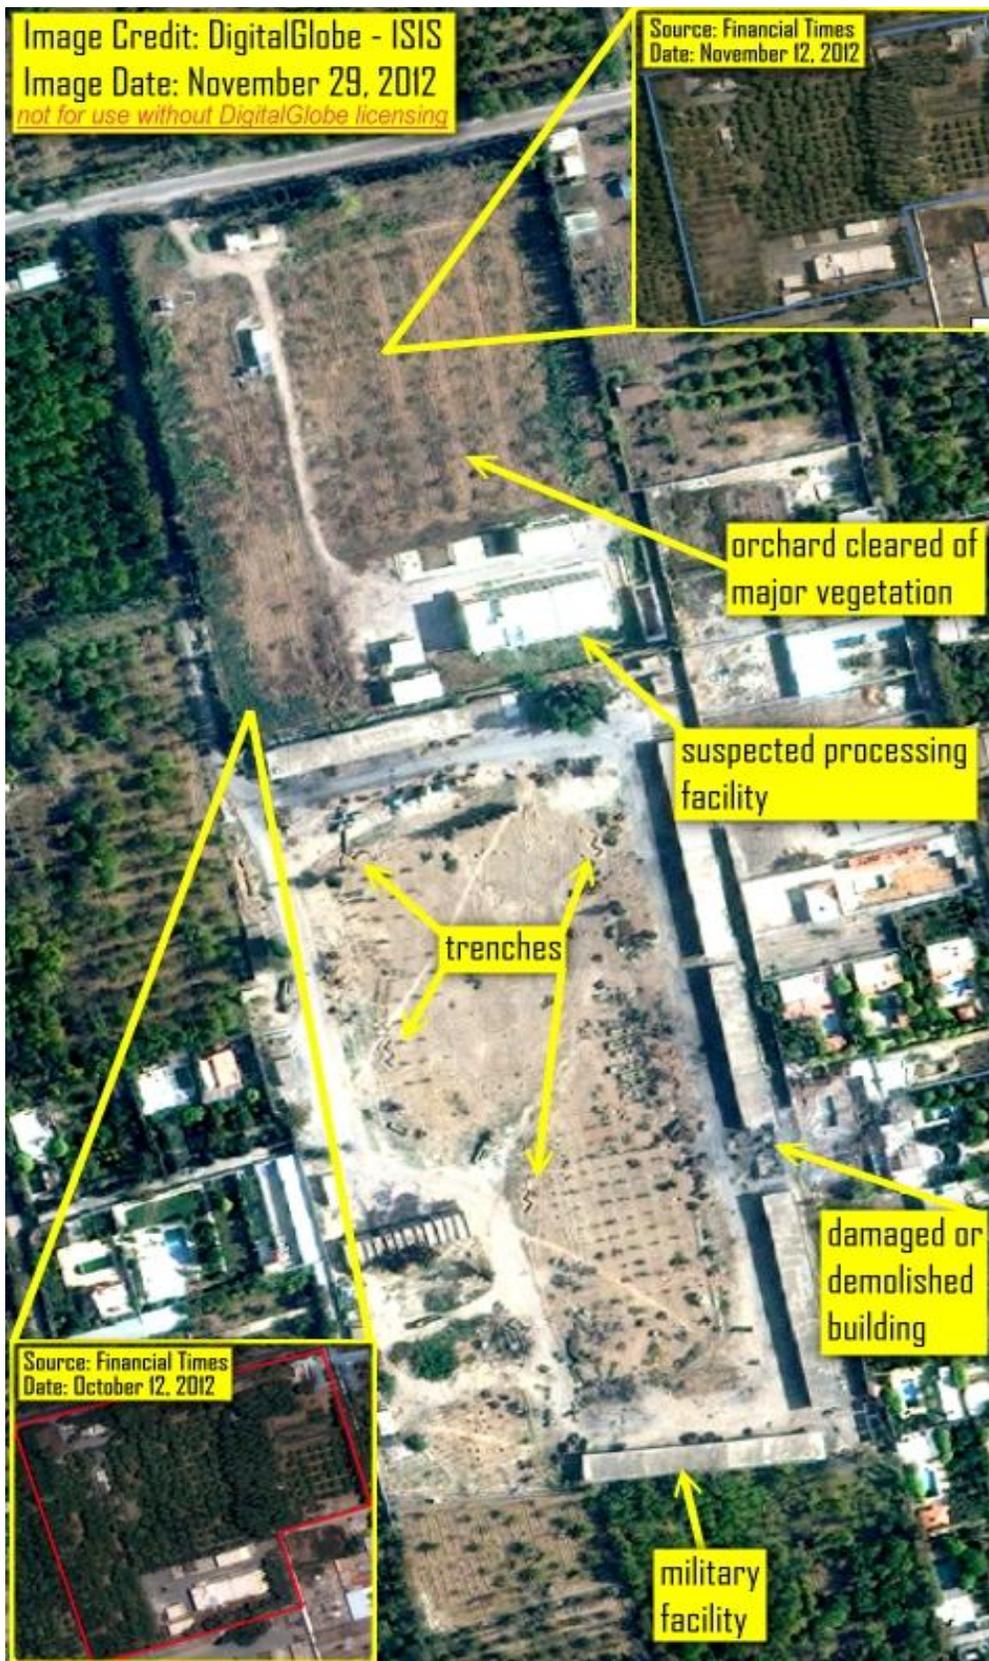
Figure 1a:
 November 29, 2012 Digital Globe image showing the area in front of the alleged processing facility cleared of vegetation. Trenches, debris from equipment and a partially collapsed building are visible in the adjacent military depot, which also shows signs of fighting. Inserted images from October 12, 2012 and November 12, 2012 show the orchard in place.

Commercial satellite images from November and December 2012 and February 2013 confirm the [report](#) by the *Financial Times* that suspicious activity occurred at the Marj as Sulṭān site. Images from November 29 and December 10, 2012 show that the trees of the orchard were cleared within the compound of the suspected processing facility (figures 1a, 1b, 1c, and 2.)⁴ The changes took place mostly in mid-to-late November 2012 (see figures 1a and 1c). There are signs that an adjacent military facility was subject to a military attack. What appear to be defensive trenches, likely against mortars or artillery, have been dug within the grounds of this facility; one of the perimeter vehicle sheds has been partially destroyed spreading debris into the nearby residential compound. Debris and remnants of equipment can be seen in the courtyard of the facility that was

previously used as a depot for military vehicles and equipment (compare figures 1 and 4). The February 4, 2013 image shows a small amount of additional vegetation clearing on the grounds of the military facility as well as at an unidentified compound adjacent to the suspected uranium processing facility (figure 3).

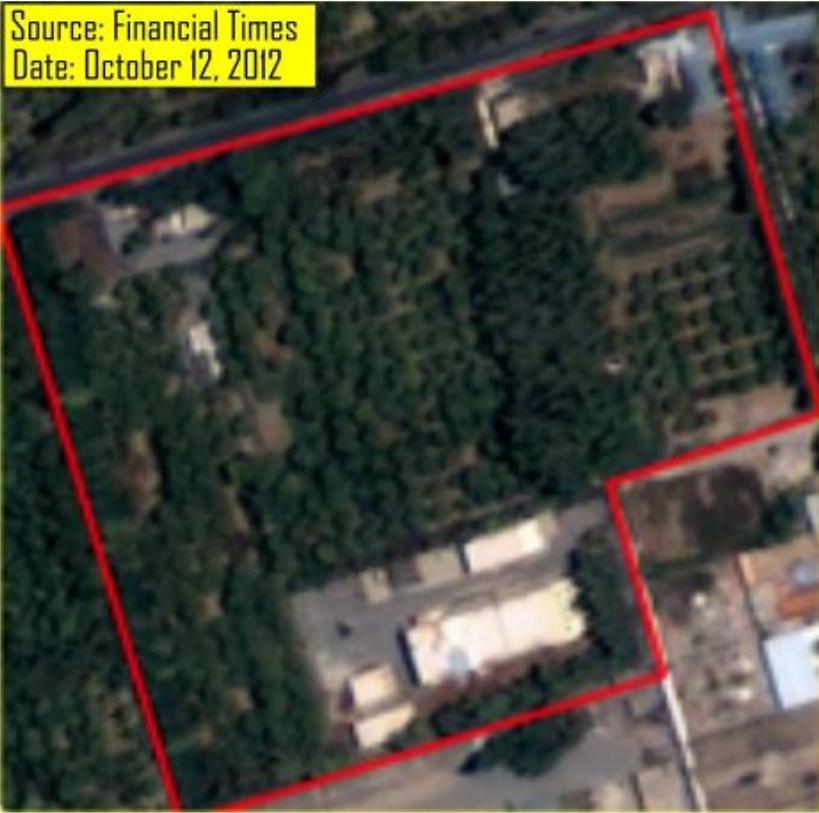
Figure 1b: October 12, 2012 image of alleged processing building showing orchard. Source: Financial Times

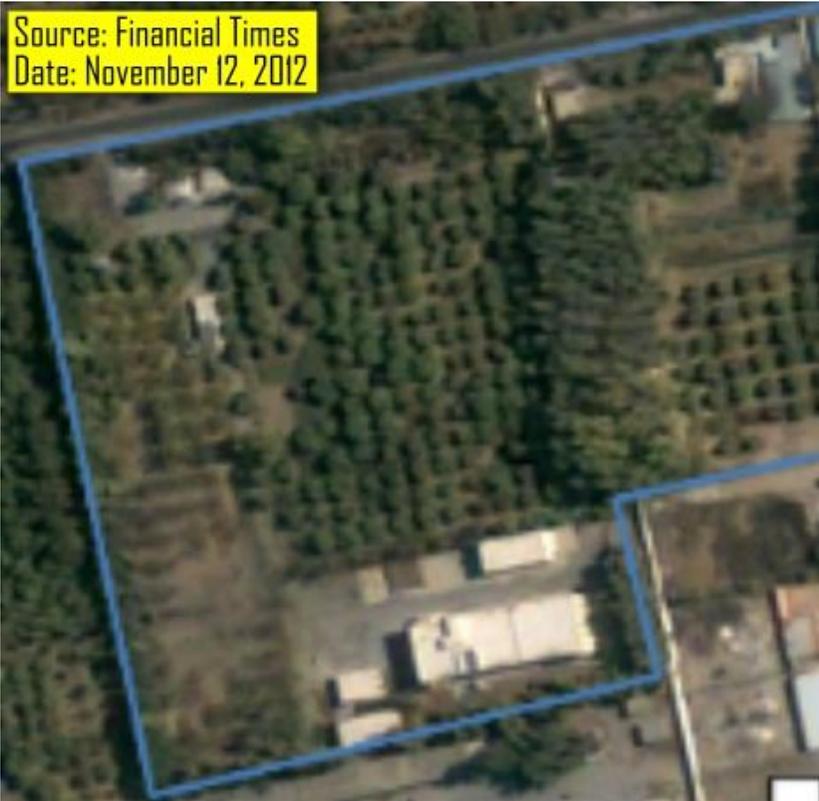
Figure 1c: November 12, 2012 image of alleged processing building showing orchard. Source: Financial Times

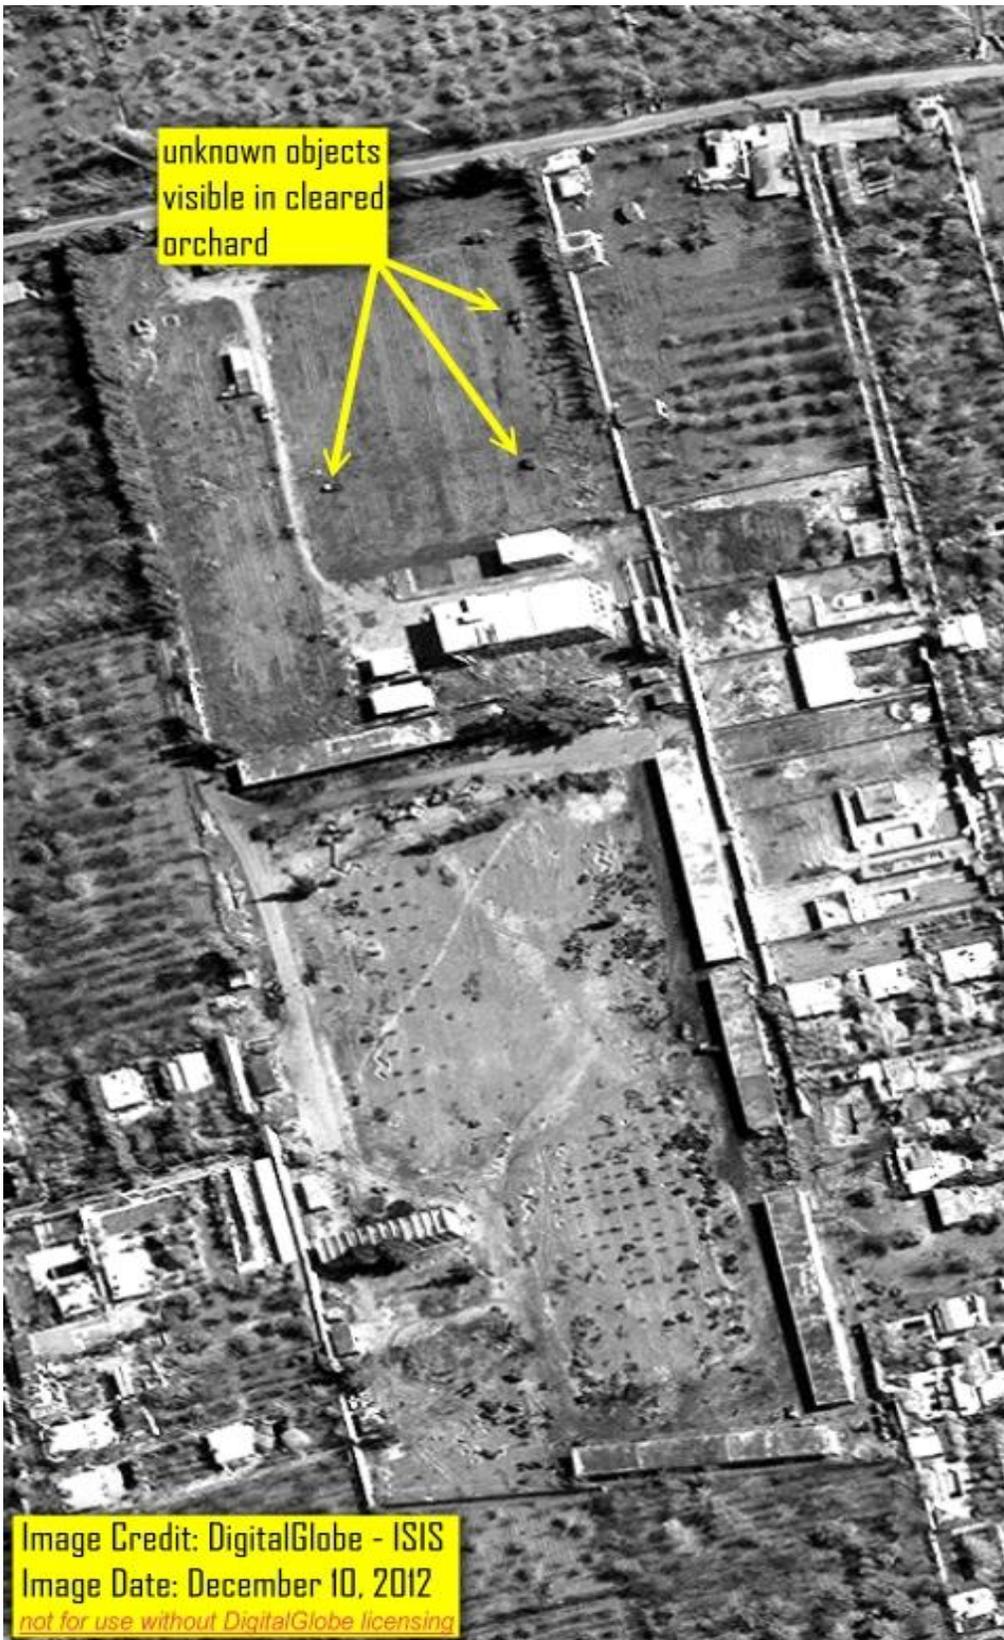
Figure 2:
December 10,
2012 Digital Globe
image of the Marj
as Sulṭān
processing facility
showing
unidentifiable
objects visible due
to the removal of
vegetation in the
courtyard of the
facility.

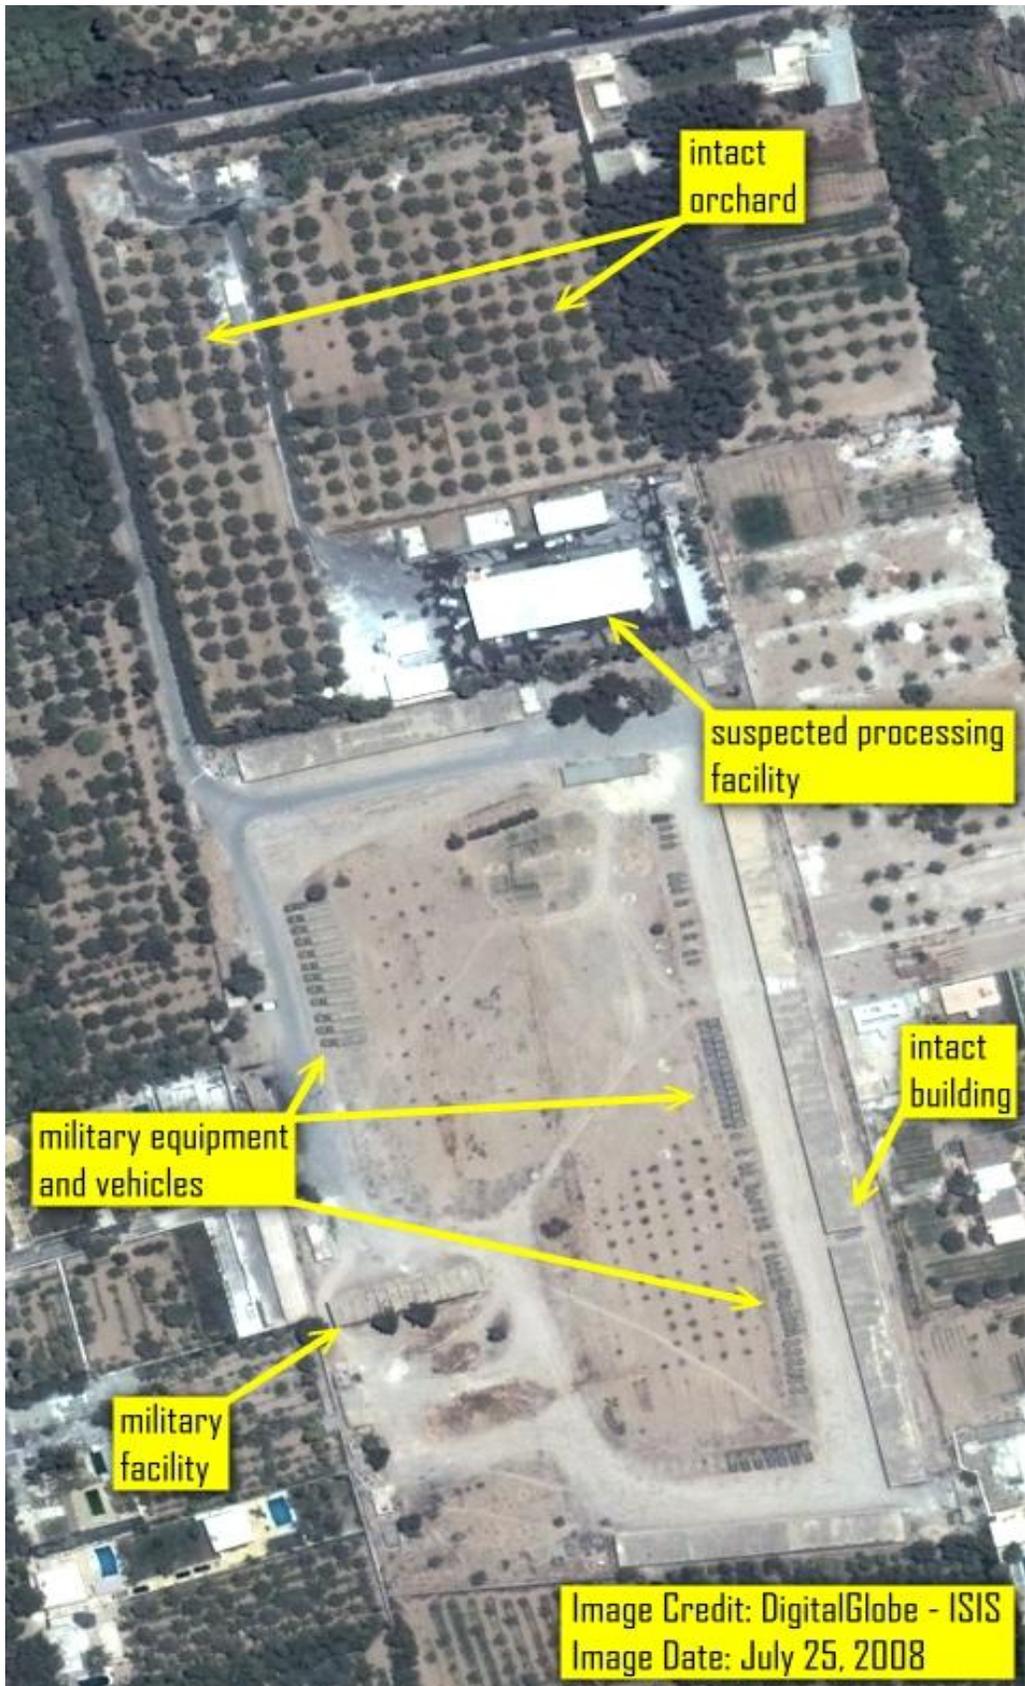
Figure 4: Image from July 25, 2008 showing clearly visible vegetation in the courtyard of the processing facility and the original state of the adjacent military depot without any debris or potential signs of fighting.

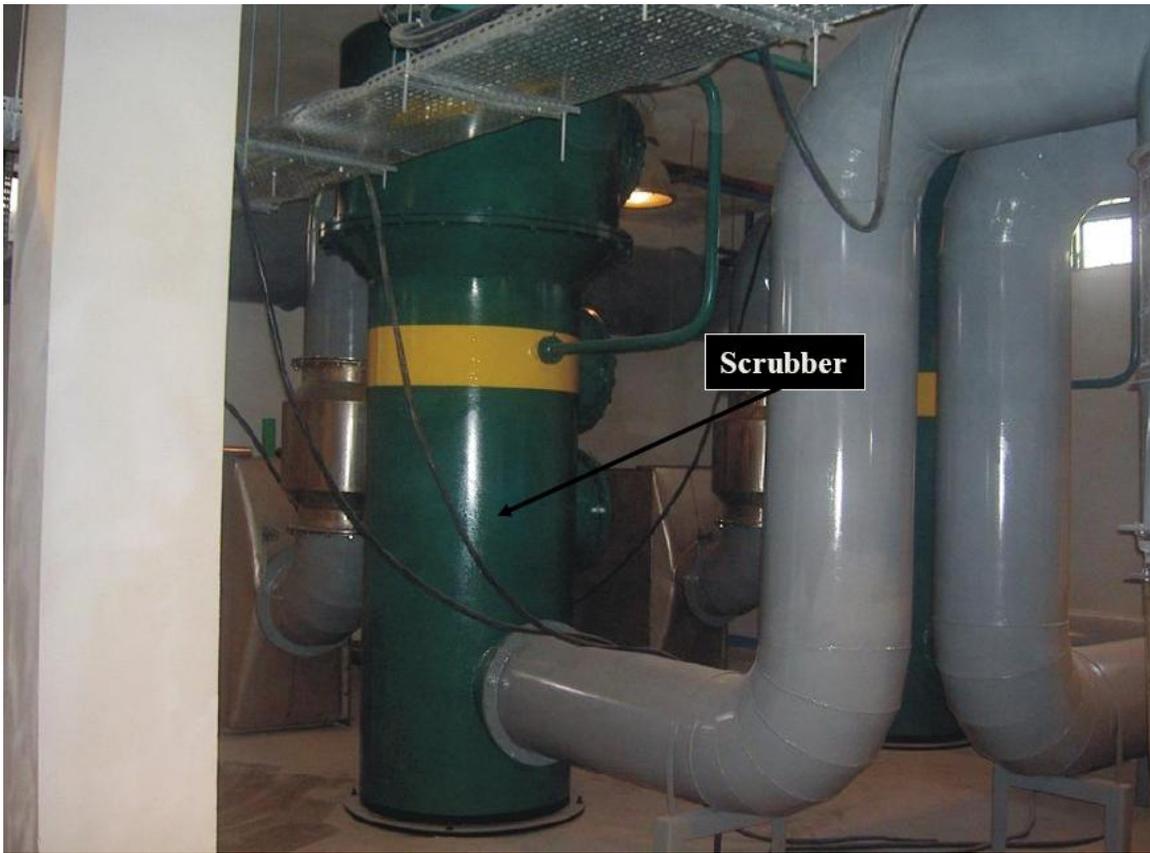
Figure 5: Image matching the description of an alleged scrubber previously mentioned by the *Süddeutsche Zeitung* and in ISIS reports on the Marj as Sulṭān facility.

Images made available to ISIS by a Western source allegedly show equipment inside the two major buildings at the Marj as Sulṭān site prior to the 2007 bombing of the Al Kibār site. The equipment correlates exactly with the descriptions given to ISIS by the *Süddeutsche Zeitung* in 2011 of a scrubber, cyclone separator, manifold, and purification column (figures 5-8). Analysis of the internal layout of the buildings in these images shows that it appears to match the external structure of the two main buildings at the site as observed in satellite imagery. Based on an assessment of these images by an ISIS technical expert, the facility was not yet

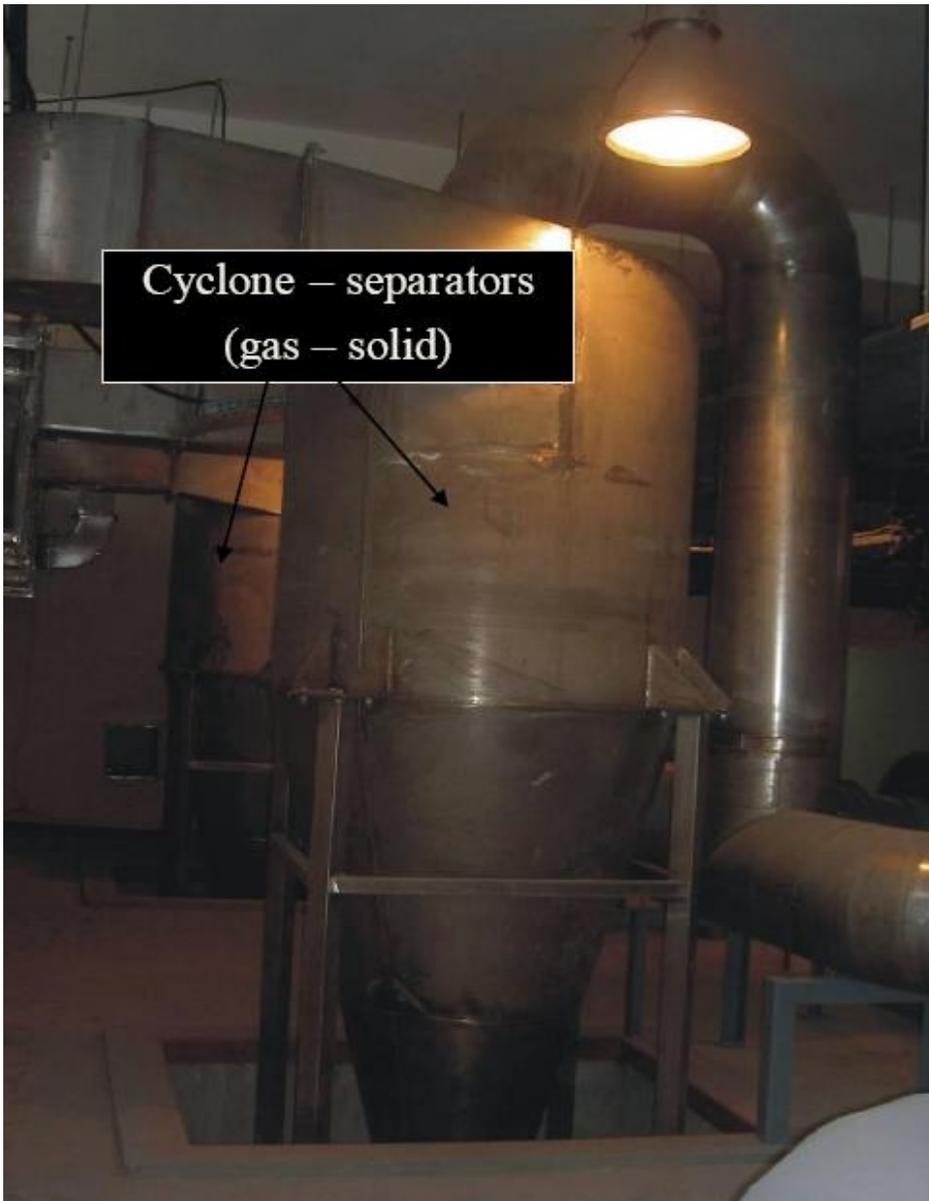
Figure 6: Image of alleged cyclone separators that were reportedly located in the basement of the main building at the Marj as Sulṭān facility.

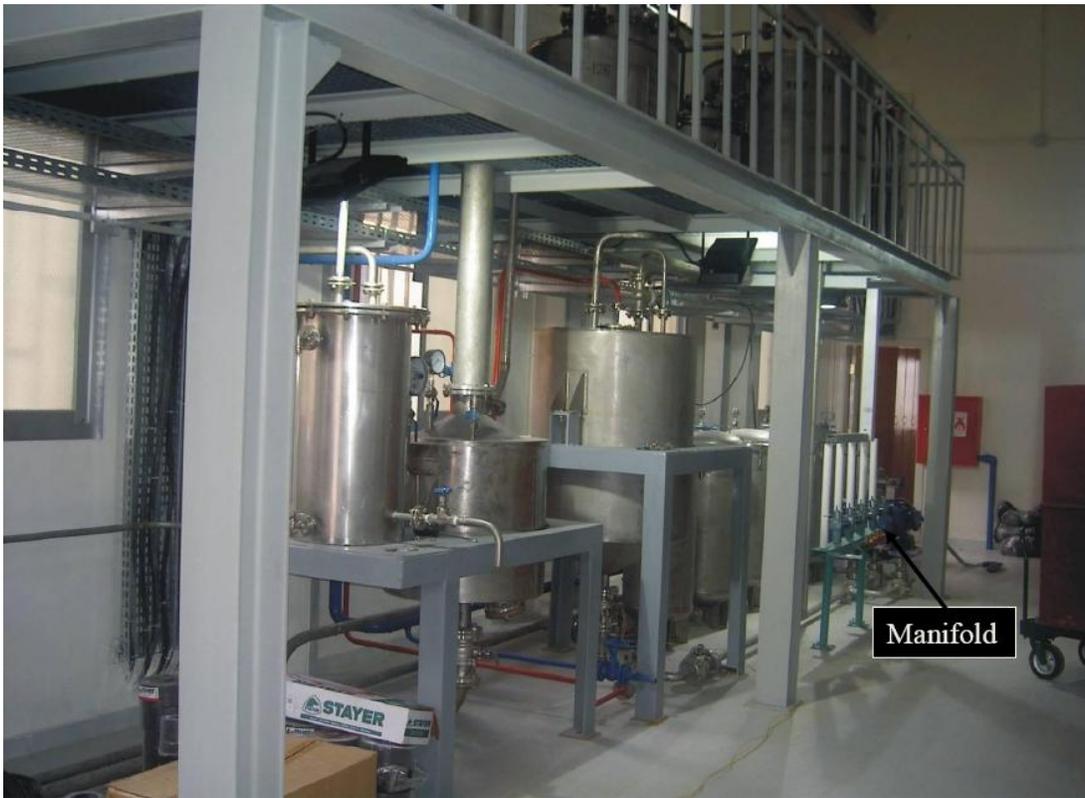
Figure 7: Image of alleged manifolds in one of the buildings at the Marj as Sulṭān facility.

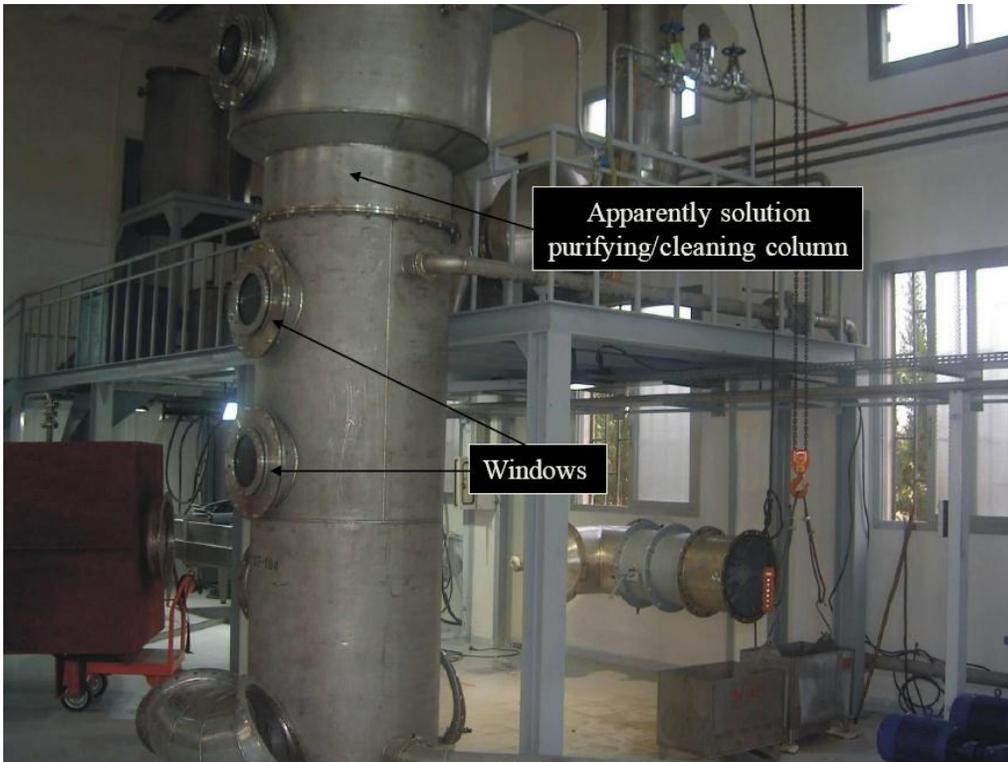
Figure 8: An image of the alleged purifying column suspected to have been housed in the secondary building at the Marj as Sulṭān compound.

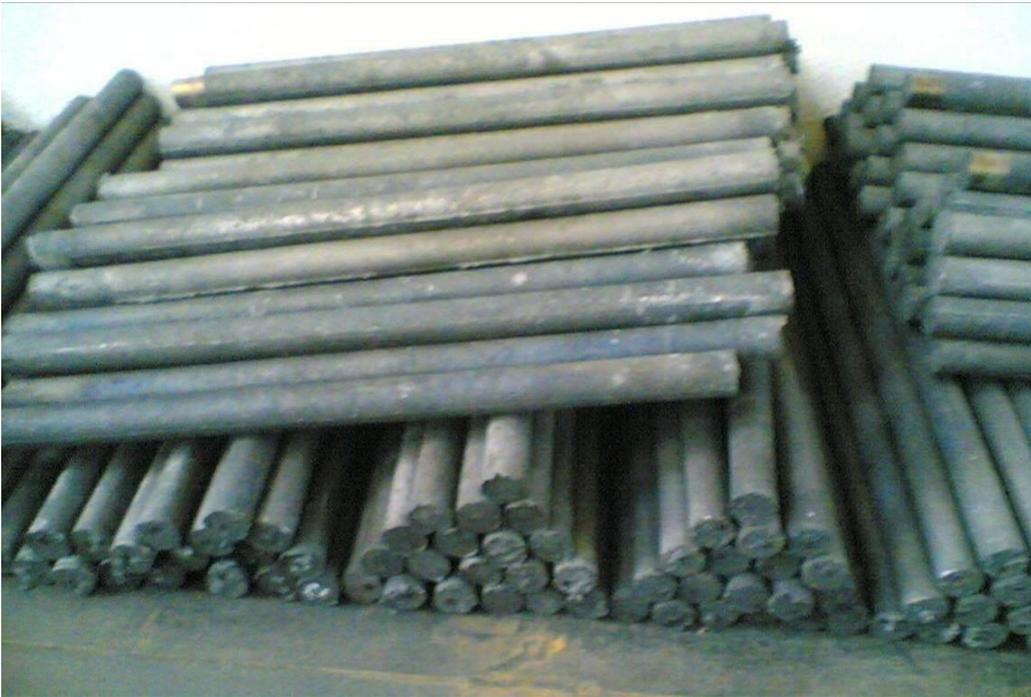
Figure 9: Image made available to ISIS of alleged natural uranium rods related to fuel in the Al Kibār reactor. The rough surface indicates the lack of cladding. The golden tips could suggest recent sampling that would have exposed the unoxidized metal.

In any case, the evidence implies that the Al Kibār reactor would have used fuel similar to the Yongbyon 5 megawatt-electric reactor. Among the images made available by the Western source is an image taken in 2005 allegedly showing uranium metal rods located in Syria that are similar to uranium rods prepared for the Yongbyon reactor (figure 9). The rods in the image would be in an intermediate state between being removed from a mold and "canning," which means to put on the fuel cladding, in this case likely a magnesium alloy used as cladding for gas-graphite reactor fuel.

ISIS asked an expert with decades of experience with reactors using natural uranium metal fuel to assess the image to evaluate whether the rods appear to be uranium metal. The expert said that the rods in the picture could be uranium metal, although the expert could not be certain from only a visual inspection of the photo. The rods show a bluish-black sheen from potential surface oxidation that occurs quickly in the case of uranium metal. The expert also pointed out that some of the rods had ridges on them, implying that they had not yet been finished after removal from a mold. Three rods also had golden tips, which the expert thought could represent recent sampling that laid bare fresh metal. He did not think that the golden areas represented sleeves over the rods.

ISIS compared the rods to known images of Yongbyon fuel rods. A comparison of the uranium rods in figure 9 with fuel rods for the Yongbyon reactor shown in the 1992 [video](#) (11:00 mark) of the IAEA visit to North Korea appear to show similarities (see figure 10). Both sets of rods have a similar color and surface texture, which, according to the ISIS expert, is consistent with un-machined, unclad natural uranium fuel rods.

ISIS could not determine the dimensions of the rods in figure 9 due to the lack of any measurable reference point. However, an estimate of the ratio of the diameter to the length of several rods shown in figure 9 matched to within three or four percent the ratio derived from data about uranium slugs for the Yongbyon 5 megawatt-electric reactor.¹⁵ Although the match was not 100 percent the same, it is very close, particularly given that the nature of the picture prohibited measuring the length and diameter of any one rod.

On balance, we could not confirm if the rods in figure 9 were inside Syria or if they were made for the Al Kibār reactor. However, it is reasonable to conclude that they appear to be un-machined natural uranium metal rods that are similar to those made for the 5 megawatt-electric reactor at Yongbyon. If U.S. and Israeli assessments of the Al Kibār reactor are correct, uranium slugs for this reactor should look similar to the ones in figure 9.

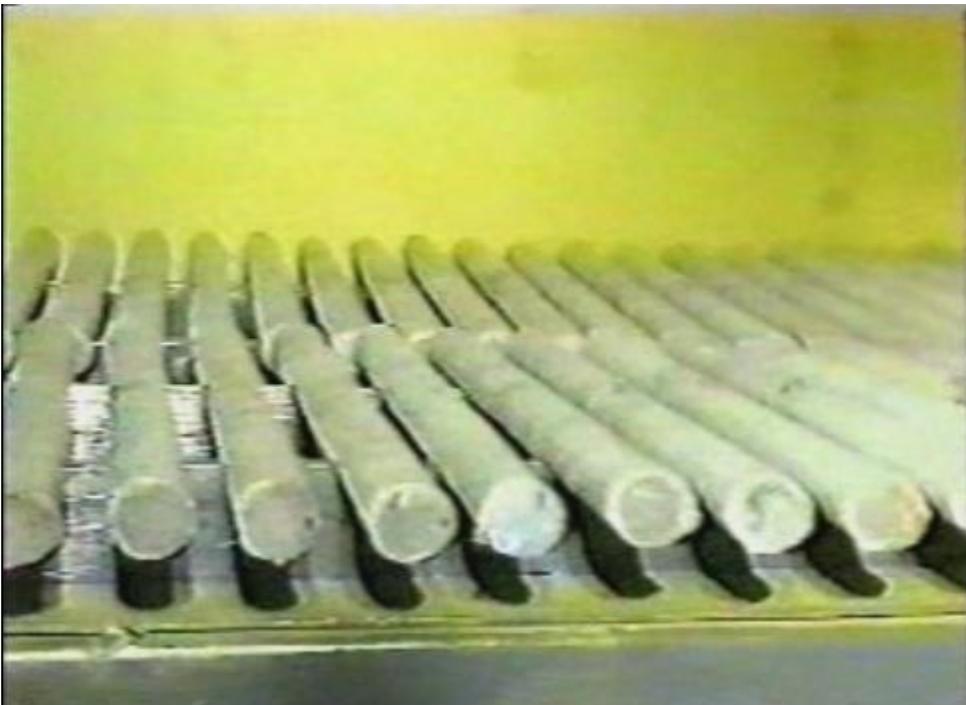
Figure 10: Image taken from the video of the 1992 IAEA tour of North Korean nuclear facilities. The image shows unclad/uncanned natural uranium rods. The rods appear very similar to those suspected to have been related to Al Kibār reactor (see also figure 9).

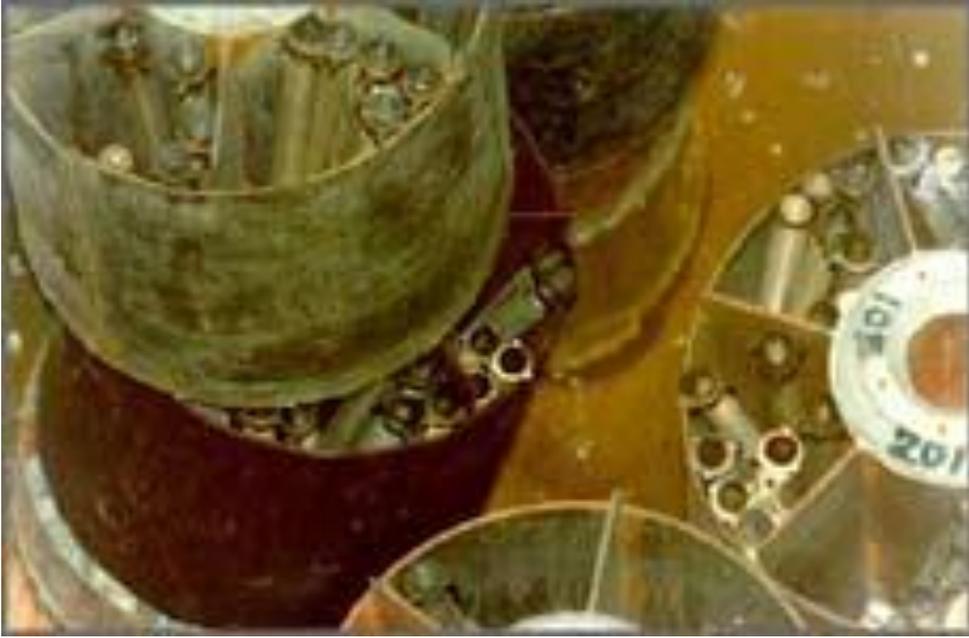
Figure 11: Spent fuel rods from the 5 megawatt-electric reactor at the Yongbyon nuclear center, showing the cladding of the fuel.

Uranium may also be in a more finished fuel form. For example, the uranium rods could be fully clad by a magnesium-zirconium alloy. In this case, the cladding of the fuel would appear silvery and have some additional physical structure. Figure 11 shows clad fuel rods from the Yongbyon 5 megawatt-electric reactor in the cooling pond next to the reactor after irradiation in the core.
