May 2016: Monitoring Activities at the Yongbyon Nuclear Site

By David Albright and Serena Kelleher-Vergantini

May 27, 2016

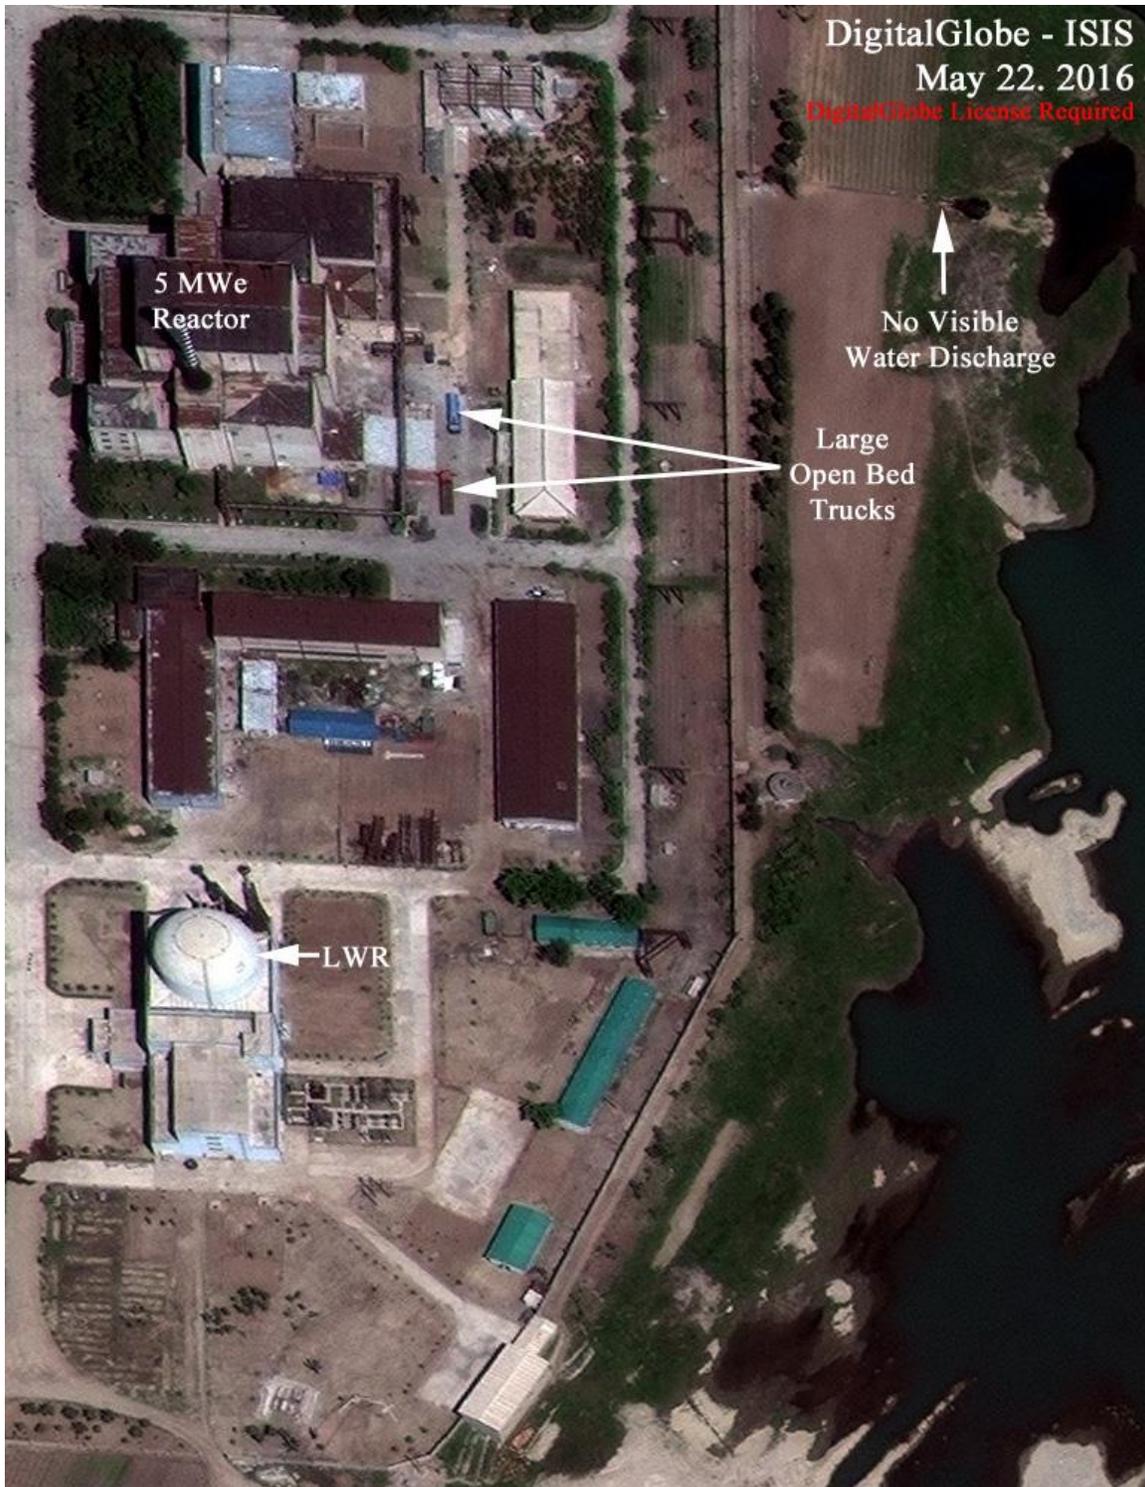
DigitalGlobe imagery dated May 22, 2016, shows no signs of full-power operation at the 5 MWe reactor, such as water discharge or steam venting from the reactor's turbine building (see figure 1). However, as mentioned previously, the absence of these two indicators does not mean the 5 MWe reactor is shut down. Our assessment is that the reactor has been operating intermittently or at low power since mid-2014.¹ On May 22, 2016, two large open bed trucks are parked at the reactor entrance, implying activity taking place at the reactor site. However, the nature of this activity is unknown.

No significant external activities are visible at the site of the Experimental Light Water Reactor (LWR).

Figure 1. DigitalGlobe imagery showing North Korea's 5 MWe and LWR reactors on May 22, 2016.

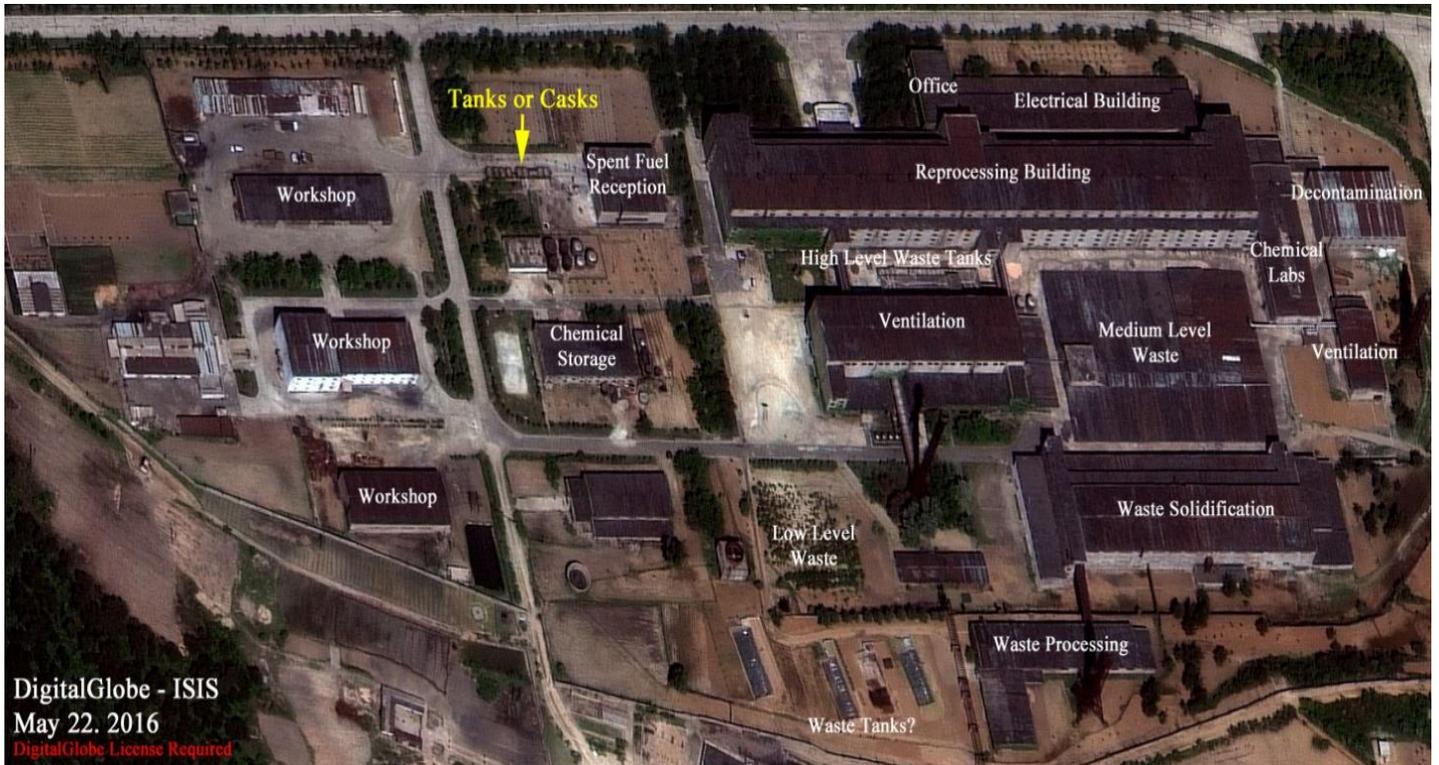
The Radiochemical Laboratory is the site where North Korea chemically processes discharged irradiated fuel from the 5 MWe reactor and separates plutonium for nuclear weapons. Figure 2 provides annotations of many of the buildings at the Radiochemical Laboratory site. The purpose is to supplement and update information in *Solving the North Korean Nuclear Puzzle*

On May 22, 2016, nine tanks (or casks) (each 3 meters by 2.6 meters) were lined up in front of the spent fuel reception building (see figure 2). Several tanks were also spotted in this location on April 11, 2016 (see [38North](#)). Additionally, the coal fired steam generation plant was active in the most recent image (see figure 3). Smoke from the coal plant is an important signature often associated with reprocessing activities at the Radiochemical Laboratory. The coal plant's main purpose is to provide a source of industrial steam for the reprocessing activities taking place there. More specifically, one of the major uses of the steam is to generate heat for nuclear waste minimization and solidification. Thus, the steam is importantly used to address the aftermath of plutonium separation.

The activity of the coal plant and the presence of tanks in front of the spent fuel reception building are signatures consistent with spent fuel reprocessing. However, it remains difficult to determine whether plutonium separation has occurred, is occurring, or will occur in the near future.³

Figure 2. DigitalGlobe imagery showing North Korea’s Radiochemical Laboratory on May 22, 2016. The slight distortions in the image are caused by the angle at which the image was taken.

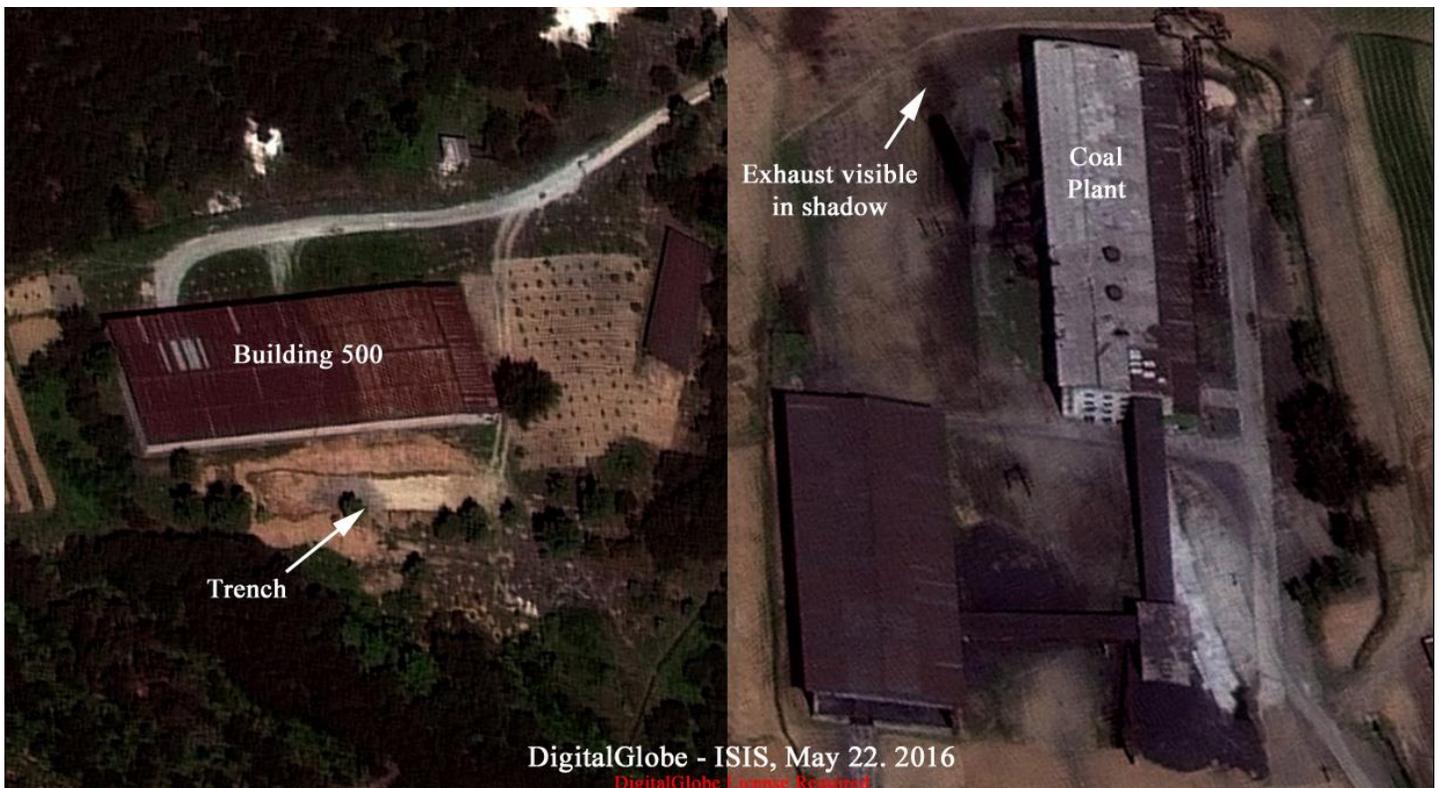
As figure 3 shows, a trench has been dug next to Building 500. This trench was dug between March 15 and April 4, 2016, based on available commercial satellite imagery of the site. Although the exact purpose of the trench remains unknown, North Korea may be attempting to access the lower portion of the building, where the waste is allegedly stored, to remediate a problem, perhaps a waste leak, or conduct maintenance activities.⁵

Figure 3. DigitalGlobe imagery showing Building 500 and the coal fired steam generation plant at Yongbyon on May 22, 2016.

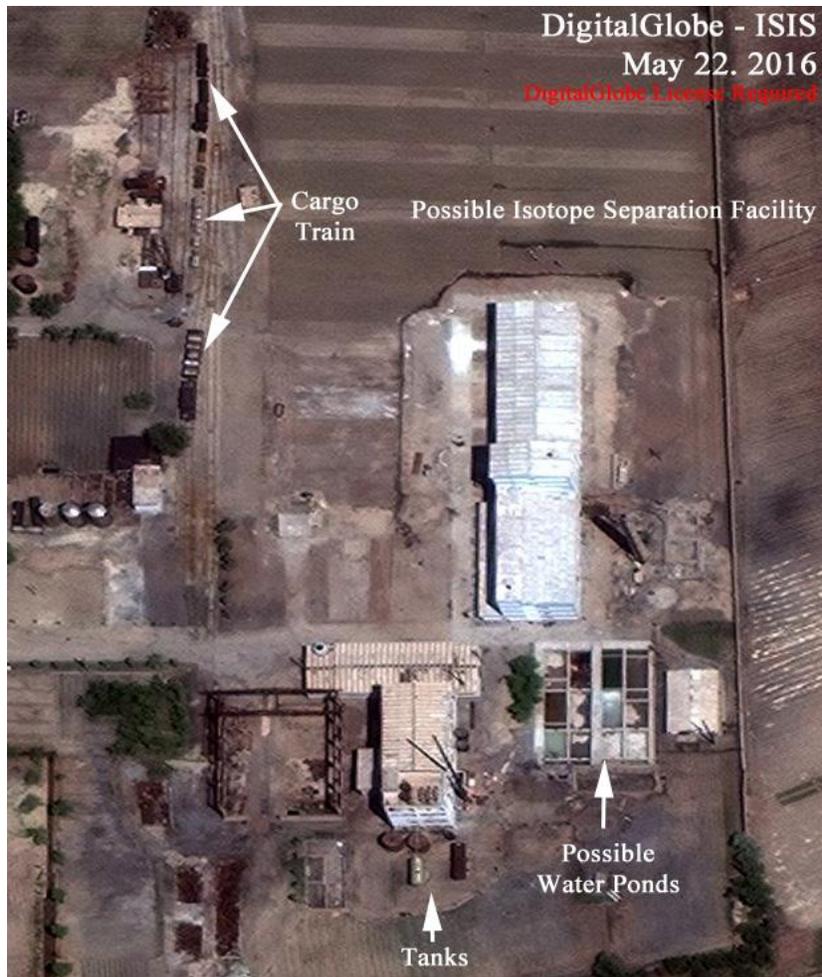
DigitalGlobe's May 22, 2016 image shows several signatures of external activity at a site ISIS identified as a possible isotope separation facility. This site is located in the southern corner of the Yongbyon nuclear complex, east of the fuel fabrication facility, and presents signatures consistent with an isotope separation facility, including tritium separation.⁶

In [April 2016](#), ISIS highlighted that water discharge was visible in front of, and on top of, the main building at the site, while circular-shaped excavation was taking place next to the main building. As of May 22, 2016, both of these signatures are no longer visible. The water was associated with ongoing external activity. The fact that it has been drained could signify that external construction activity could soon be complete. This theory is reinforced by the fact that the area in front of the main building is being cleared of most construction material. The purpose of the circular-shaped excavation was, and remains, unknown. Additionally, the May 2016 image shows the presence of possible water ponds located immediately south of the main building at the site.

Figure 4. DigitalGlobe imagery showing the possible isotope separation facility at Yongbyon on May 22, 2016.

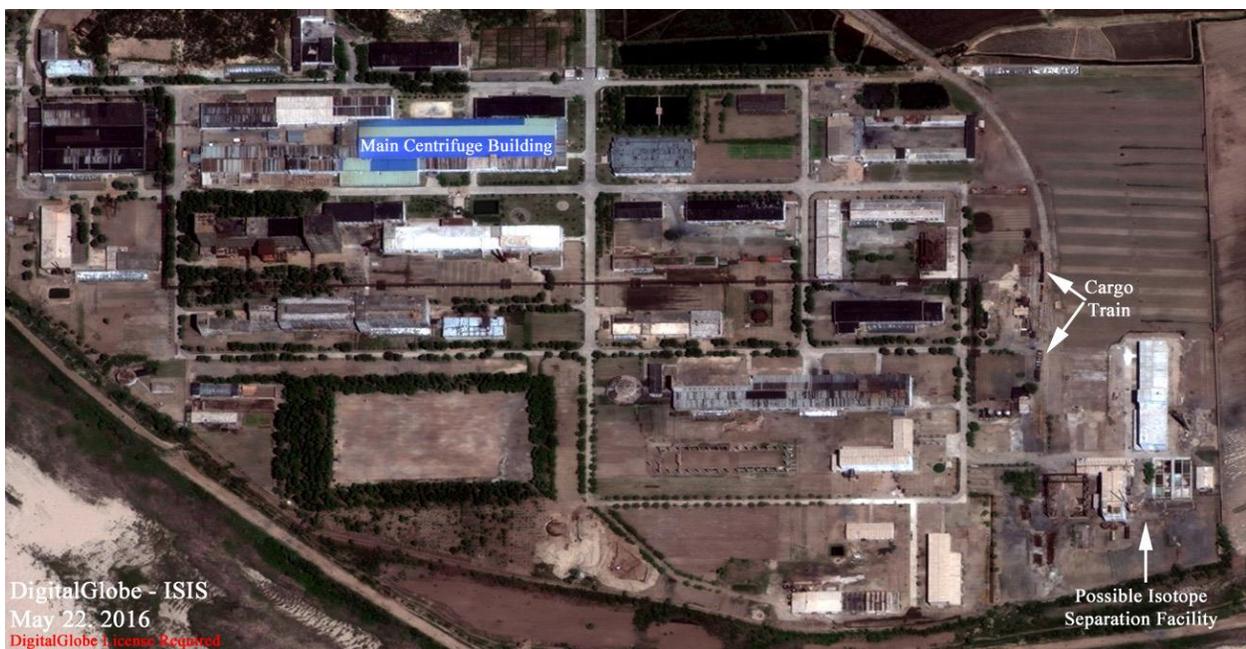
Figure 5. DigitalGlobe imagery showing the fuel fabrication facility at Yongbyon on May 22, 2016.
