## On-Going Monitoring of Activities at the Yongbyon Nuclear Site

By David Albright, Sarah Burkhard, and Allison Lach

February 13, 2018

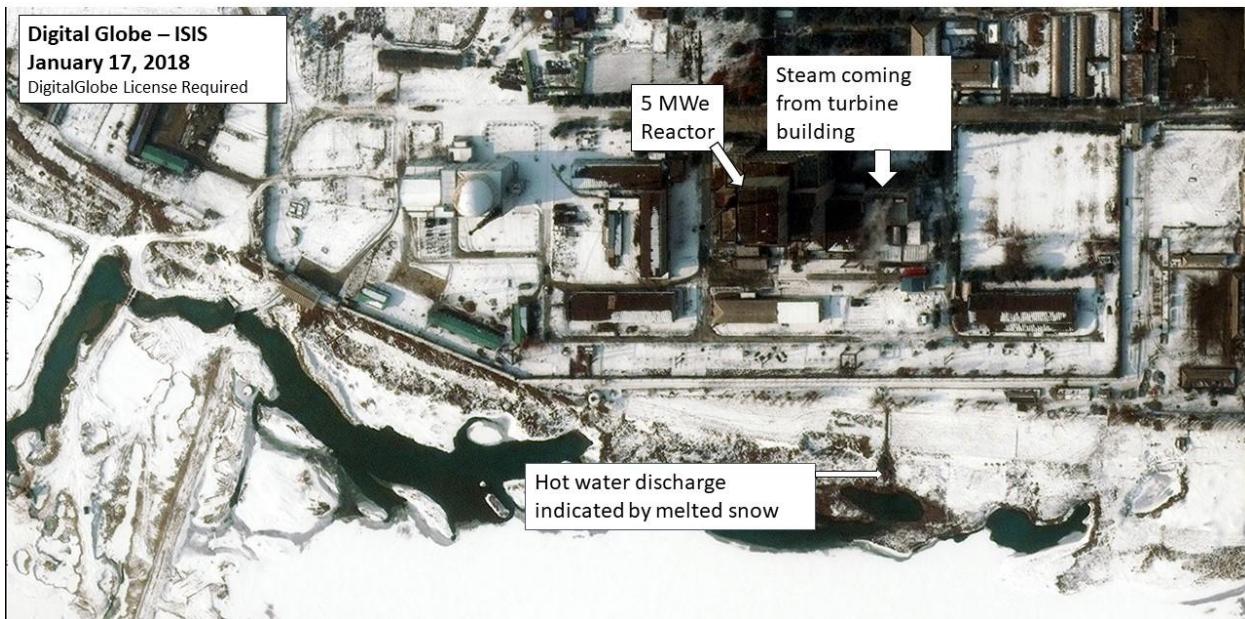
**Figure 1.** A January 17, 2018 Digital Globe image showing the Yongbyon 5 MWe reactor, with steam visible from the reactor's turbine building, implying the reactor is operational.

North Korea's 5 MWe reactor at the Yongbyon nuclear center remains operational, producing plutonium for nuclear weapons. In a Digital Globe image dated January 17, 2018, steam is visible coming from the reactor's turbine building, and hot water appears to be melting snow at the discharge pipe for this reactor (see figure 1). Steam emission suggests that the reactor is producing electricity. The water discharge is most likely from a secondary cooling system used

to cool the carbon dioxide gas from the 5 MWe reactor core. The Institute assesses that the 5 MWe reactor's secondary cooling system may be receiving water through a very long piping system connected to a water intake building 1.5 kilometers (km) north of the reactor.<sup>2</sup>

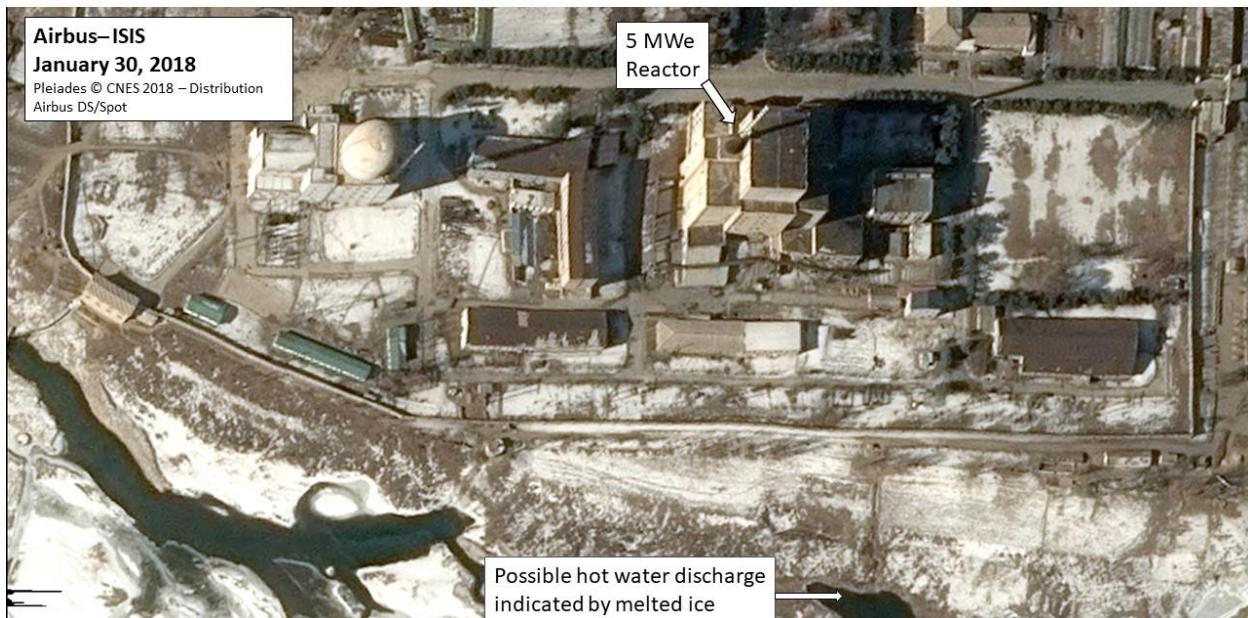
**Figure 2.** A January 30, 2018 Airbus image showing the Yongbyon 5 MWe Reactor.

In a January 30, 2018 Airbus image, no steam is visible but hot water may be coming from the discharge pipe (see figure 2).

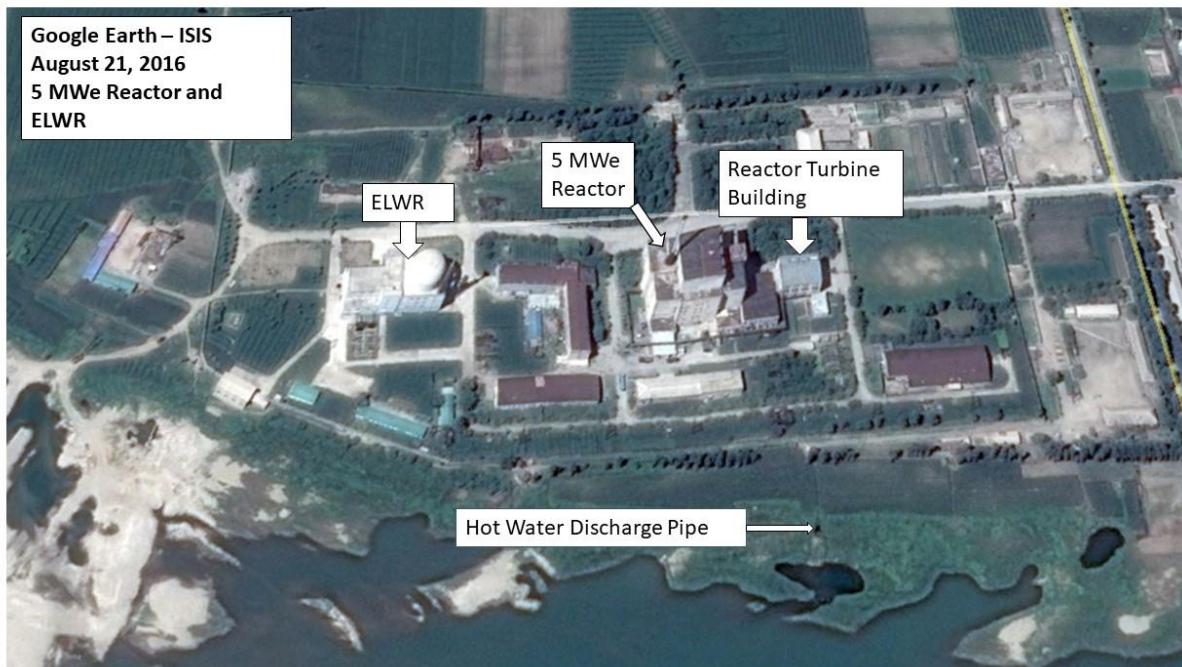
**Figure 3.** An August 21, 2016 Google Earth image showing the 5 MWe Reactor and the ELWR during summer months.

Figure 3 is a Google Earth image from August 21, 2016 which shows what the reactor site and the river look like during warm summer months.

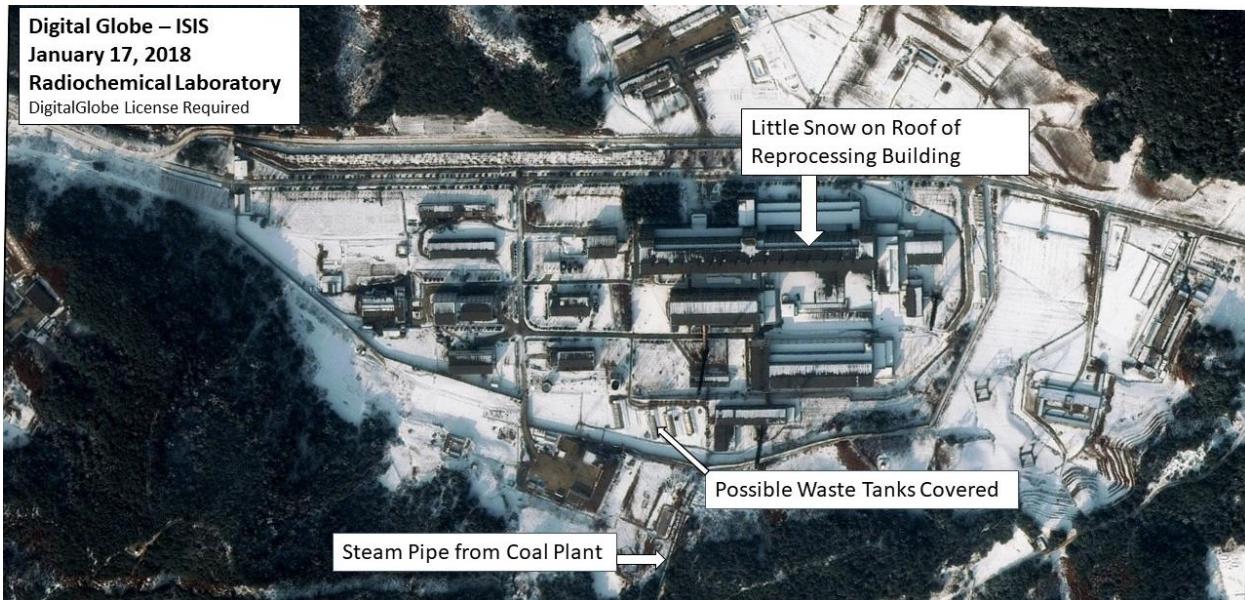
**Figure 4.** A January 17, 2018 Digital Globe image showing the Radiochemical Laboratory at the Yongbyon nuclear site.

Little activity is visible at the Radiochemical Laboratory site where North Korea chemically processes irradiated fuel from the 5 MWE reactor, separating plutonium for nuclear weapons, and processing the resulting nuclear waste; however, the long main building, where plutonium is separated from the fuel, may be heated. Mid-January was very cold in North Korea. The weather service in Pyongyang reported temperatures mostly in the teens (Fahrenheit).<sup>4</sup> Therefore, it is significant that despite the lack of other visible signs of major activity, the January 17, 2018 Digital Globe image shows almost no snow on the roof of the long plutonium separation building and a few workshop buildings (see figure 4), which implies that these

buildings may be heated and are thus in use. Other roofs are at least half-covered by snow. The workshops show some activity outside of their entrances, indicated by melted snow and traces of snow. Previously empty and open, possible waste tanks in the south of the plant are covered.

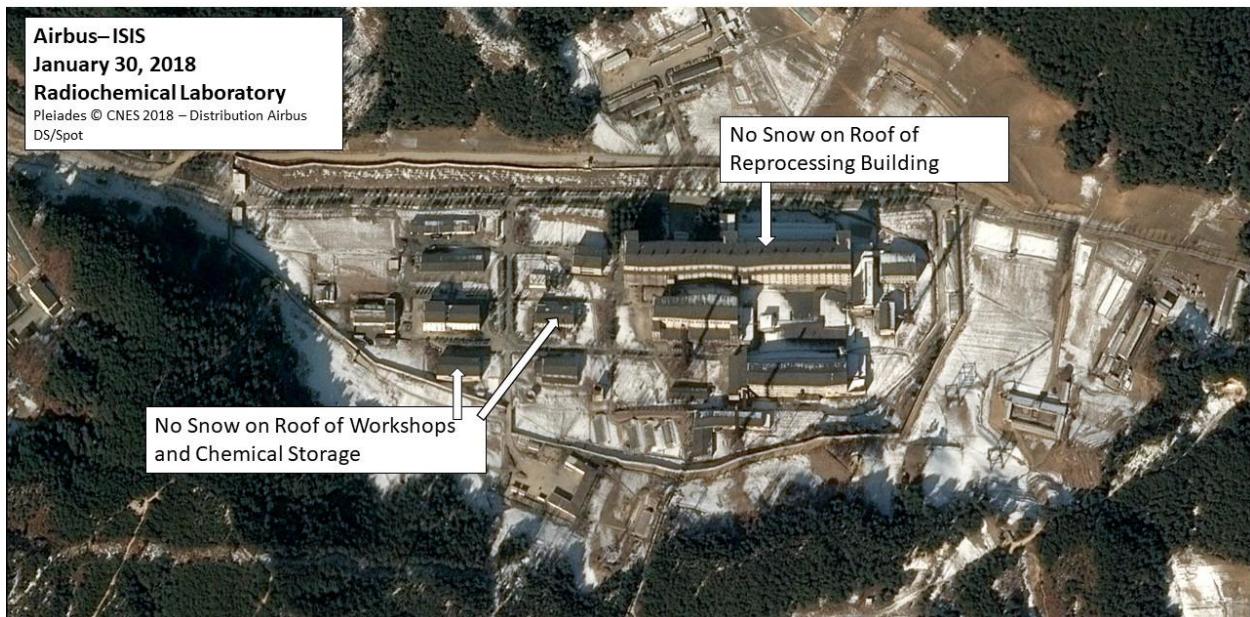
**Figure 5.** A January 30, 2018 Airbus image showing the Radiochemical Laboratory at the Yongbyon nuclear site.

The January 30, 2018 Airbus image shows that many roofs are still partially covered by snow, while the long reprocessing building, spent fuel reception area, chemical storage, and workshops appear snow-free (see figure 5).

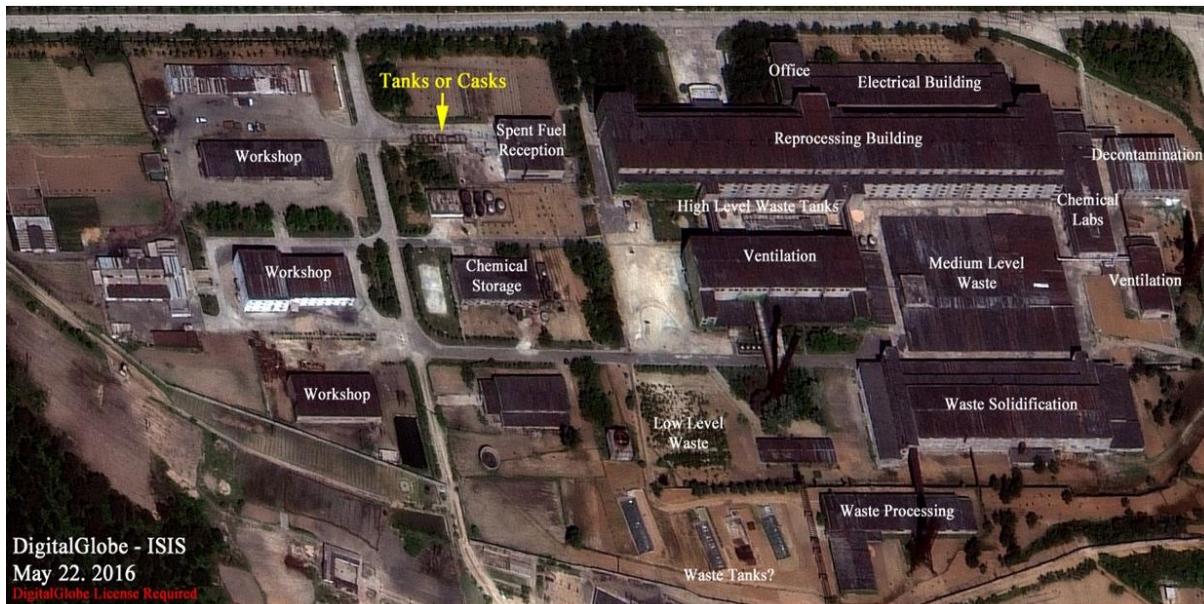
**Figure 6.** A May 22, 2016 Digital Globe image with full annotation of the Radiochemical Laboratory at the Yongbyon nuclear site.

Figure 6 provides comprehensive annotation of the site. No tanks or casks similar to those in the May 2016 Digital Globe image are visible in the two January images.

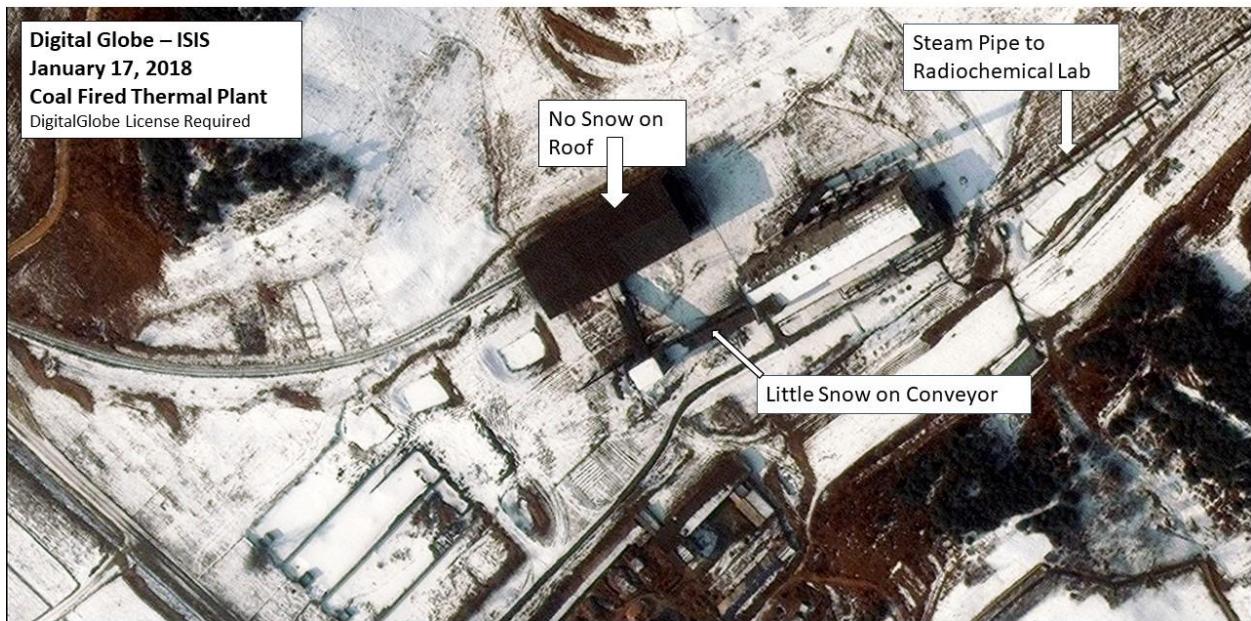
**Figure 7.** A January 17, 2018 Digital Globe image showing the Coal Fired Thermal Plant at the Yongbyon nuclear site.

The coal fired steam plant to the south-east of the Radiochemical Laboratory generates steam used in several activities at the Radiochemical Laboratory. For example, the steam provides heat for nuclear waste minimization and solidification. As such, activity at the steam plant would be a major indicator for reprocessing activities. Neither of the recent images acquired by the Institute show concrete signs of activity (such as exhaust plumes). The coal stockpiles are covered in snow; however, the images show no snow on the roof of the reception building, and on top of the coal conveyors (see figures 7 and 8). Vehicle tracks visible in the snow can be traced to the reception building. The pipe that transfers the steam from the coal plant to the Radiochemical Laboratory also seems free of snow.

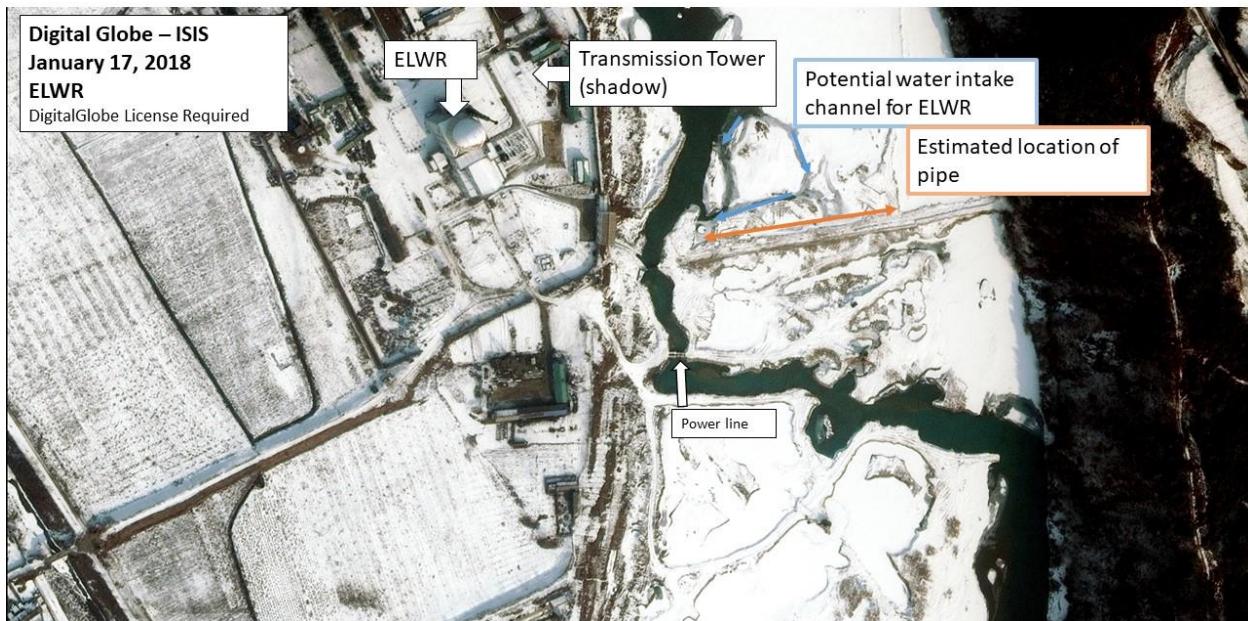
**Figure 9.** A January 17, 2018 Digital Globe image showing developments at the Experimental Light Water Reactor at the Yongbyon nuclear site.

Yet, it is difficult to know when it could start. Some analysts believe the reactor has undergone testing of its secondary cooling system and other preparations.<sup>8</sup> Others are not so sure. Moreover, the two recent commercial satellite images do not have visible signatures suggesting operation during January 2018 (see figures 9 and 10).

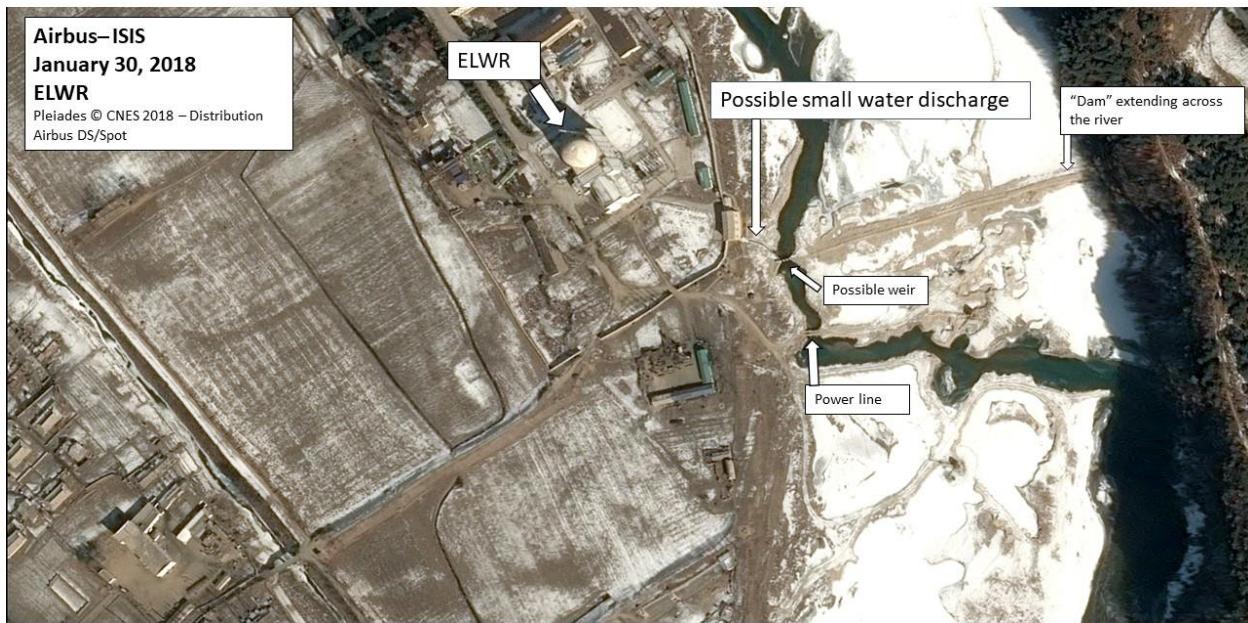
**Figure 10.** A January 30, 2018 Airbus image showing developments at the Experimental Light Water Reactor at the Yongbyon nuclear site.

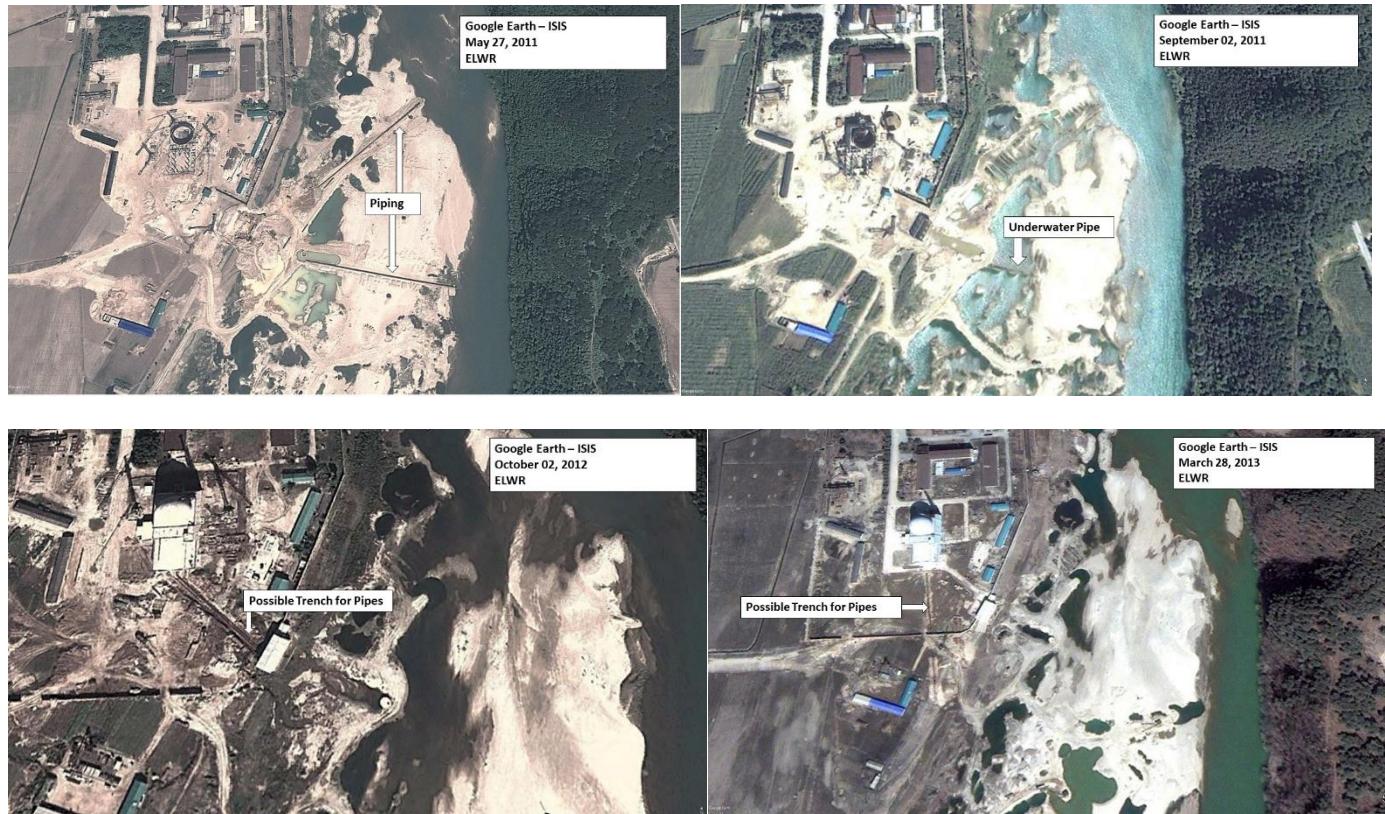
**Figures 11a – 11d.** Google Earth Images of the ELWR during construction. Top left: May 27, 2011; Top right: September 2, 2011; Bottom left: October 2, 2012; Bottom right: March 28, 2013

Other secondary cooling system possibilities for the ELWR include piping laid in 2012 and 2013. The trenches seen in figure 11c seem to lead to a building near the river. Some people call this the ELWR pump house,<sup>12</sup> but it seems to be quite far from the river with no clear and visible

connection to it. The river water level also seems to fluctuate considerably during the year, which would make the pump house potentially unreliable. The trenches seen in figure 11d lead to the river, and several people have proposed this to be a potential discharge channel for hot water from the ELWR's secondary cooling system.<sup>13</sup>

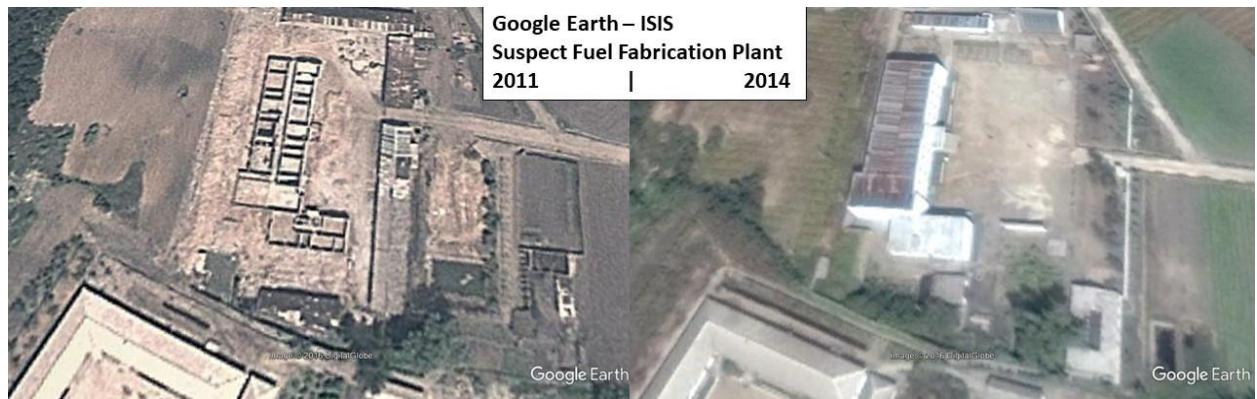
**Figure 12.** Google Earth imagery from 2011 and 2014 showing the suspect ELWR fuel fabrication plant during and after construction.

Figures 12 through 15 show the building during and after construction, which started in 2011, a logical time period in which to construct this building based on the then-expected startup date of 2013 (see above). The internal structure of the building includes several rooms, which could be used to conduct the various aspects of making fuel pellets.

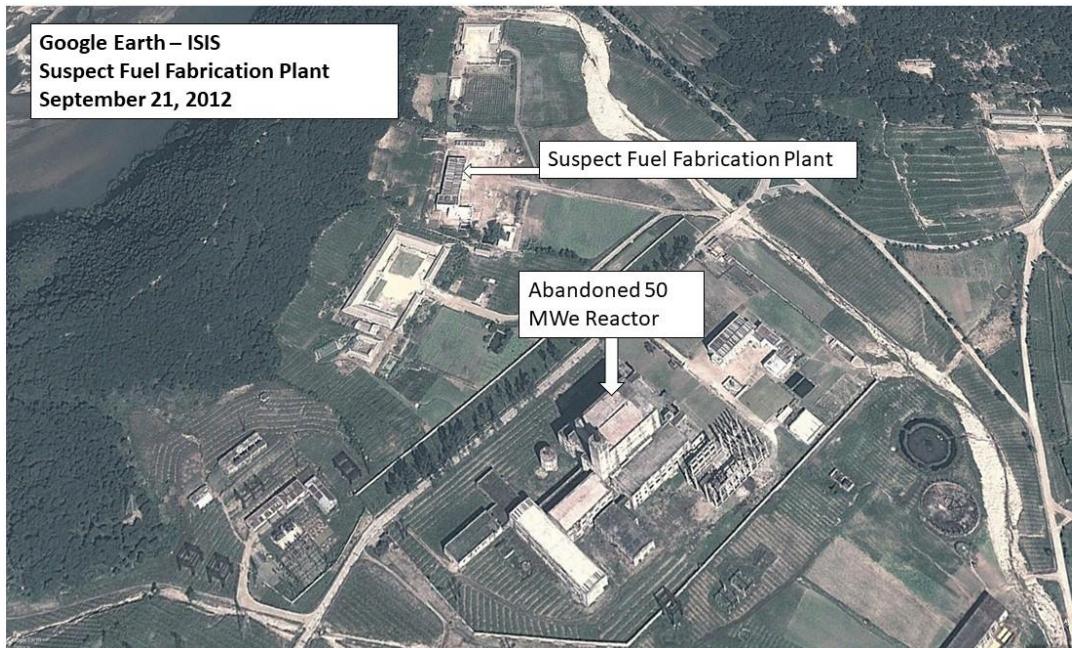
**Figure 13.** A September 21, 2012 Google Earth image showing the suspect fuel fabrication plant near the abandoned 50 MWe Reactor at the Yongbyon nuclear site.

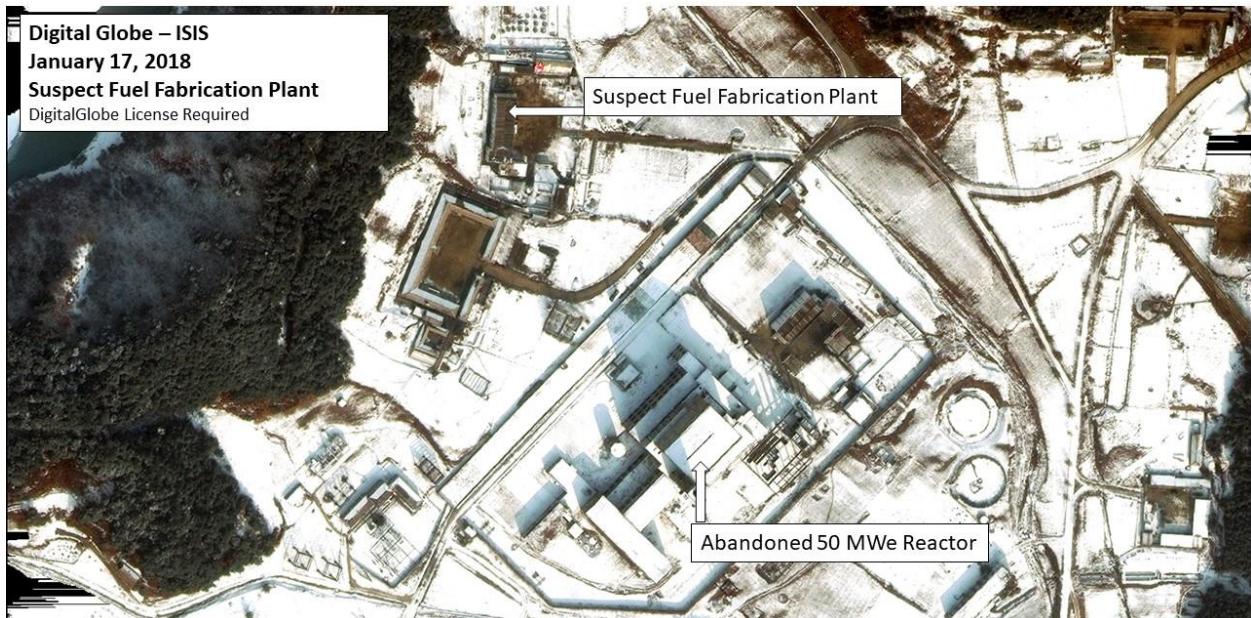
**Figure 14.** A January 17, 2018 Digital Globe image showing the suspect fuel fabrication plant near the abandoned 50 MWe Reactor at the Yongbyon nuclear site.

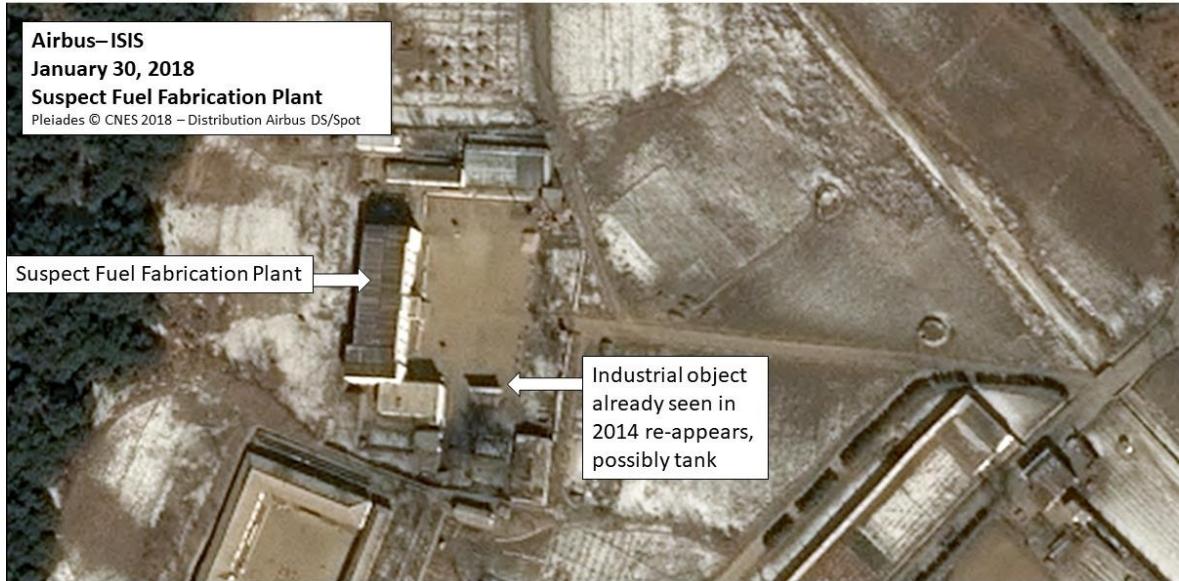
**Figure 15.** A January 30, 2018 Airbus image showing the suspect fuel fabrication plant at the Yongbyon nuclear site.

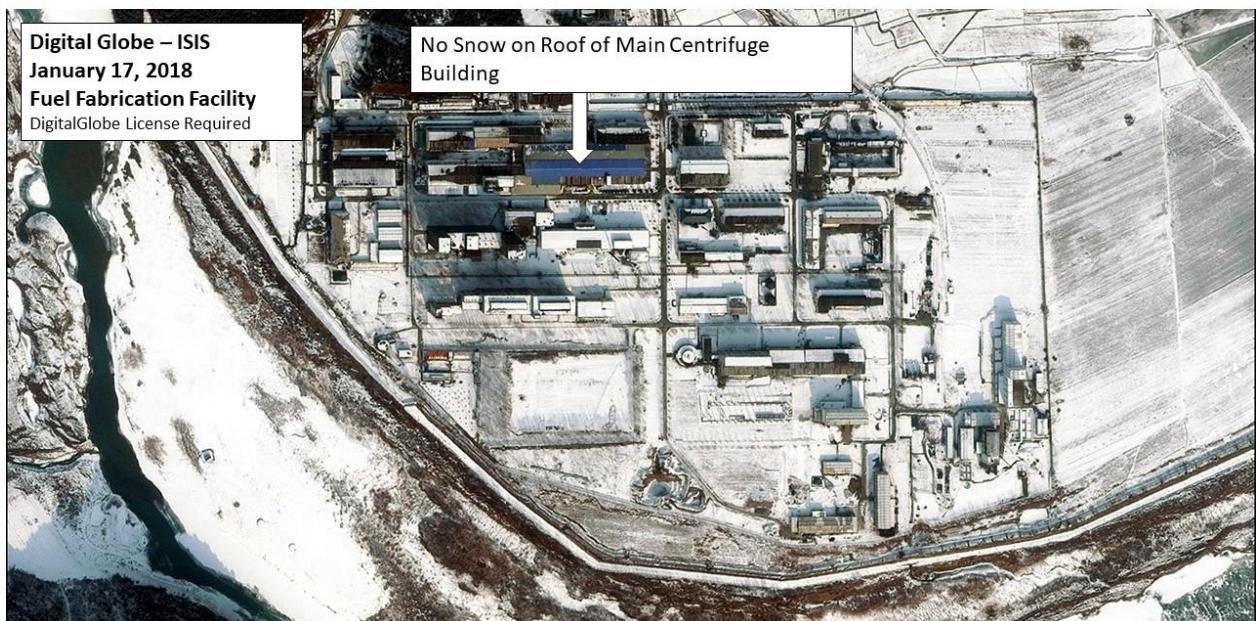
**Figure 16.** A January 17, 2018 DigitalGlobe image showing the original Fuel Fabrication Complex in the south-east of the Yongbyon nuclear site.

At the Fuel Fabrication Complex in the southern part of the site, the January 17, 2018 Digital Globe image in particular shows that the majority of roofs are covered by snow (figure 16). An exception is the main centrifuge building, where the snow has almost completely melted. If the centrifuges are operating, as believed, they are kept at a near constant temperature well above freezing, which would account for the snow melt. (A temperature of 20° C is reasonable.)

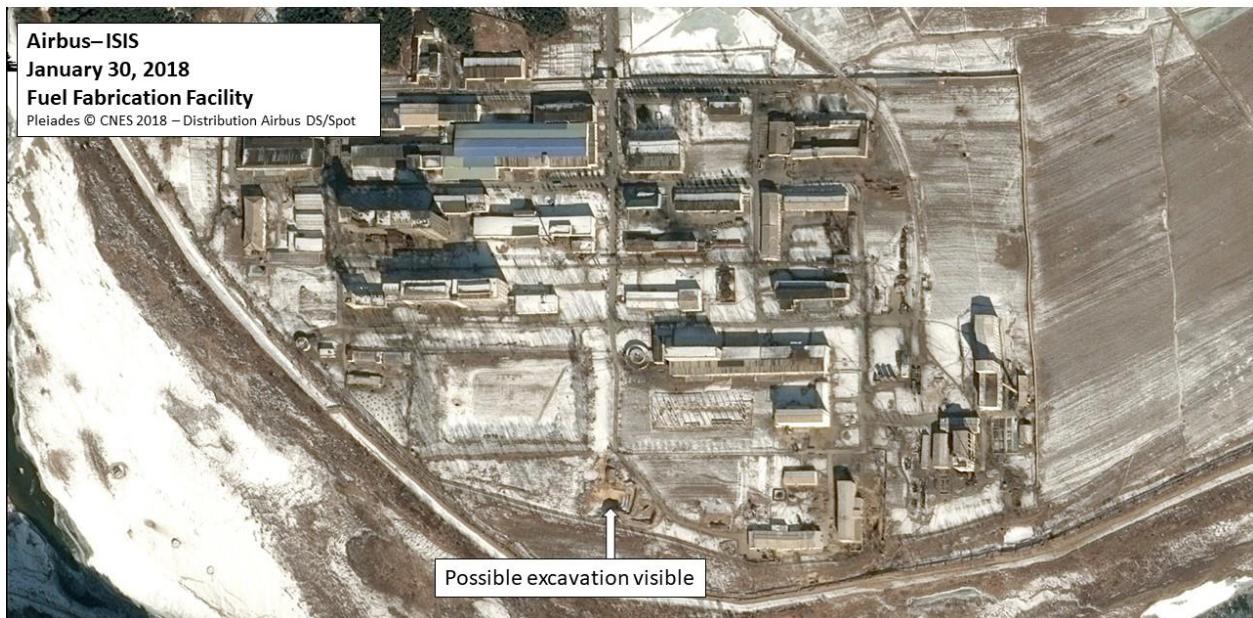
**Figure 17.** A January 30, 2018 Airbus image showing the original Fuel Fabrication Complex in the south-east of the Yongbyon nuclear site.

The January 30, 2018 Airbus images shows that, with exception of a few buildings, more roofs are free of snow. Possible excavation is visible in the south of the facility (figure 17).

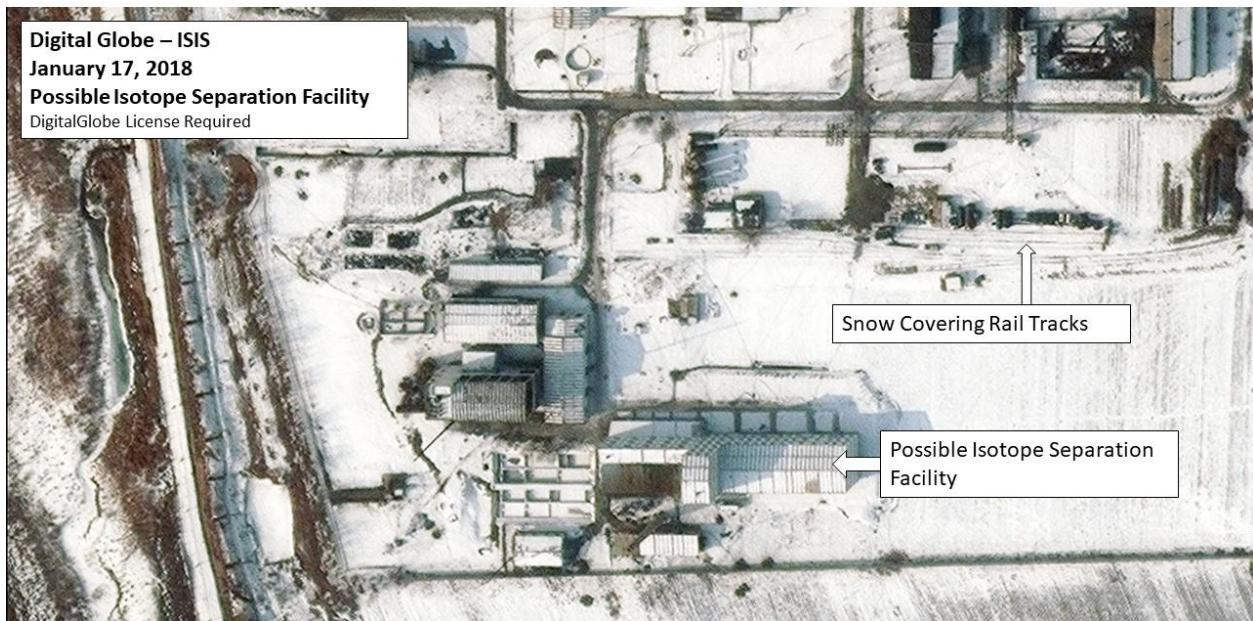
**Figure 18.** A January 17, 2018 Digital Globe image showing the Possible Isotope Separation Facility at the Yongbyon nuclear site.

Already present in the January 17, 2018 image, but pointed out in the January 30, 2018 Airbus image, is a completed roof of a small building near the main building of the possible Isotope Separation Facility that, when operational, could separate tritium for boosted or thermonuclear nuclear weapons (see figures 18 and 19). What initially looked like the construction of one building was later divided into two smaller buildings with a path in between them (see figure 20). The January 17, 2018 Digital Globe image shows that the rail tracks leading to the plant are

covered in snow. Some construction material seems yet to be cleared, and uncovered dirt and traces in the snow indicate other minor activity around the plant.

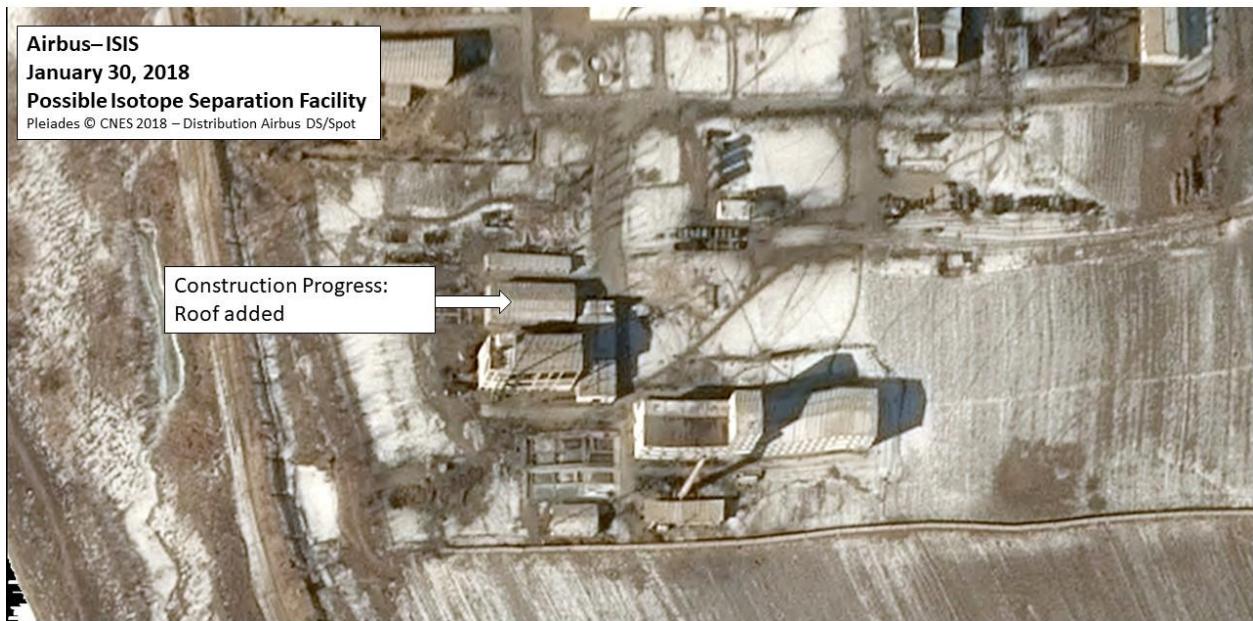
**Figure 19.** A January 30, 2018 Airbus image showing the Possible Isotope Separation Facility at the Yongbyon nuclear site and a nearby, possibly associated building where a roof has been added.

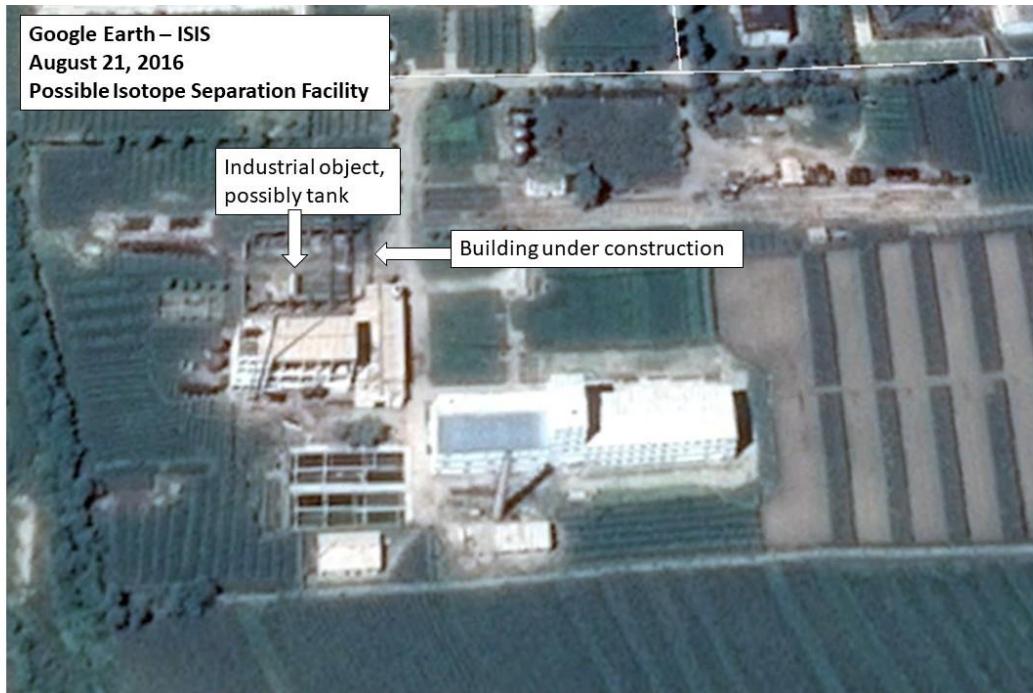
**Figure 20.** An August 21, 2016 Google Earth image showing the building discussed in figure 19 near the Possible Isotope Separation Facility before the roof was added.
