## Finding the Site of the Alleged Explosion at the Parchin Military Complex

October 8, 2014

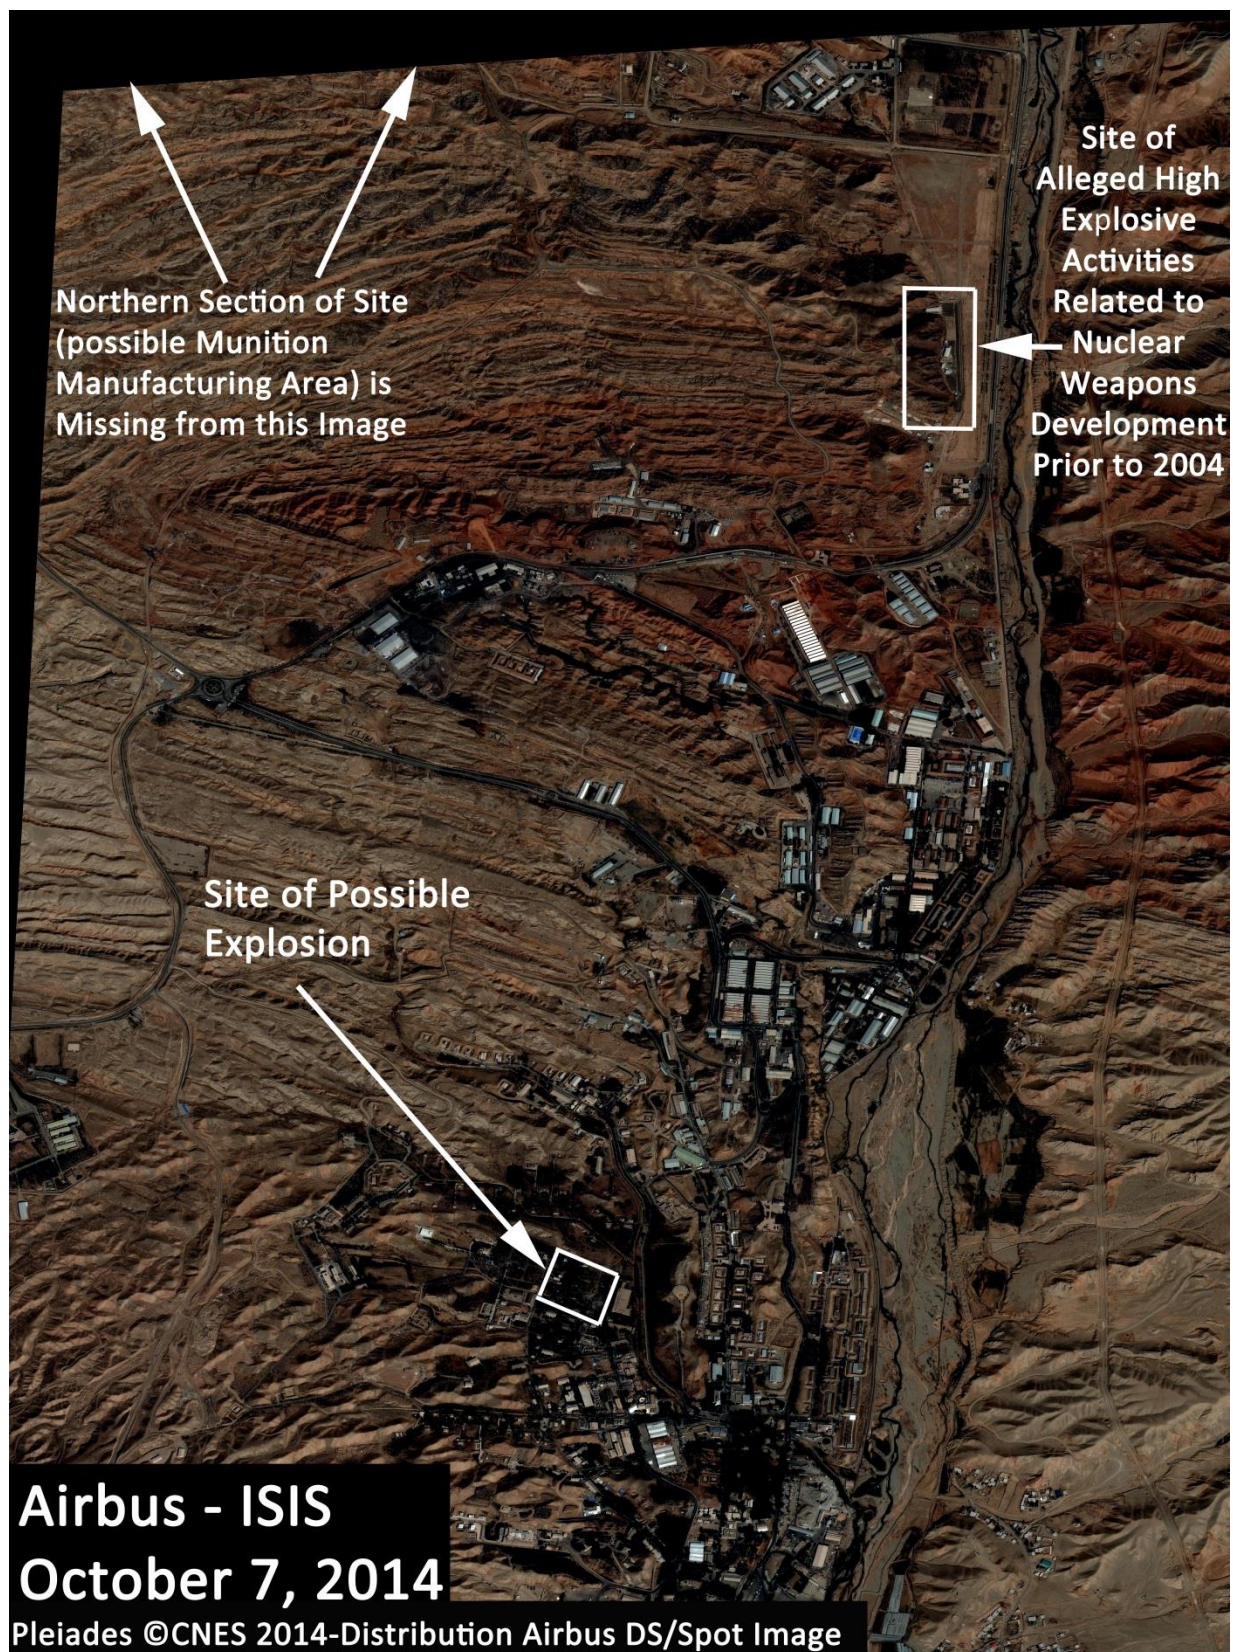
**Figure 1.** Airbus imagery showing the Parchin Military Complex in Iran on October 7, 2014 one day after a reported explosion.

Earlier today, it has been [reported](#) that the imagery shows that the damage is consistent with an attack against bunkers and that the locality is adjacent to another installation where work was being conducted that involves controlled detonation of fuses intended to serve as triggers for nuclear devices. However, it is important to note that there is no evidence of either an attack or nuclear weapon-related activities at this specific site. There may be confusion over alleged high explosive nuclear weapon-related activities at another site at Parchin that occurred prior to 2004 (see figure 1).

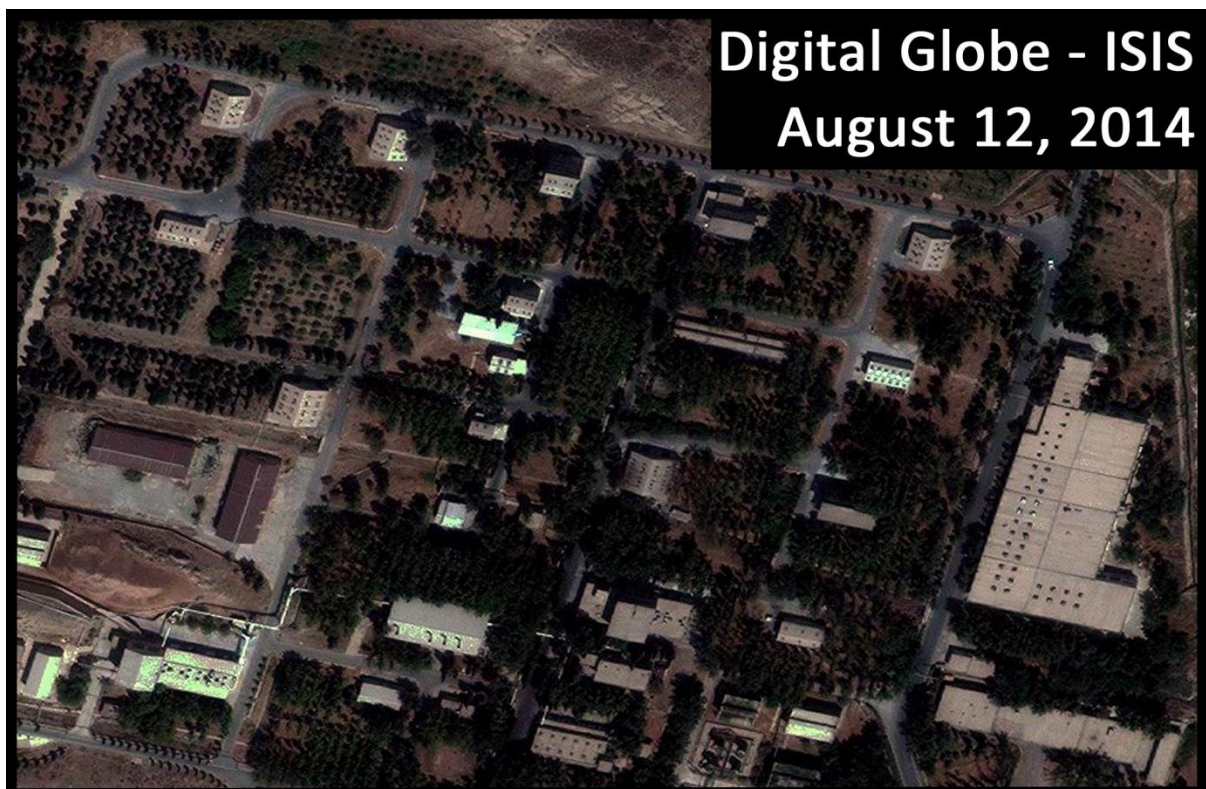
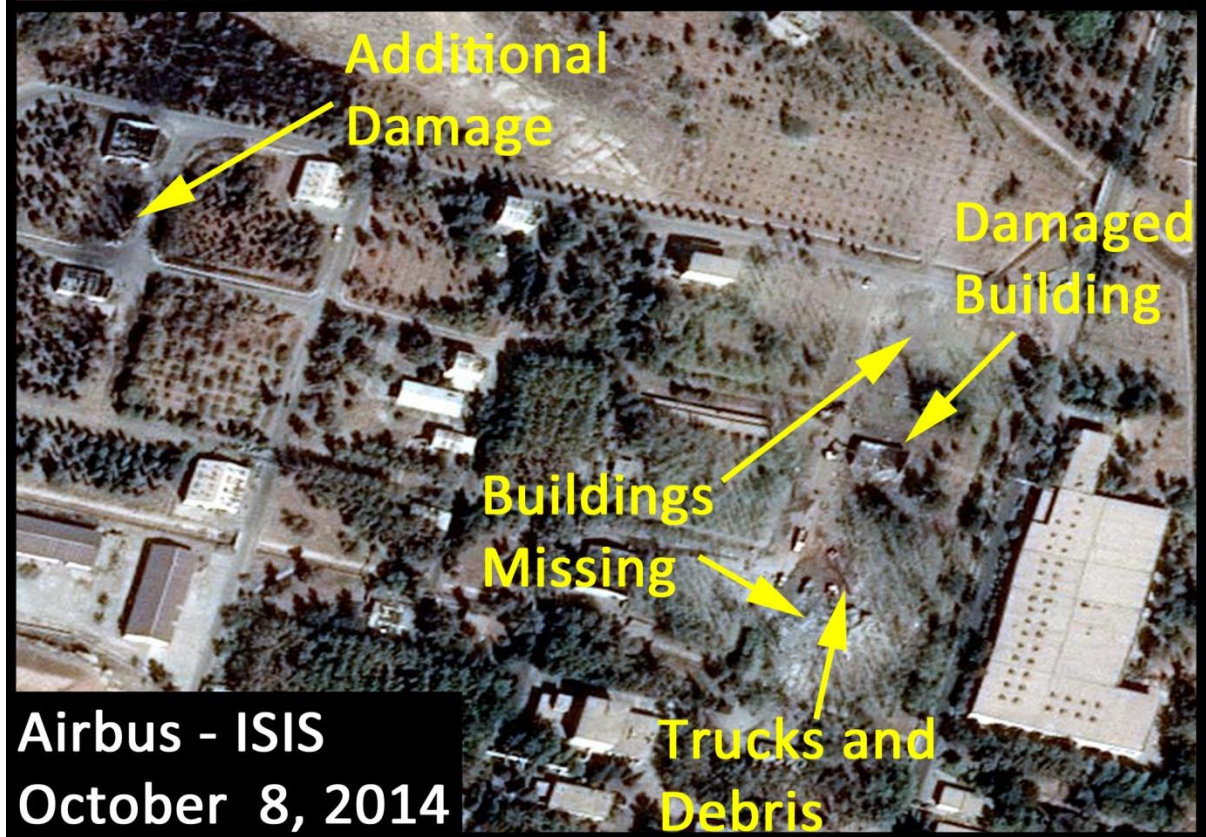
**Digital Globe - ISIS**  
**August 12, 2014**

**Airbus - ISIS**  
**October 8, 2014**

**Figure 2.** Before and after imagery of a possible site of the reported explosion. Digital Globe imagery from August 12, 2014 and Airbus imagery from October 7, 2014.

Several signatures that coincide with those expected from an explosion site are visible here. Two buildings that were present in August 2014 are no longer there, while a third building appears to be severely damaged. In total at least six buildings appear damaged or destroyed. Several trucks are present at the site. The shape and size of these trucks is consistent with those of either fire or debris removal trucks. The irregular line and color of the vegetation seems to indicate that some unexpected activity took place (possibly a fire, explosion, scattering of debris etc.). Finally, grey debris is visible at the center of the potential explosion area and is also scattered into the surrounding vegetation.
