## Modifications at the Parchin Site: A Comprehensive Timeline; New Imagery Suggests Re-Asphalting

By David Albright, Serena Kelleher-Vergantini, and Christopher Coughlin

February 11, 2015

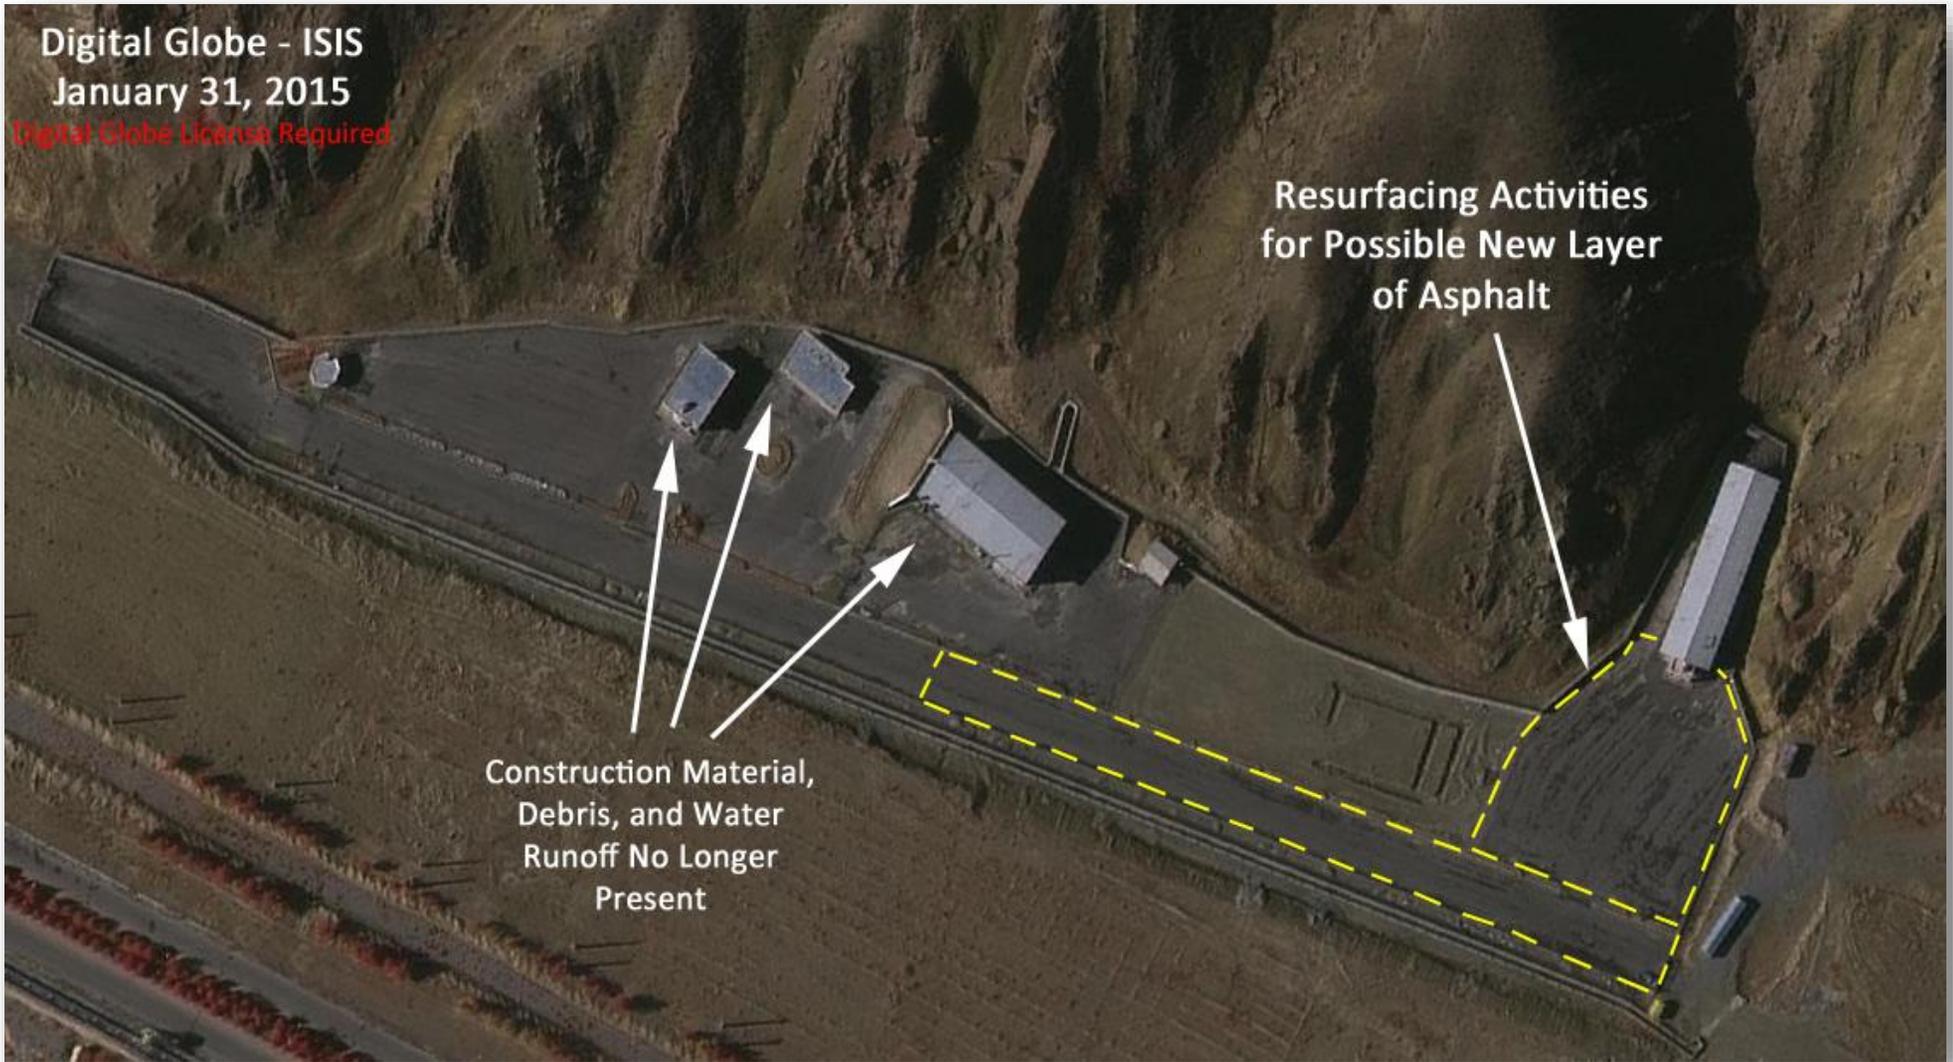
**Figure 1.** Digital Globe imagery showing the status of the alleged high explosive test site at the Parchin military complex on January 31, 2015.

*New Digital Globe imagery purchased and analyzed by ISIS shows continued signs of external activity at the Parchin military site where Iran is alleged to have conducted work related to nuclear weapons development (see figure 1). The signatures visible in the most recent imagery indicate that Iran may be engaging in new asphaltting at the site, efforts likely aimed at concealing past banned activities.*

More recent Digital Globe satellite imagery dated January 31, 2015, shows signs of external activity at the northern section of the site and the absence of most of the material/debris and the dirt/water runoff by the main building (see figure 1, where the northern section is on the right side of the image). In front of the large building in the north end of the site, another building of interest to the inspectors, imagery shows the presence of gravel or recycled asphalt. These signatures are consistent with activities of resurfacing that are usually undertaken prior to the lay-down of new asphalt. It is, therefore, possible that Iran is engaging again in asphaltting activities in the northern portion of the Parchin site.

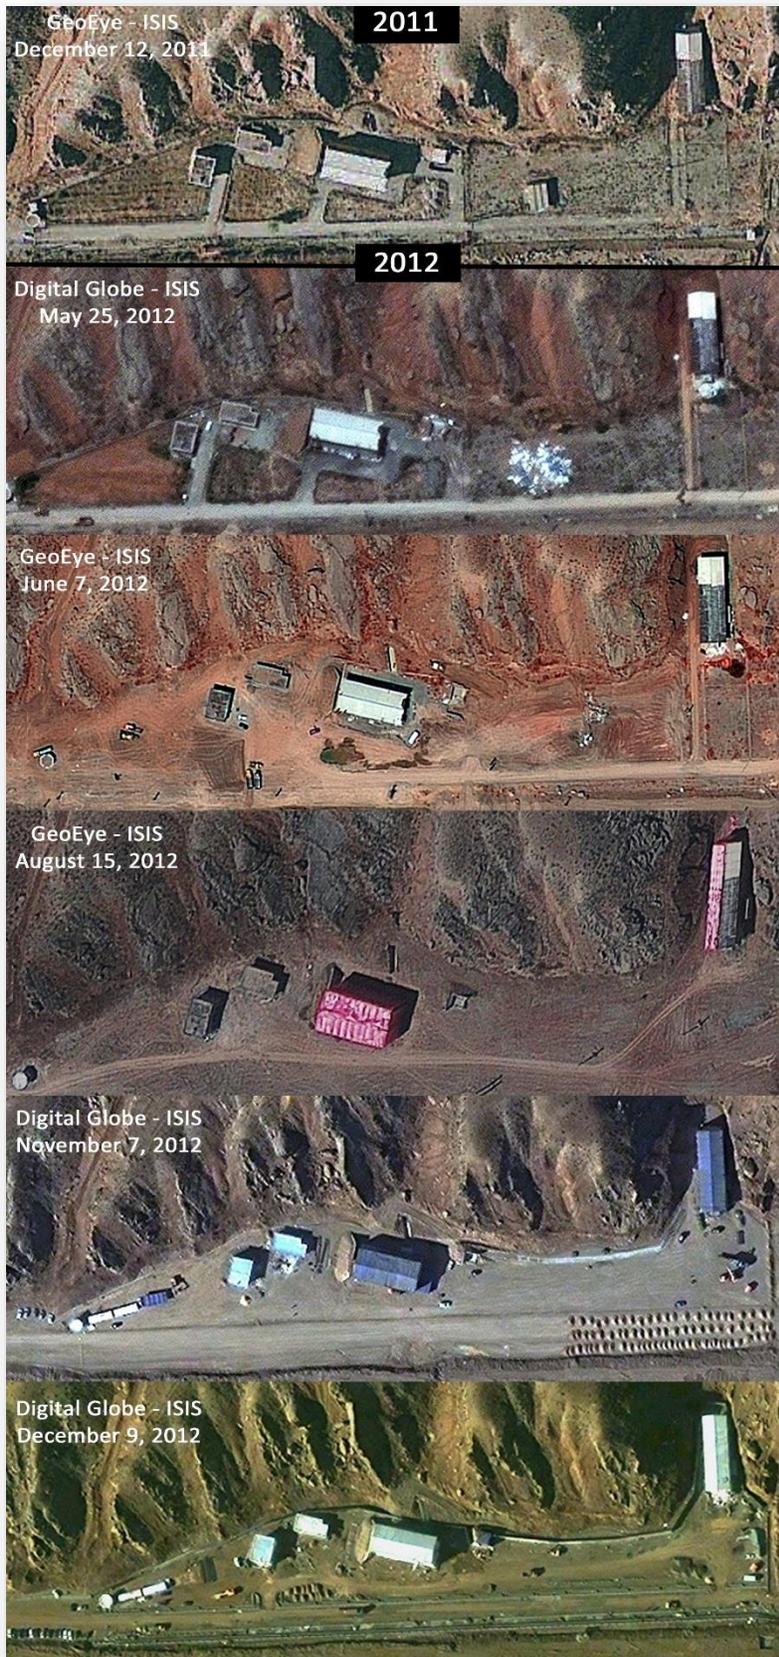
**Figure 2.** GeoEye/Digital Globe high resolution satellite imagery showing changes at the alleged high explosive test site at the Parchin military complex between December 2011 and December 2012.

Figures 2, 3, and 4 show the progressive activities at the Parchin site between December 2011 and January 2015. Figure 2 shows the status of the site in December 2011, before the IAEA's request to visit and the subsequent modifications that took place after the inspectors requested access to the site.

During the year 2012, Iran engaged in several clean-up, demolition, and reconstruction activities. Iran completely demolished and removed debris from one medium size building, partially demolished and rebuilt a small building near the alleged explosive chamber (located in the center of figure 2 and other figures). Iran removed equipment from the building alleged to hold the explosive chamber, modified/replaced the roof and walls of this and the northern-most building (also possibly housing suspicious activity and located on the right side of figure 2 and other figures). Between June and December 2012 multiple vehicles, large open bed trucks, and earth piles were present at the site. Considerable earth moving activities took place, possibly to remove layers of original soil and replace it with new soil. Iran also removed and rebuilt a new solid wall security perimeter and trenches surrounding the site. During this year, Iran engaged in re-designing the layout and security of the site.

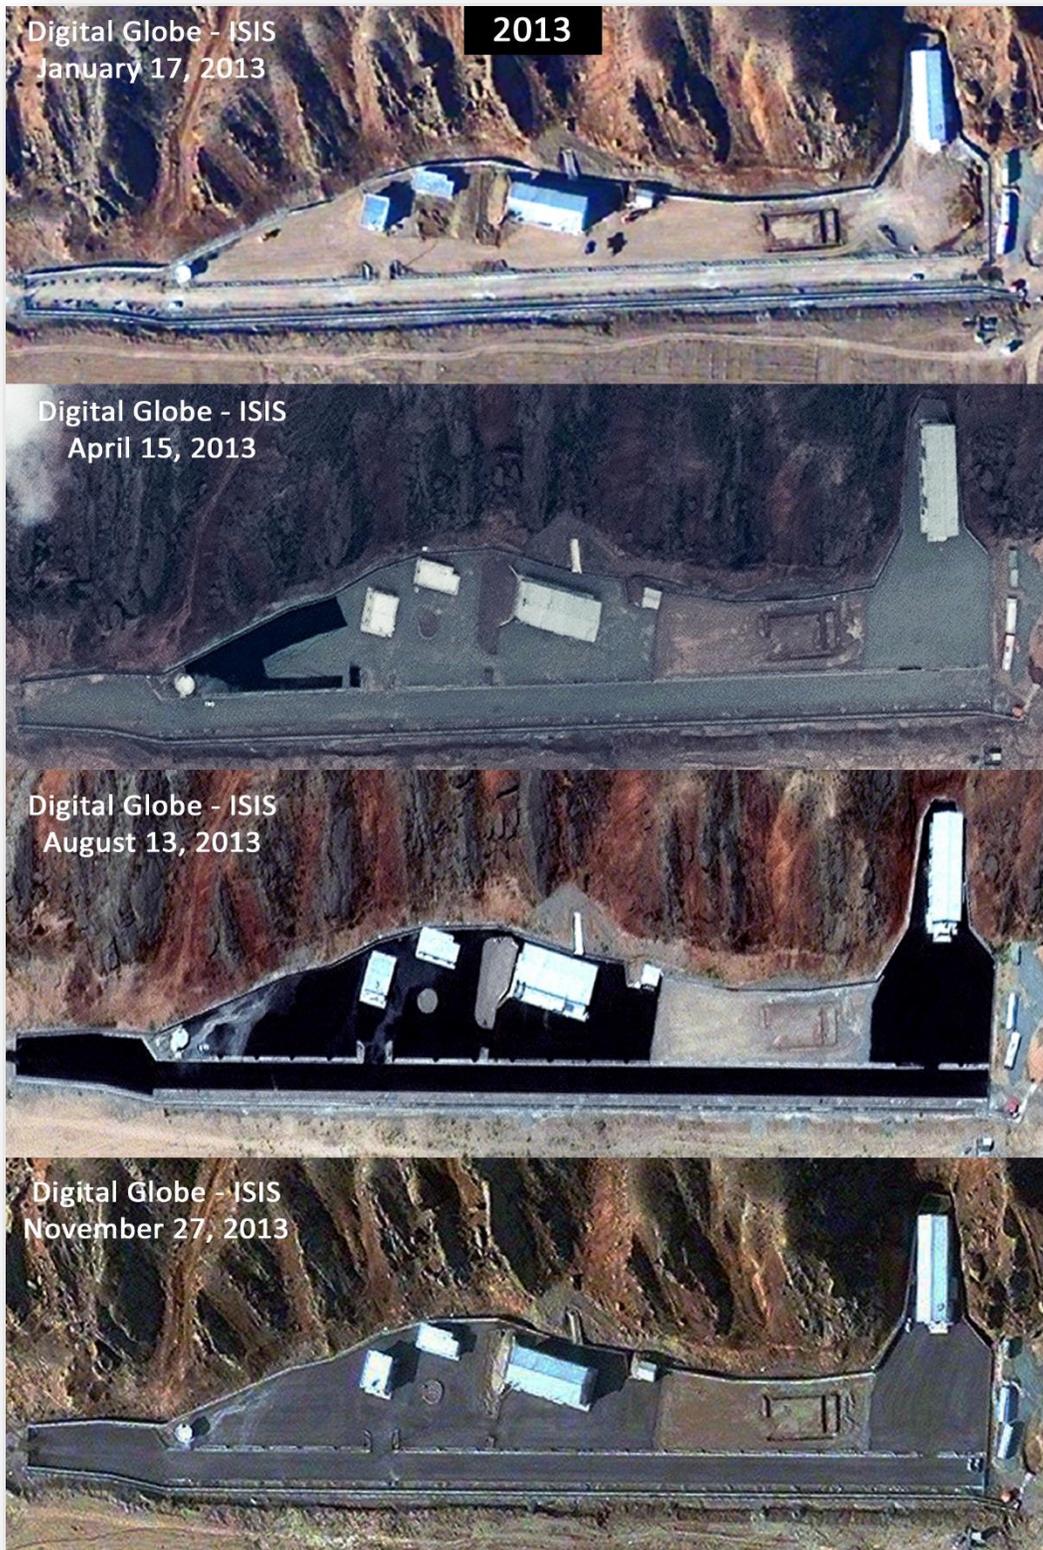
**Figure 3.** Digital Globe high resolution satellite imagery showing changes at the alleged high explosive test site at the Parchin military complex between January 2013 and November 2013.

By January 2013, several earlier activities had been completed, and by August 2013 Iran had asphalted large sections of the site (see figure 3). As noted in several of the IAEA's quarterly Iran safeguards reports, asphaltting and the other documented activities have significantly changed the site and impacted the ability of IAEA inspectors to collect environmental samples and other evidence that it could use to determine whether nuclear weapons-related activities once took place there.

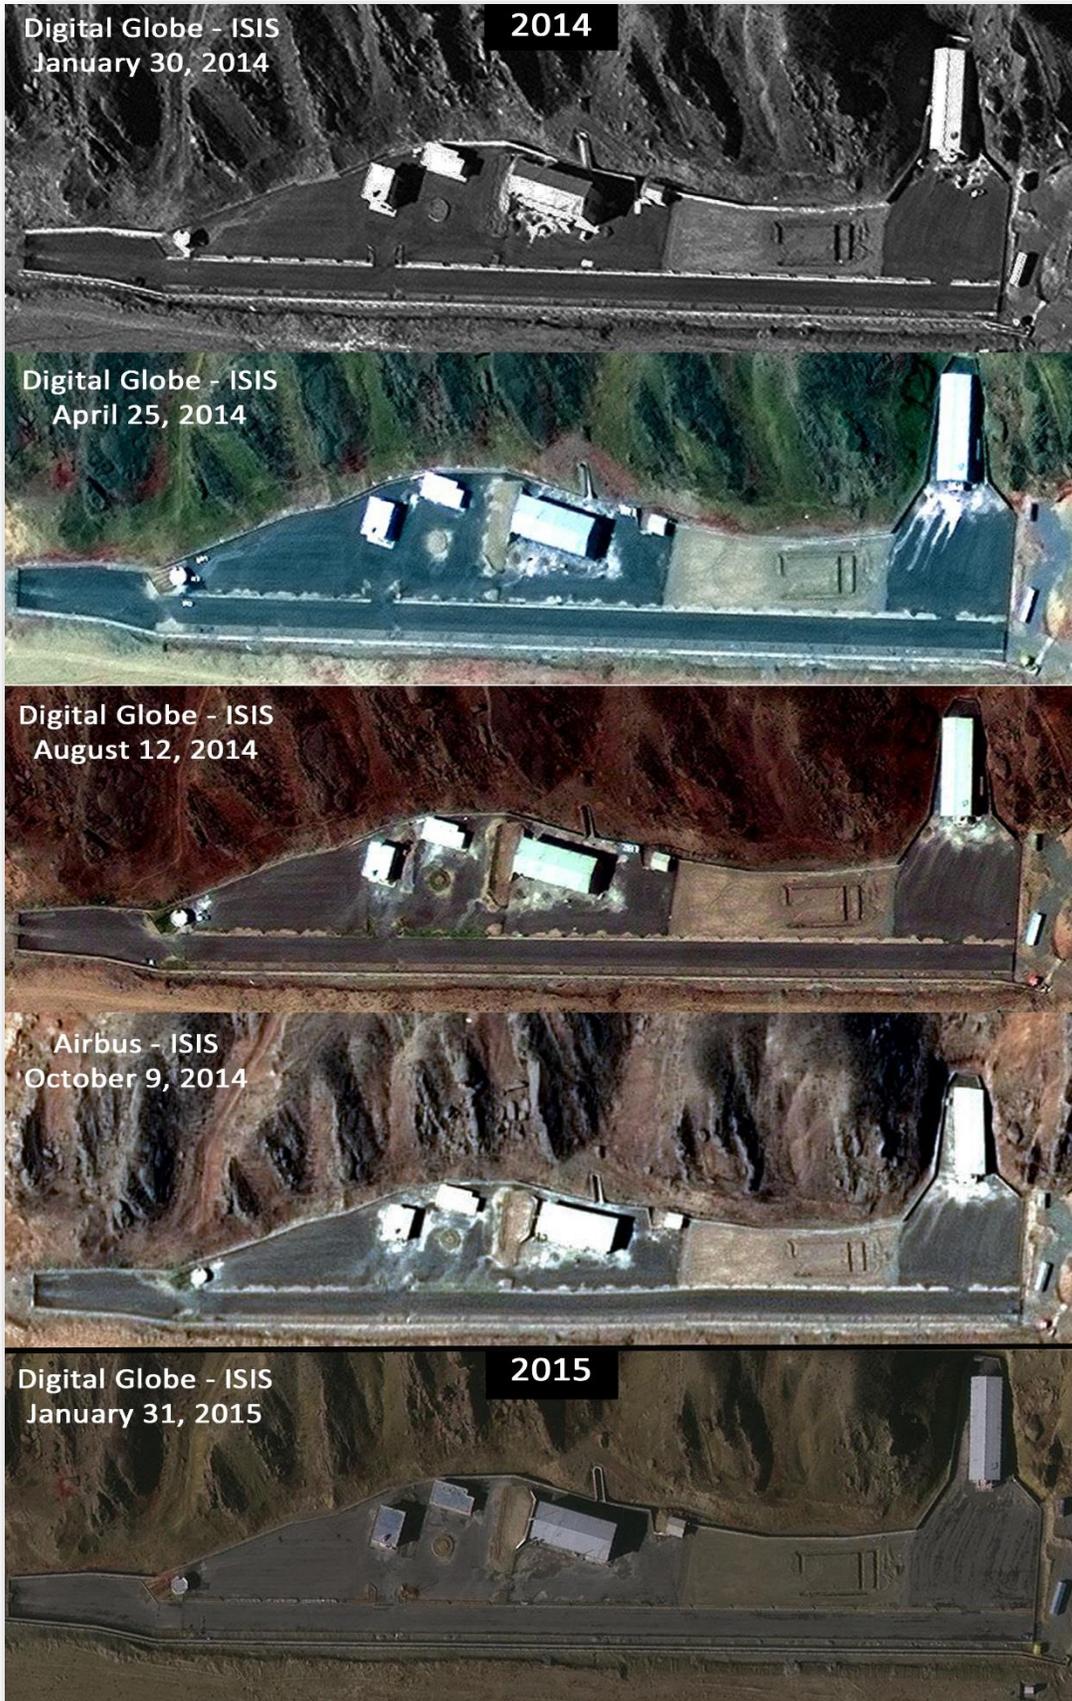
**Figure 4.** Digital Globe/Airbus high resolution satellite imagery showing changes at the alleged high explosive test site at the Parchin military complex between January 2014 and January 2015.

In the latter part of 2013, commercial satellite imagery showed no significant visible alterations. However, activity commenced again in early 2014 (see figure 4). In January 2014, commercial satellite [imagery](#) confirmed the presence of building material and debris at the site, as reported by the IAEA.<sup>5</sup>

April 2014 [imagery](#) showed several signs of external activity at the site. The imagery showed building material and debris in front of the two main buildings, the movement of two trucks or containers, the appearance of a larger object, possibly a truck or large container, north of the main building, and dirt or water runoff in front of the northern building.

This activity continued into [August 2014](#), when satellite imagery showed that although new construction material or debris, as well as new dirt or water runoff, appeared in front of the three buildings in the southern part of the site, the dirt or water runoff and some of the possible construction material that previously appeared in front of the northern building was no longer visible. In October 2014, much of the construction material/debris and the dirt/water runoff was still visible at the site, although no other significant changes were visible.
