Parchin: A Pre-Comprehensive Agreement Update

By David Albright and Serena Kelleher-Vergantini

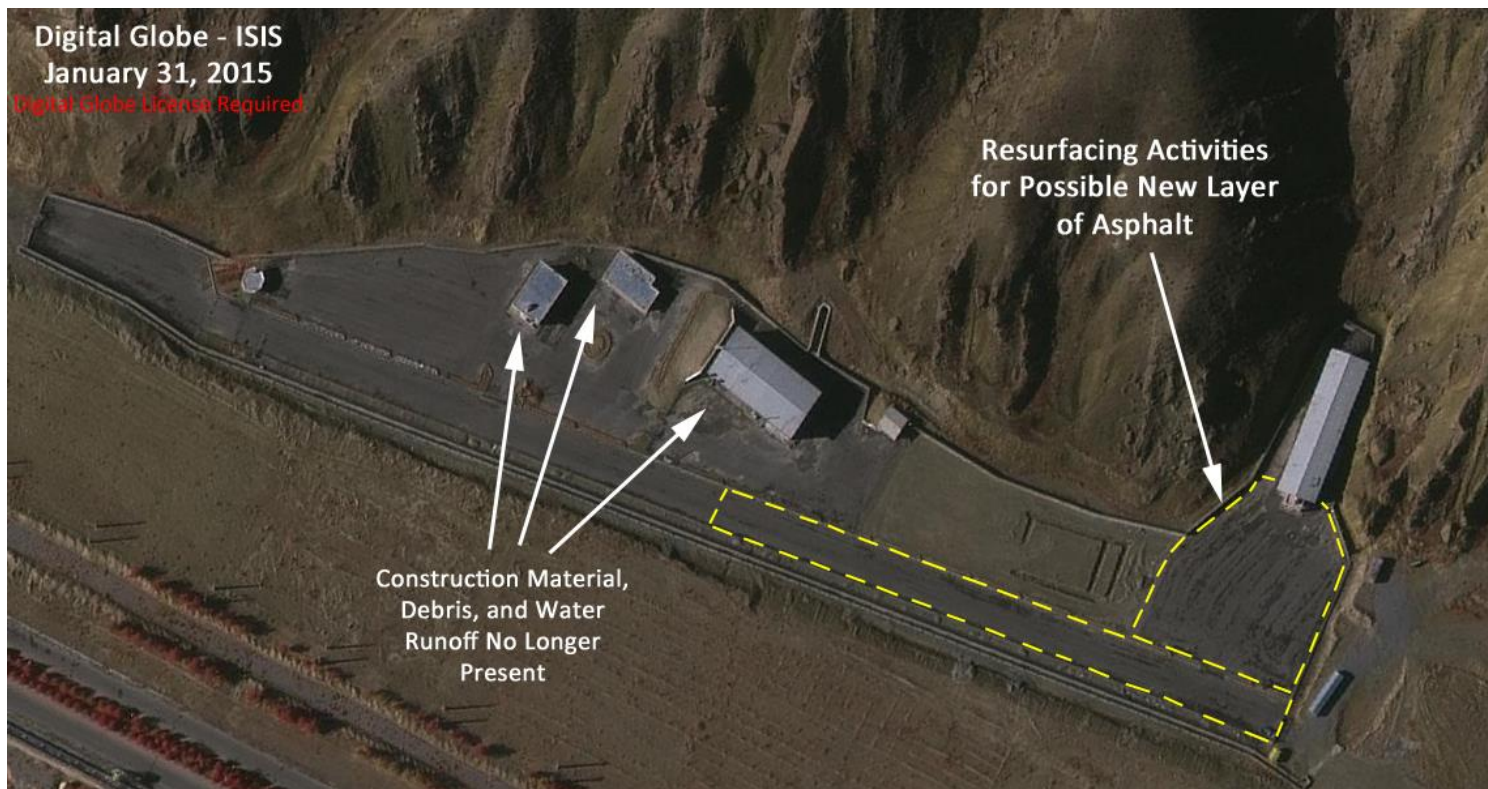
¹ Why this debris is not visible in January 2015 image is unknown. It is possible that the pavement had been altered as a result of resurfacing activities. Several signatures in the January image suggest that Iran was sealing chips and cracks in the asphalt.

Figure 2. DigitalGlobe imagery showing the status of the alleged high explosive test site at the Parchin military complex on January 31, 2015. This is a color infrared image in which healthy vegetation appears red.

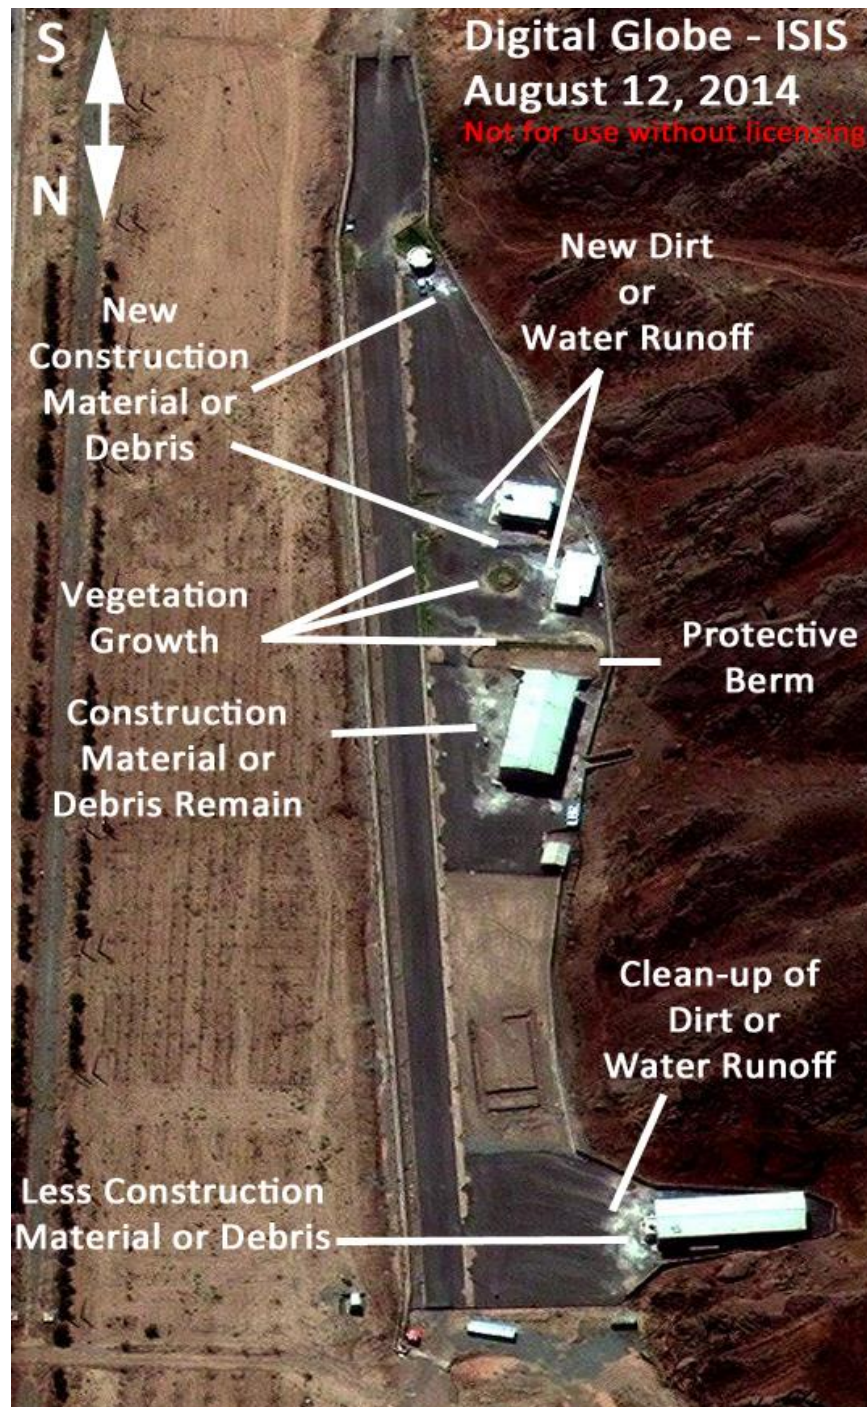
This type of debris has been visible in earlier images (see figures 3, 4, and 5). In May 2014, the IAEA reported that satellite imagery showed construction activity related to the removal/replacement or refurbishment of the site's two main buildings' external wall structures."² The April 25, 2015 image (figure 4) taken just before the May 2014 IAEA finding shows debris similar to that in the most recent image. Similarly, the debris in the most recent image may be related to refurbishment of the external parts of the buildings or the subsequent clean-up.

Figure 3. DigitalGlobe imagery shows the status of the alleged high explosive test site at the Parchin military complex on August 12, 2014.

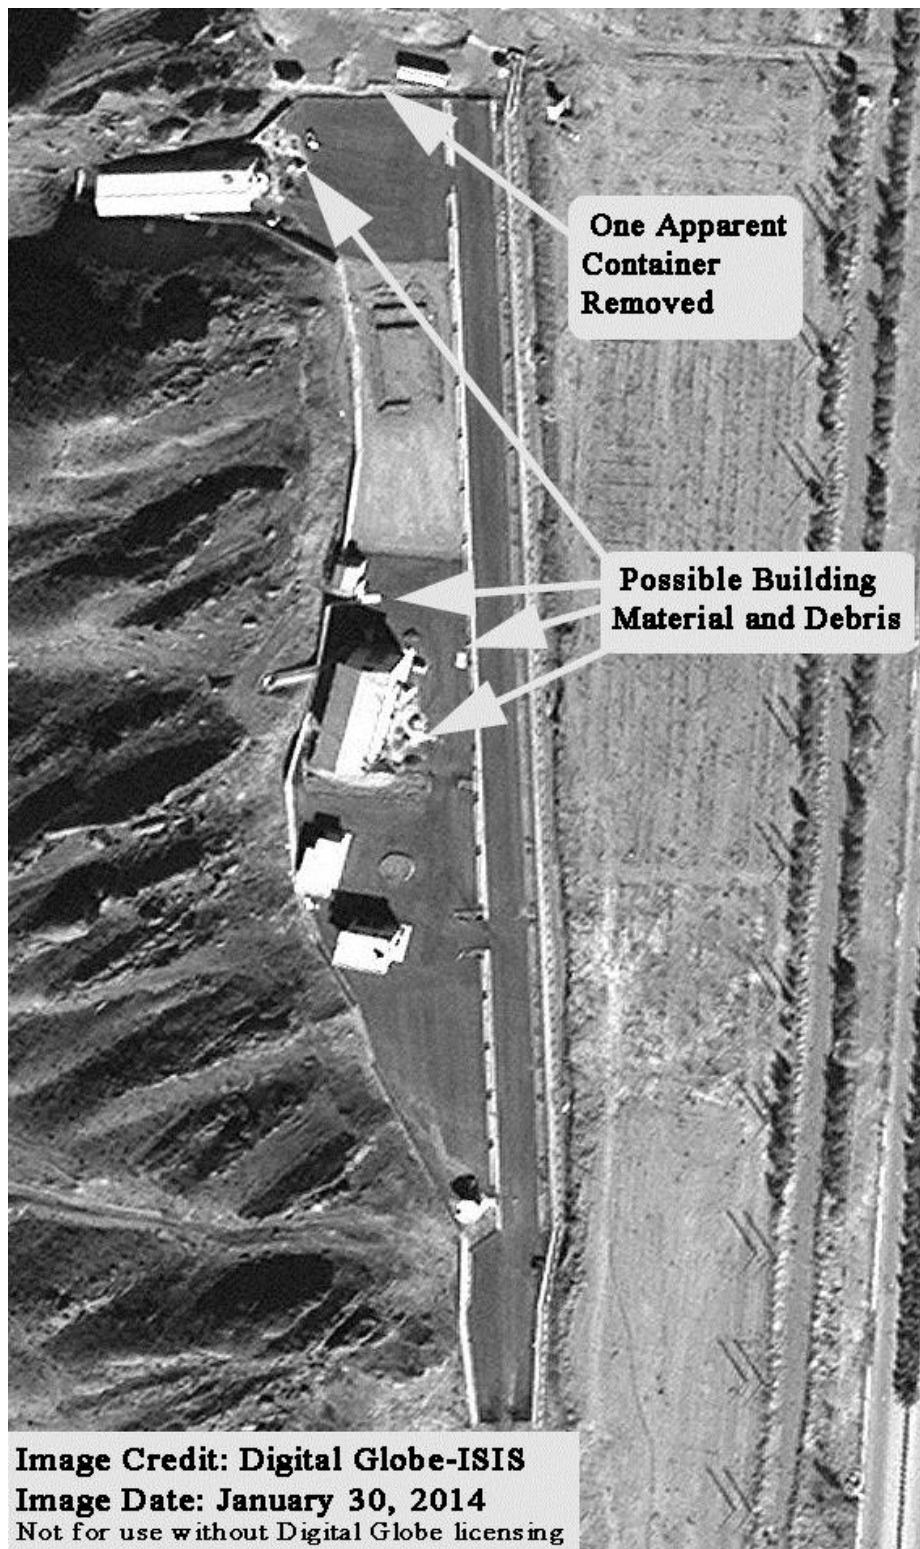
Figure 5. DigitalGlobe imagery shows the status of the alleged high explosive test site at the Parchin military complex on January 30, 2014.
