May 30, 2012

Further Activity at Suspected Parchin High Explosive Testing Site: Two Small Buildings Razed

By David Albright and Robert Avagyan

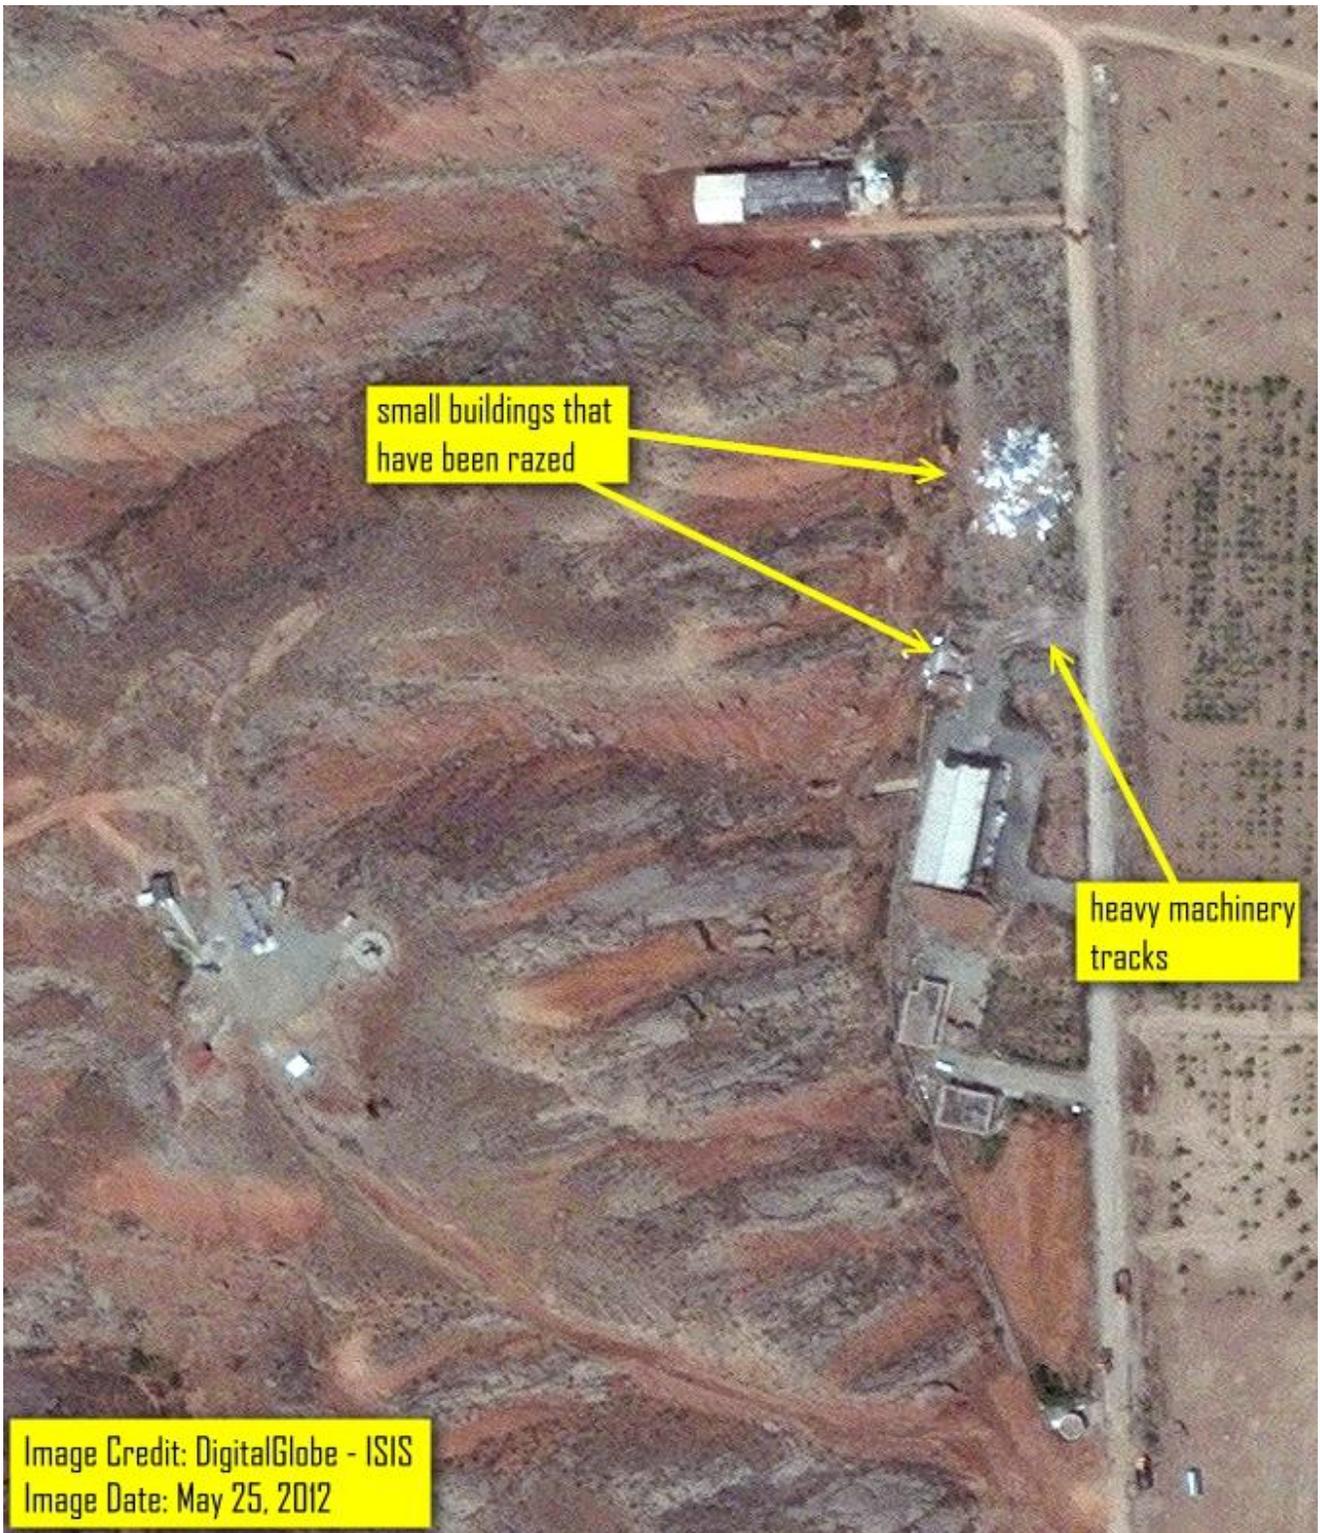
Figure 1. Imagery from May 25, 2012 showing the razing of two small support buildings. It also shows heavy machinery tracks near the site

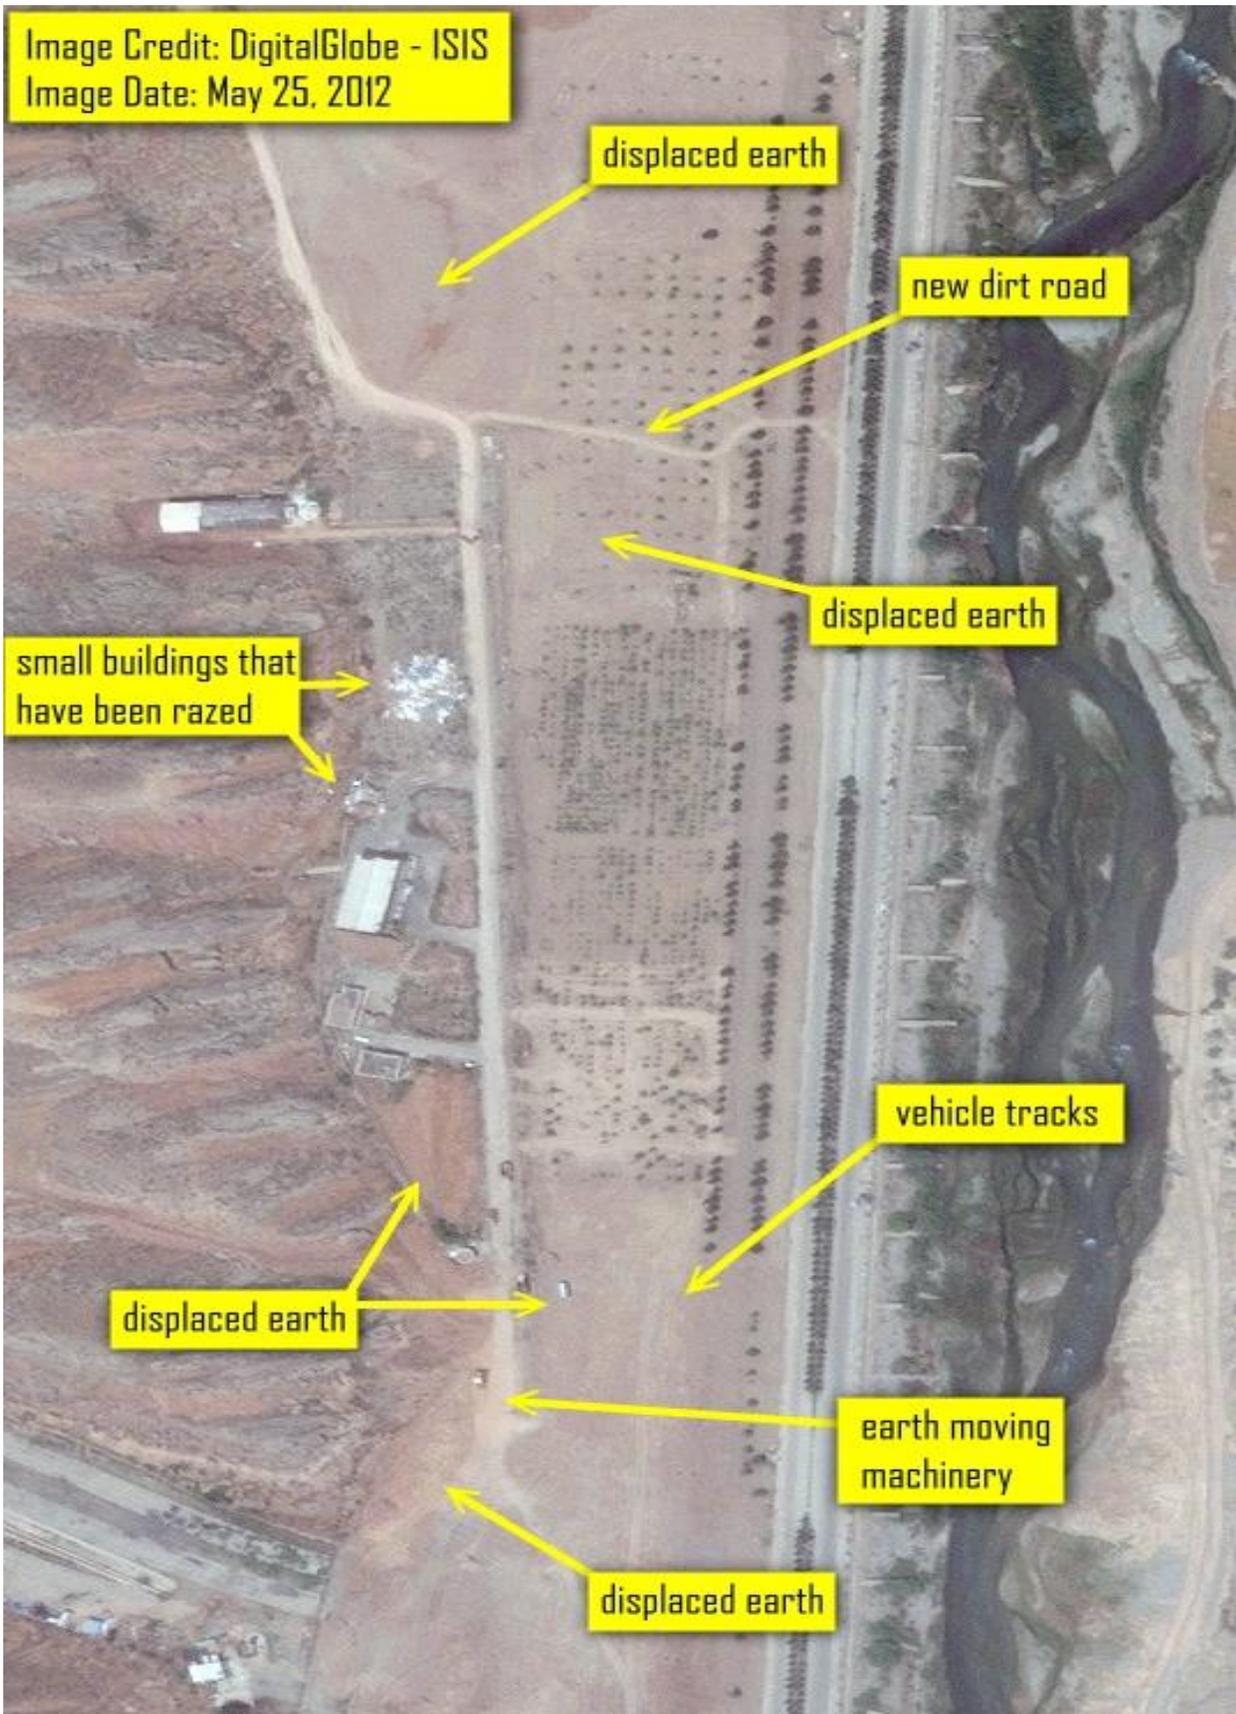
Figure 2. Wide view image of the suspected high explosive testing site showing extensive evidence of earth displacement activity.

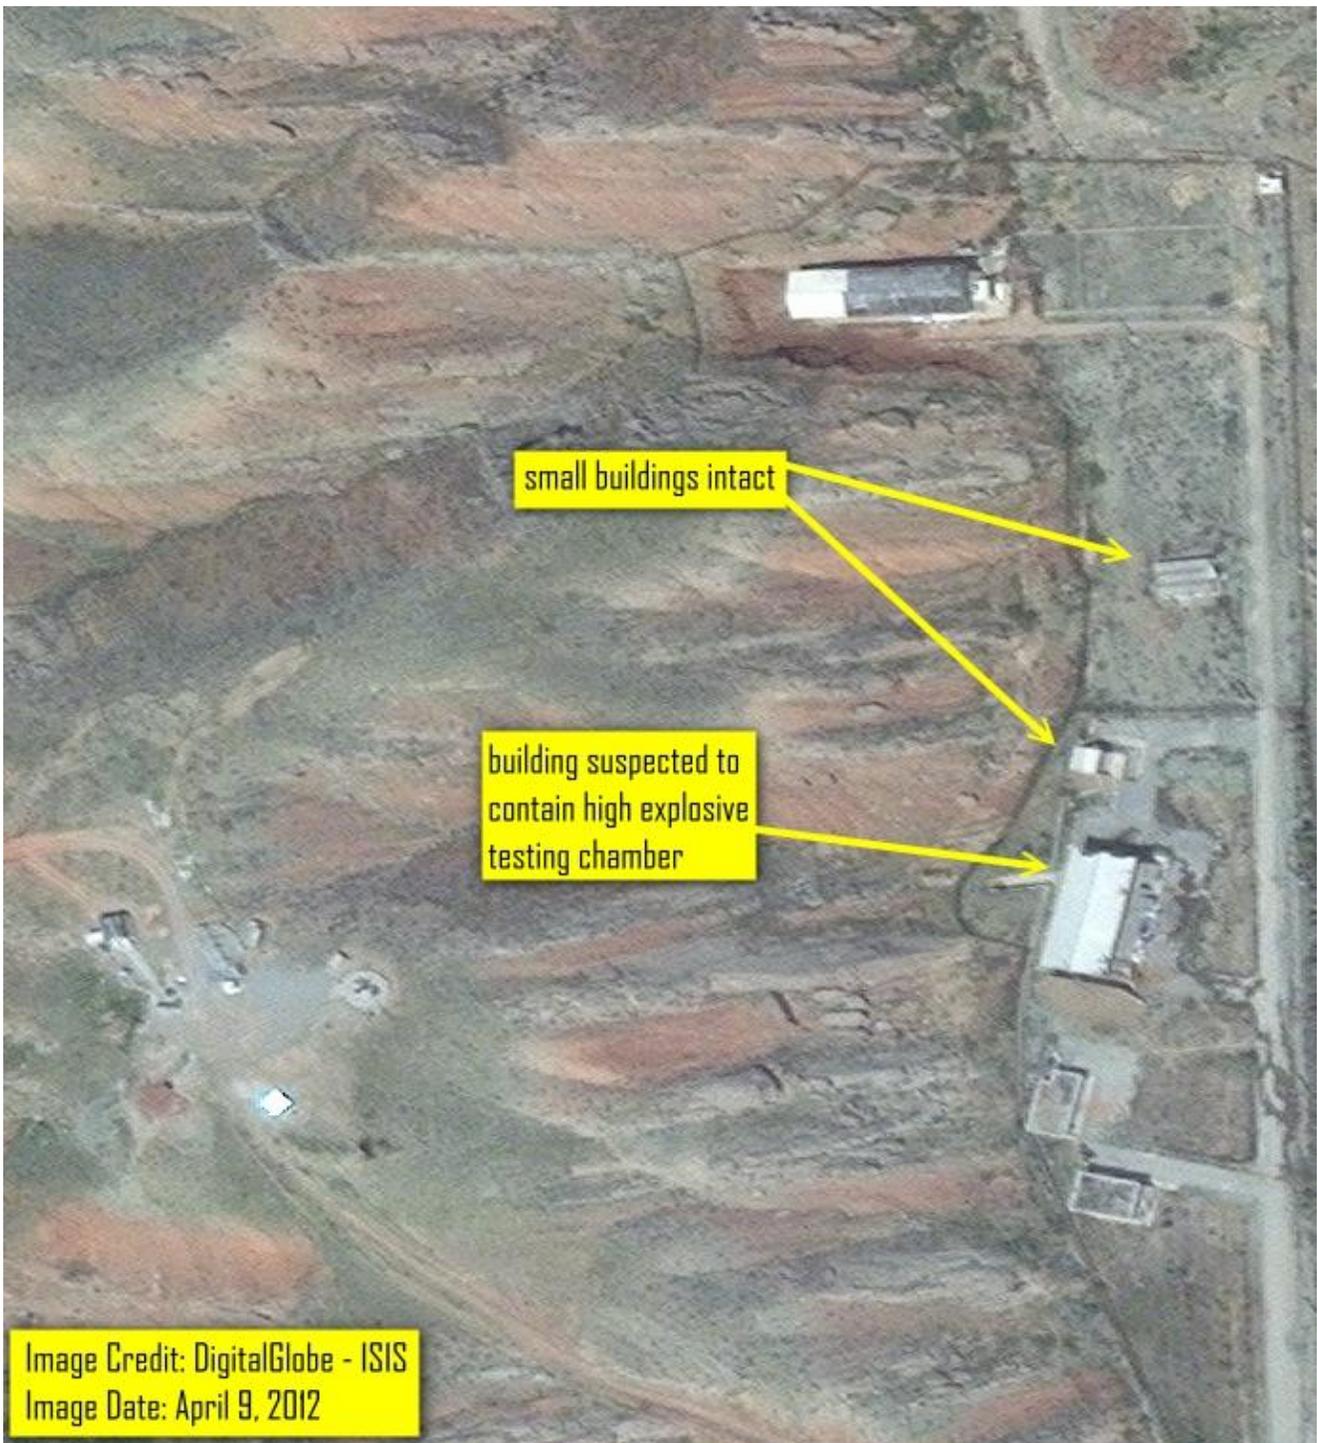
Figure 3. Imagery from April 9, 2012 showing the two small buildings intact near what is suspected to be the high explosives testing building.

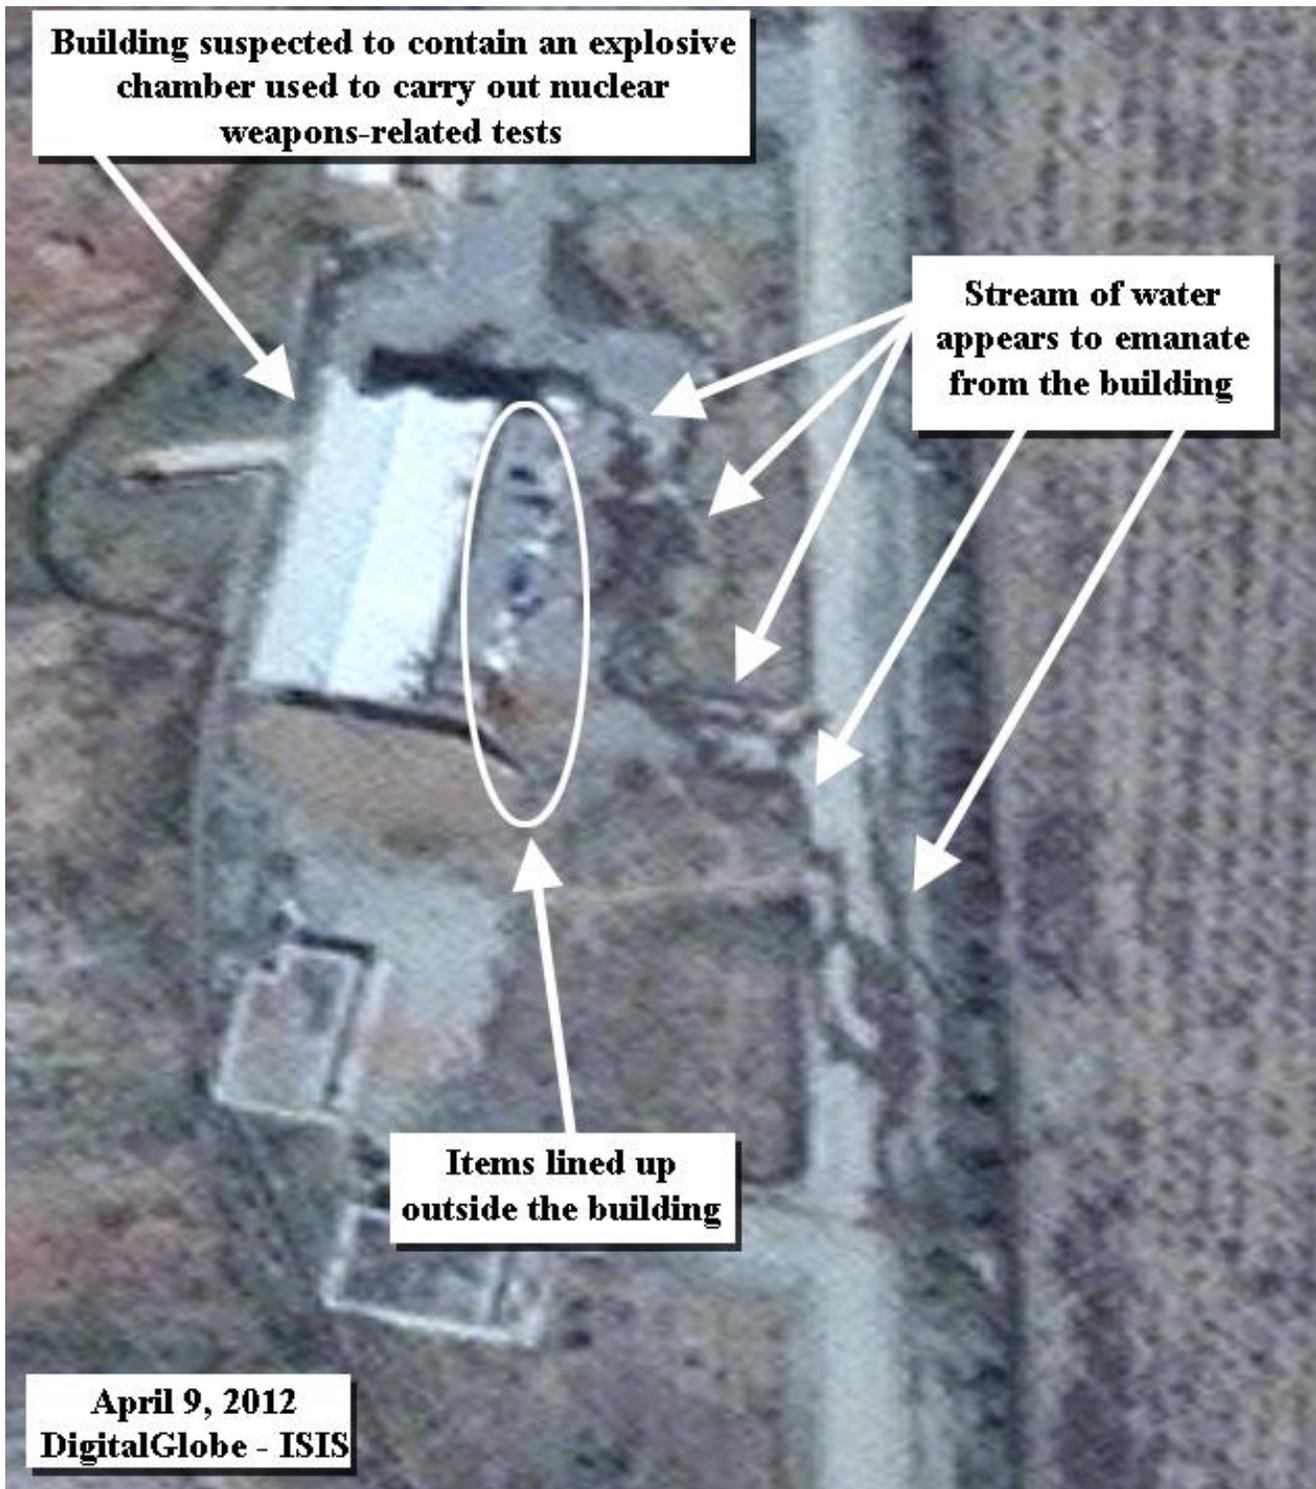
Figure 4. Imagery from April 9, 2012 showing suspected cleanup activities at the building alleged to contain the high explosive chamber used for nuclear weapon related tests.

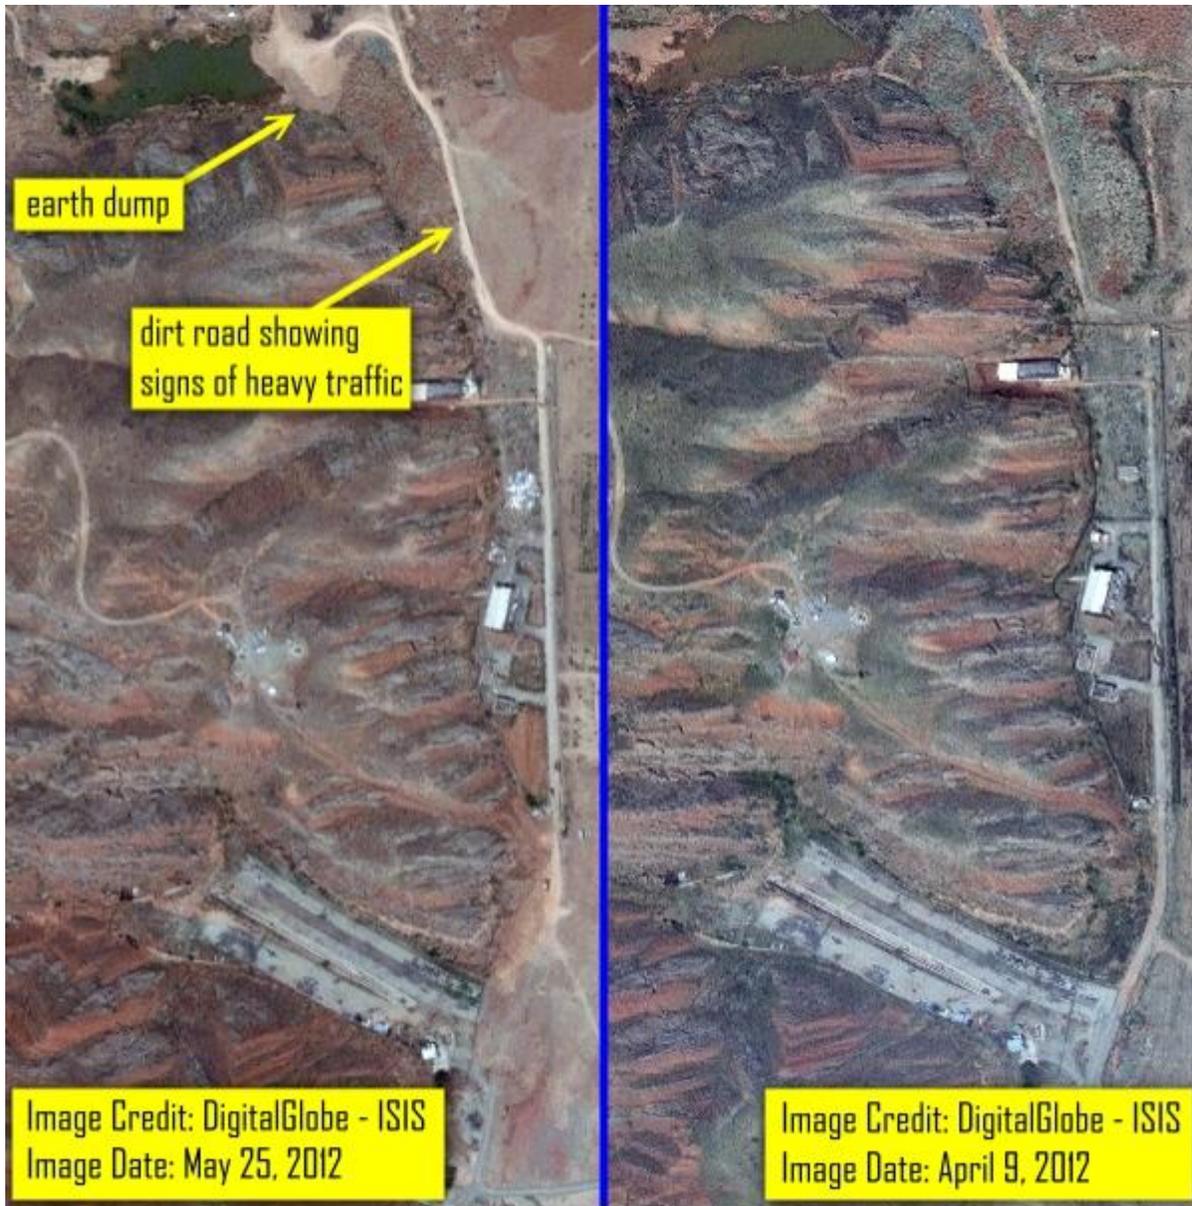
Figure 5. Evidence of extensive earth dumping in the pond to the north of the Parchin high explosive test site. Signs of fresh traffic on road leading to pond.
