November 29, 2012

Significant Changes Made to Parchin High Explosives Test Site, Further Activity Likely

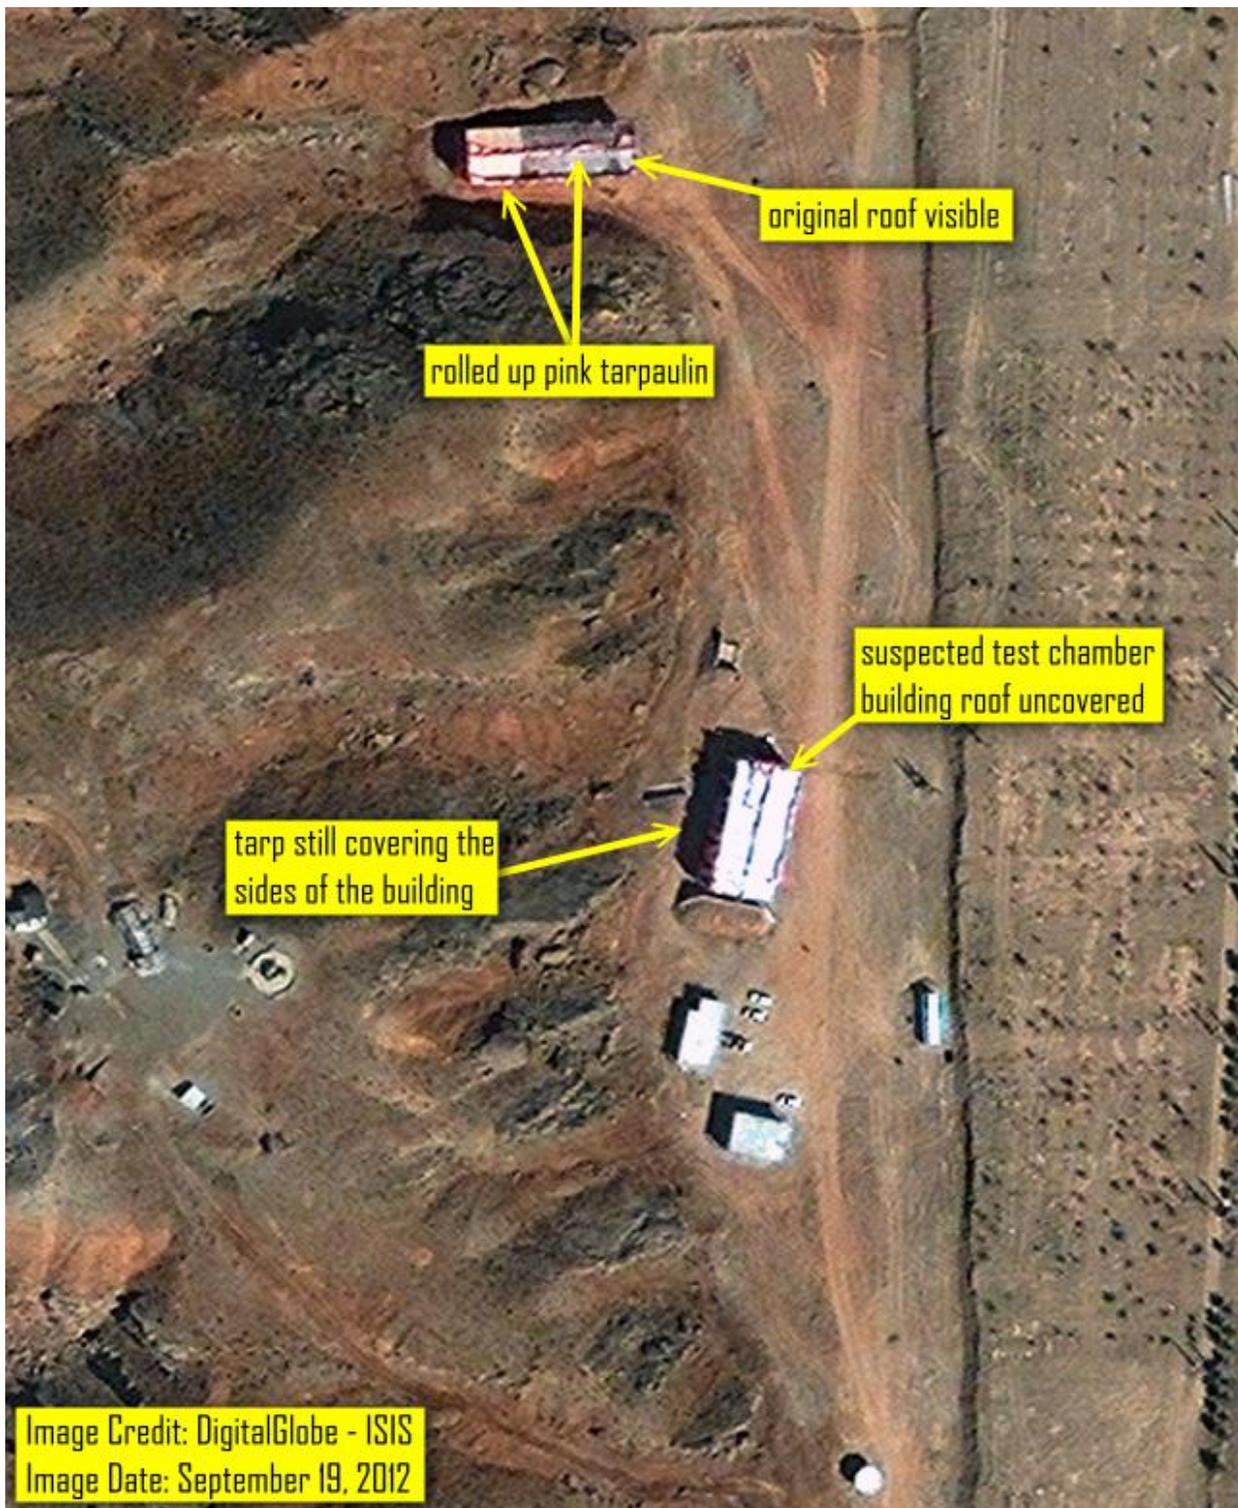
Figure 1: September 19, 2012 imagery showing the pink tarpaulins that previously covered the buildings being rolled back. There are no signs of construction of the terrace/wall or of the dirt piles that appear in later imagery.

The latest commercial satellite imagery dated November 7, 2012 shows a considerable amount of activity has taken place at the alleged Parchin high explosives testing site in Iran linked to the development of nuclear weapons. A previous [ISIS report](#) with imagery from September 19, 2012 showed the ongoing removal of tarpaulins that had covered the two major buildings at the site since early August 2012 (see figure 1).

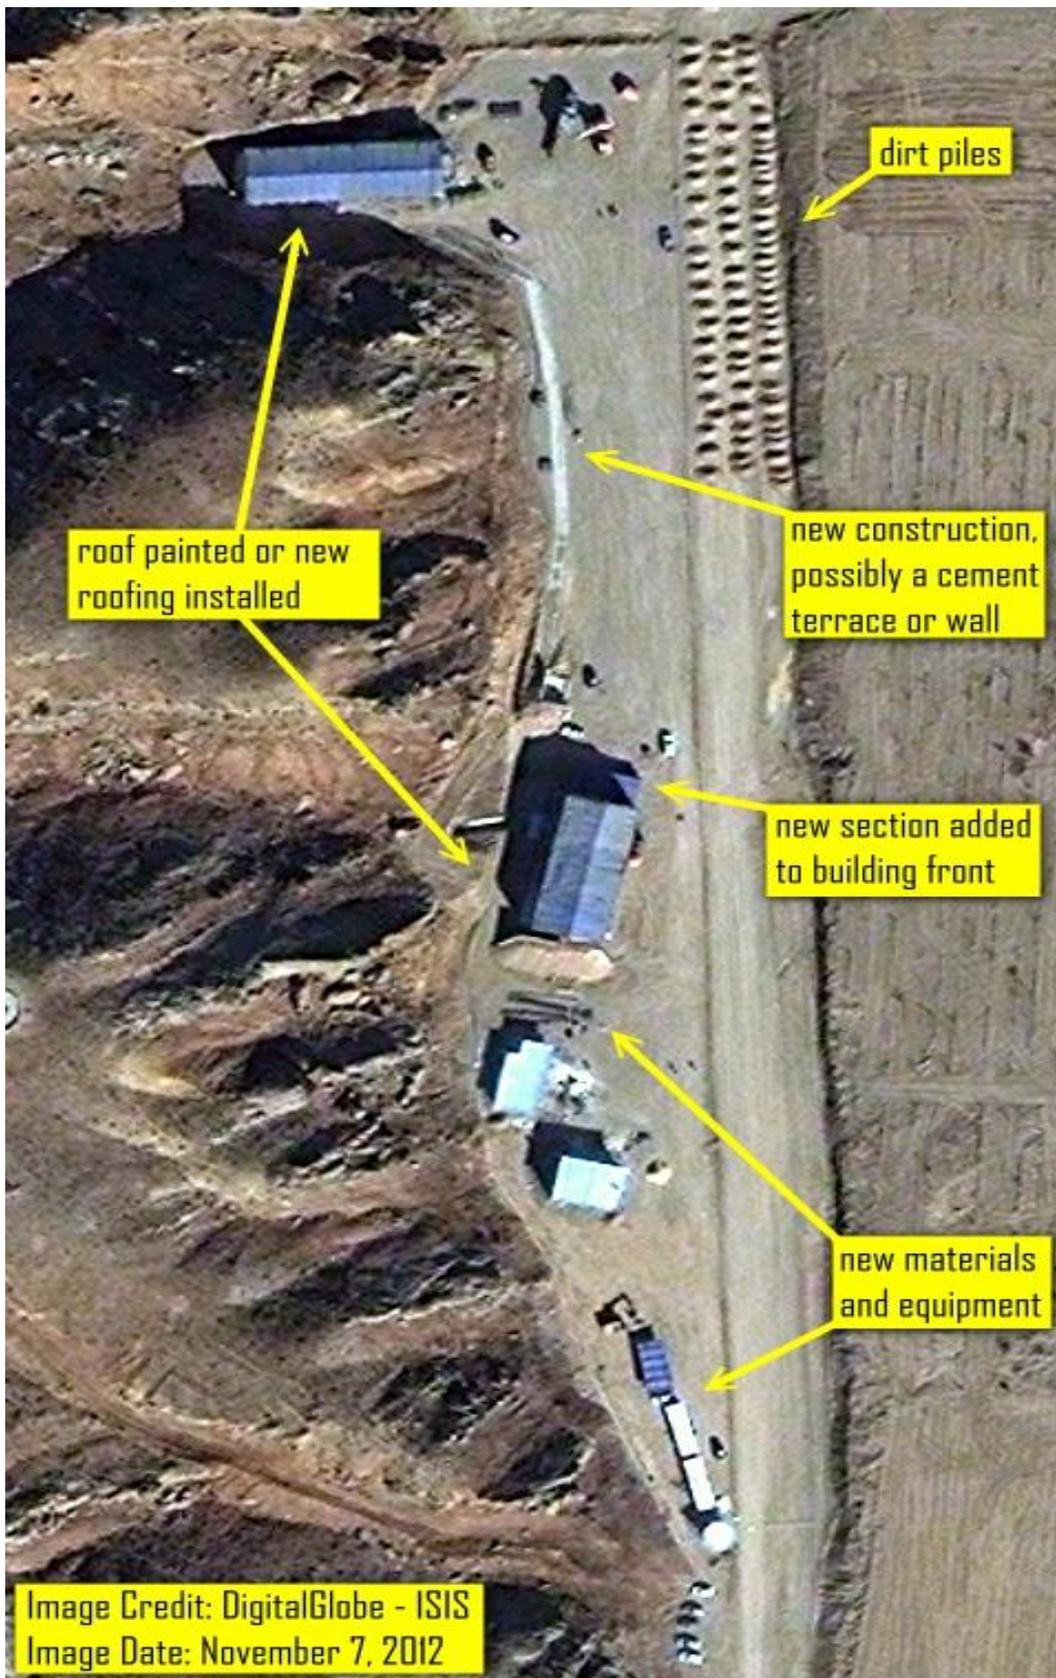
Figure 2: The latest image from DigitalGlobe clearly showing the new blue roofing of the two major buildings, new equipment and materials and the rows of earth piles. Numerous cars present at the site suggest a considerable level of activity at the site.

In the latest November 7, 2012 image the tarpaulins are no longer present. Following the removal of the tarps the roofs of the two buildings previously covered have been repainted with blue paint or there has possibly been completely new roofing installed (the imagery does not allow the determination of whether the sides have also been repainted or replaced). In addition to the new roofing, the building suspected to contain the high explosives test chamber has been extended with the addition of a new section on the front of the building (figure 2). What appears to be a cement wall or terrace has been constructed alongside the perimeter spanning the two major buildings at the site.

The image shows many piles of dirt that were not in the last image (see figure 2). According to [Reuters](#), a diplomat who attended a recent technical briefing for member states on Iran and the Parchin site by the International Atomic Energy Agency (IAEA), said that Iran has "been scraping the earth. Now they obviously want to put down new earth."

The considerable amount of new materials, equipment, and rows of earth piles suggest that further construction will be taking place thus increasing the level of alteration and further degrading the chance of obtaining reliable environmental samples if and when IAEA inspectors gain access to the site.
