Strikes on Russia's Shahed Launch Capabilities

July 9, 2024

By David Albright, Sarah Burkhard, Dr. Igor Anokhin, and the Good ISIS Team

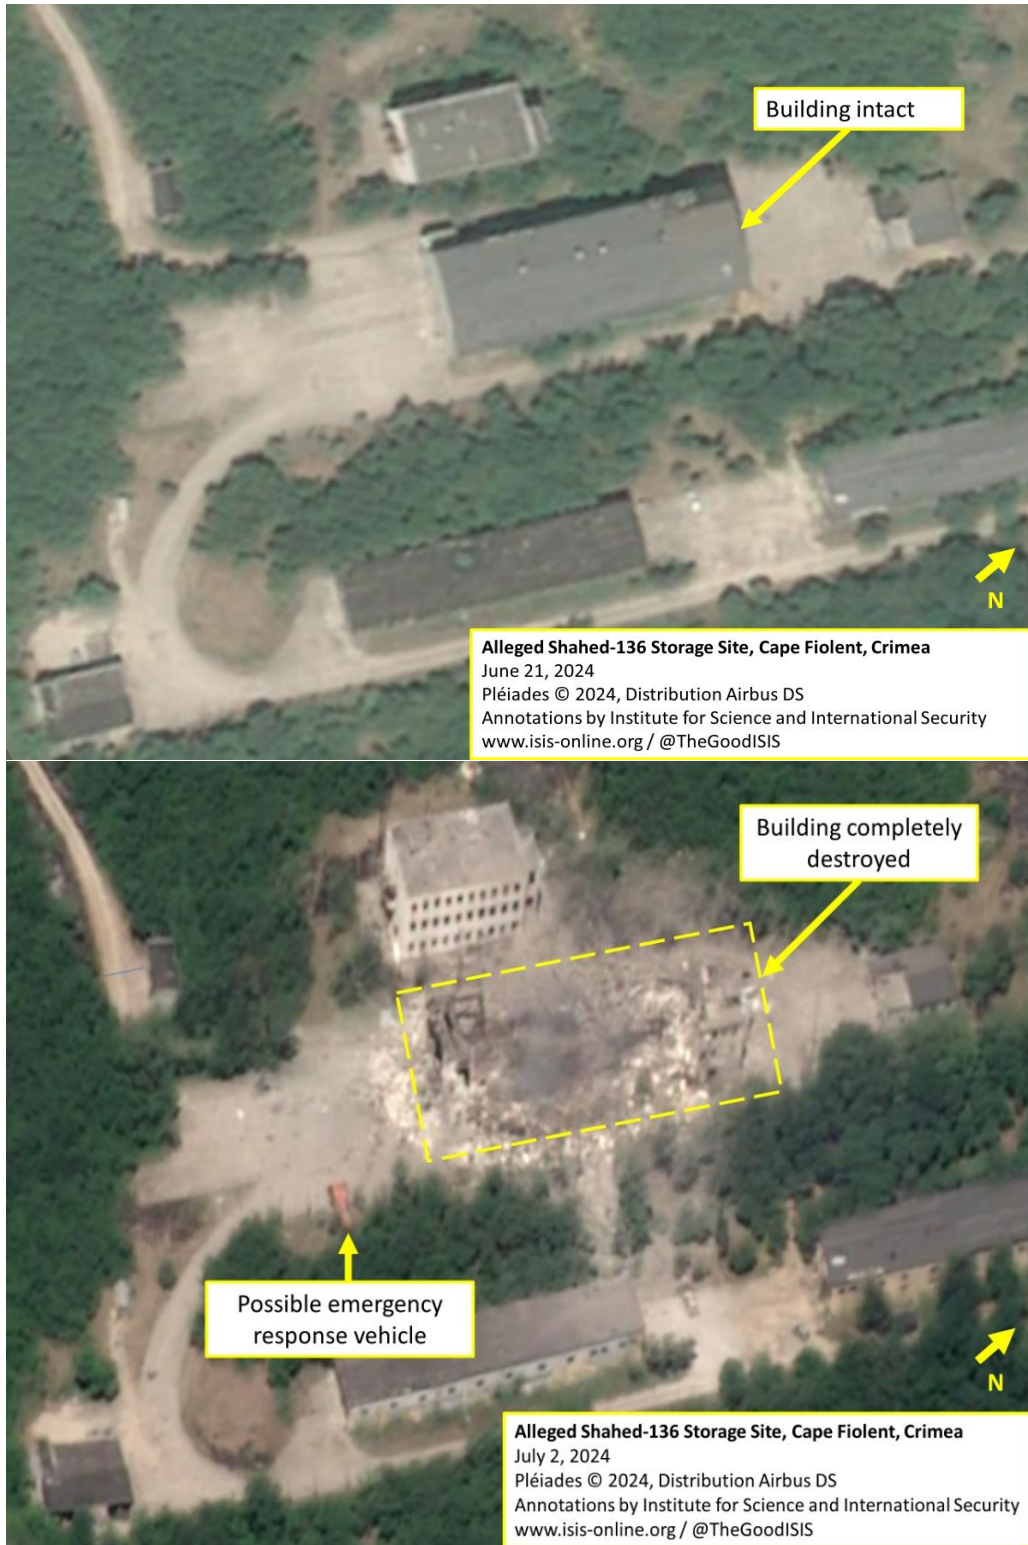
Figure 1. Top: An Airbus Pleiades image predating the attack on the alleged Shahed-136 storage site. Bottom: Shortly after the reported attack, one of the main buildings at the site is completely destroyed. 44°30'24.93"N, 33°32'25.07"E.

Figure 1 shows pre- and post-attack images of the site at Cape Fiolent. One of the buildings has completely collapsed. Of note, NASA satellites did not pick up any fire in the area in that week (see Figure 2). Reportedly, the strike was carried out using an aircraft-launched missile,⁵ and the site was also known as abandoned military base #99375, which previously belonged to the USSR Navy.⁶

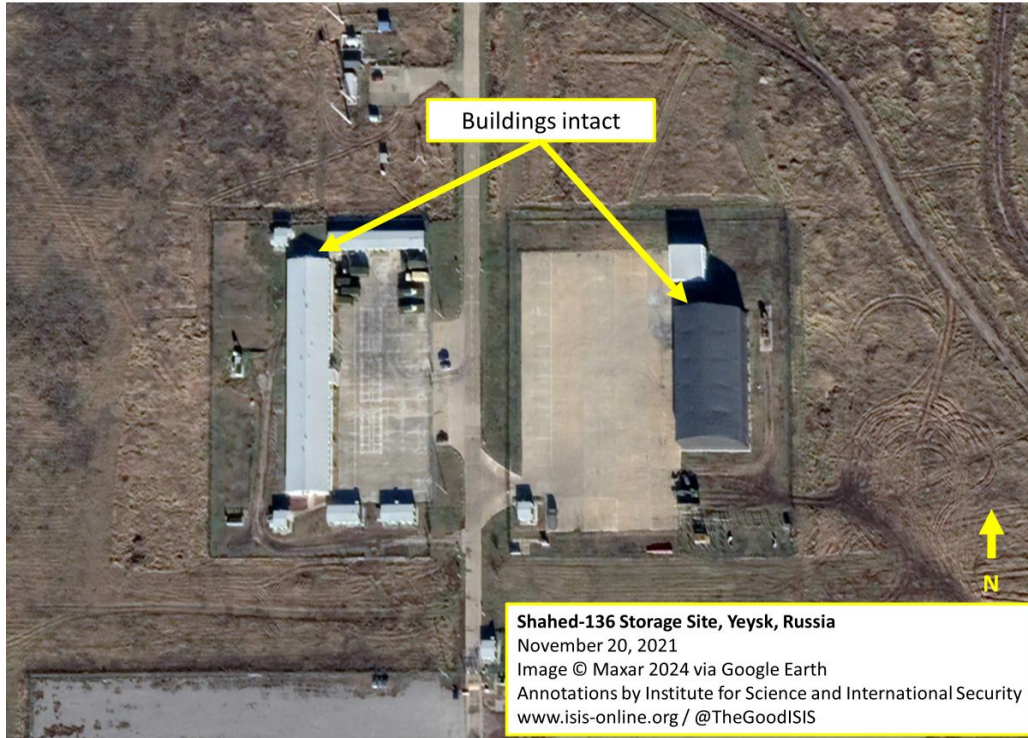
Figure 3. Top: A Google Earth image predating the attack on the Shahed-136 storage and launch preparation site. Bottom: Both main buildings at the site show damage. The building to the east especially shows significant damage from explosions and fire, with a large radius of fallen debris and an inside that is burned out. 46°40'34.48"N, 38° 7'49.75"E.

Figure 3 shows pre- and post-attack images of the Shahed storage and launch preparation site in Yeysk, Russia. The image shows that the two buildings identified by the Ukrainian Navy sustained significant damage from explosions and fire. In line with this, the NASA FIRMS database reported a fire at the specific coordinates of the site (see Figure 4.) Reportedly, at least one of the strikes was carried out by drones.⁷ According to other reports, Ukrainian Neptune missiles could have been used.⁸

The different damage signatures could be indicative of the different types of strikes, or different contents of the buildings, where a large explosion and fire is more consistent with Shahed drones that are fueled up and armed with a warhead, ready for launch.

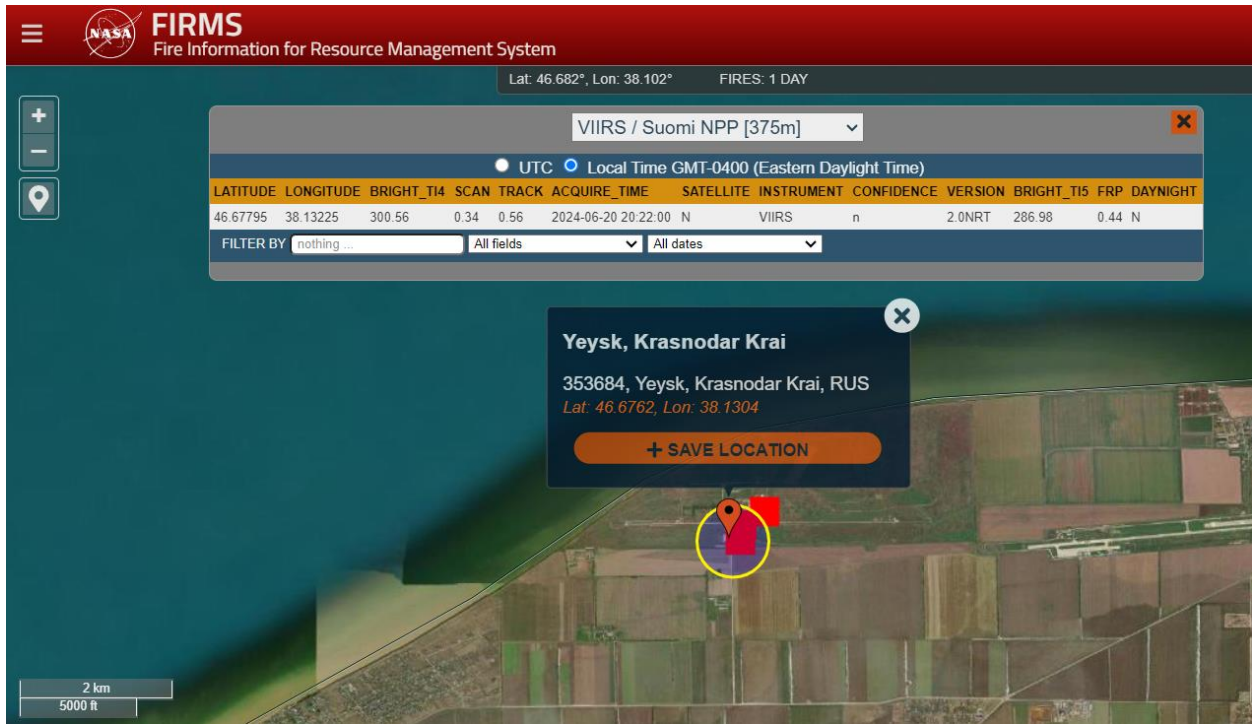
Figure 4. Consistent with the visible damage from fire, the NASA FIRMS database picked up significant fire at that site the night of the attack. The site shows significant damage from explosions and fire.
