September 2016: Monitoring Activities at the Yongbyon Nuclear Site

By David Albright, Sarah Burkhard, Allison Lach, and Samta Savla

September 20, 2016 (Rev.1)

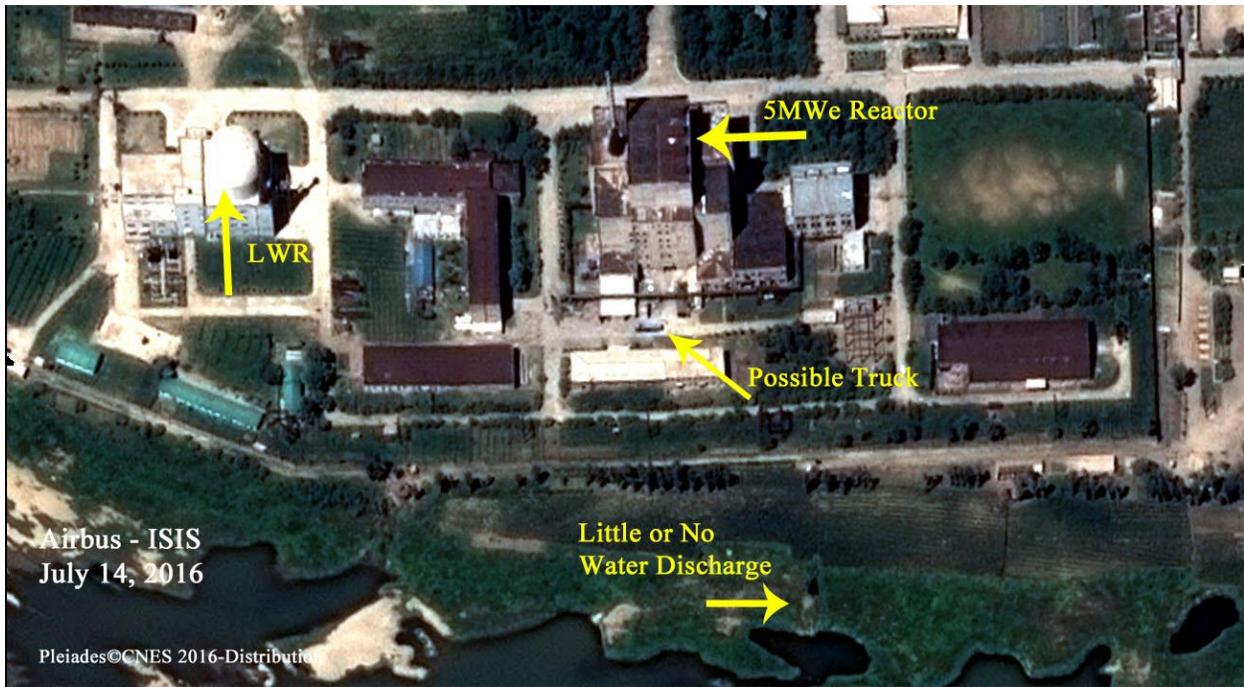
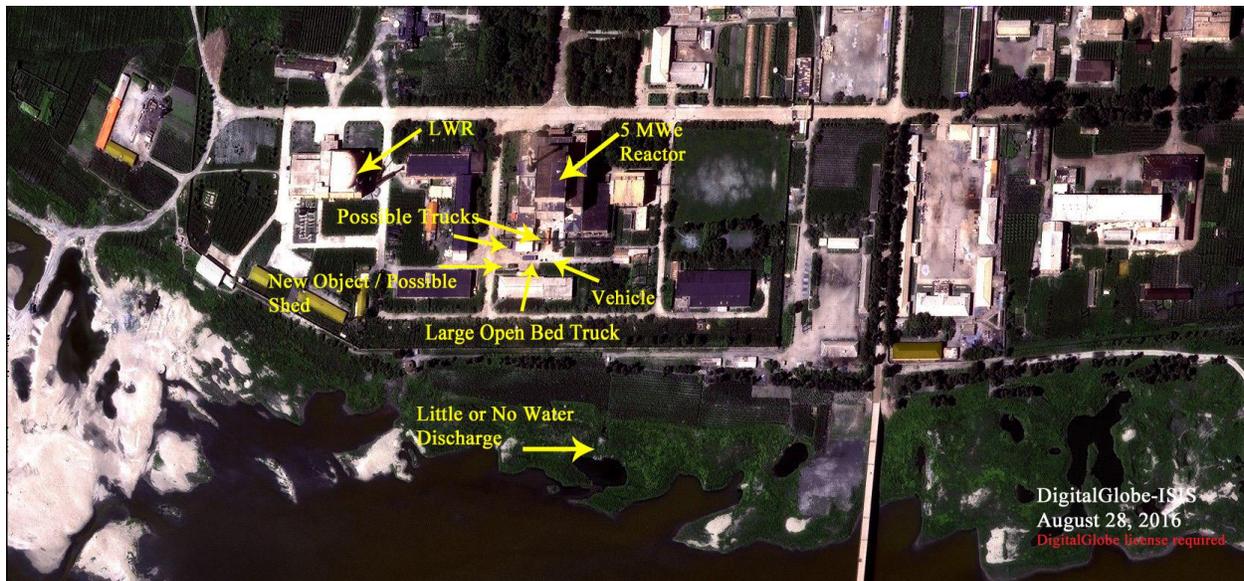
Figure 1: Commercial satellite imagery showing North Korea’s 5 megawatt-electric reactor and Experimental LWR on July 14, 2016 and August 28, 2016.

The 5 megawatt-electric (MWe) reactor is the site where North Korea produces plutonium in natural uranium fuel. DigitalGlobe commercial satellite imagery dated August 26, 2016 showed no outward signs of full power, such as extensive water discharge into the nearby river or steam venting from the reactor's turbine structure (see figure 1). An Airbus commercial image dated July 14, 2016 also shows no water or steam discharge (Also figure 1).

The August 28 image depicts vehicles, including what appears to be a flatbed truck, at the building's entrance as well as additional, unidentifiable new objects. Although this implies activity at the reactor site, the nature of the activity is unknown. The flatbed truck that is present at the building's entrance appears to be the same truck previously identified in a May

22, 2016 image and possibly the July 14, 2016 image. This suggests this vehicle is regularly used or scheduled for use; however, its purpose is unknown.

The Experimental Light Water Reactor (LWR) is still under construction, although North Korea announced that the reactor would be finished several years ago. In the recent July and August imagery, there does not appear to be any external activity taking place (see figure 1). The lack of any activity is consistent with the August report of the IAEA. According to the IAEA report: "The construction of what appears to be an electrical switchyard adjacent to the LWR was completed in December 2015. The Agency has not observed indications of the delivery or introduction of major reactor components into the reactor containment building." When this reactor may start remains a mystery. In addition, although North Korea has stated that the reactor would concentrate of producing electricity, another question is whether it will also make plutonium for nuclear weapons. Given the age and size of the 5 MWe reactor and the importance of plutonium for making nuclear weapons, North Korea would have a strong incentive to finish the reactor and produce weapon-grade plutonium in it.

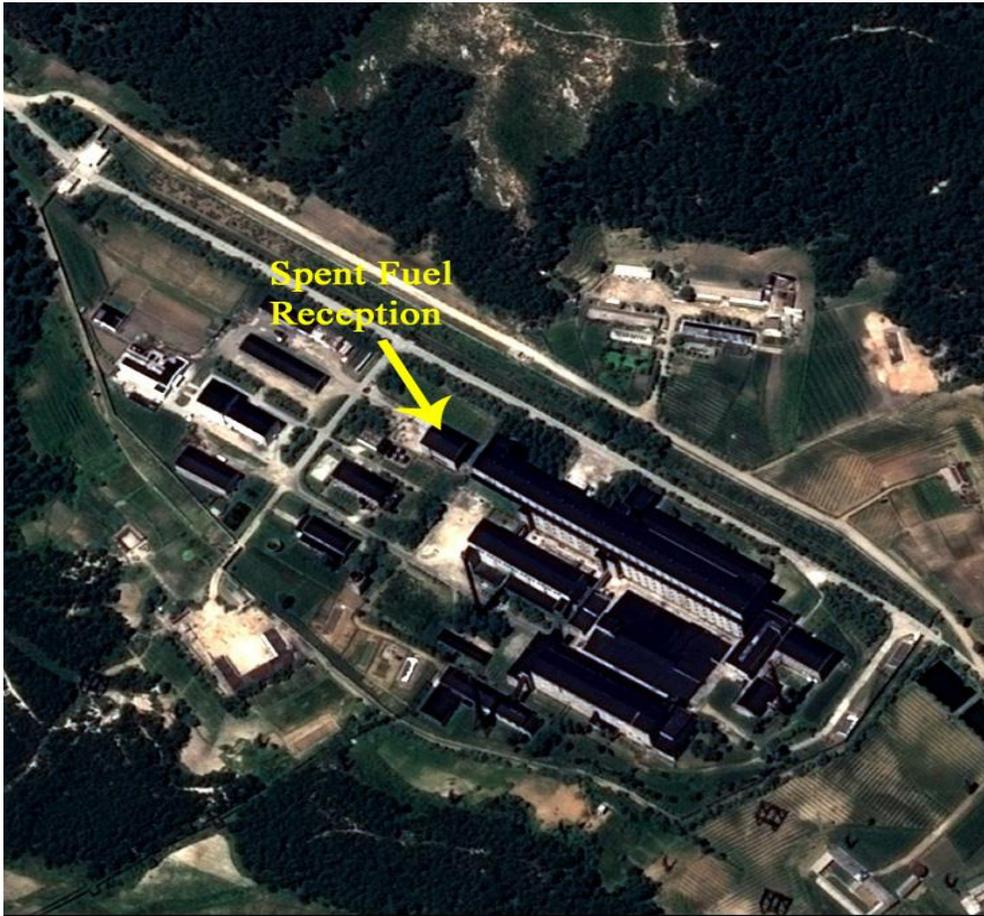
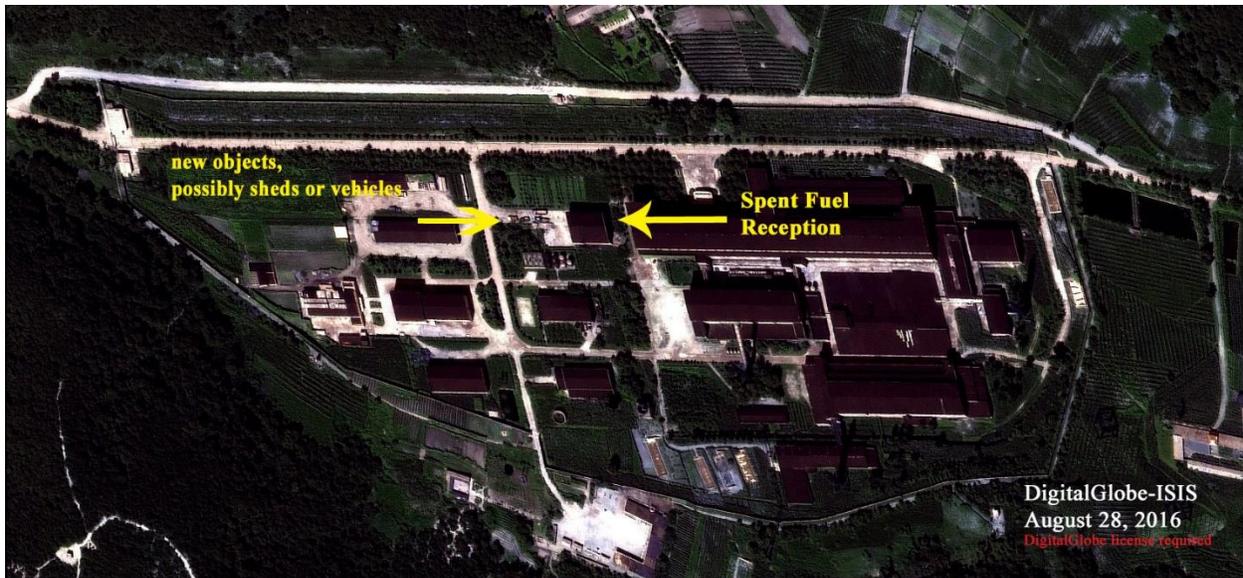
Figure 2: Commercial satellite imagery showing North Korea's Radiochemical Laboratory on July 14, 2016 and August 28, 2016.

The July 14 and August 28, 2016 imagery shows little activity at the Radiochemical Laboratory, including no smoke being emitted at the coal fired steam plant (see figures 2 and 3). As of August 28, there are only a few new objects, most likely vehicles and possibly sheds, in proximity to the spent fuel reception building (see figure 2). In addition, there is no obvious work around the nuclear-waste-related building 500, where earlier, trench work was being done next to the building (figure 4).

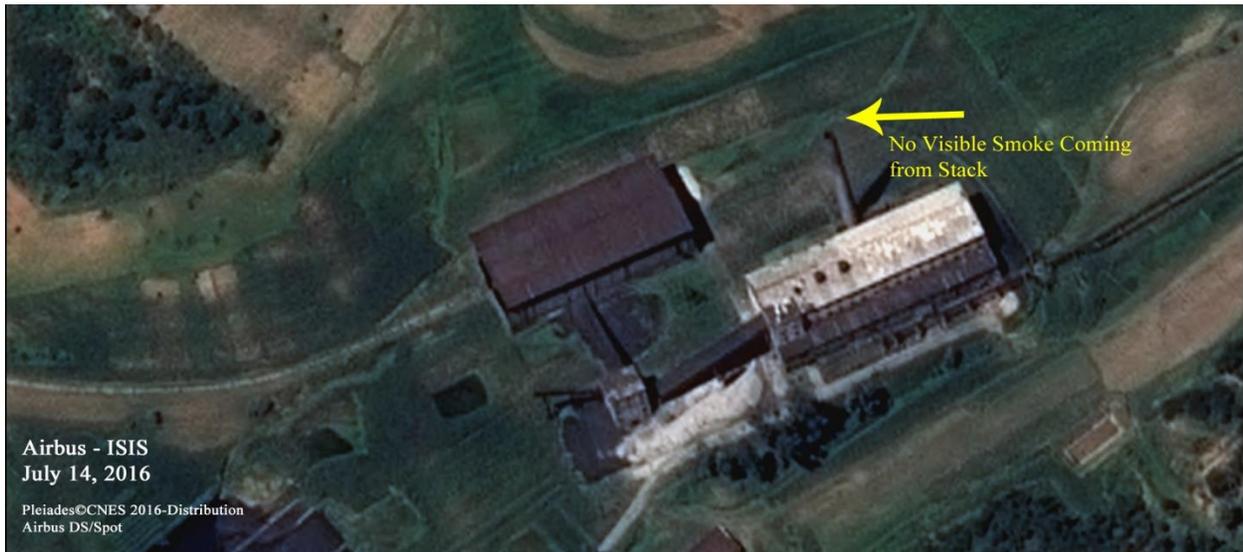
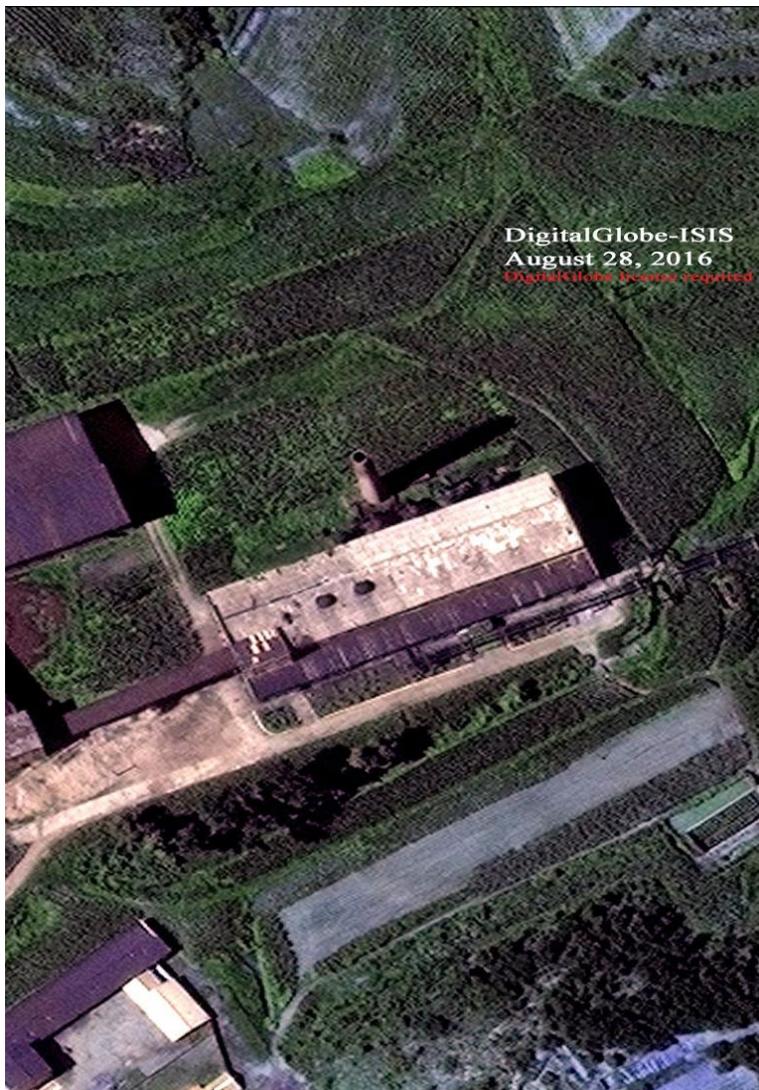
Figure 3: Commercial satellite imagery showing North Korea's coal fired steam plant on July 14, 2016 and August 28, 2016. No smoke is emerging from the stack.

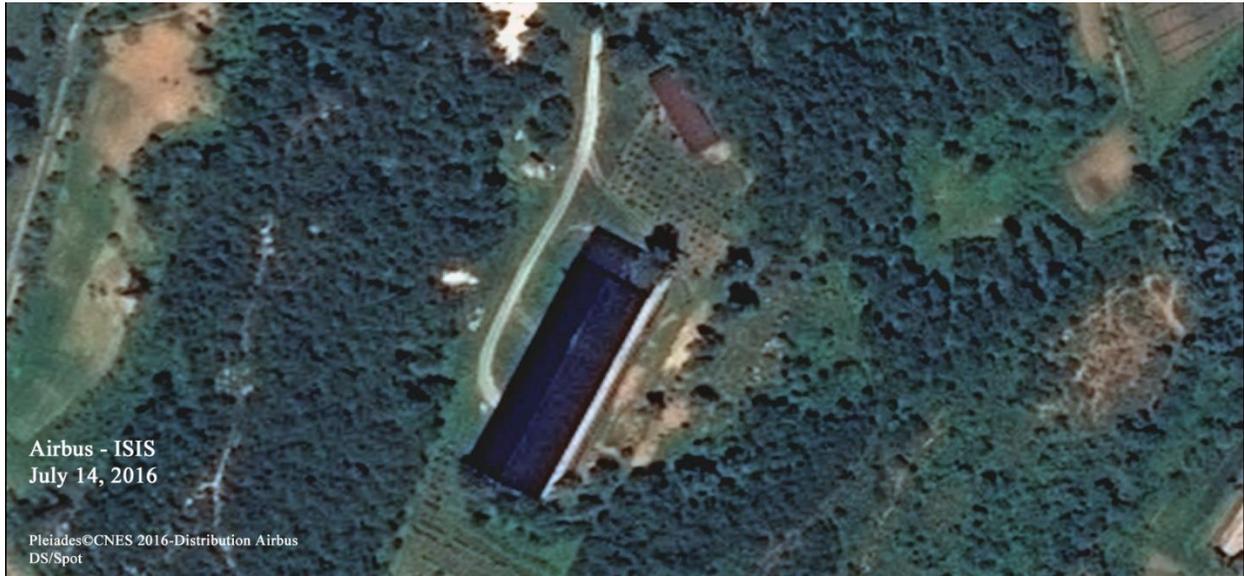
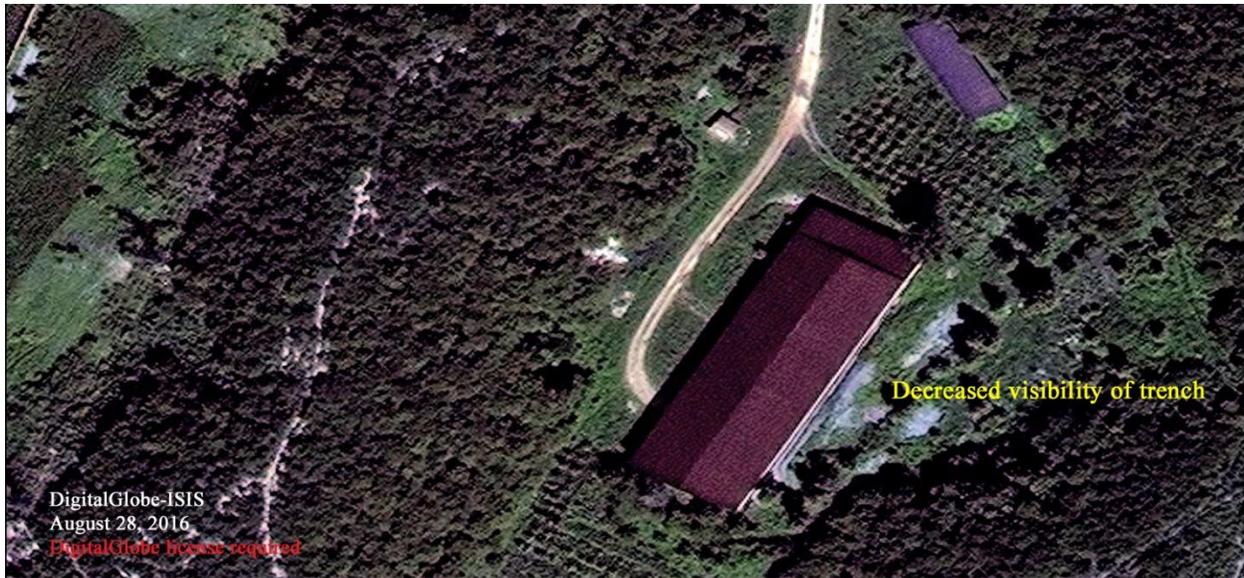
Figure 4: Commercial satellite imagery showing North Korea’s Building 500 on July 14, 2016 and August 28, 2016.

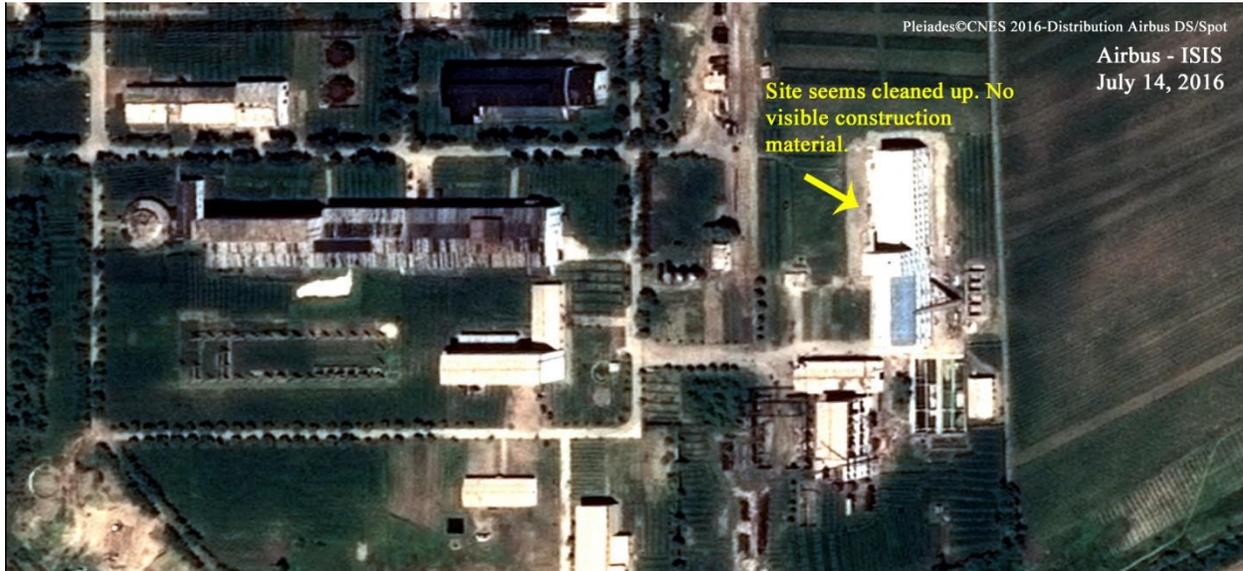
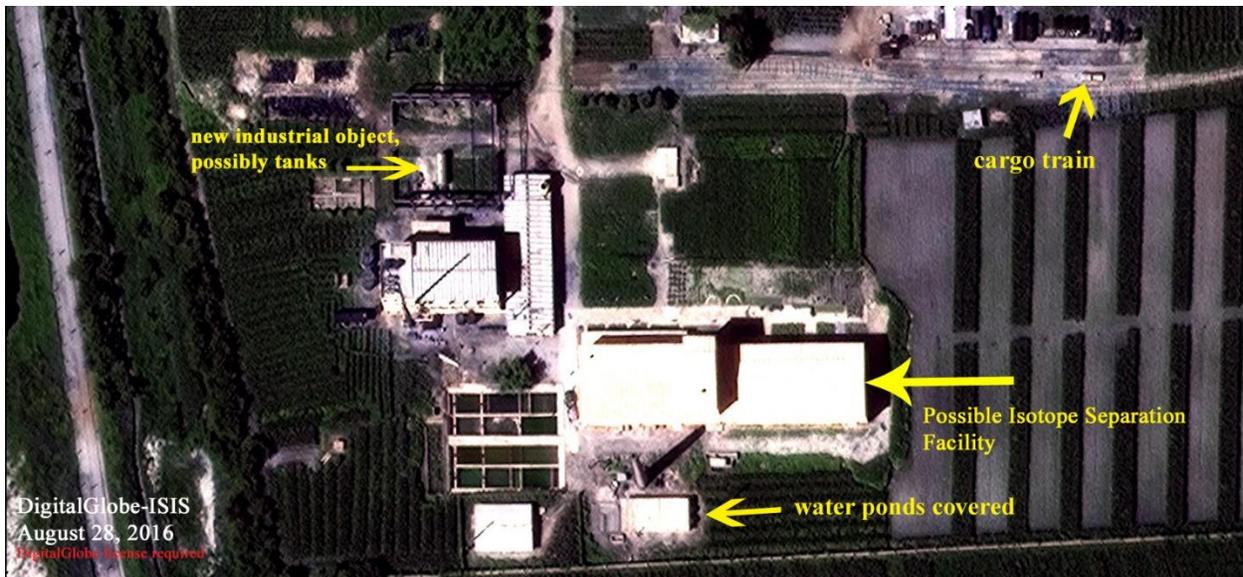
Figure 5: Commercial satellite imagery showing North Korea's suspected isotope separation plant on July 14, 2016 and August 28, 2016.

The possible isotope separation plant appears outwardly to be nearing completion (see figure 5). This facility is located east of the fuel fabrication complex and possibly slated at least in part to separate tritium and other isotopes for nuclear weapons purposes. This facility could increase North Korea's separation of tritium, which could benefit a program to make different types of thermonuclear nuclear weapons, particularly boosted designs.

External construction may be finishing at the site. June 2016 satellite imagery showed trucks and construction material, but the July 14 imagery shows the site to be relatively clean of construction material (see figure 5). Changes visible in the August 28 imagery include the covering of a seemingly empty water tank and the presence in close proximity of an object which could possibly be a gas tank.

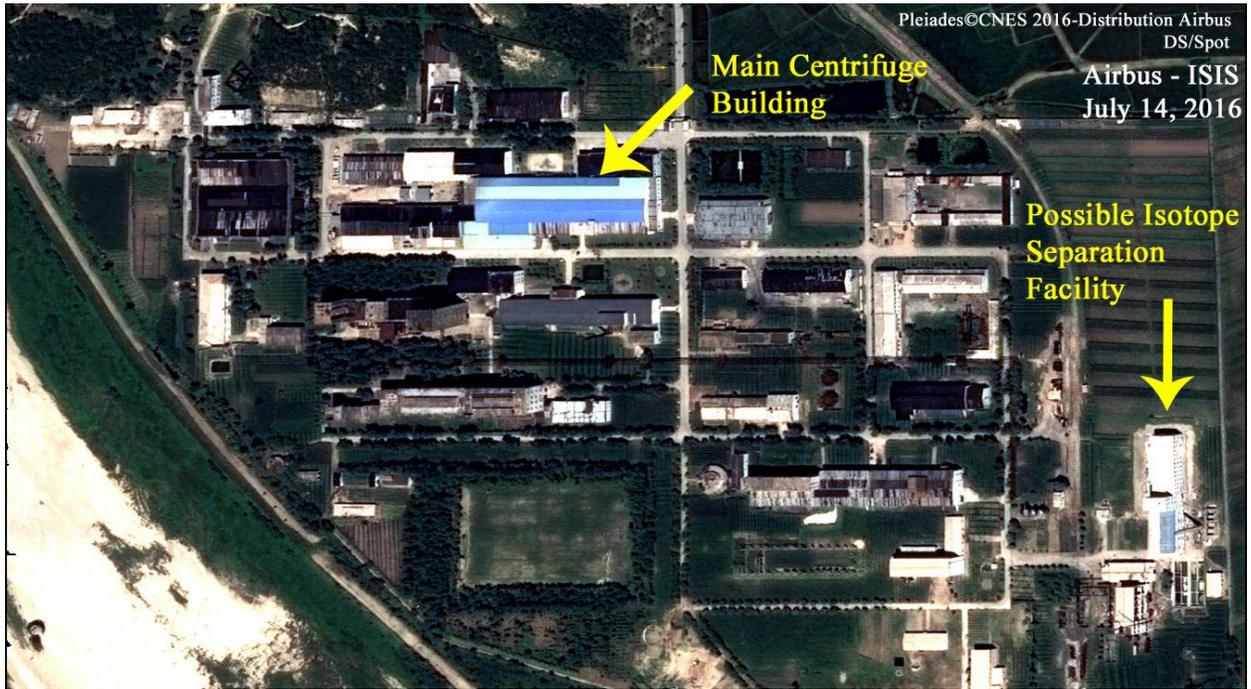
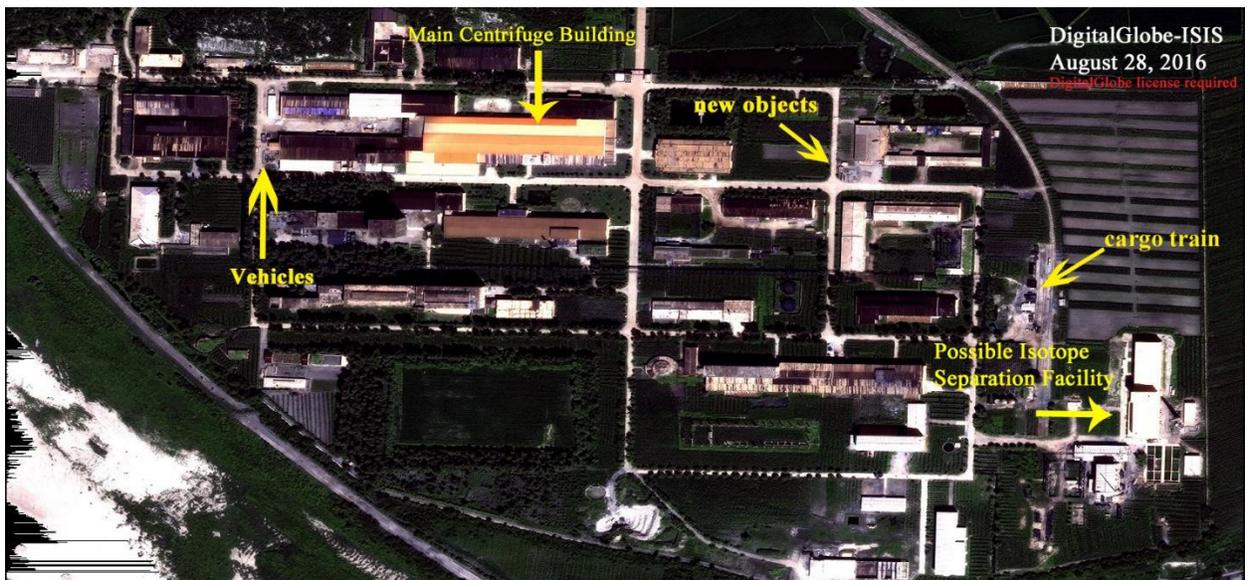
Figure 6: Commercial satellite imagery dated July 14, 2016 and August 28, 2016 showing North Korea's centrifuge plant, which is located in the fuel production complex.

The July and August 2016 images do not show significant external activity at the centrifuge plant, which is located in the fuel production complex and believed to be operational (see figure 6). In the August image, there appear to be vehicles located west of the main centrifuge building and new objects to the east of it, leading to the conclusion that construction may be happening nearby.
