Serial Bombings Observed at Masyaf, Syria

By David Albright, Sarah Burkhard, and Frank Pabian

December 28, 2020

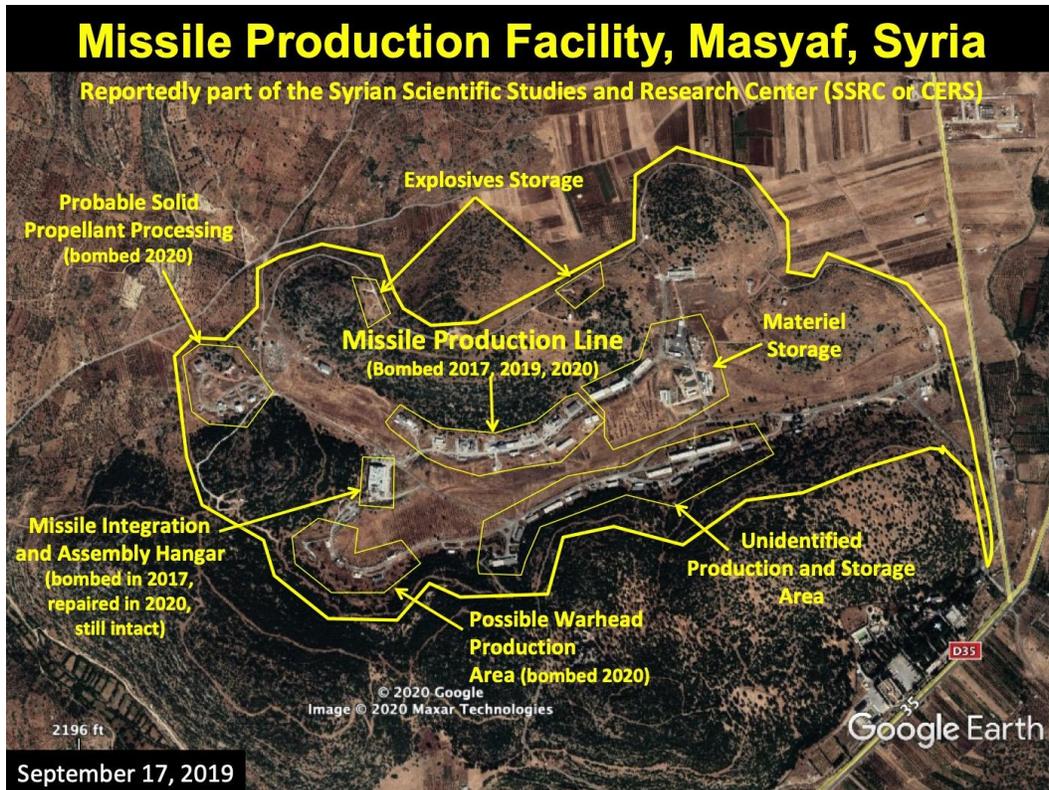
Figure 1. An overview of the Masyaf site, reportedly part of the Syrian Scientific Studies and Research Center and target of a series of air strikes.

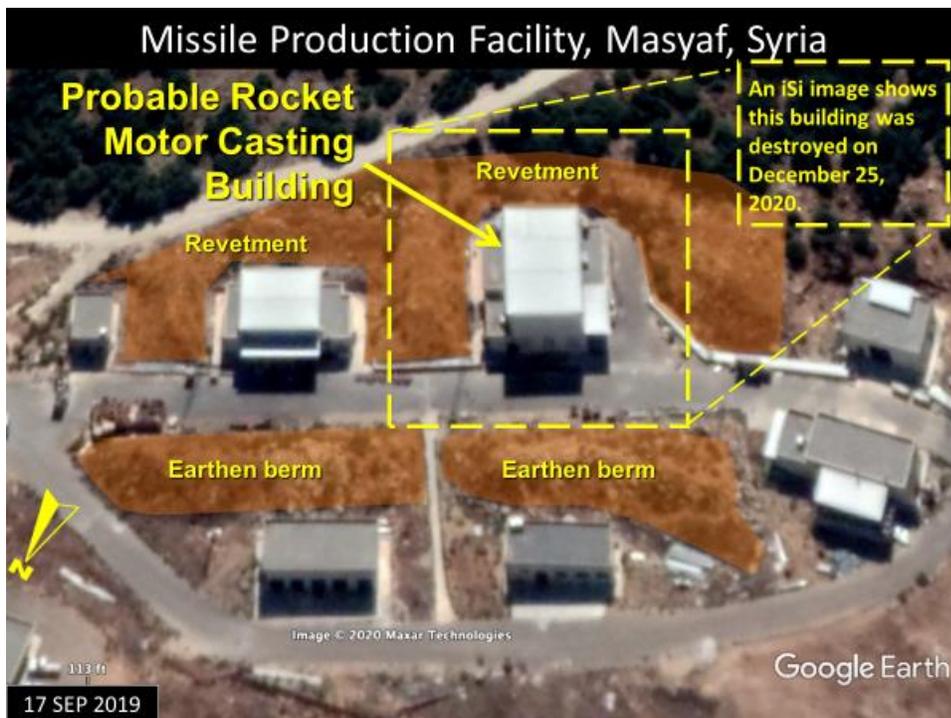
Figure 2. A close-up of the probable rocket motor casting building, target of an airstrike in the early hours of December 25, 2020.

Recent media reporting describes an alleged Israeli missile attack against what has been described as part of the Syrian Scientific Studies and Research Center (SSRC or CERS) near Masyaf, Syria, that occurred after midnight on Christmas Eve, December 24, 2020.¹ Acquisition and analysis of satellite imagery by ImageSat International determined that the target of that precision bombardment was a number of buildings, including one revetted building that was likely to have been engaged in the casting of solid rocket motors as part of a larger surface-to-surface missile production facility.² Figure 1 provides an overview of the site as of 2019. Figure 2 shows a close-up of the probable rocket motor casting building before destruction; an ImageSat International image shows the destruction that occurred in the early hours of December 25, 2020. Several other buildings/warehouses were destroyed as well.

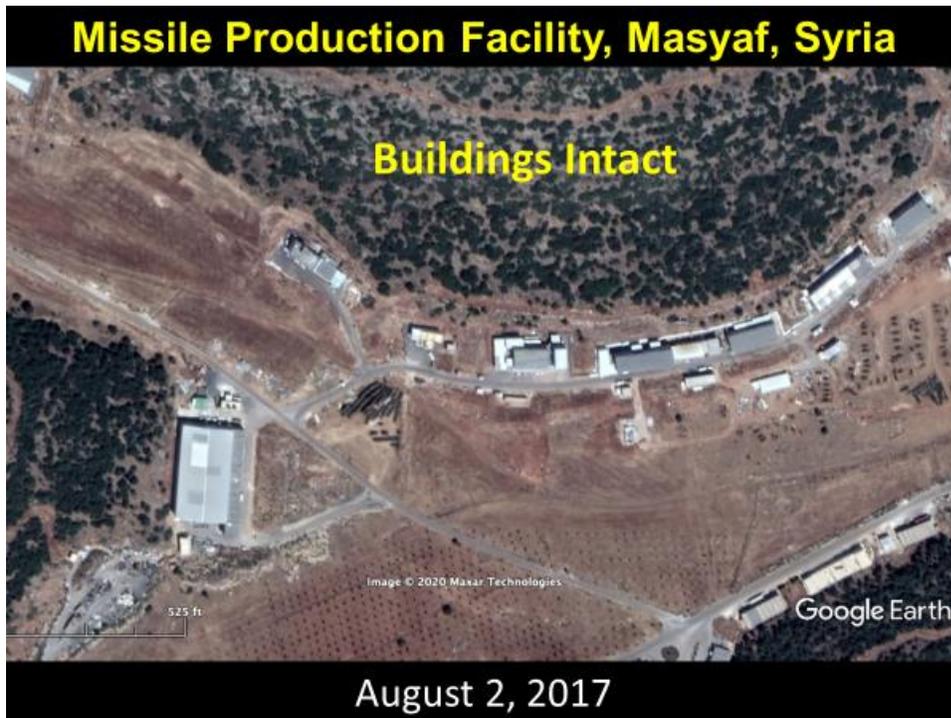
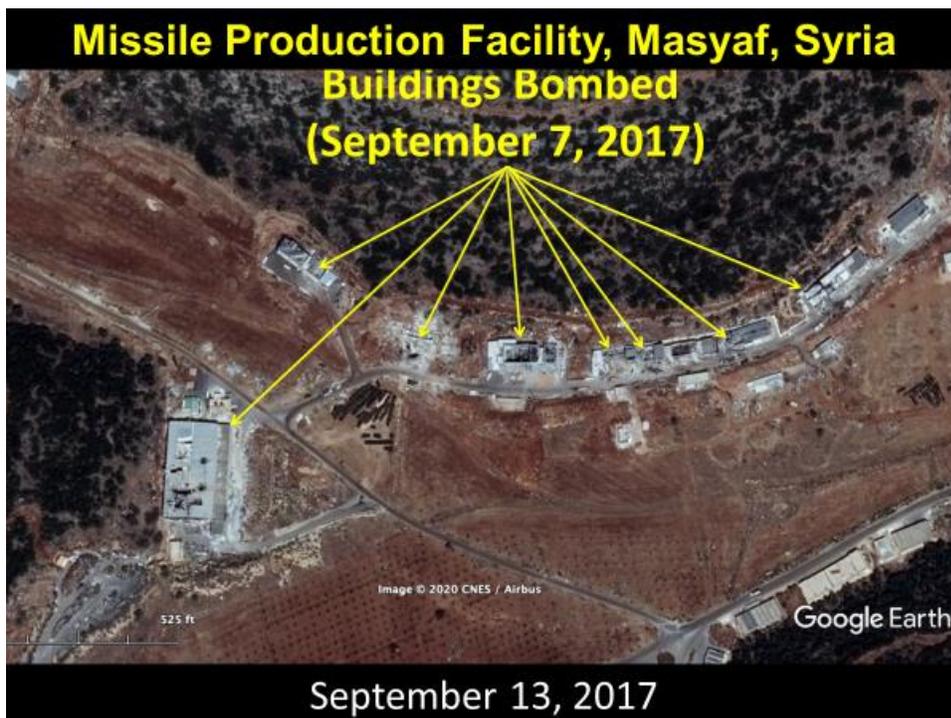
Figure 3. A before and after image, top and bottom, respectively, show the site had been targeted by airstrikes before, in September 2017, where multiple buildings were bombed.

determined that there was indeed evidence of at least one other (initial) major aerial sortie against this missile production facility that reportedly occurred on September 7, 2017.⁷ Figure 3 shows the facility before and after the bombing in 2017.

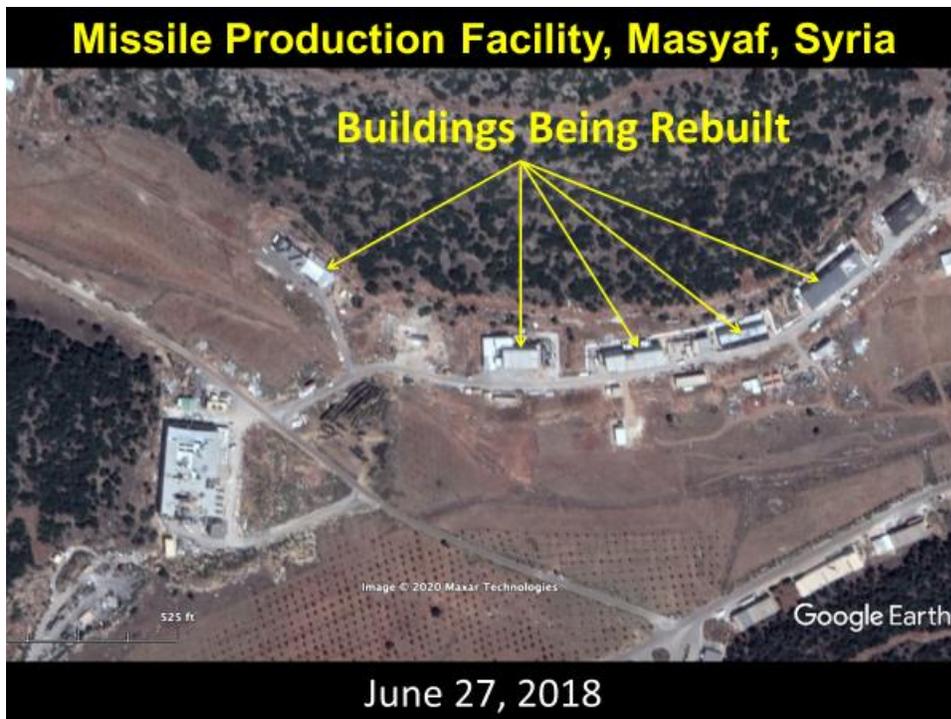
Figure 4. The buildings were subsequently rebuilt in 2018.

This Masyaf surface to surface missile production facility had previously served as a simple storage depot for army artillery and other military hardware (materiel), and as the Institute previously reported, possibly a storage site for equipment and materials from the Al Kibar reactor, such as nuclear-grade graphite. The site was later expanded beginning in 2010, for unknown purposes, and, by 2016, which expansion included what now appears to have been a missile production line for as yet undetermined type of missile, but one evidently involving solid rocket motors. The probable missile production line was heavily damaged in the first bombing attack in 2017, but was then rebuilt over the next two years (see Figure 4) after which a second bombardment destroyed many of those same rebuilt buildings on April 12, 2019 (see Figure 5).

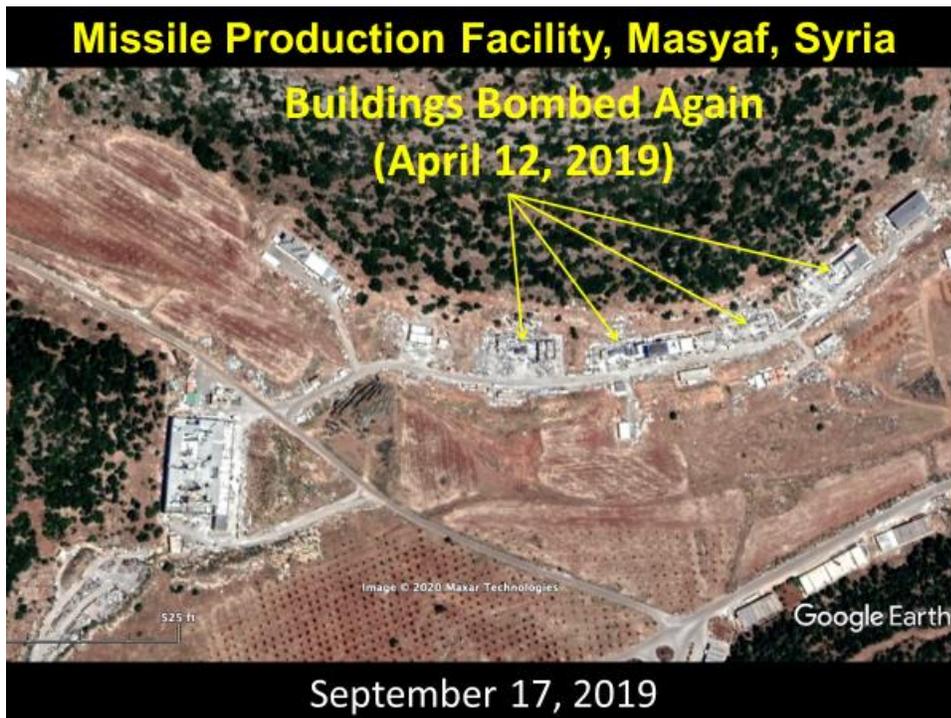
Figure 5. Several of the buildings were bombed again in April 2019. The damage can still be seen in this September 2019 image.
