## Taleghan 2: Pre- and Post Strike Assessment

By David Albright, Sarah Burkhard, Spencer Faragasso, and the Good ISIS Team

December 12, 2024

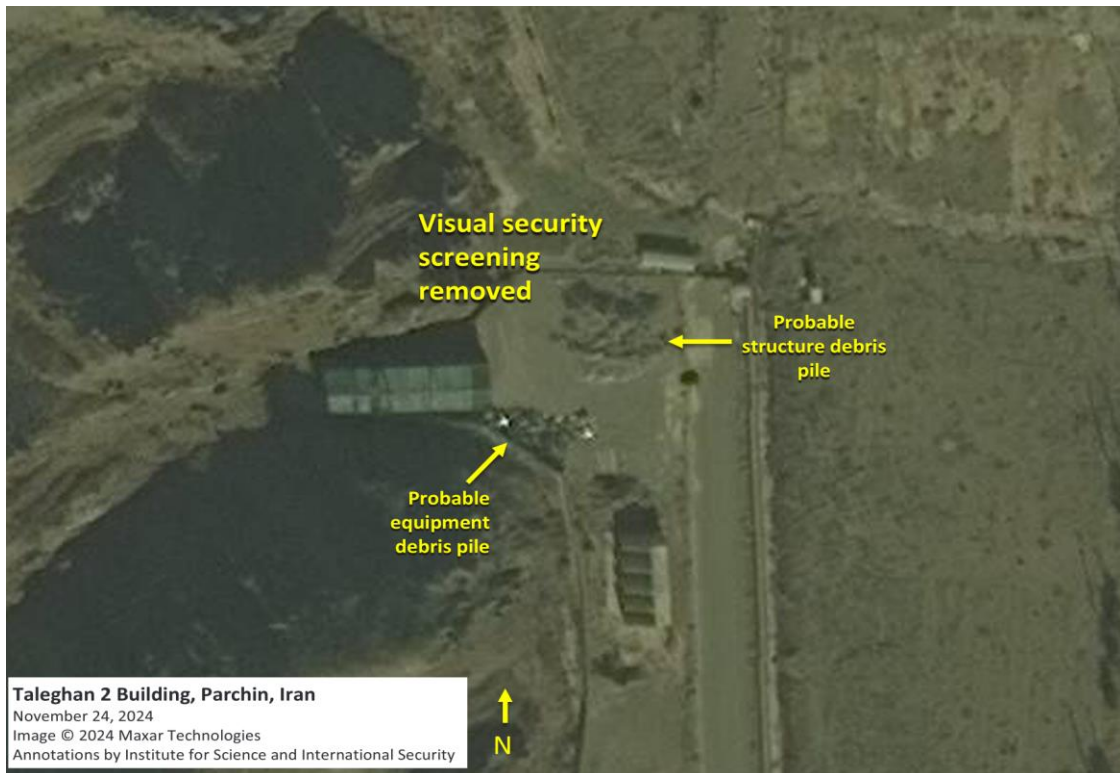
**Figure 7.** Later in November, the demolished building remains covered, but the visual security screening is removed.

More recent Maxar satellite imagery dated November 24, 2024, shows the visual security screening removed. The makeshift structure over the demolished building and the debris piles remain (see Figure 7).

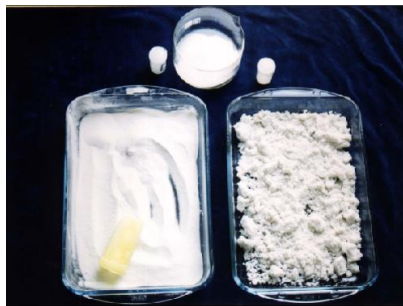
PETN powder image from the archive (left). Mixer image from the archive (right).

**Figure A1.** Nuclear archive pictures of plastic explosive manufacturing and product storage during the AMAD plan at Sanjarian. The equipment and/or finished explosives may have been moved to Taleghan 2.

In the Amad Plan, plasticized pentaerythritol tetranitrate (or PETN) for use in the shock wave generator channels was not made at Taleghan 2, but at the Sanjarian site. Figure A1 includes six pictures from the nuclear archive, showing some of the equipment and plasticized products that were at Sanjarian and thus may have been in Taleghan 2 when it was destroyed.

They show PETN powder, manufacturing equipment, and the final sheets of plasticized PETN in storage. The sheets are then cut and inserted into the channels of the shock wave generator. The explosive selected by Iran was PETN because, once mixed with a plasticizer, in this case polyisobutylene or PIB, it is easy to mold.

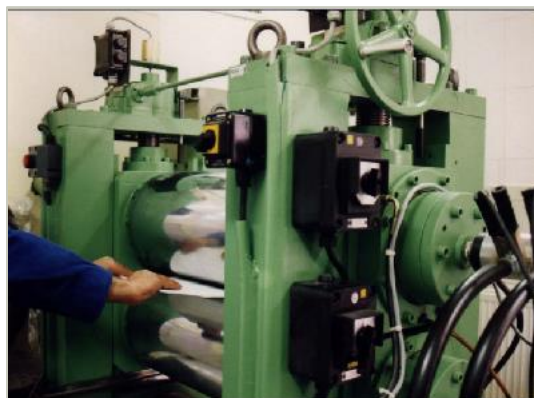
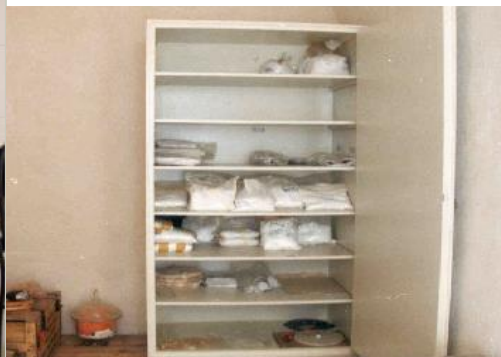
Hydraulic roller image from the archive (left). Plasticized PETN sheet storage, image from the archive (right).

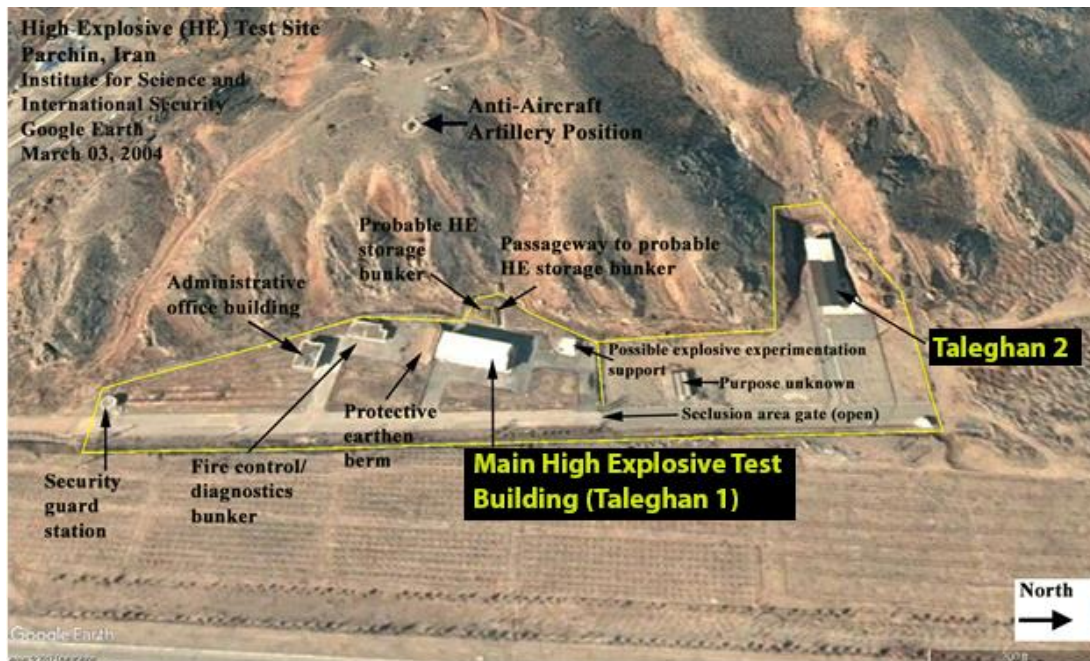
**Figure A3.** Taleghan 1 and 2 in 2004.

Figure A3 shows Taleghan 2 in 2004. It is next to Taleghan 1, a building containing another, larger high explosive test chamber, used for hydrodynamic experiments involving high explosives and in the development of a neutron initiator, according to nuclear archive documents.

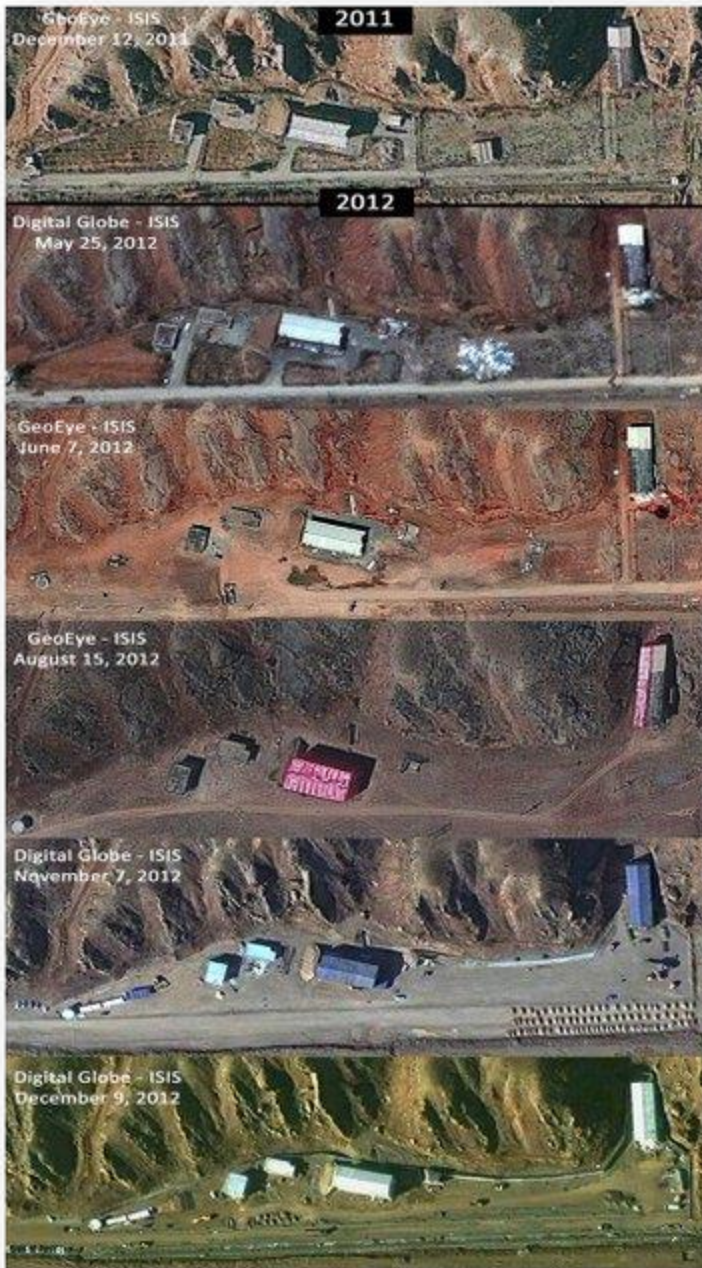
**Figure A4.** GeoEye/Digital Globe high resolution satellite imagery showing changes at Taleghan 1 and 2 at the Parchin military complex between December 2011 and December 2012.

Substantial cleanup efforts occurred at Taleghan 1 and 2 starting in 2011, when the International Atomic Energy Agency indicated interest in visiting the site, specifically in the context of investigating Iran's use of high explosive test chambers and high speed diagnostic equipment, including neutron detectors and flash x-rays, for nuclear weapons development purposes. It is thus judged as unlikely that the high explosive chamber and the flash x-ray, remained at Taleghan 2 following Iran's sanitization efforts (see Figures A4 and A5)

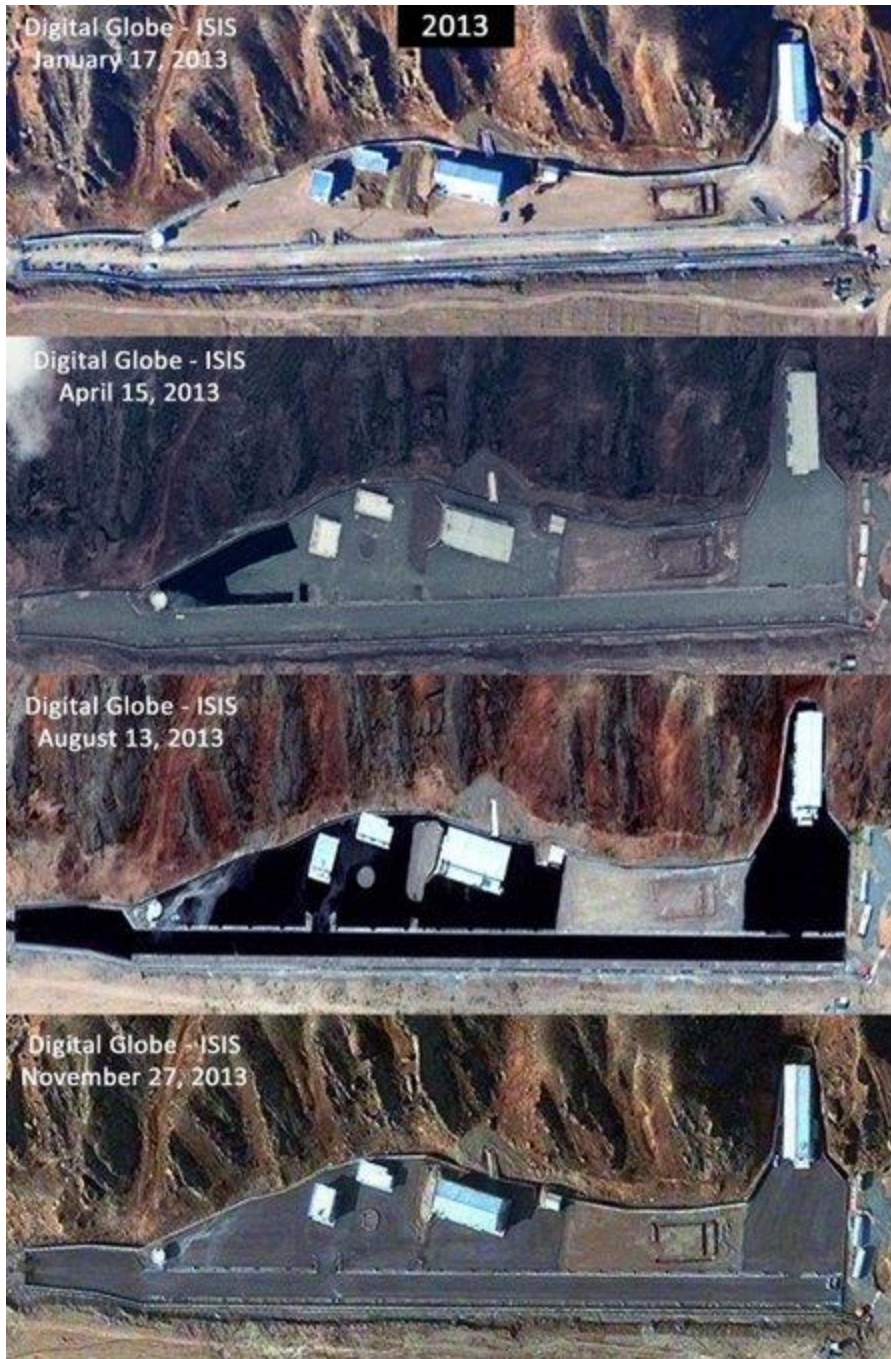
**Figure A5.** Digital Globe high resolution satellite imagery showing changes at Taleghan 1 and 2 between January 2013 and November 2013.
