Update on North Korea's Yongbyon Nuclear Site

By David Albright and Serena Kelleher-Vergantini

September 15, 2015

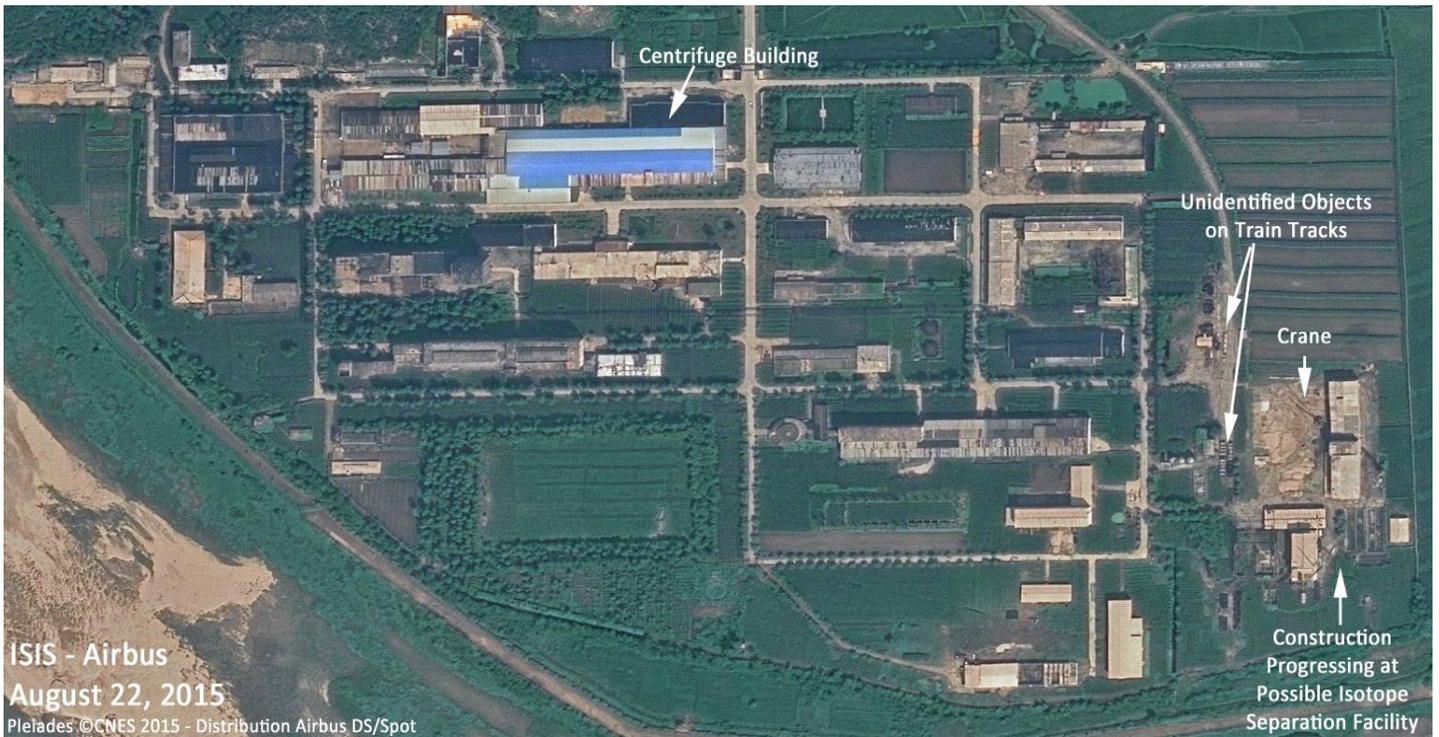
Figure 1. Airbus imagery showing the status of North Korea’s Yongbyon Fuel Fabrication Complex on August 22, 2015.

This announcement implies that the [expansion](#) section of the centrifuge plant is operational (figure 1). However, there is no concrete evidence of such operation visible via satellite imagery. We and others noted snow melt on the building last winter (see [here](#)). Although this signature implies the building is heated, it does not reveal whether centrifuges are in operation, particularly in the expansion section.

However, there are a range of factors which would support that the plant, in particular the extension, is operational, as North Korea states. North Korean engineers and scientists are experienced enough to have finished the extension and enough time has passed to accomplish this task and get it into operation. Moreover, this plant is a major priority of the government, so the project likely received ample resources. North Korea is also known to have procured many dual-use goods in sufficient quantity for the extension of this facility. These goods were purchased in China and include a range of vacuum equipment, computer control equipment, and frequency-inverters or related subcomponents. Thus, although the available information does not confirm the plant's operation, nothing contradicts the North Korean statement that the plant, including the extension, is operational.

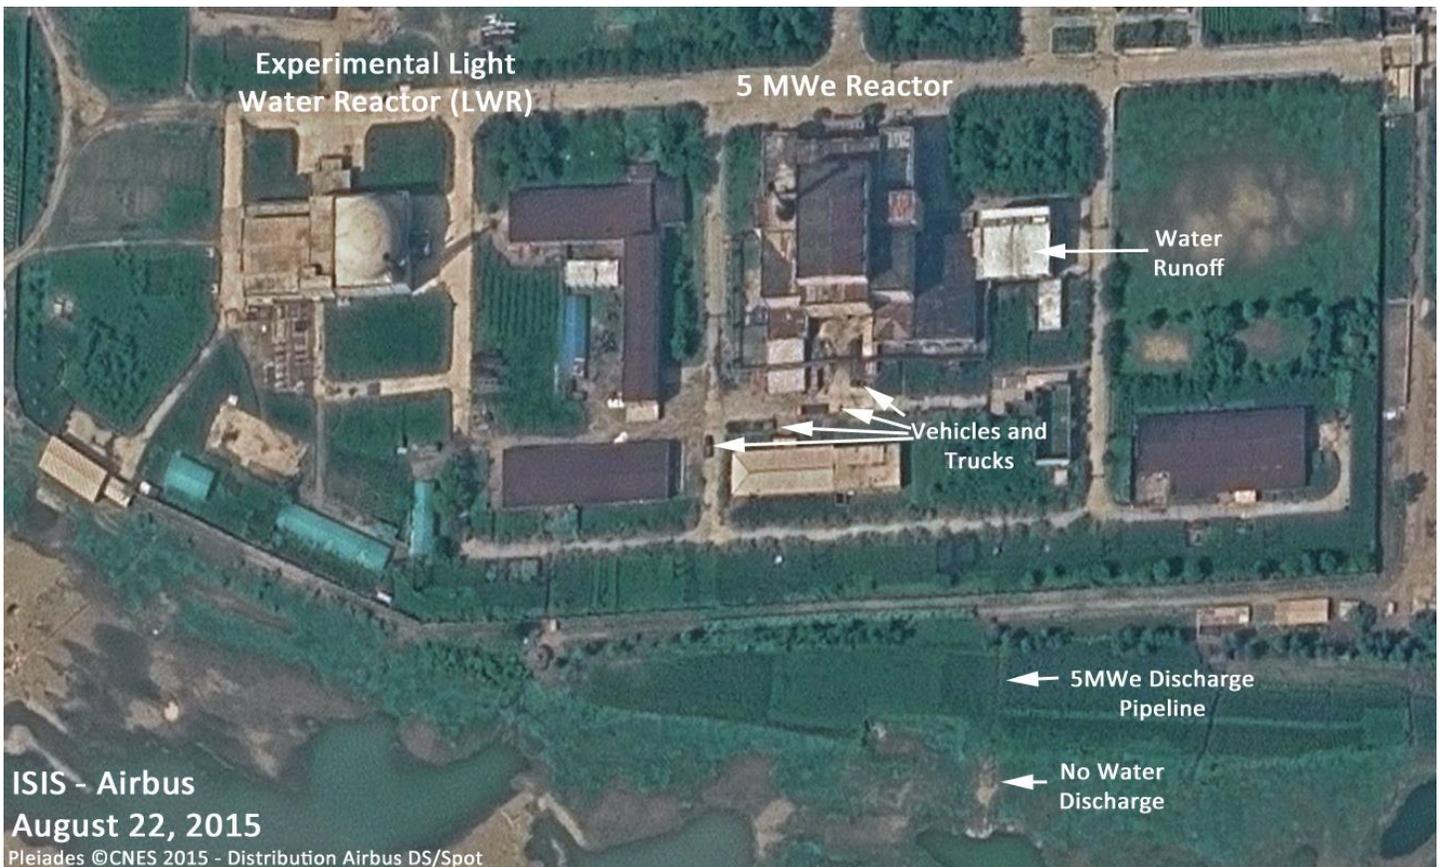
Figure 2. Airbus imagery showing North Korea’s Yongbyon 5 megawatt-electric and experimental light water reactors on August 22, 2015.

gathered during the end of 2014 and January, February, March, April, June and August 2015.¹ Recent imagery dated August 22, 2015 does not show a steady stream of water being discharged from the reactor's discharge pipeline, which is the main sign of full-power operation (see figure 2). Thus, it is harder to confirm North Korea's claim about "normal" operation. Nonetheless, other signatures suggesting renewed activity are visible in this August 2015 image. Several vehicles and trucks are visible at the entrance of the 5 MWe reactor and water runoff is present on the roof of the reactor's turbine building, indicating recent turbine activity. It is, therefore, very likely that the reactor was still operating intermittently as of August.

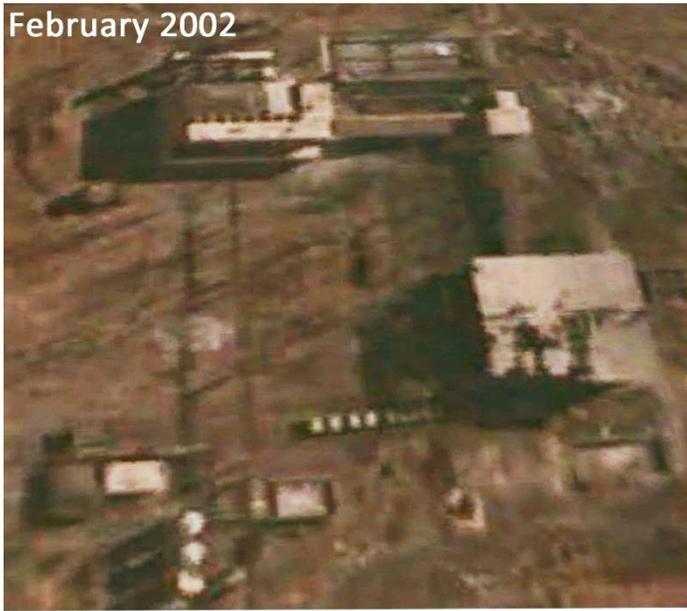
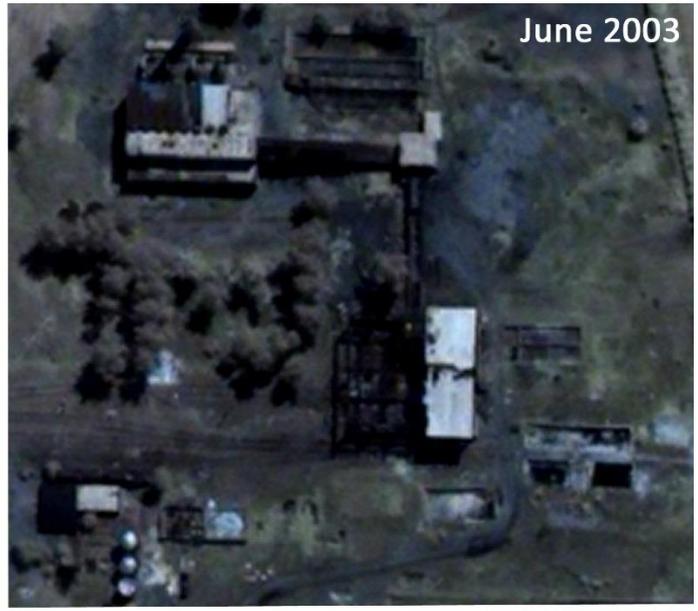
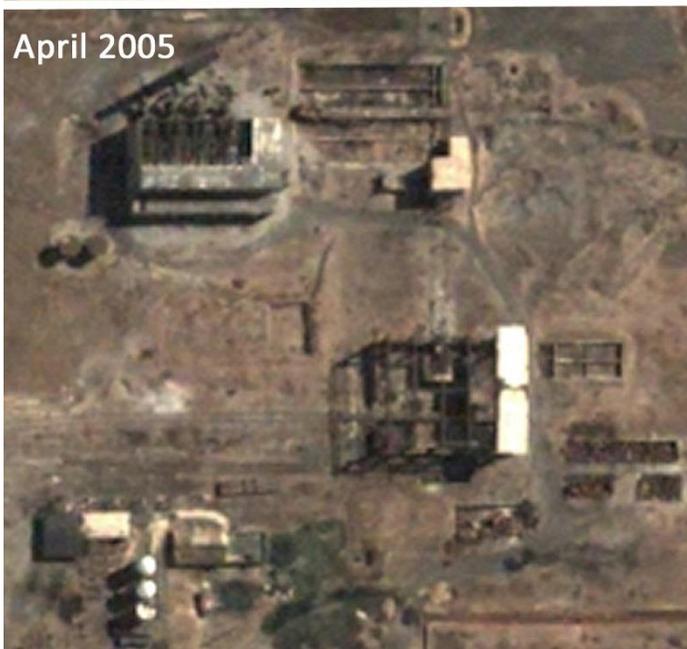
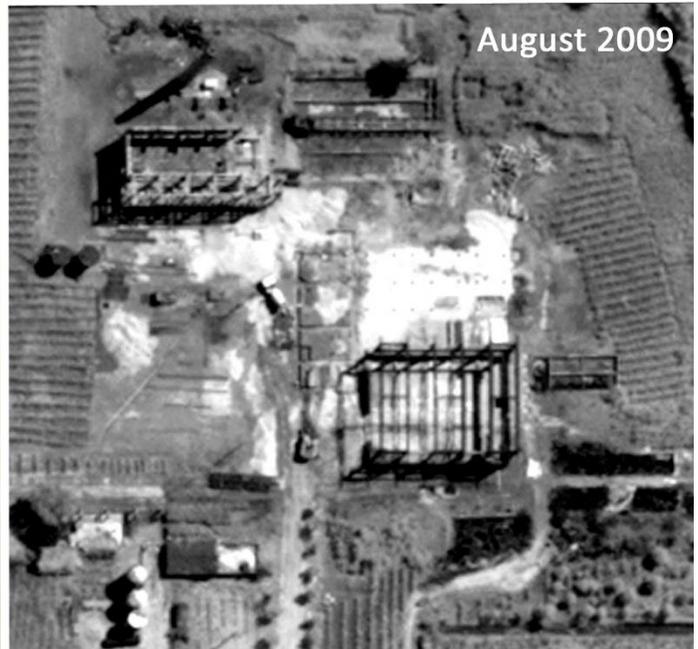
Figure 3. Google Earth/DigitalGlobe/Airbus imagery showing the demolition of the existing buildings east of the fuel fabrication complex between 2002 and 2009.

As figures 3 and 4 show, the site containing this facility has been repurposed since 2009. In February 2002, two buildings and a stack were present. Prior to 2003, these buildings were believed to have been devoted to supporting activities, according to a former senior UN official close to the IAEA who had frequently visited the site when the Agreed Framework was in effect. However, between 2003 and 2009 both buildings were demolished. Since 2009, the site has been fundamentally reconstructed.

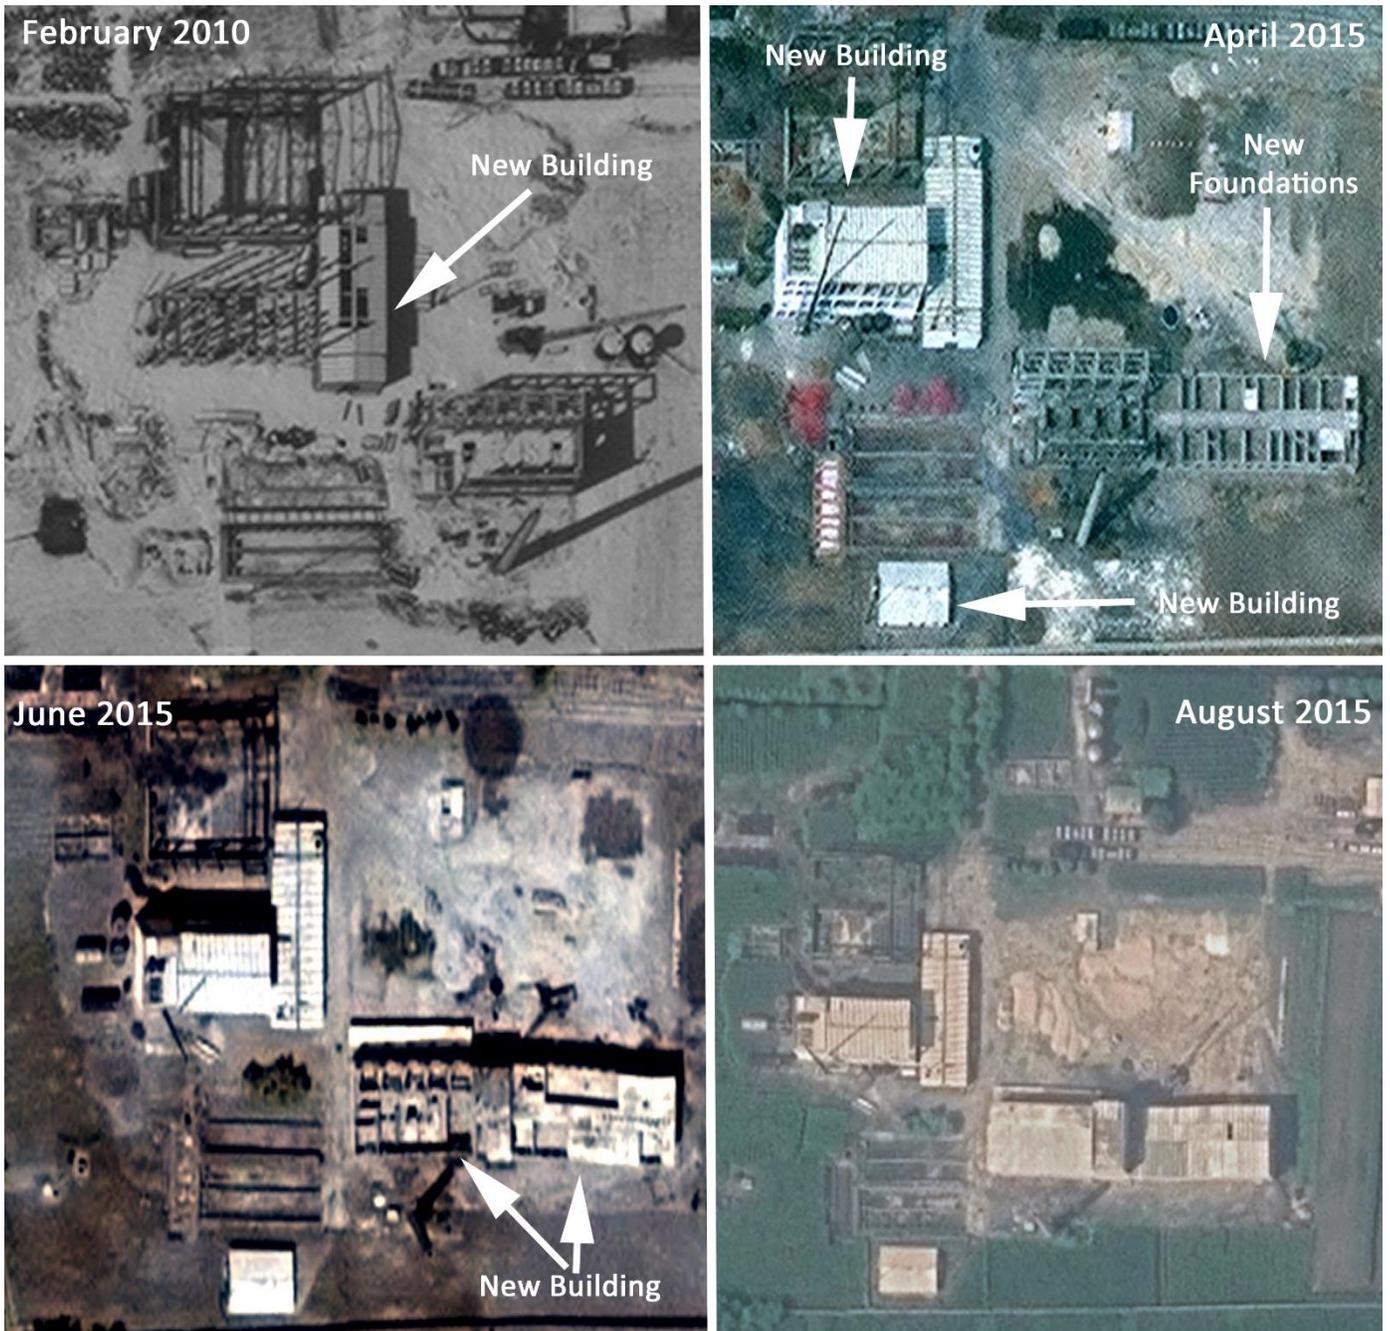
Figure 4. Google Earth/DigitalGlobe/Airbus imagery showing the construction activities east of the fuel fabrication complex between 2010 and 2015.

As of August 2015, the site consists of one large building, two medium size buildings, and one small one. The foundations for two additional buildings are visible and it is possible that North Korea is preparing to lay down foundations for a new large building in the area it has used, so far, as a construction staging area. The two medium size buildings are adjacent to each other. One is three stories tall and is adjacent to a shorter rectangular-shaped one. The taller building has a stack, several possible vents on the roof, and tanks behind it while the shorter one seems to have an entrance connected to the train tracks and a large object on the roof, possibly also a large vent. Nearby is a large rectangular shaped building with a large stack. ISIS was able to purchase satellite imagery of this site during the construction phase of this building. Imagery from April and June 2015 allow the visualization of the internal structure of this building. The left side of the building is taller and is divided into five cells. The lower side of the building is also divided into cells. Finally, nearby is a smaller building with a stack.

Although the precise purpose of this site is unknown, the signatures visible through an historical analysis of satellite imagery are consistent with an isotope separation facility, including tritium separation, according to an expert we consulted. This assessment is also shared by a government expert we consulted who has long experience in assessing activities at the Yongbyon site. The presence of three stacks indicates activities that require the release of harmful gases. The presence of tanks suggest processes using chemicals. The signatures of the cells within the larger building are consistent with hot cells possibly for isotope separation. ISIS does not believe this building to be related to reprocessing activities since the thickness of the cell walls is not consistent with that expected for reprocessing activities.
