Update on Assessing the Detonation at the Natanz Iran Centrifuge Assembly Center: New High Resolution Satellite Imagery Refines Details on the Explosion and Fire

By David Albright, Sarah Burkhard, and Frank Pabian

July 9, 2020

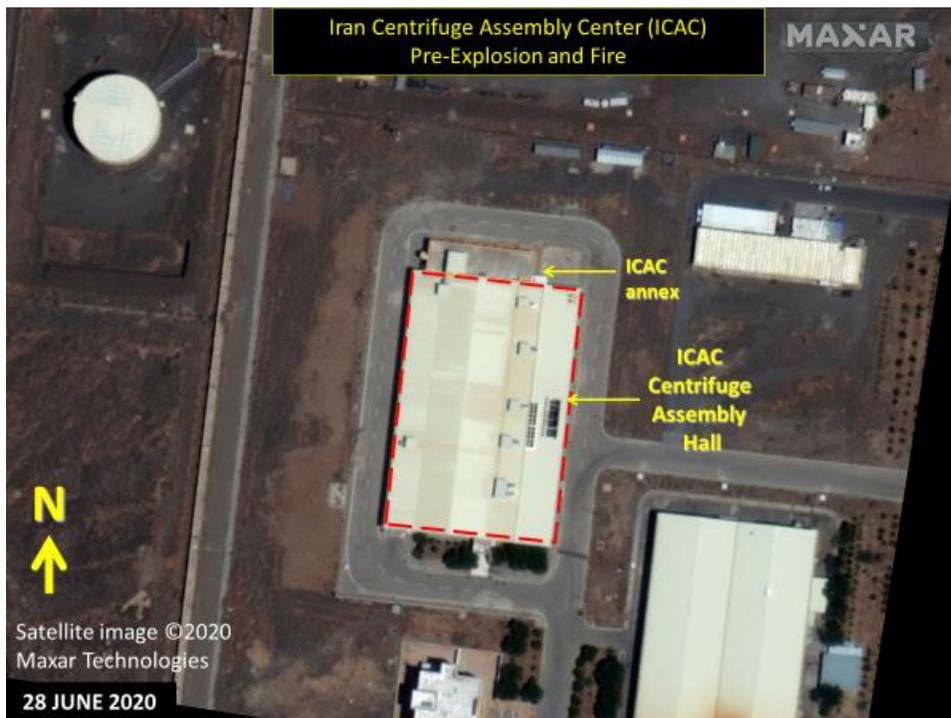
Figure 1. High resolution satellite image of the Iran Centrifuge Assembly Center prior to the explosion, dated June 28, 2020, released by Maxar, via Christiaan Triebert of the *New York Times* on Twitter, July 8, 2020. Satellite image ©2020 Maxar Technologies.

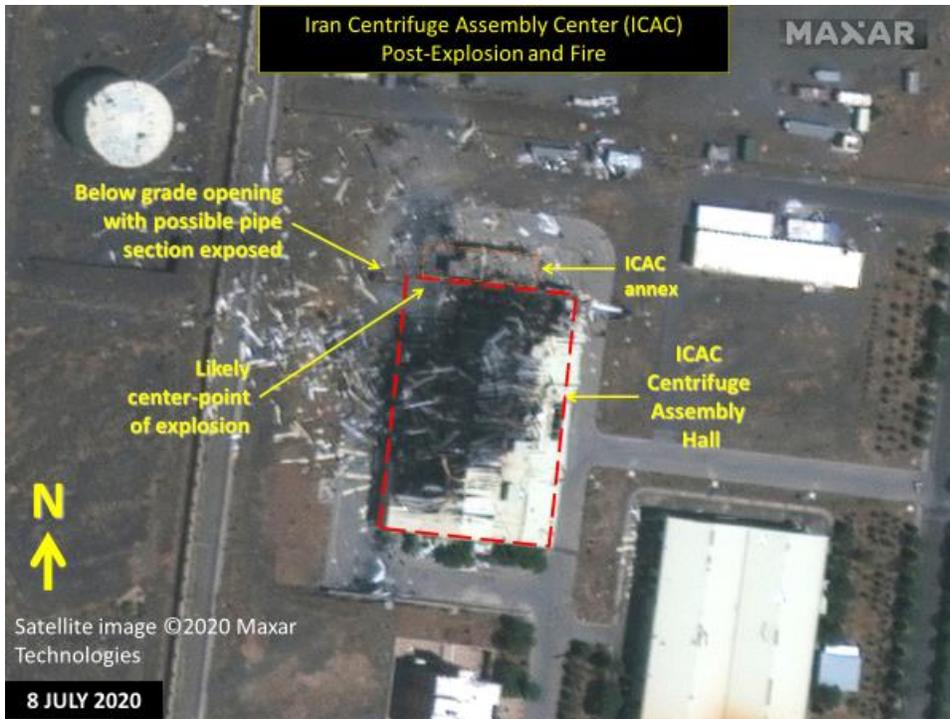
Figure 2. July 8, 2020 post-explosion high resolution satellite image of the ICAC, annotated by the Institute, image released by Maxar, via Christiaan Triebert of the *New York Times* on Twitter, July 8, 2020. Satellite image ©2020 Maxar Technologies.

That apparent below grade feature appears to extend to a small crater-like feature that is the likely center-point of the explosion that destroyed the ICAC and part of the annex, and created an outward radiating pattern of destruction (see Figure 3). We are also more confident in suggesting that this center point was most likely situated just inside the former corner walls of the ICAC. Moreover, what we had previously perceived in 2-D as a possible crater, now appears

in 3-D more like a rubble pile created by the blast (where about 25 percent of the adjacent annex was destroyed).
