Video Walk-Through of Iran's New Interim Centrifuge Assembly Center

By David Albright and Sarah Burkhard

June 29, 2022 (Updated July 19, 2022, to remove a typo in the wall thickness of the IR-6 centrifuge.)

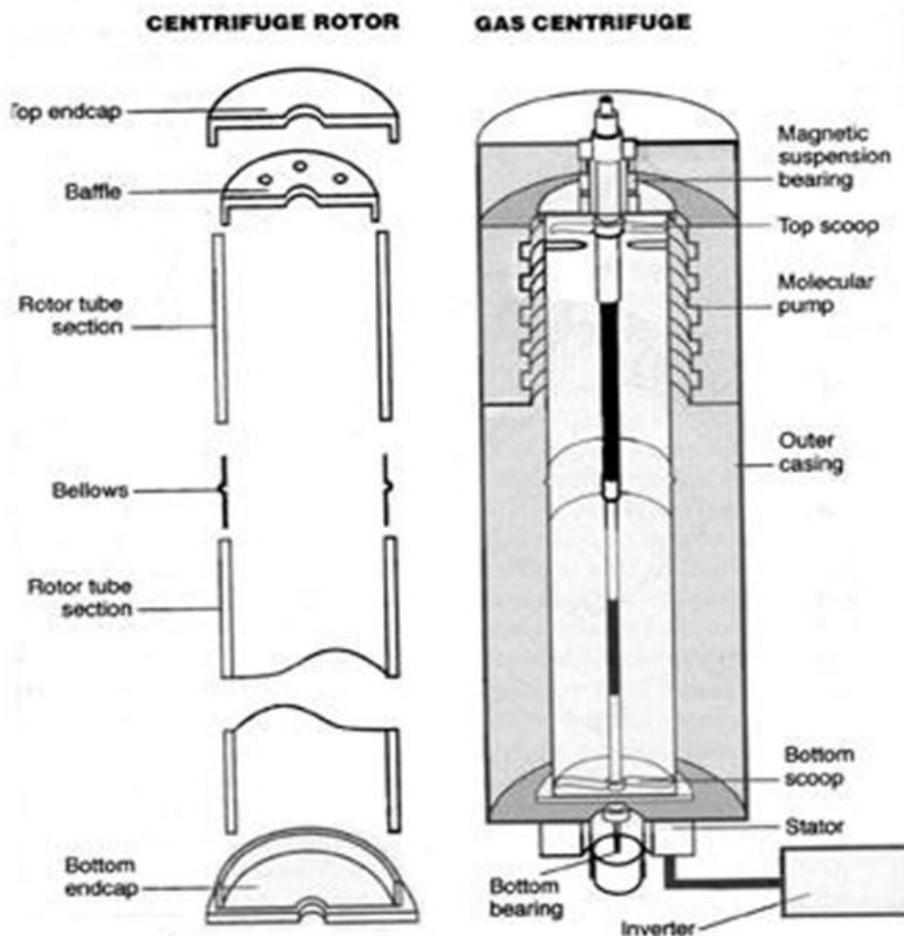
Figure 1. Schematics showing a supercritical Zippe-type centrifuge with two-rotor tubes and one bellows, a design with similarities to the IR-6 centrifuge. The type of bellows in the schematic, with an outward pointing convulsion, is not the same as found in Iranian bellows, which have an inward pointing bellows, as can be seen in the video.

Many components of centrifuges are visible in the video, including whole rotor assemblies, rotor tubes, end caps, possible top and bottom cap inserts, motor housings, bottom stands, and baffles (see Figure 1 for a centrifuge schematic.) Several components and aspects of centrifuge assembly are missing in the video, including top and bottom bearing assemblies, balancing rooms and associated equipment for individual centrifuge components, motor assembly, and clean rooms necessary for assembling the top and bottom bearings.

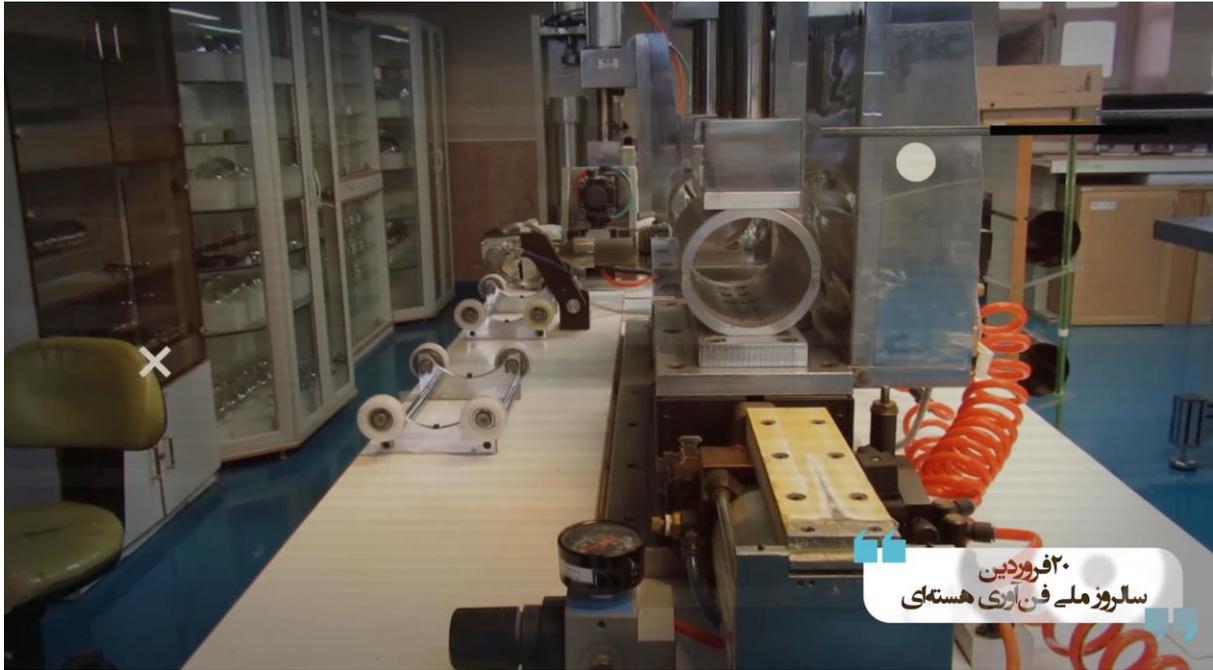
Figure 2. A general view of a small-scale assembly workshop. On the tabletop are support rollers for supporting cylinders in accordance with standard laboratory practices. Various centrifuge components are seen in glass cabinets. The machine in the center could not be identified.

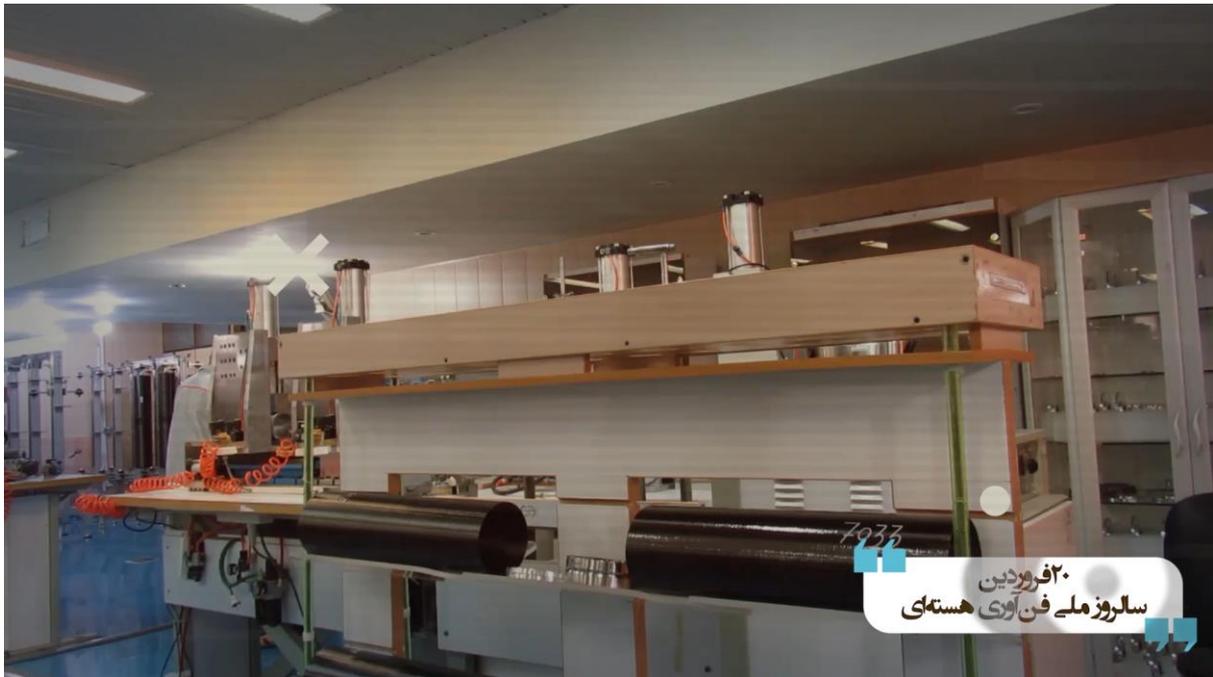
Figure 3. In same room as in Figure 2, two carbon fiber cylinders awaiting assembly. Between them is possibly a metal bellows, most logically made of maraging steel because of the relatively high speeds achieved by the advanced centrifuges.

Despite Iran’s past difficulties to procure maraging steel, the video shows what appear to be IR-6 bellows in storage cabinets that appear silver rather than black grayish, indicating metal instead of carbon fiber. Maraging steel is a logical candidate for these bellows given the speed requirements of Iran’s deployed advanced centrifuges, claimed to reach tangential speeds of up to 600 meters per second. This is partially confirmed by IAEA reporting. On January 23, 2021, the IAEA verified that Iran had started manufacturing metal bellows for IR-6 centrifuges for testing, which Iran plans to reinforce with carbon fiber.⁸ It is possible that the new bellows use a lower quality maraging steel, requiring carbon fiber reinforcement, or use another metal other than maraging steel, also necessitating carbon fiber support.

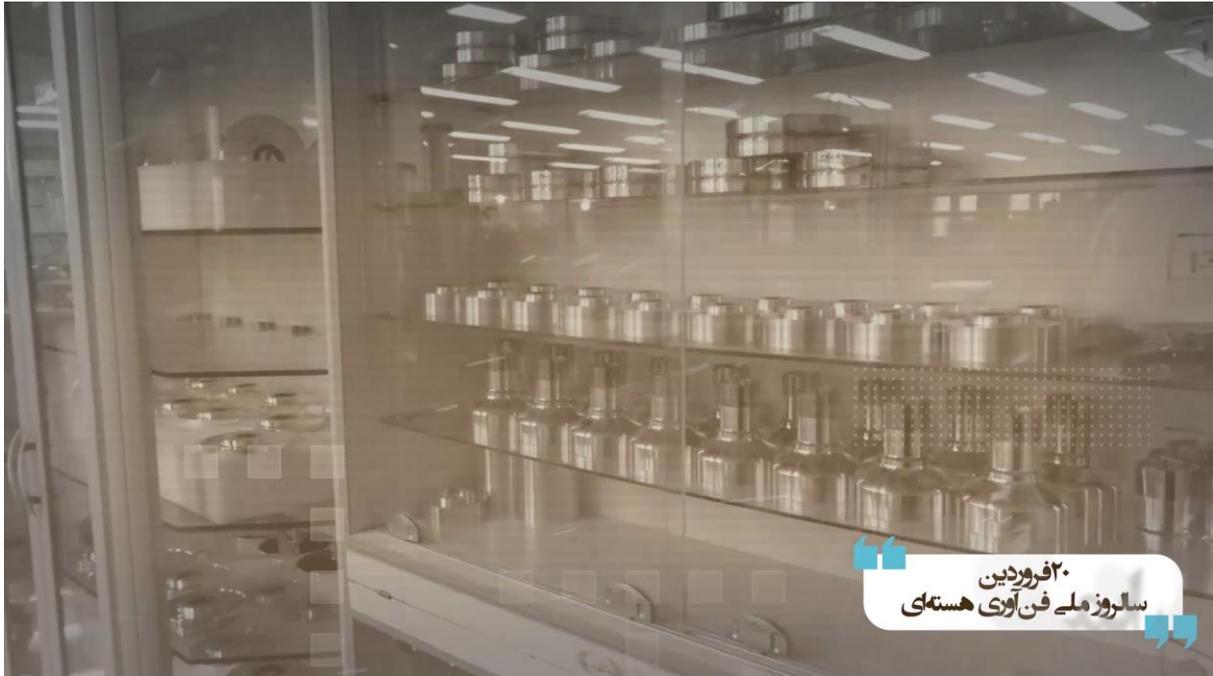
Figure 4. Two component storage cabinets. In the cabinet on the right side, on the upper two shelves are more metal bellows, again possibly made of maraging steel although high strength aluminum cannot be excluded. The lower two shelves also hold subcomponents, which have diameters slightly smaller than the bellows. One shelf may hold top cap metal inserts that hold the rotating magnet and catch the top end of the rotor when unintended rotor vibrations occur during startup and rotor failure. The other shelf may hold bottom cap metal inserts for holding the rotating elements of the drive and bottom bearing pin and ball. These subcomponents could be of high strength aluminum alloy or maraging steel. All of these components appear to have been degreased and cleaned, hence stored in a closed cabinet.

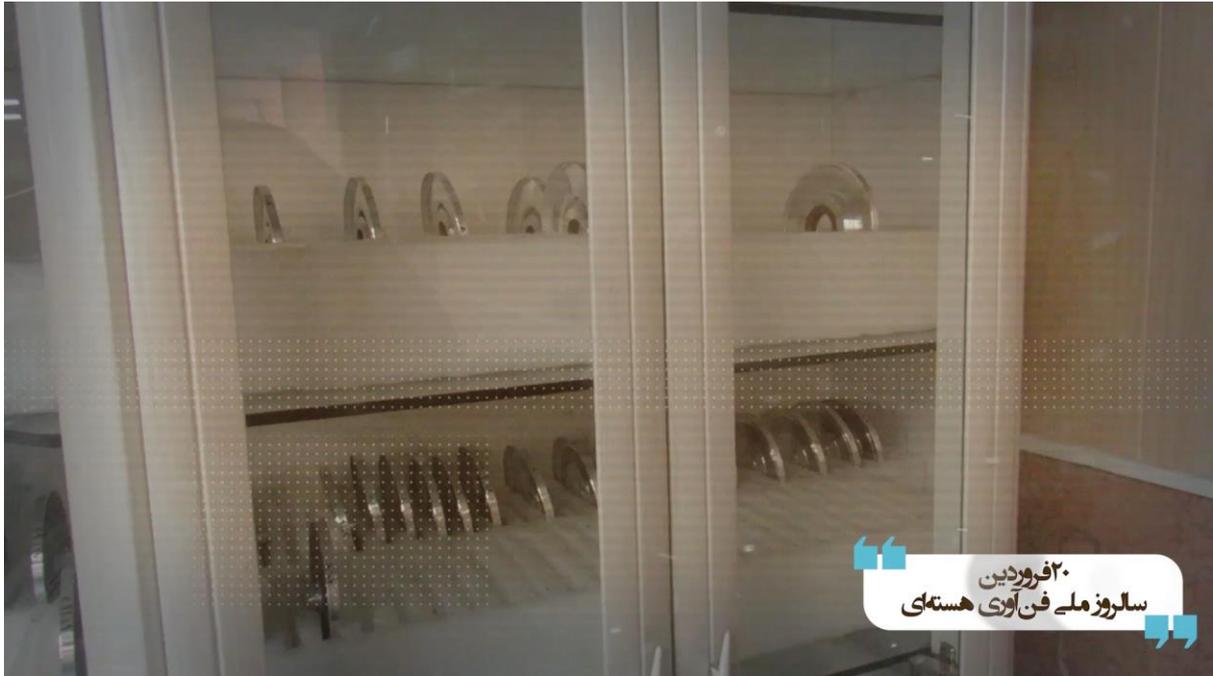
Figure 5. This cabinet contains a stock of centrifuge subcomponents. At first glance, they look like baffles made from metal rather than carbon fiber. Baffles are inserted in the rotor to create the counter-current gas flow and to isolate the top scoop extraction chamber. Note that the subcomponent is made of metal and not a carbon composite, and is likely made of maraging steel or high strength aluminum. They could also be end caps made out of high strength aluminum, where they are inserted inside the carbon fiber rotor tube, providing strengthening.

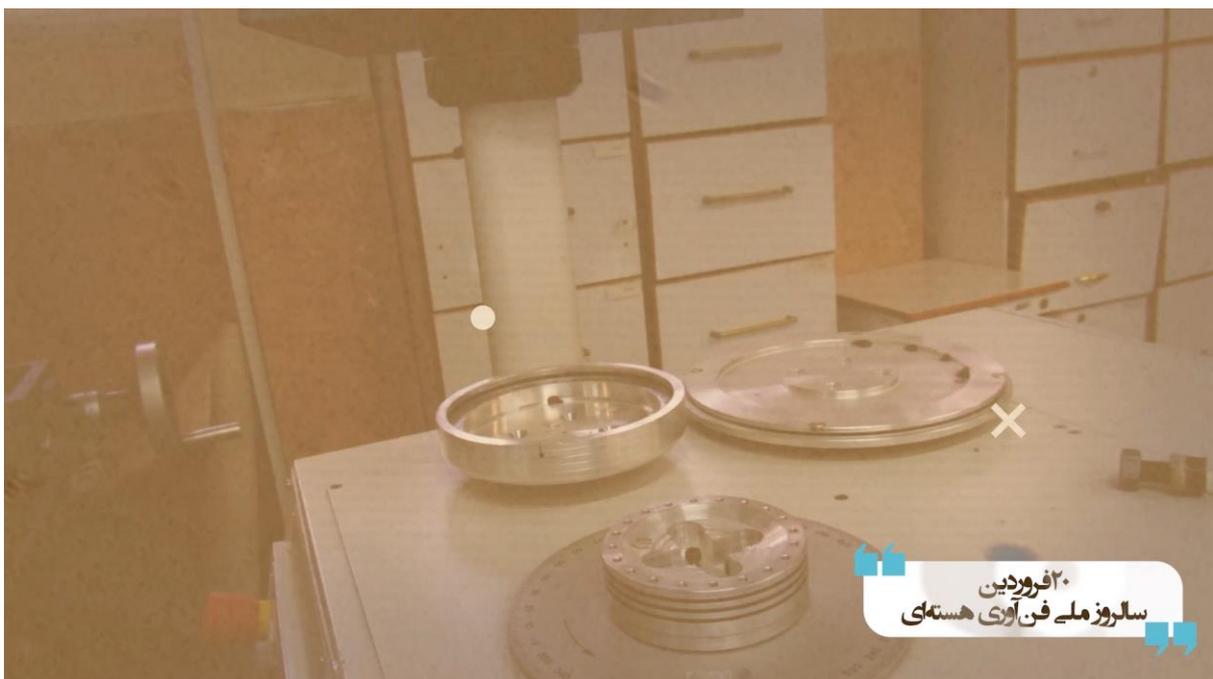
Figure 6. A photo with possible top and bottom end flanges of the outer casing, also known as the recipient.

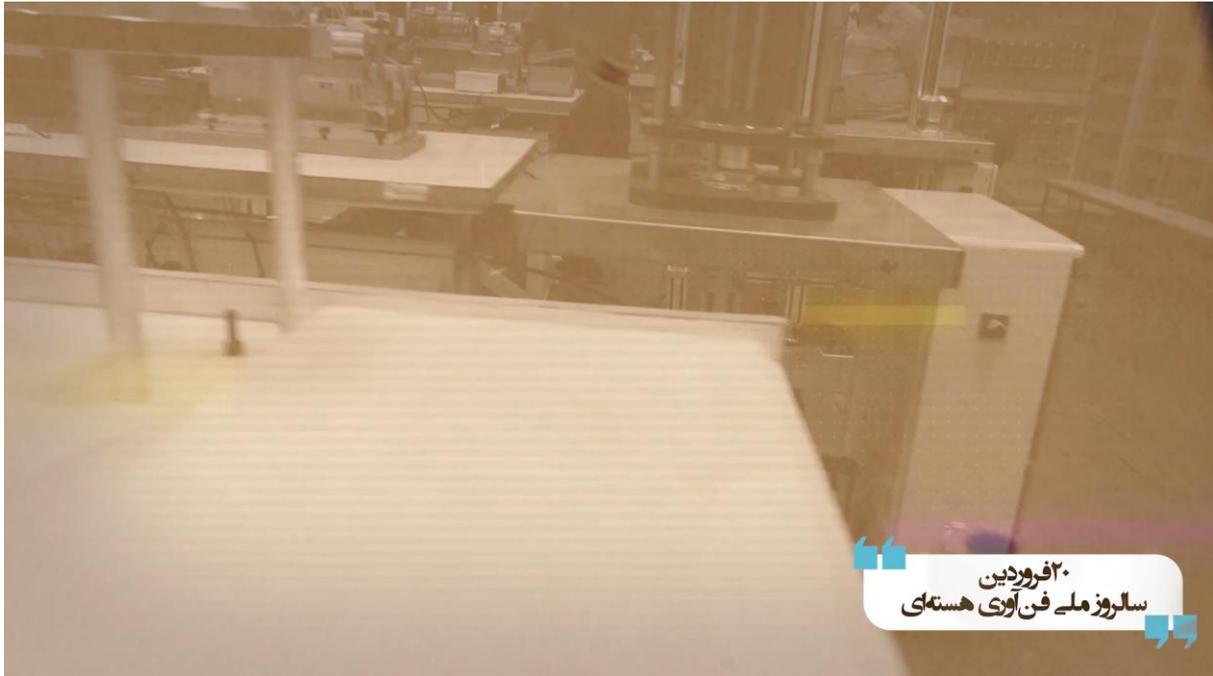
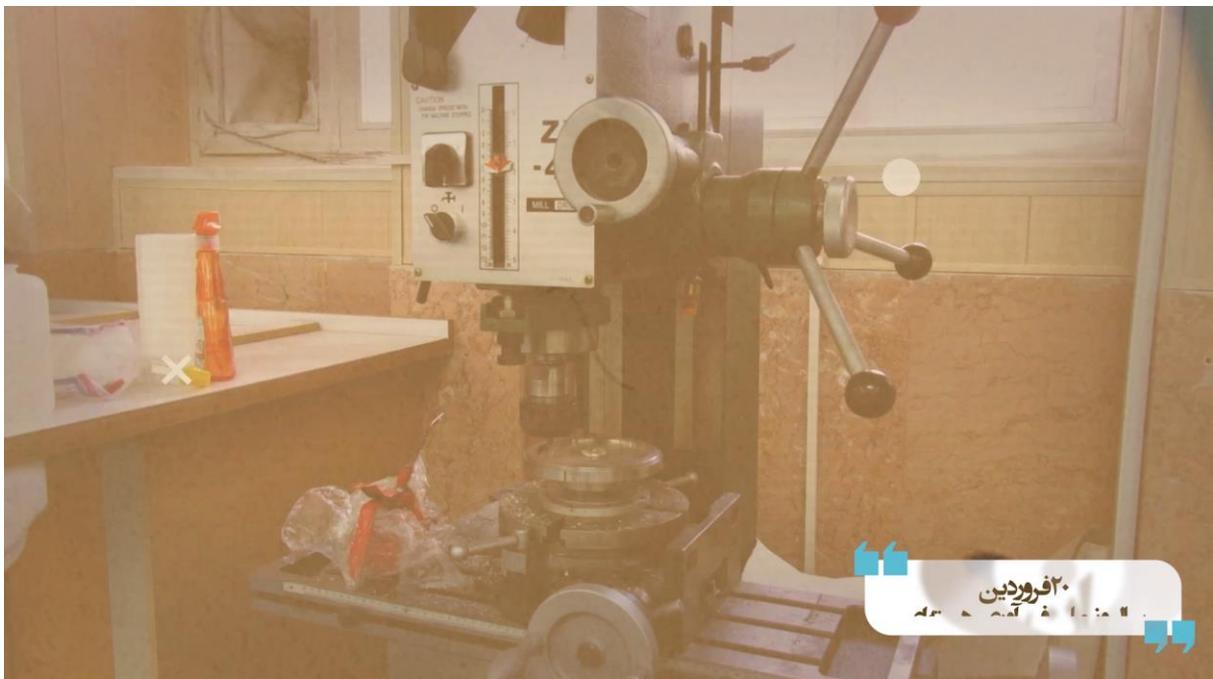
Figure 7. Top photo: A relatively crowded room showing equipment used in the assembly of the base flange, the motor housing and the bottom flange of the outer casing. Bottom photo: An old milling and drilling machine (also see right side of top image in figure 8); apparently, there is a need to drill holes and to remove some surplus metal during this subassembly operation.

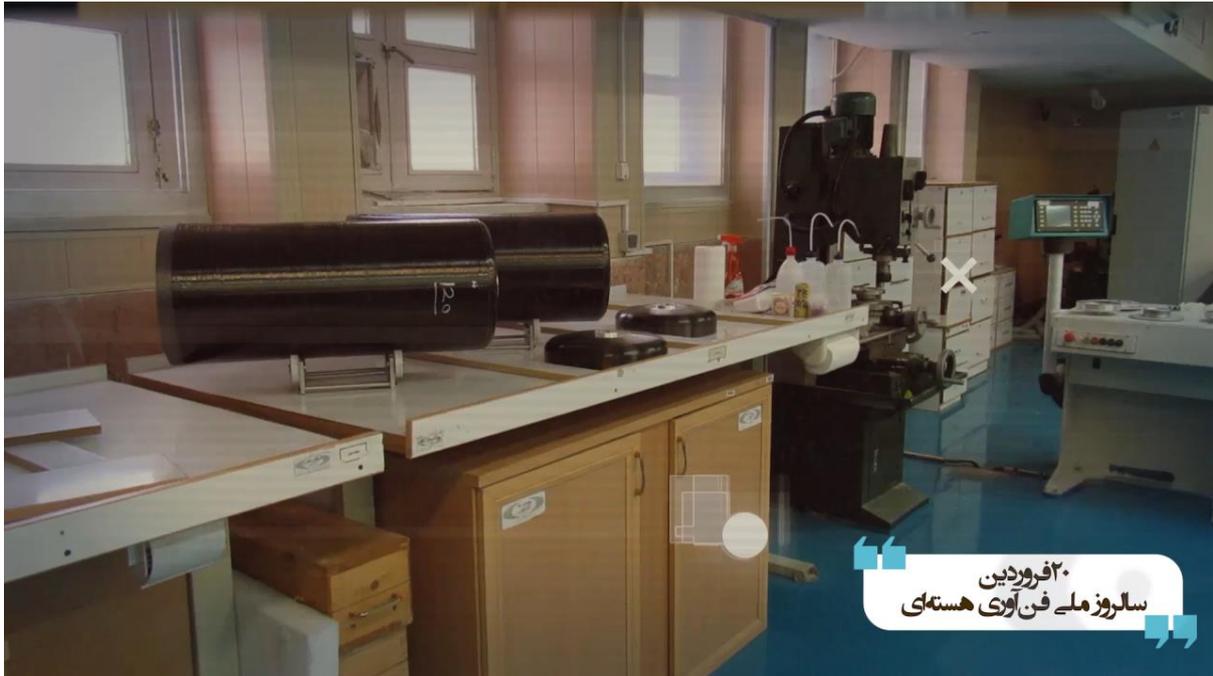
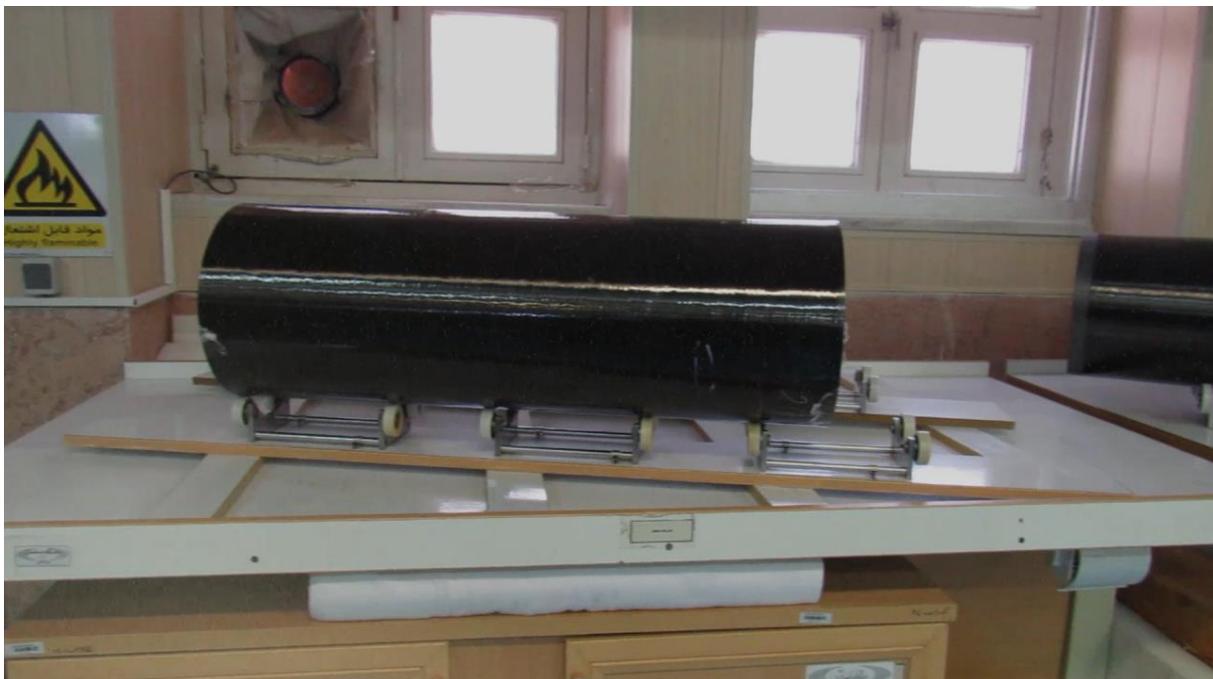
Figure 8. IR-6 rotor tubes on two adjacent work surfaces shown in consecutive freeze frames, panning from right to left. The top photo shows that the end of one rotor tube has been partly machined, likely for fitting purposes, and the other end holds a domed end cap (the machined end can also be seen in the partial rotor tube on the right side of the bottom image.) Accepting that the cylinder diameter is 200 millimeters then one can roughly measure the length from the photo as about 600 millimeters, as expected). Note that in the top image there are two domed top caps on the table awaiting to be fitted onto the cylinders. The caps appear to be made from carbon fiber and have a metal insert. The windows are consistent with being in a half-basement, such as found in the Natanz administration building (see text).

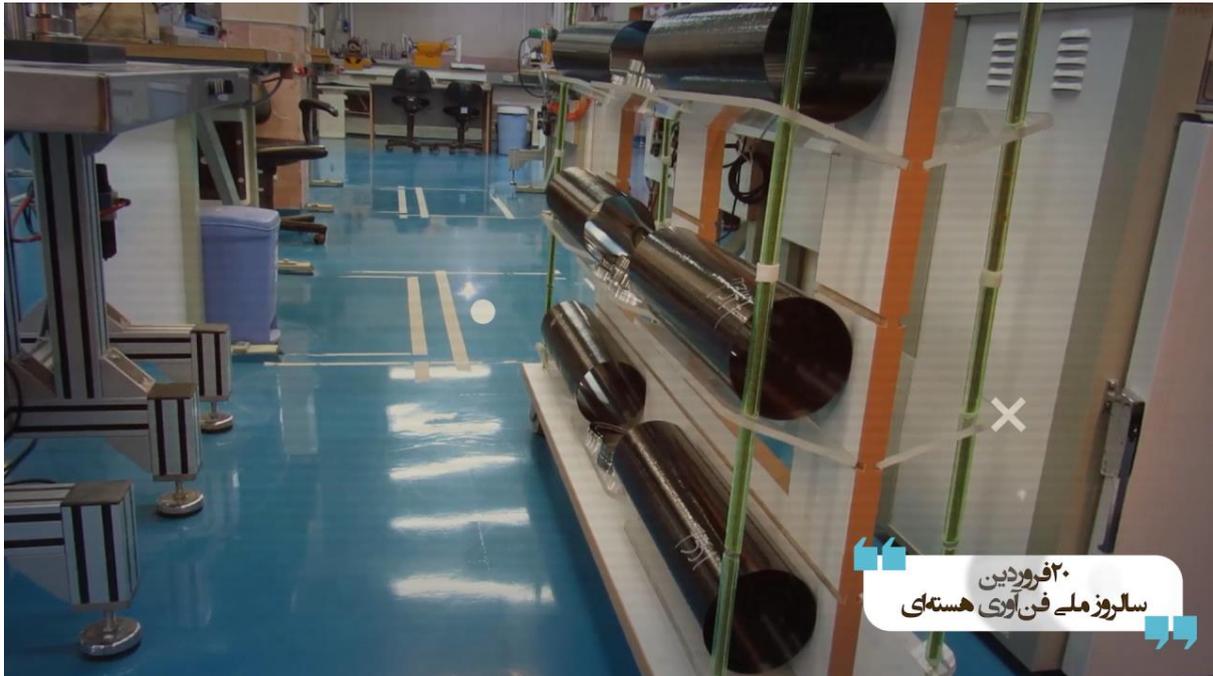
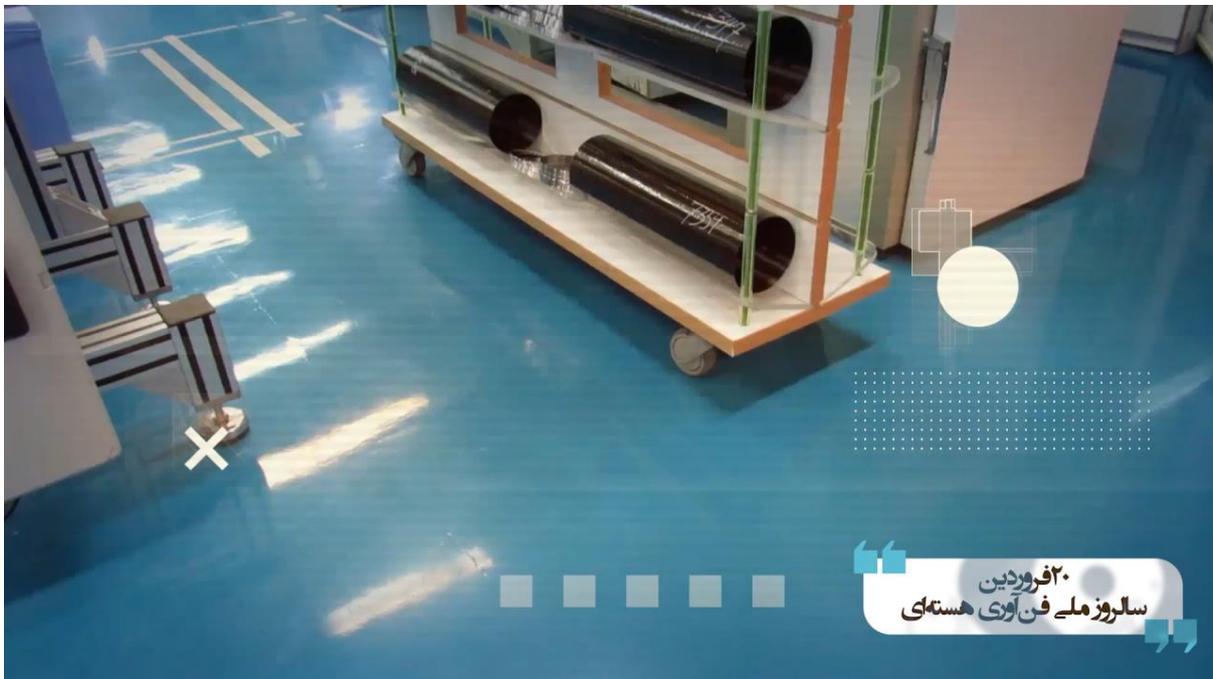
Figure 9. Photos showing how the cylinders are handled and moved around a subassembly shop.

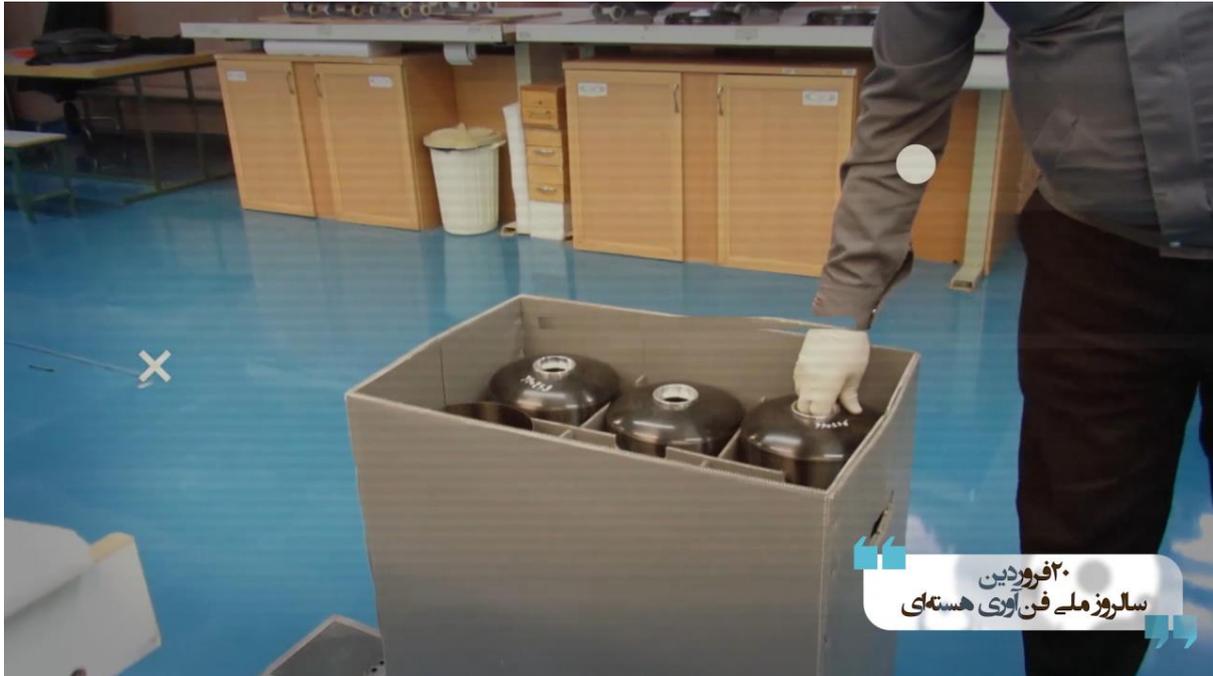
Figure 10. Visible is a carton box large enough for containing IR-6 rotor tubes and top caps. The top caps are domed with a flat section in the middle. Using the man's leg as a guide, the box appears to be about 800 millimeters in depth. Note that the end caps do not have rotating magnets installed at this point, although they look like they have a metal insert to hold the magnet. (The magnet holder, absent the magnet, may be used to hold the rotor vertically while checking its balance and straightness (see below.))

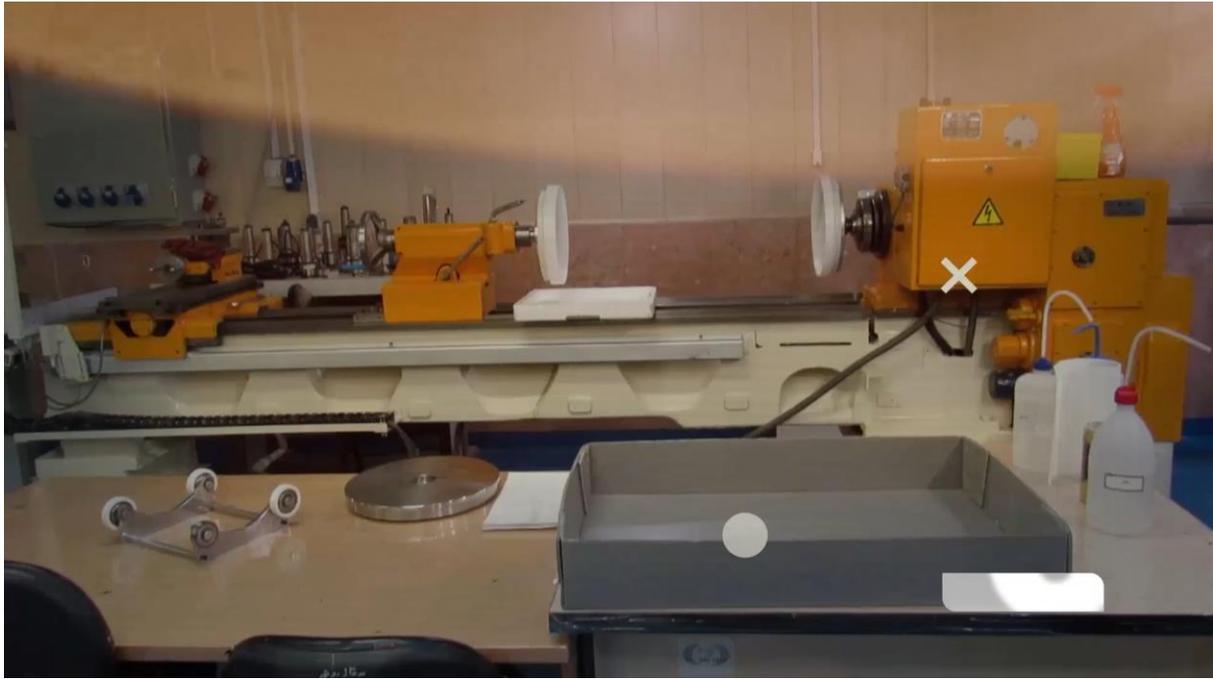
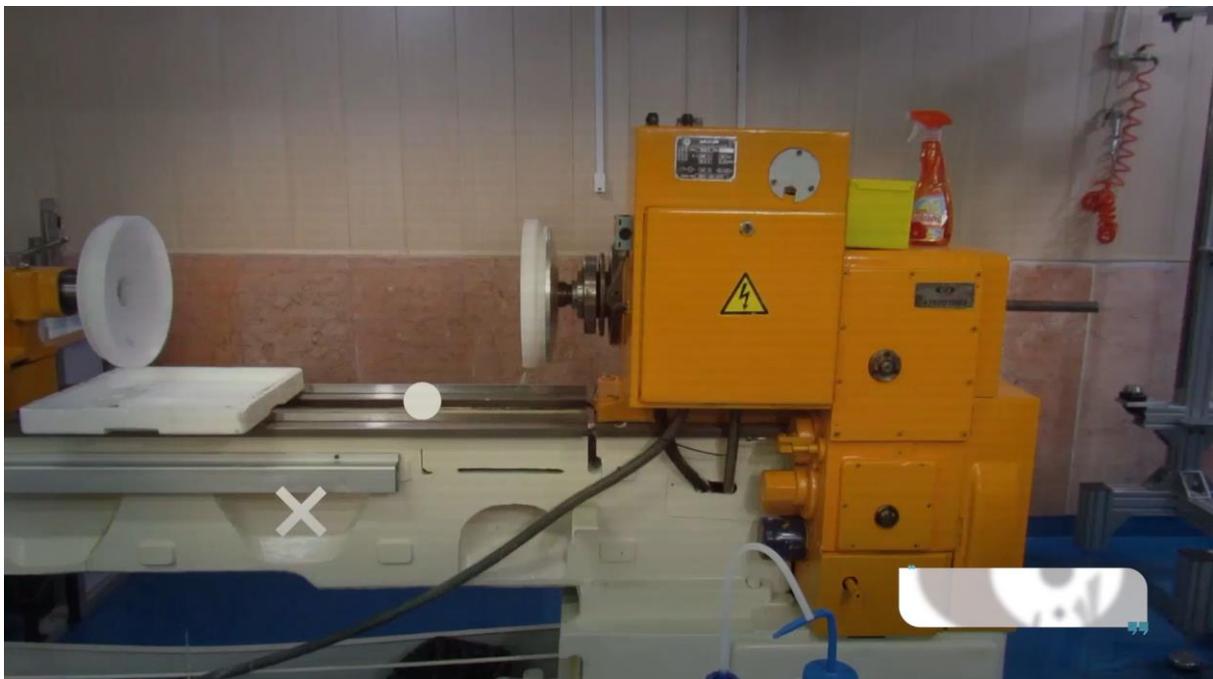
Figure 11. Measuring and balancing equipment used to quality check incoming rotor tubes and other components. It can hold a rotor tube horizontally to check its dimensions, such as length, diameter, ovality, and straightness, and also ensure it is balanced.

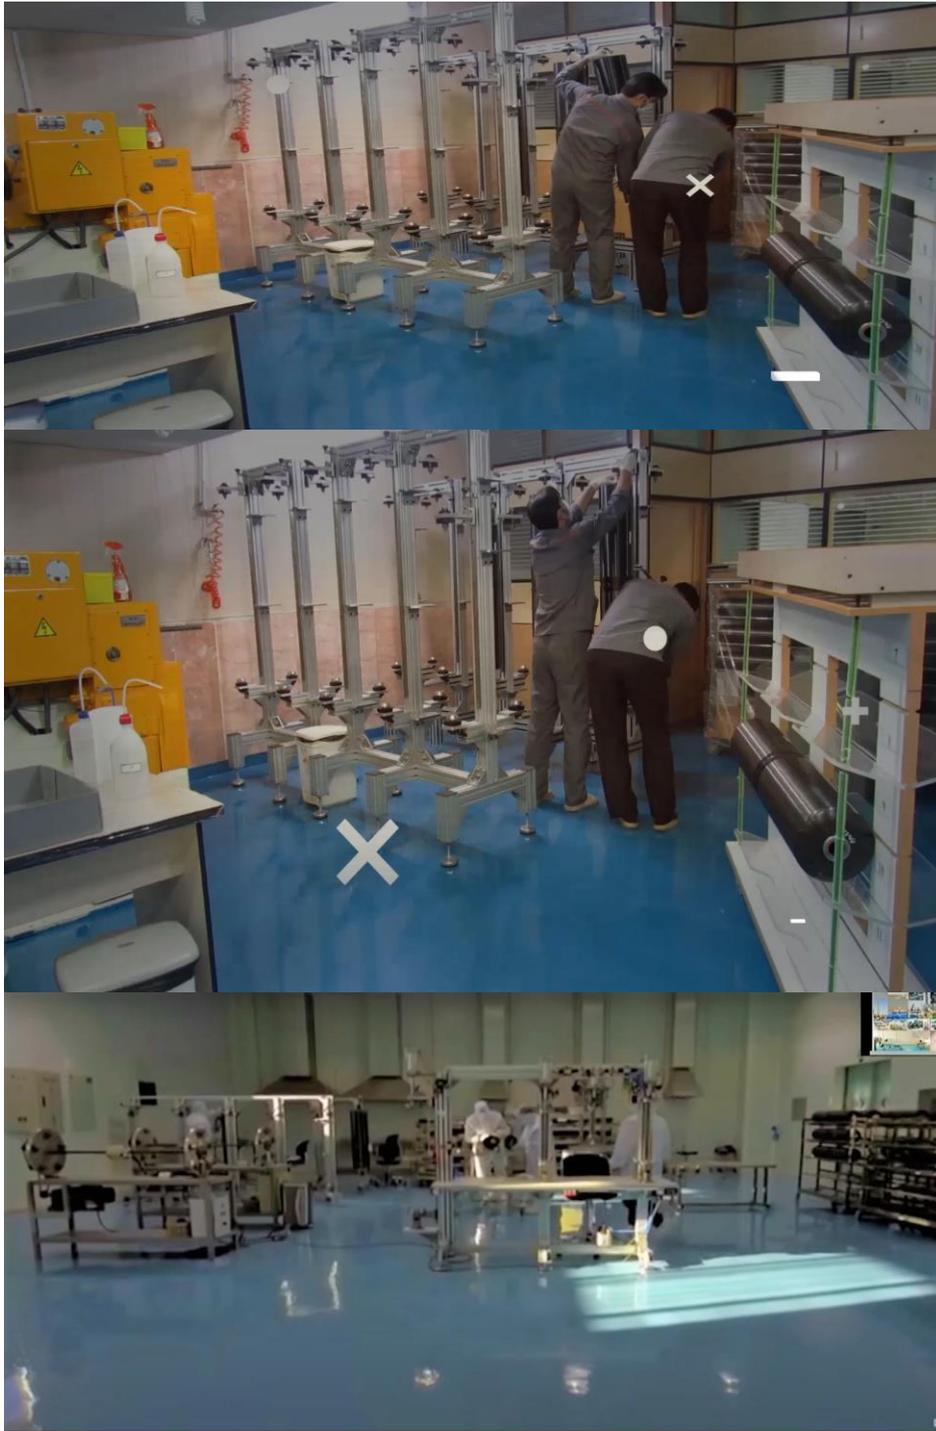
Figure 12. The top two photos show two workers loading an IR-6 assembled rotor vertically into a rotor straightening and balancing rig. Three or four rotor assemblies are visible in the photo. There are 20 rigs in total, some with different heights. The two personnel may be working with more than one rig at the same time. The workers must ensure that the rotor assembly is straight, which can be done by slowly rotating the assembly, while using probes and simple adjustments. For comparison, the bottom photo is of a similar, albeit far larger, room in the destroyed Iran Centrifuge Assembly Center, showing straightening and balancing equipment and rigs, racks of rotor tubes, and workers in protective, sanitary clothing. Such clothing is absent from personnel in the video, perhaps consistent with staged activities conducted for the video.

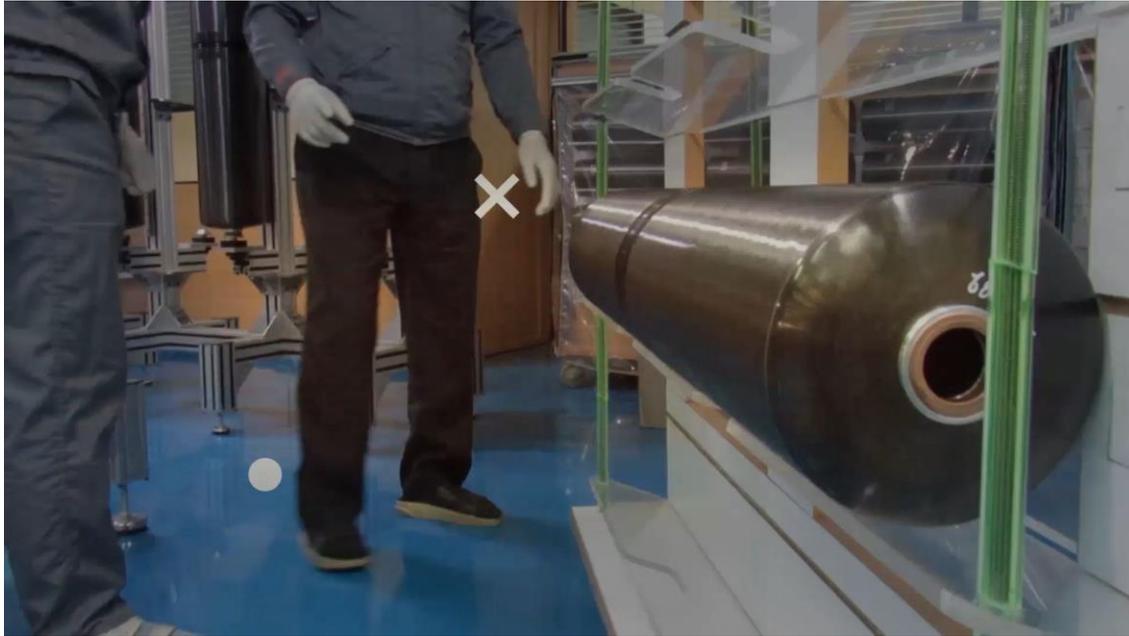
Figure 13. A close-up of an assembled IR-6 rotor assembly. Note that the rotating magnet, possibly made from cobalt samarium, is inserted into the metal insert of the top end cap. It is unclear if a bottom bearing pin and motor armature have been attached to the bottom of the rotor assembly. The bellows looks darker than those on the shelf made from metal, but the lighting complicates a determination of the bellows being made from carbon fiber instead of metal. However, perhaps these are carbon fiber strengthened metal bellows, e.g. overwrapped metal bellows, with the color of the carbon fiber overwrap.

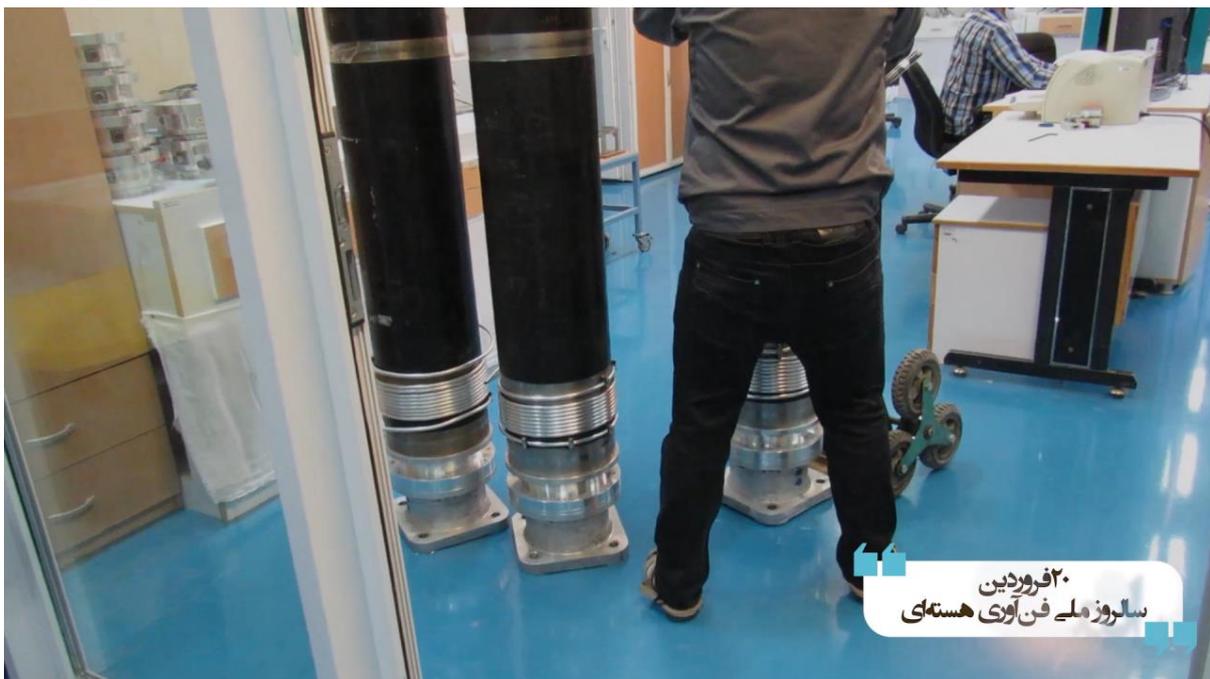
Figure 14. The image is a view of the bottom half of recipients and their base, showing the cooling water coils around the bottom of the recipient. The cooling is used to remove surplus heat from the rotor and to set up the temperature gradient along the rotor to stimulate the internal uranium hexafluoride gas flow. Stacks of motor housings may be visible in the left top of the top photo.

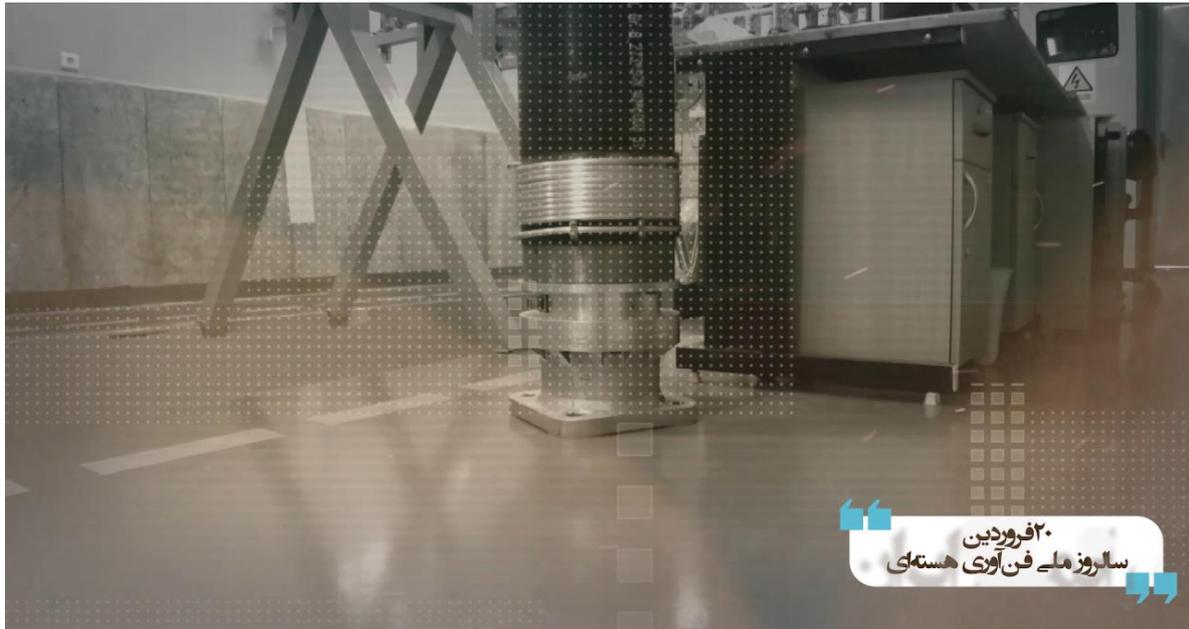
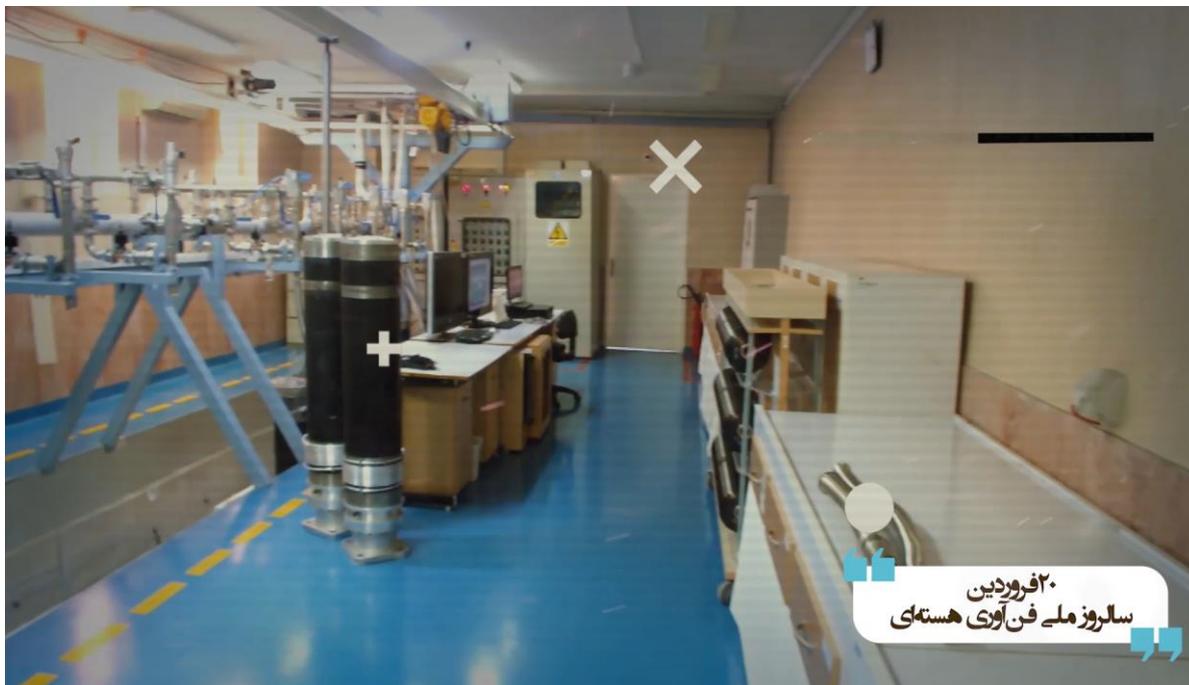
Figure 15. The video shows preparation for the installation of the centrifuge test stands in a testing pit. In the top photo, visible is the base flange of the centrifuge which will be bolted to the floor. The two IR-6 centrifuges in the bottom photo are awaiting lowering into the test pit, located to the left. Three rotor assemblies are visible along the right wall. The outer casings appear to be made of carbon steel rather than aluminum. Carbon steel casings have the advantage of being less expensive than aluminum ones, leading to frequent use in centrifuge programs, but carbon steel corrodes more easily, making aluminum preferable in Iranian enrichment plants.

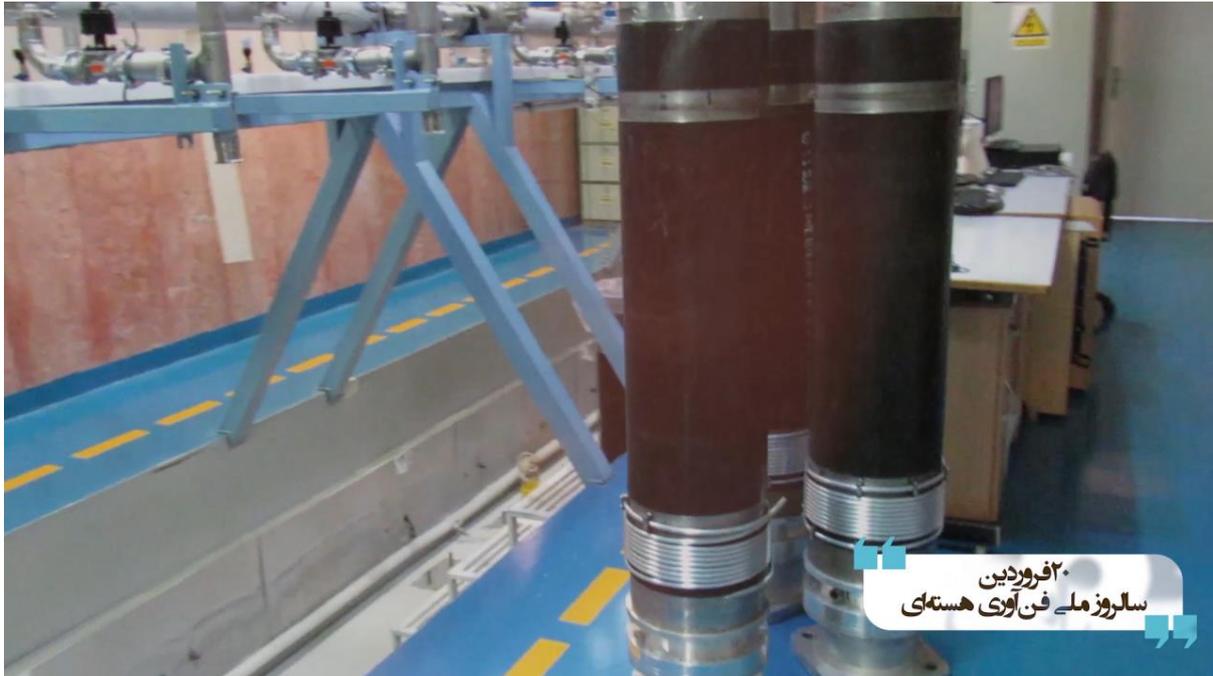
Figure 16. Three IR-6 test stands, with “case and base,” are awaiting to be lowered into a test pit.

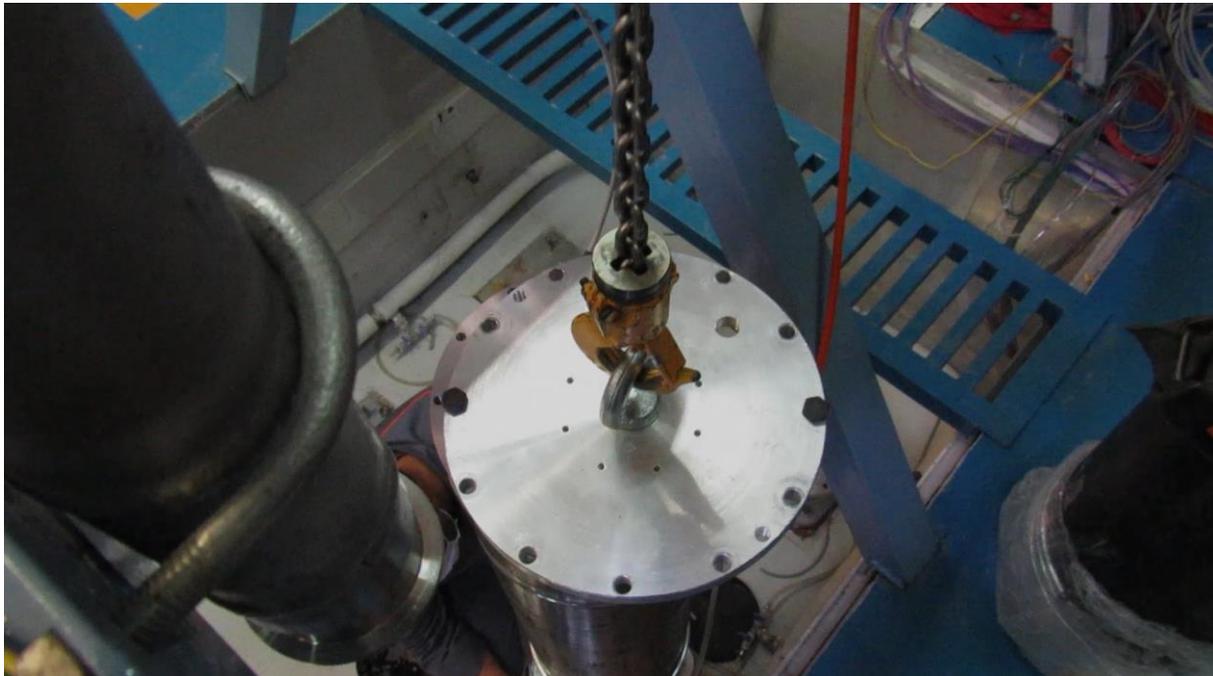
Figure 17. A close-up of the equipment used to lower the centrifuge test machines into the test pit.

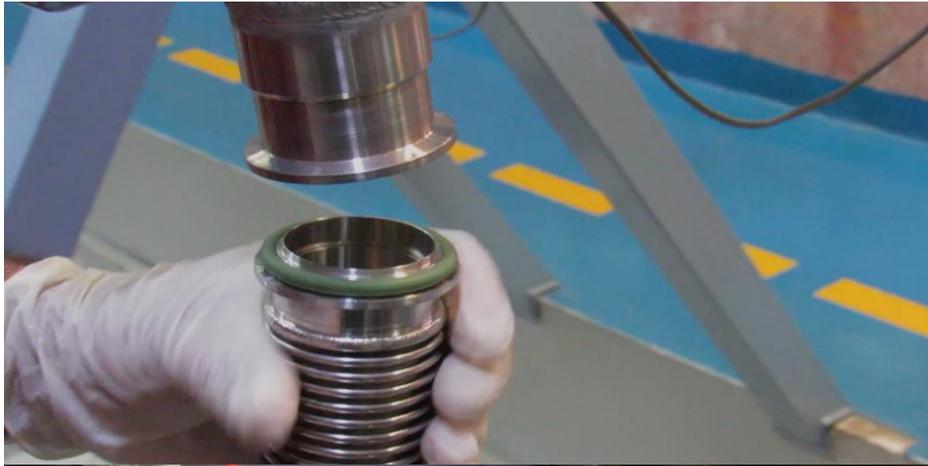
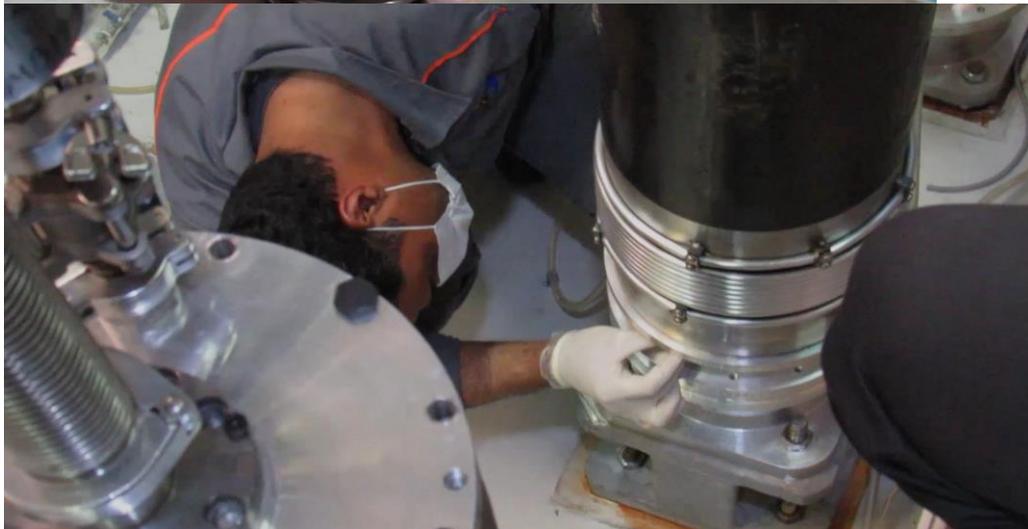
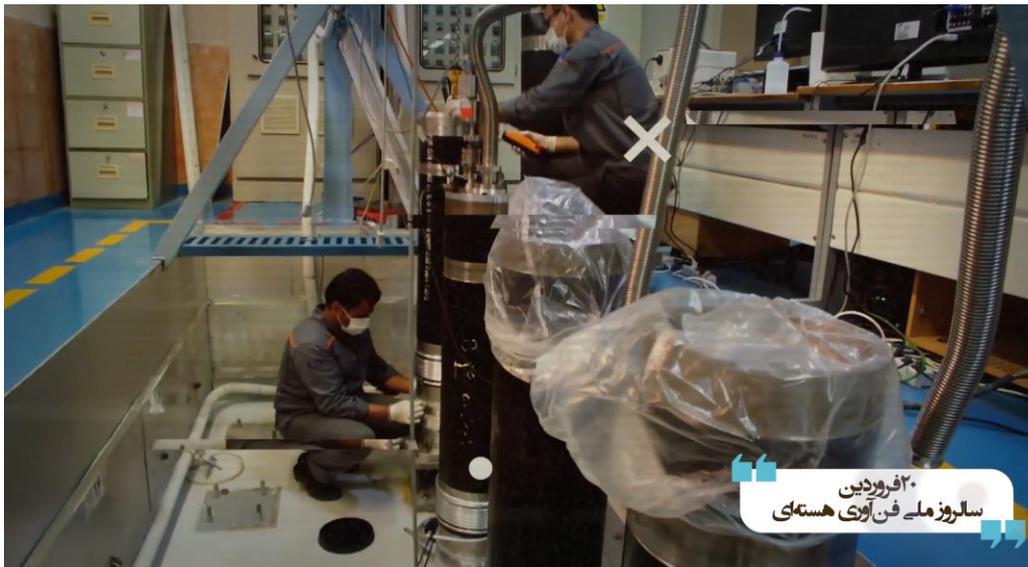
Figure 18. Installing the centrifuge case and base, including the outer casing, bearing housing, and motor drive housing, in a pit for mechanical testing or low speed spin tests related to quality control and assurance, likely for IR-6 centrifuges. The top photo shows the connection of the vacuum hose pipe to the top of the recipient, where a clamp is visible in a later image not included here. The middle and bottom photo shows the attachment of the motor drive unit to the bottom of the recipient.
