Video Walk-Through of Iran's New Interim Centrifuge Assembly Center

By David Albright and Sarah Burkhard

June 29, 2022 (Updated July 19, 2022, to remove a typo in the wall thickness of the IR-6 centrifuge.)

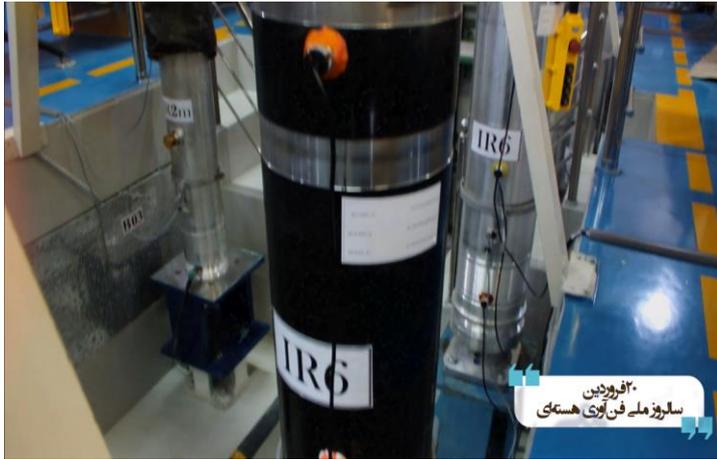
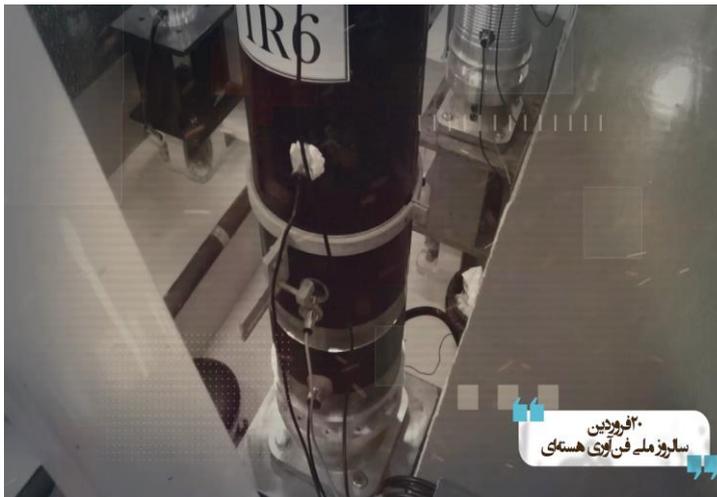
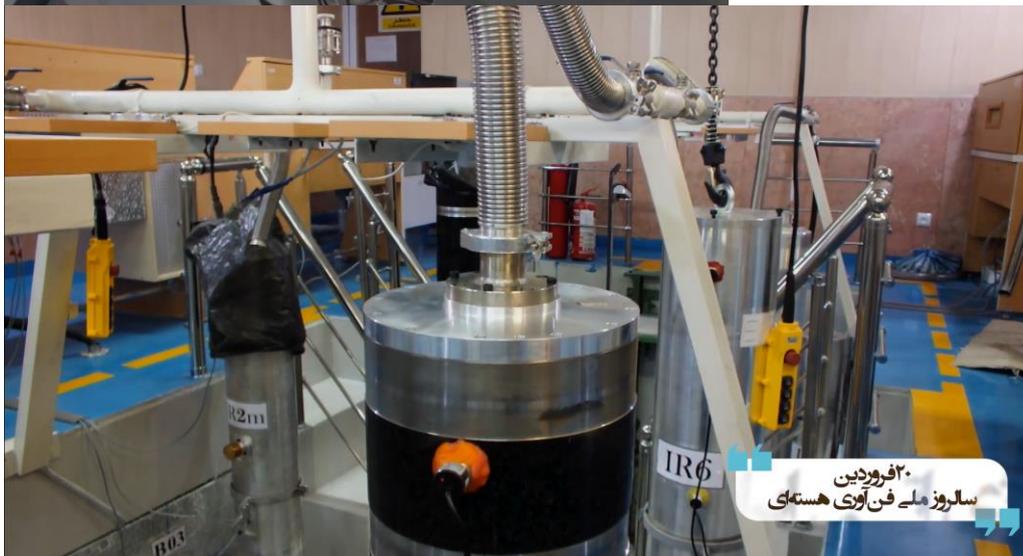
Figure 19. Top two images show close-ups of centrifuge test stands in a pit, labeled as the IR-6 centrifuge. Note that to the left of the IR-6 is an IR-2m machine test stand and to the right and slightly behind may be a version of an IR-6 machine with an aluminum outer casing rather than carbon steel. In the bottom photo, the IR-6 centrifuge is connected to vacuum piping and may be undergoing spin testing. The pit is marked B03, possibly related to location, and is not the same pit as in earlier images. In addition, the water coils appear to be missing. The labelling may reflect their use in other public videos released by the AEOL.

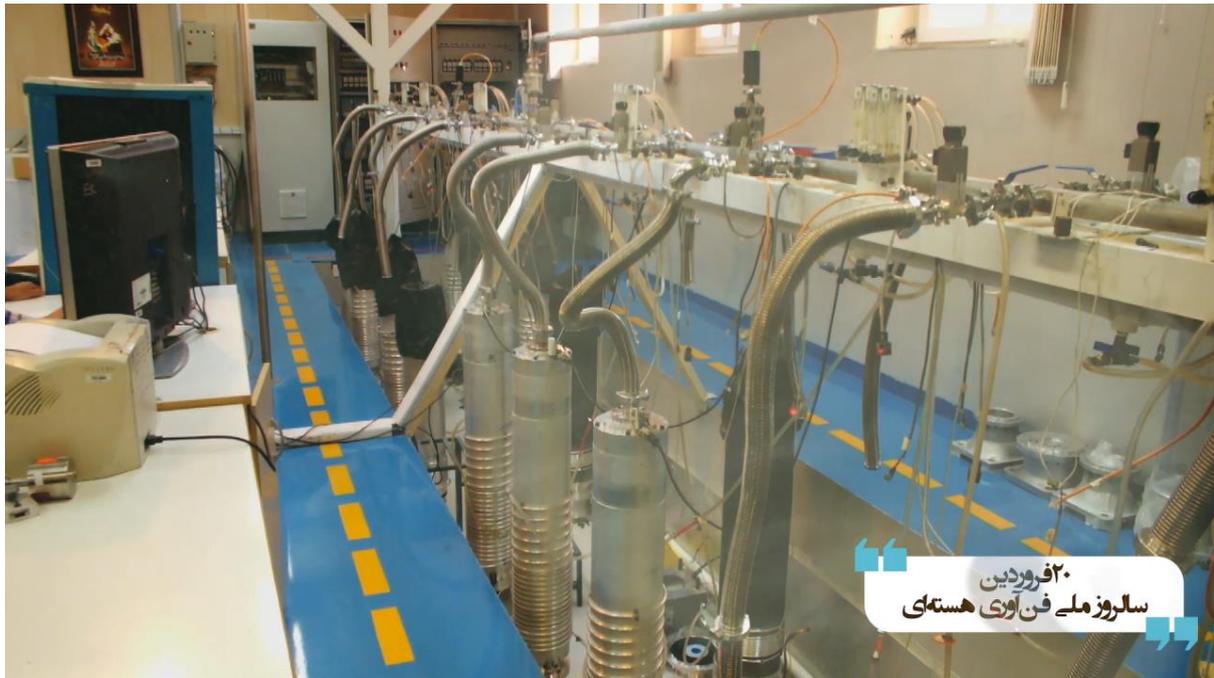
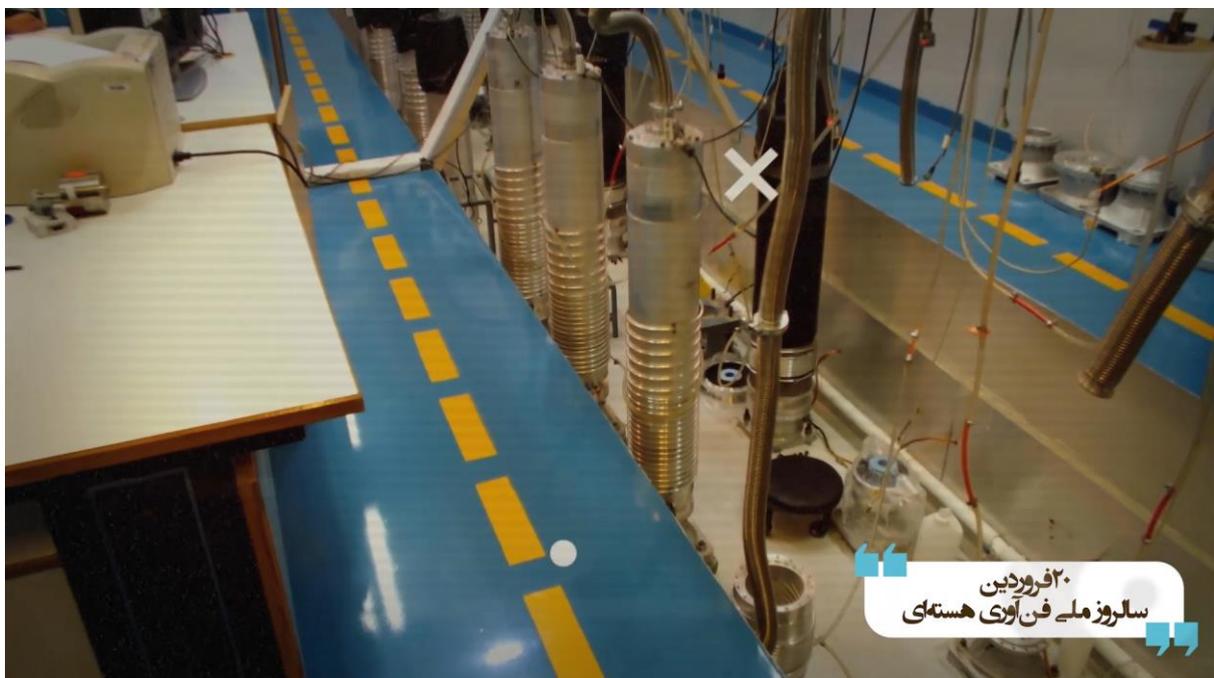
Figure 20. General views of advanced centrifuges in a pit, which looks different than the two discussed above. There are five or six IR-2m machines in the front row, all having metallic recipients and smaller in diameter. Several appear to be under vacuum and could be operating. Three others, with coverings, have the vacuum pipe unattached and may be on standby awaiting the insertion of new rotor assemblies. In the second row, visible is the possible installation and bolting of additional IR-6 centrifuge test stands. A motor housing with a motor inserted may be visible in the bottom photo on the bottom right. Stands of different diameters are visible in the lower right of the top photo and upper right of the bottom photo. Hand-operated vacuum valves are visible in the top image. The top photo has at least five sets of measuring or regulating devices, possibly for the water in the cooling cables.

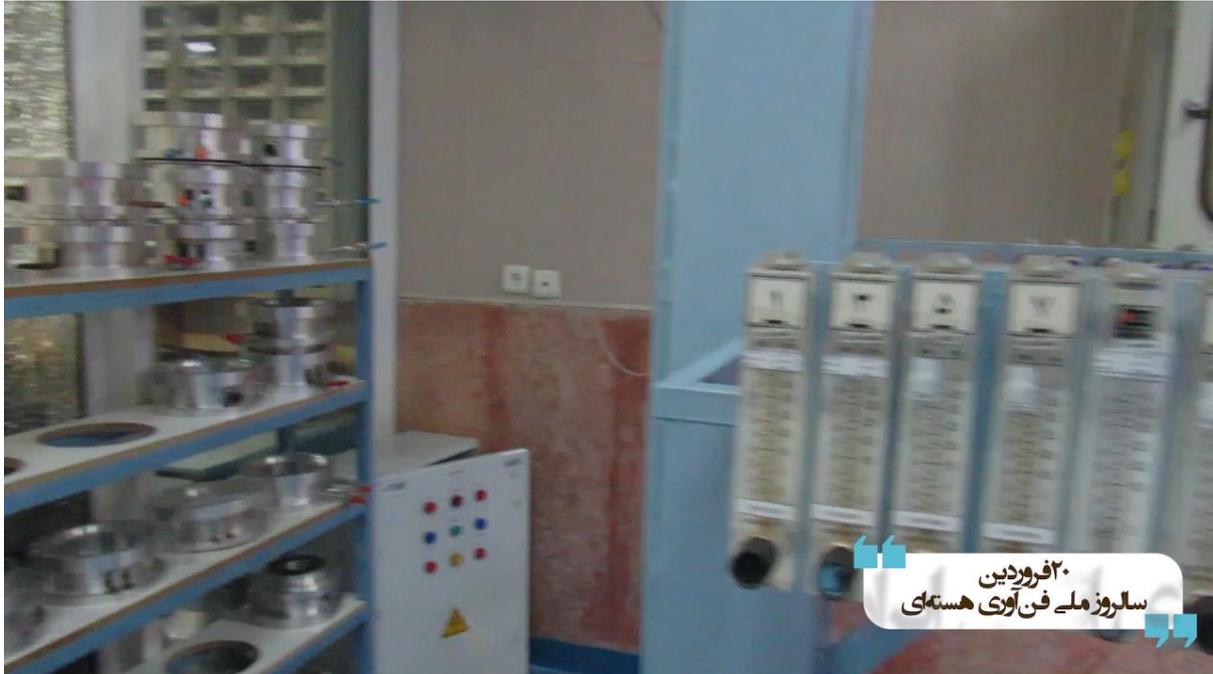
Figure 21. Visible are a number of components and subassemblies in the racks on the shelf. They may be motor housings, some with motors inserted. A pit may be visible behind the five monitoring or regulating devices

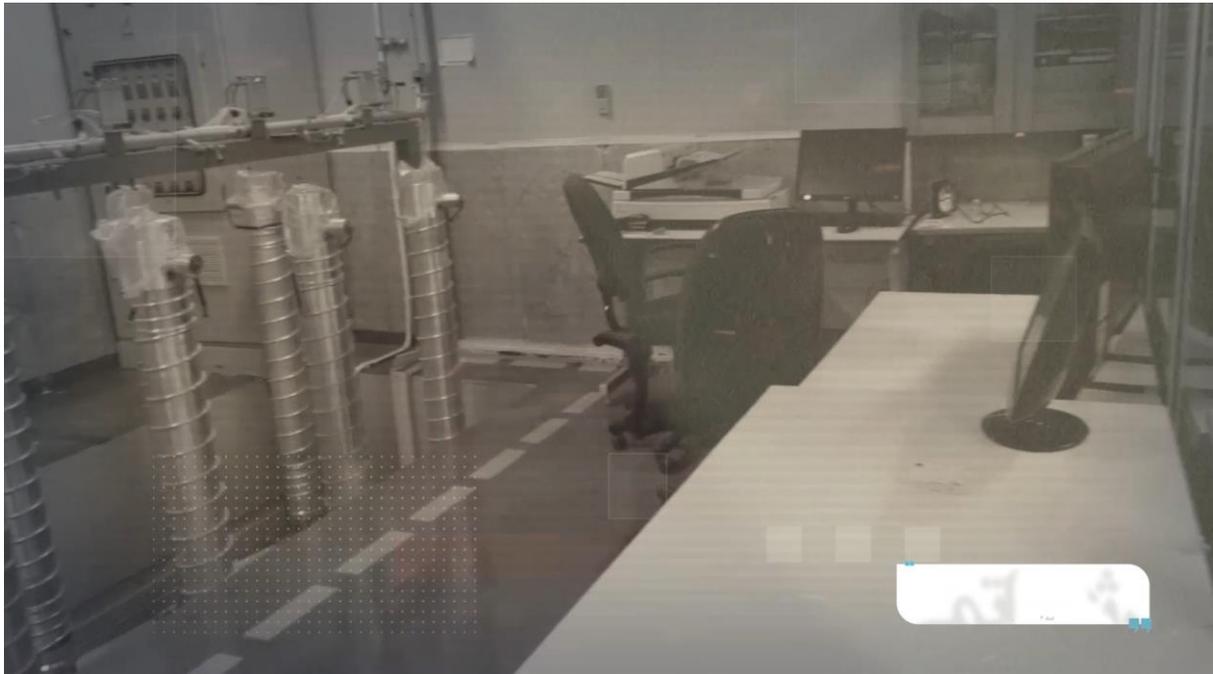
Figure 22. Based on their diameters and cooling cables, the centrifuge stands in the pit look to hold IR-1 centrifuge rotor assemblies. This pit may be a different one from the other three in earlier photos. For example, the overhead beam looks different from the others, and only one dotted warning line is visible. The test stands look to be on standby, consistent with the video's narration.
