North Korea Continues Expanding Its Reactor Capability for Making Plutonium for Nuclear Weapons

By David Albright and Sarah Burkhard

April 5, 2018

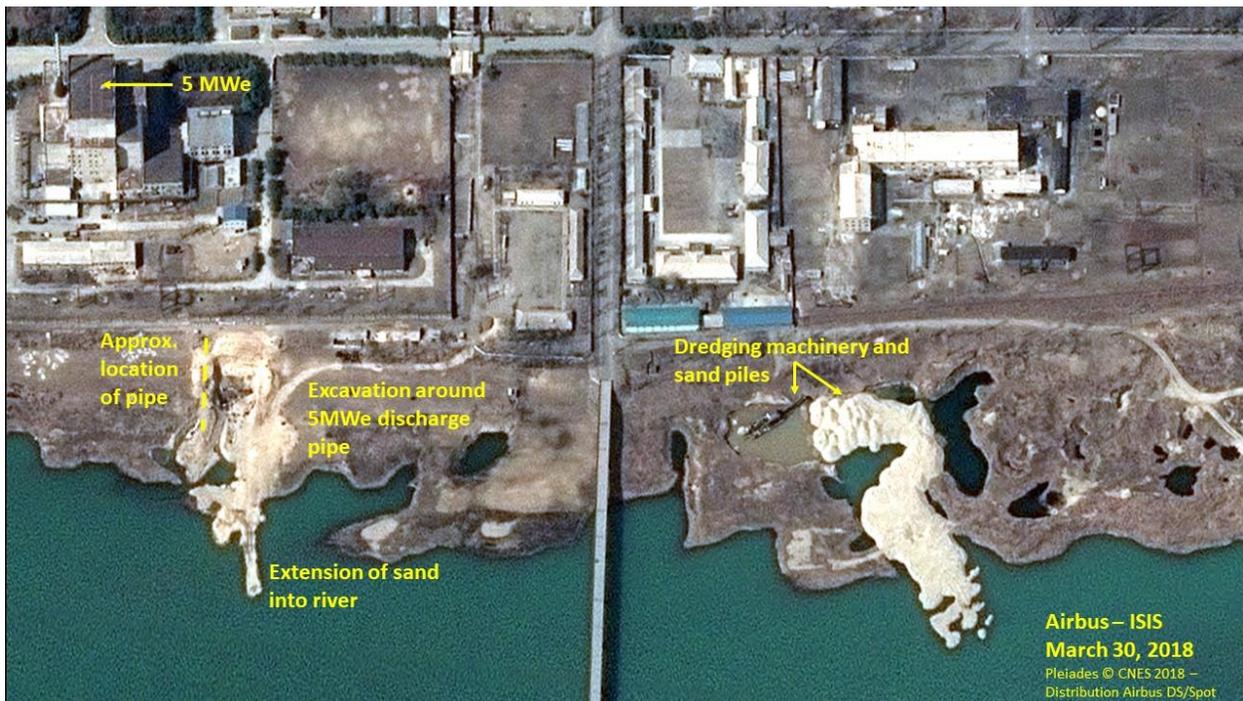
Figure 1. The piping system of the secondary cooling system of the 5-MWe reactor at the Yongbyon nuclear site may be undergoing or have undergone modification, possibly the extension of the discharge pipe into the river.

The water discharge portion of the 5 MWe reactor's secondary cooling system may be undergoing modification (see figure 1). Near the water discharge pipe, activity is visible, including the apparent dredging and movement of sand. A small sandbank now extends well into the river. That sandbank was not visible in January 2018 imagery or in earlier imagery.

However, there is no visible indication of water piping extending into the river, which could imply it is already in place, as suggested by *38North* in a March report.¹

It is unclear if the reactor is operating from the visible evidence. It could be operating at low power or operating at higher power and discharging water into the river through a newly installed pipe that is no longer visible in commercial satellite imagery.

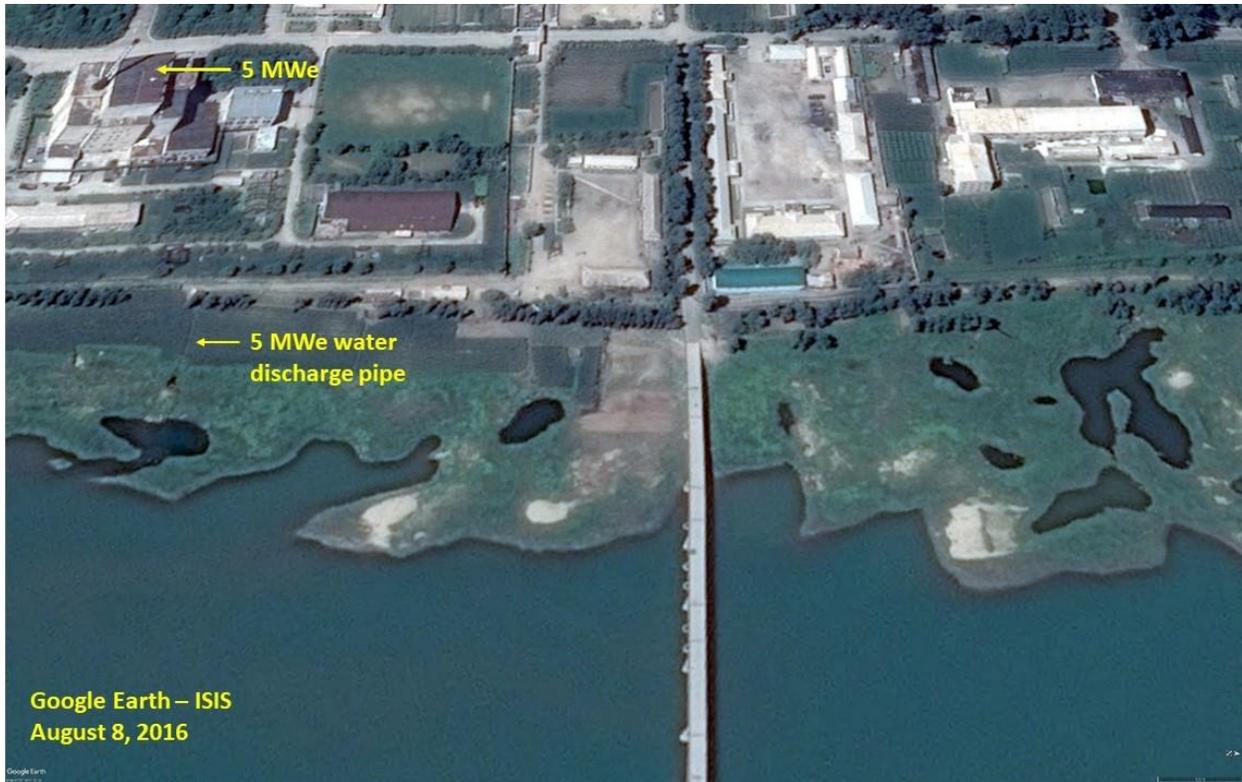
Figure 2. The riverbank and the water discharge pipe in 2016.

Additional excavation and dredging activities are also occurring further upstream of the river, indicating that North Korea is maintaining its efforts to control the flow of the river. Figure 2, which is a 2016 Google Earth image, shows what the riverbank used to look like.

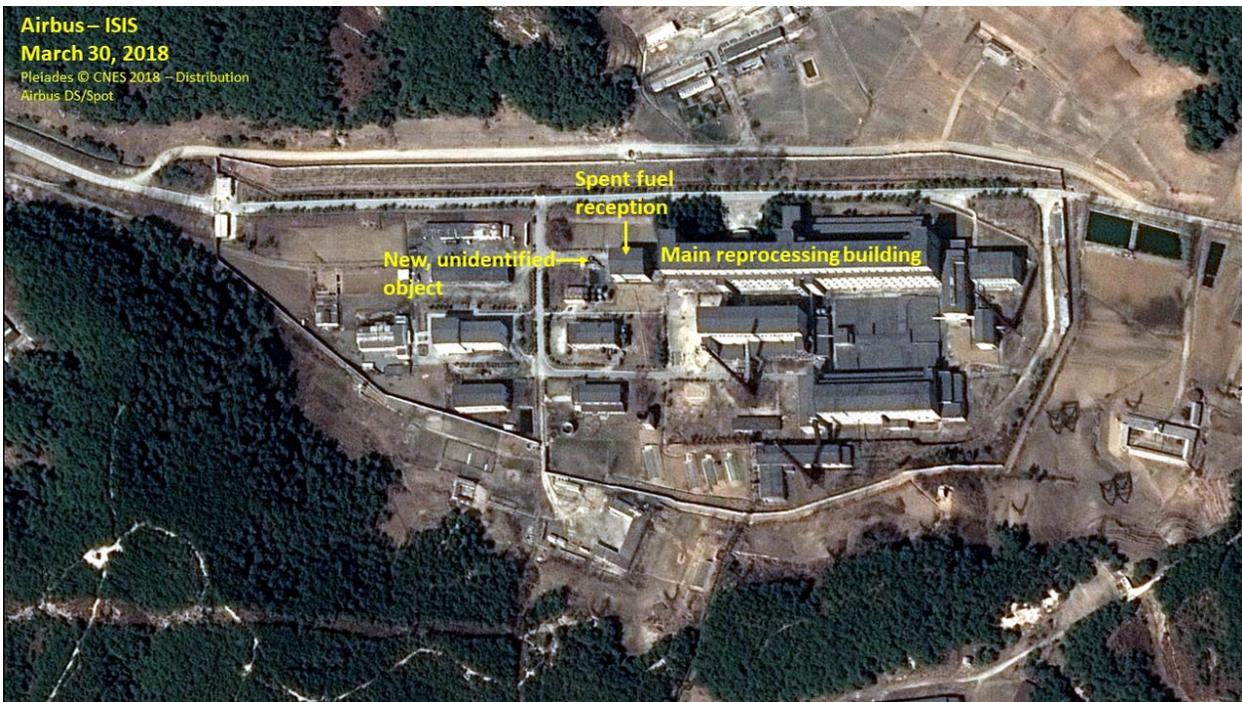
Figure 3. The Radiochemical Laboratory shows no major visible signs of activity.

In recent months, there has been no indication of reprocessing visible at the Radiochemical Laboratory or nearby coal-fired thermal plant that produces steam for the reprocessing plant. The most recent imagery also shows no visible tell-tale activity (see figures 3 and 4). However, North Korea has demonstrated in the past that it can avoid producing visible and other signatures when it is chemically dissolving the irradiated fuel and separating the plutonium. Typically, reprocessing is accompanied by the production of steam at the coal plant, but this steam is needed more for waste reduction activities following the plutonium separation work. It should be noted that any separation of plutonium would be controversial at this point in time and North Korea should be encouraged not to reprocess any spent fuel.

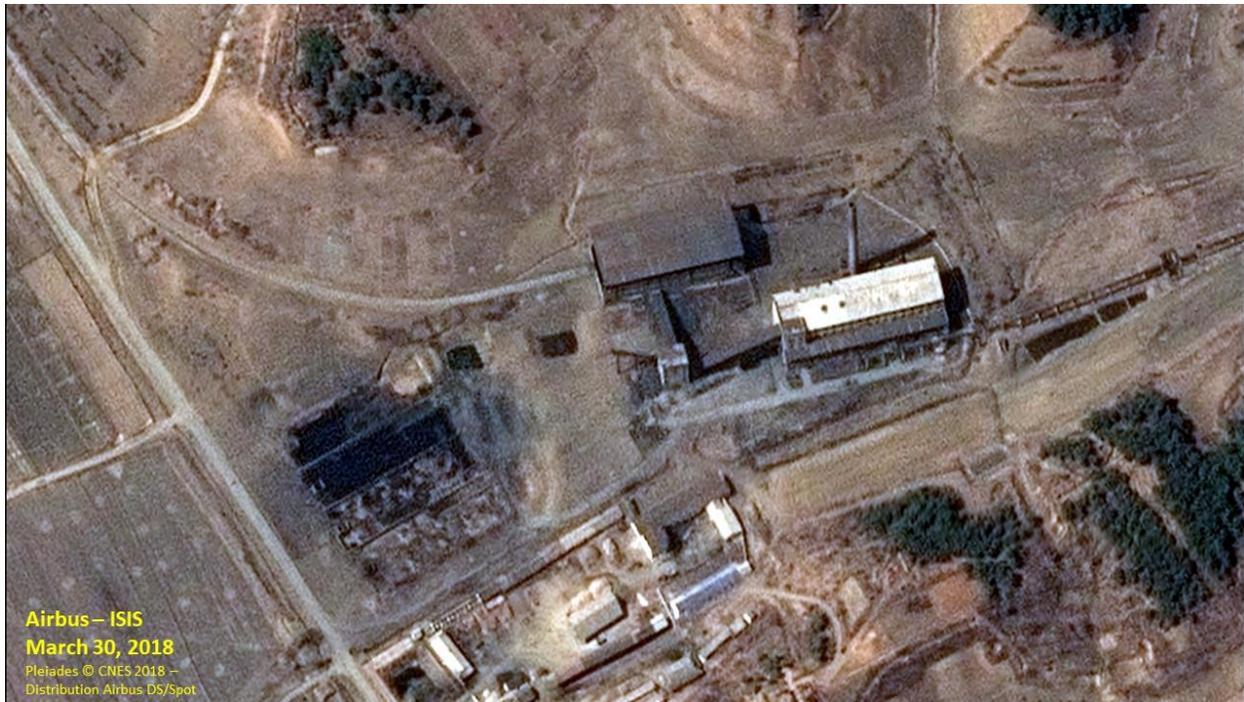
Figure 4. The coal-fired steam generation plant shows no visible signs of activity.

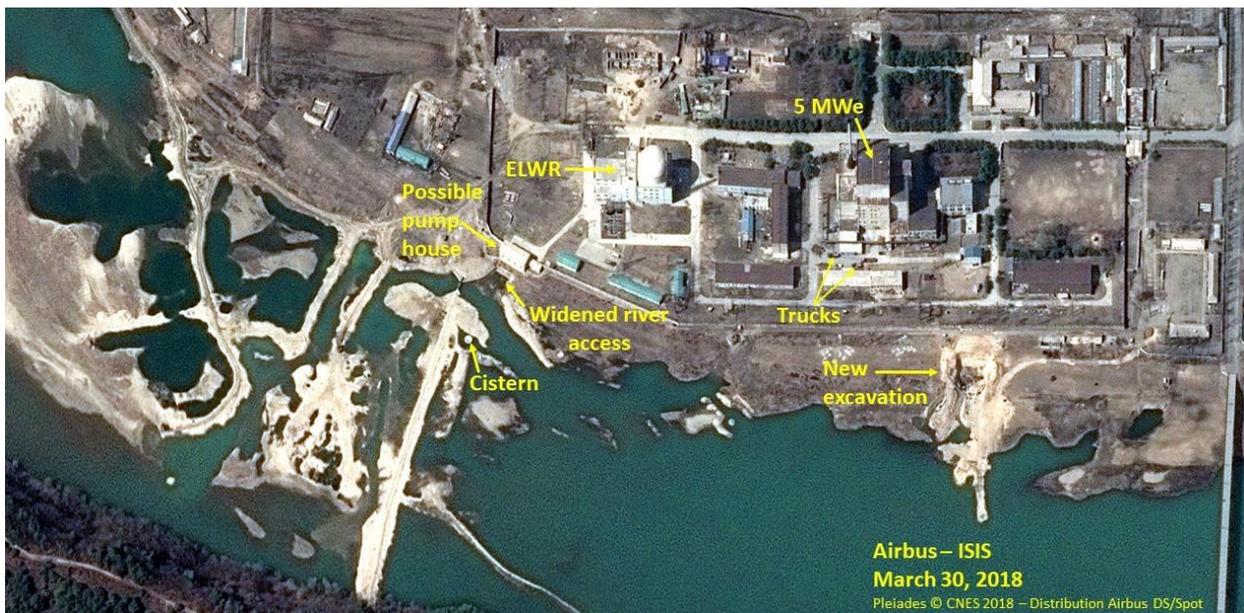
Figure 5. Widened water access below the probable pump house may serve to facilitate water intake or outflow for the reactor. The water in the immediate area is noticeably discolored, possibly indicating water movement or flow, the direction of which cannot be determined.

Based on assessing commercial satellite imagery from March 30, 2018, near a small building adjacent to the river, which may be a pump house, access to the river seems to have been cleared and widened (figure 5). That this building is a pump house is supported by imagery from October 2012, which shows that a trench, possibly for pipes, was dug from this building to the reactor (see figure 6).

The broadened river access supports that this is a water intake or outflow point for the reactor and is part of the secondary cooling system of the reactor. Water discoloration visible in figure 5 may show that water is being pumped to the reactor via the pump house or is flowing into the river after exiting the reactor's secondary cooling system, which could mean the reactor is already operating or the cooling system is currently being tested.

However, some have suggested that the cistern labeled in figure 5 is the water intake point of the reactor.⁵ In that case, the pump house could still facilitate water intake from the cistern for the reactor. More information on the ELWR secondary cooling system is needed.

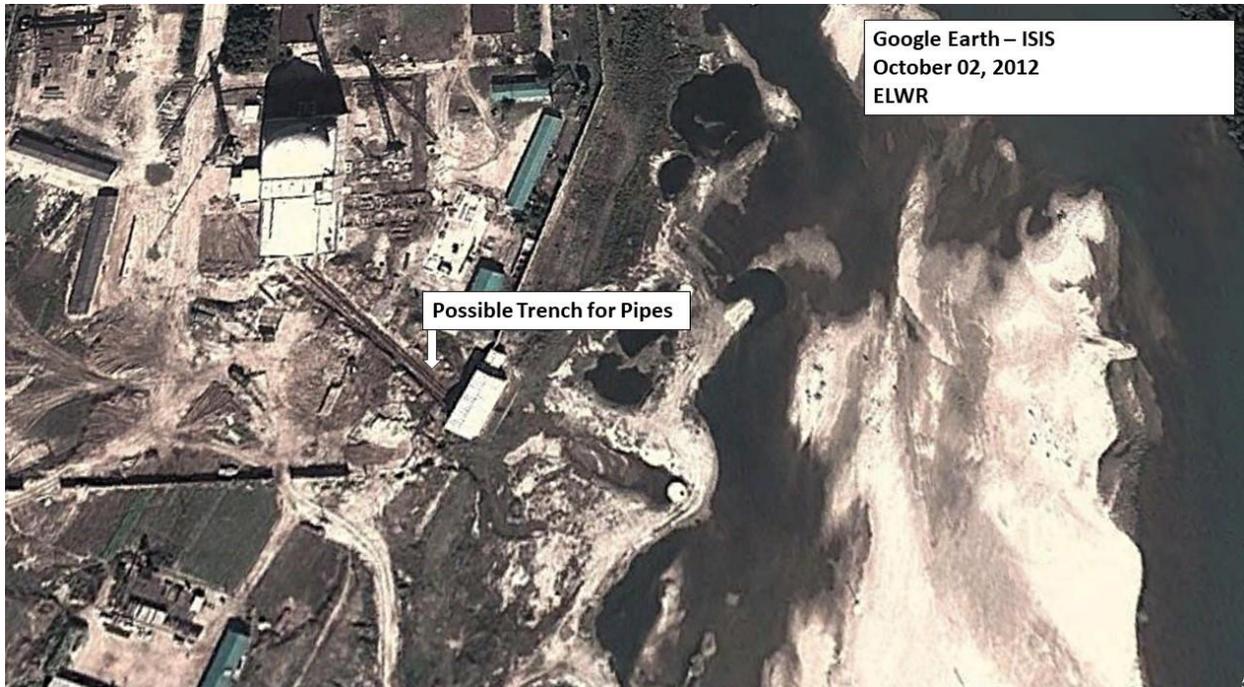
Figure 6. Possible pipe work in 2012 is one of the main indicators that the building by the river is a pump house or otherwise part of the ELWR's secondary cooling system.

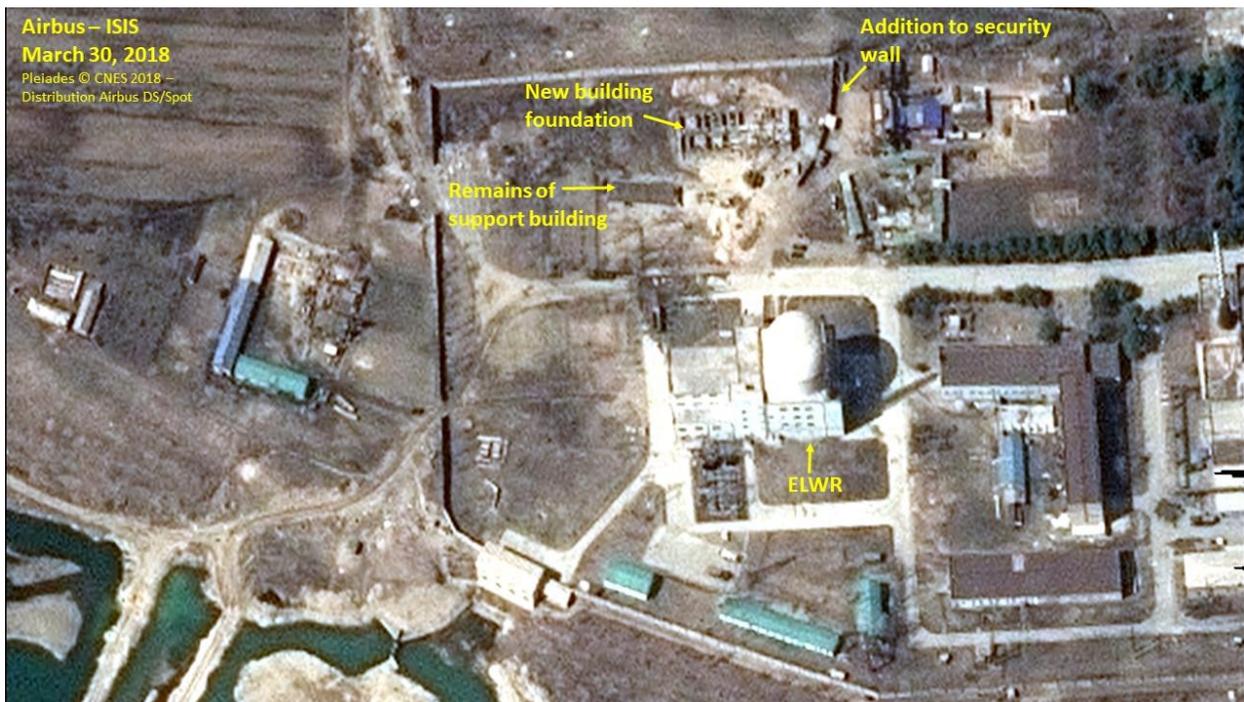
Figure 7. Construction of a new building is taking place near the ELWR. However, it is unlikely that the building is critical for reactor operation or an indication of when the reactor may commence operation.

At the end of March, there was new construction visible adjacent to the reactor's entrance within the security perimeter (see figure 7). Half of an original support building was taken down, and a new building foundation is now visible as first reported by *38North* on March 30, 2018.⁶ It should be noted that a similar original support building in the same vicinity was taken down between 2015 and 2016 (see figure 8).

Based on looking at the internal structure of the building, it is difficult to determine the new building's purpose, but its apparent internal structure suggests it is likely unrelated to any activity critical to starting the reactor. Moreover, the structure of the building appears unrelated to nuclear waste storage. In any case, such buildings are likely not needed until after startup and could be finished in parallel to commencement of reactor operation. Thus, reactor operation is likely independent of the construction of this building and reactor operation could have commenced or could soon commence before construction of this building is completed.

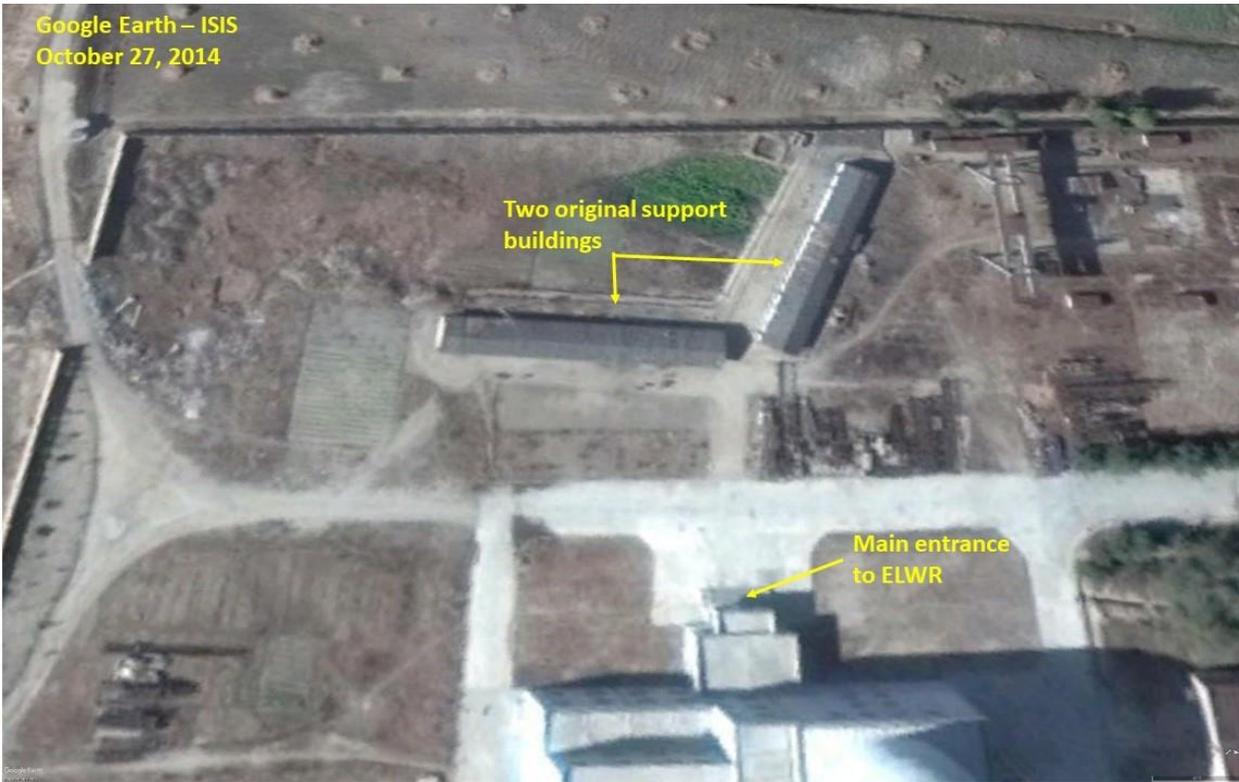
Figure 8. Two support buildings used to be located where construction of a new building is currently taking place.
